**No.11 Rosslyn Hill, Hampstead  
Basement Impact Assessment**

**March 2015**

### **Basement Impact Assessment**

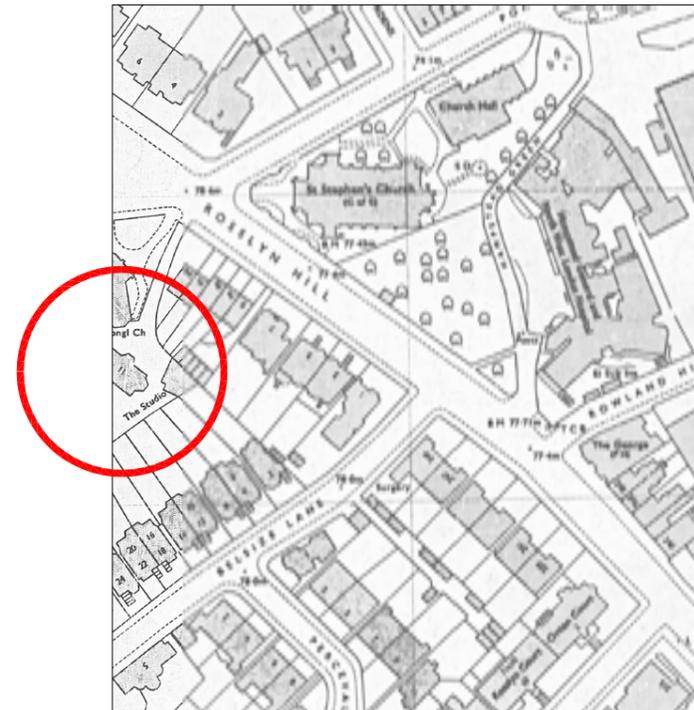
1974-2015

IN THE 1960's A ROW GARAGES WERE BUILT DIRECTLY ADJACENT TO THE EAST BOUNDARY, REPLACING ONE OF THE VICTORIAN TOWNHOUSES ON HAVERSTOCK HILL. AT A SIMILAR TIME THE SINGLE STOREY STUDIO BUILDING AND THE TIMBER SHED WERE CONSTRUCTED. THE SITE AND THE ADJACENT PROPERTIES HAVE REMAINED MATERIALLY UNCHANGED SINCE THE 1970's.
