WeWork - 3 Waterhouse Square, 138 - 142 Holborn, London, EC1N 2SW

30 November 2015

Design and Access

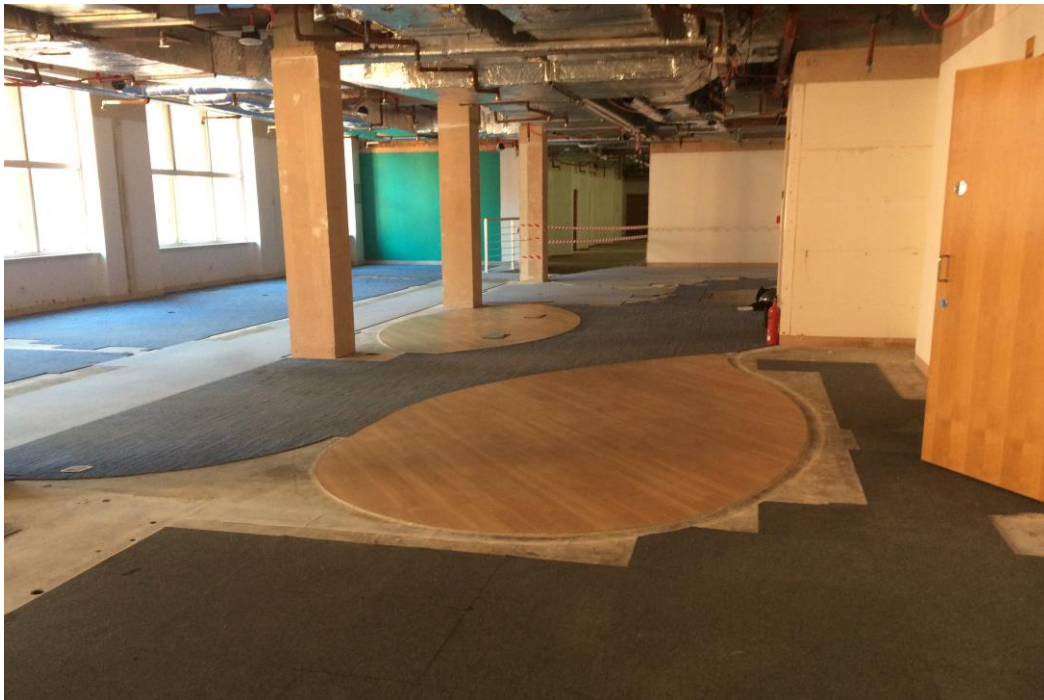
View of existing entrance space in the East Wing.

- 1.0 The creation of a new reception, lounge, pantry and meeting rooms. New timber and tile floor coverings, painted walls, wallpaper coverings, light fittings and exposed mechanical and electrical services. Existing cornicing made good. Plaster ceilings made good and painted where required. Exposed brickwork and wall tiles to retain and any plasterboard edges made good. See below photo for current interior condition.

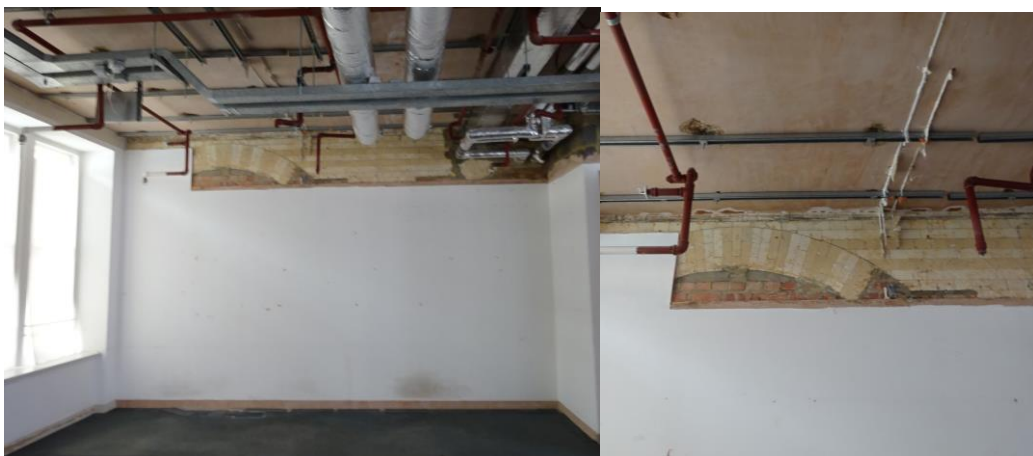
Example of existing exposed building features to be retained.

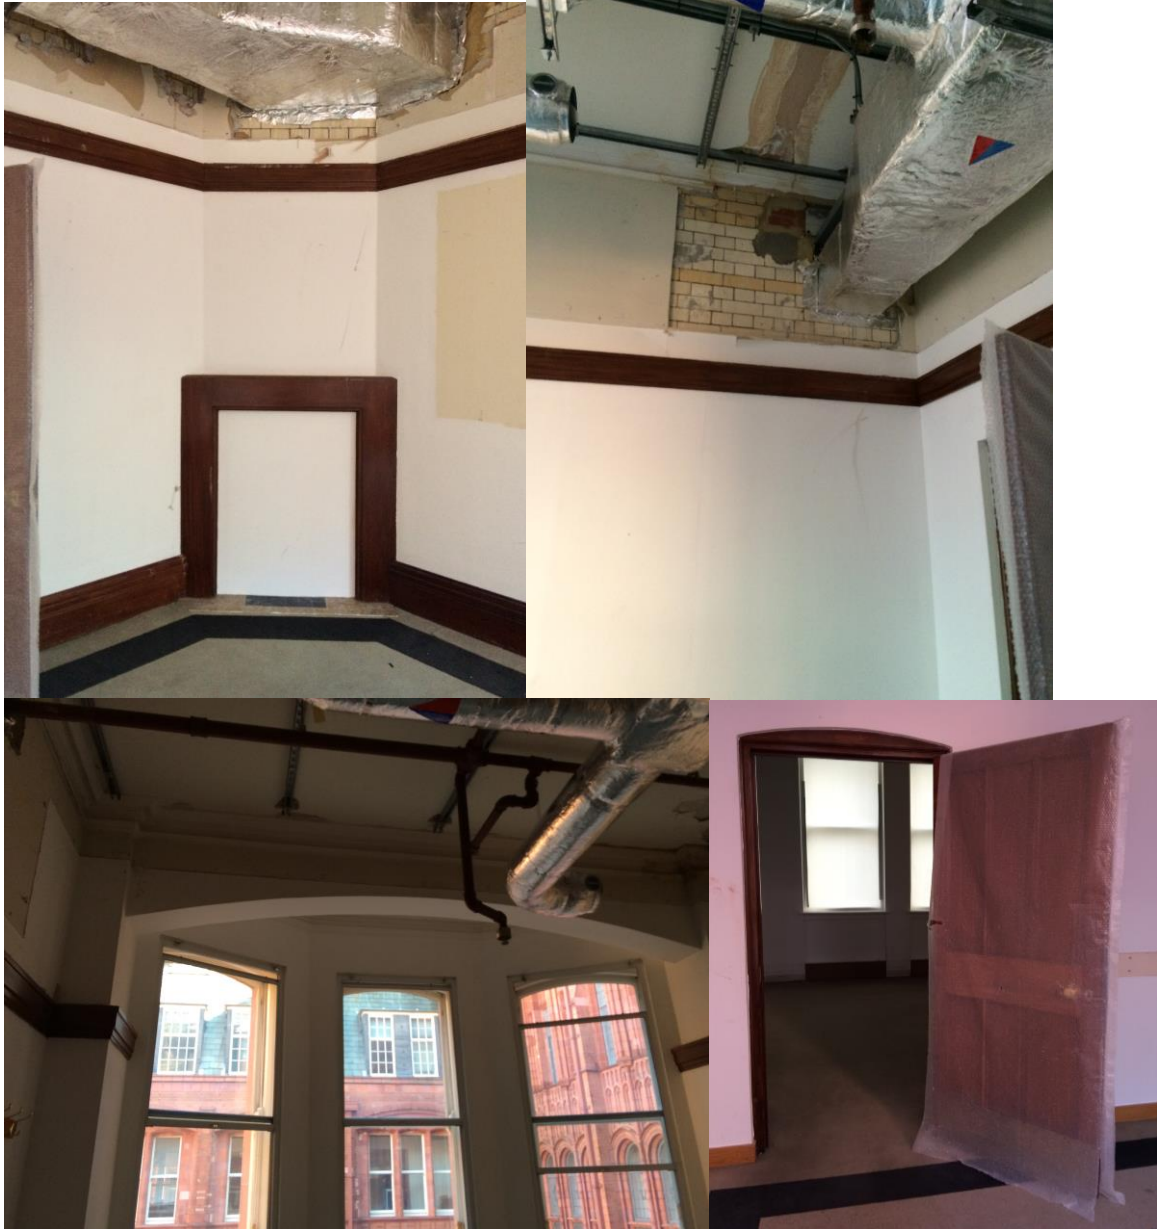
Existing features in proposed “heritage room”

- 2.0 Creating cellular office spaces with the use of glazed framed partitions.
- 3.0 Existing rooms with heritage interest to become offices with minimal works to the structure. Existing architectural features to remain. One room within this space will be investigated on site to look at stripping back to any original features previously boarded over. This to become a “heritage” room.

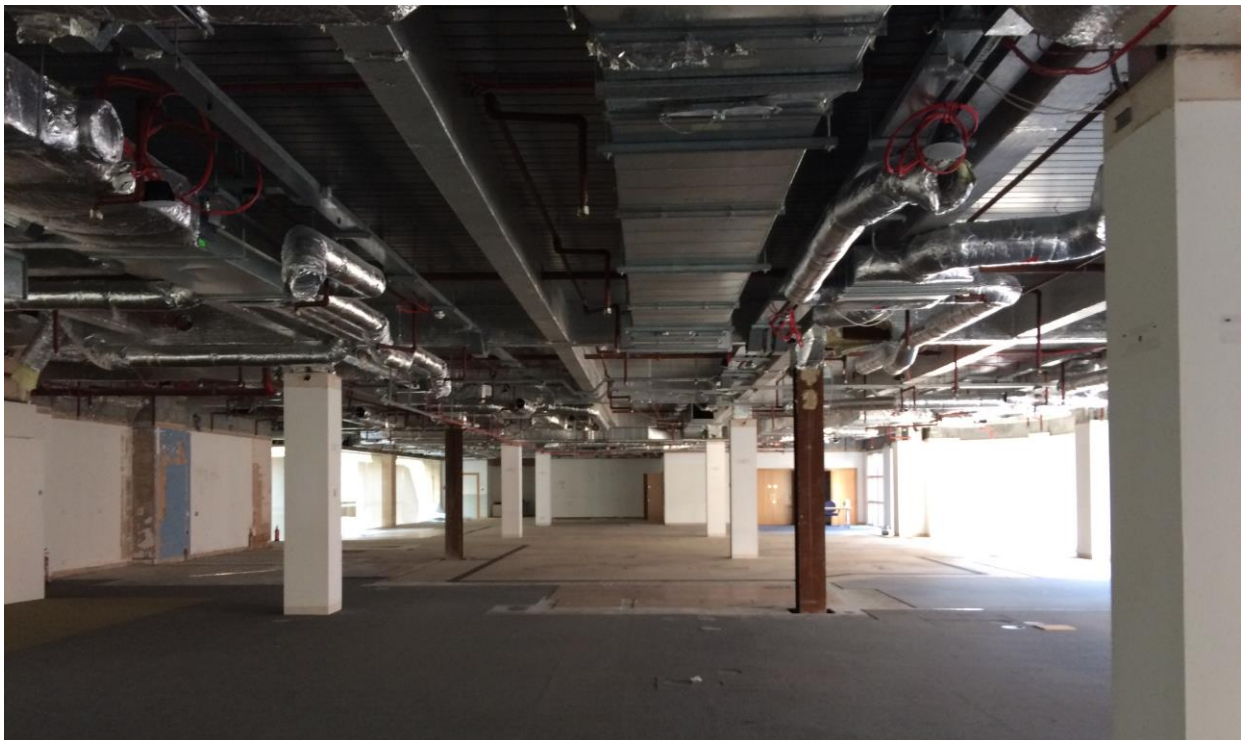
View of existing open plan space in the West Wing.

- 6.0 The creation of cellular offices, meeting rooms and additional WC toilets. New timber floor covering, painted walls, wallpaper coverings, light fittings and exposed mechanical and electrical services. Metal slab ceiling to remain as existing. Existing plasterboard edges made good. See below photo for current interior condition.

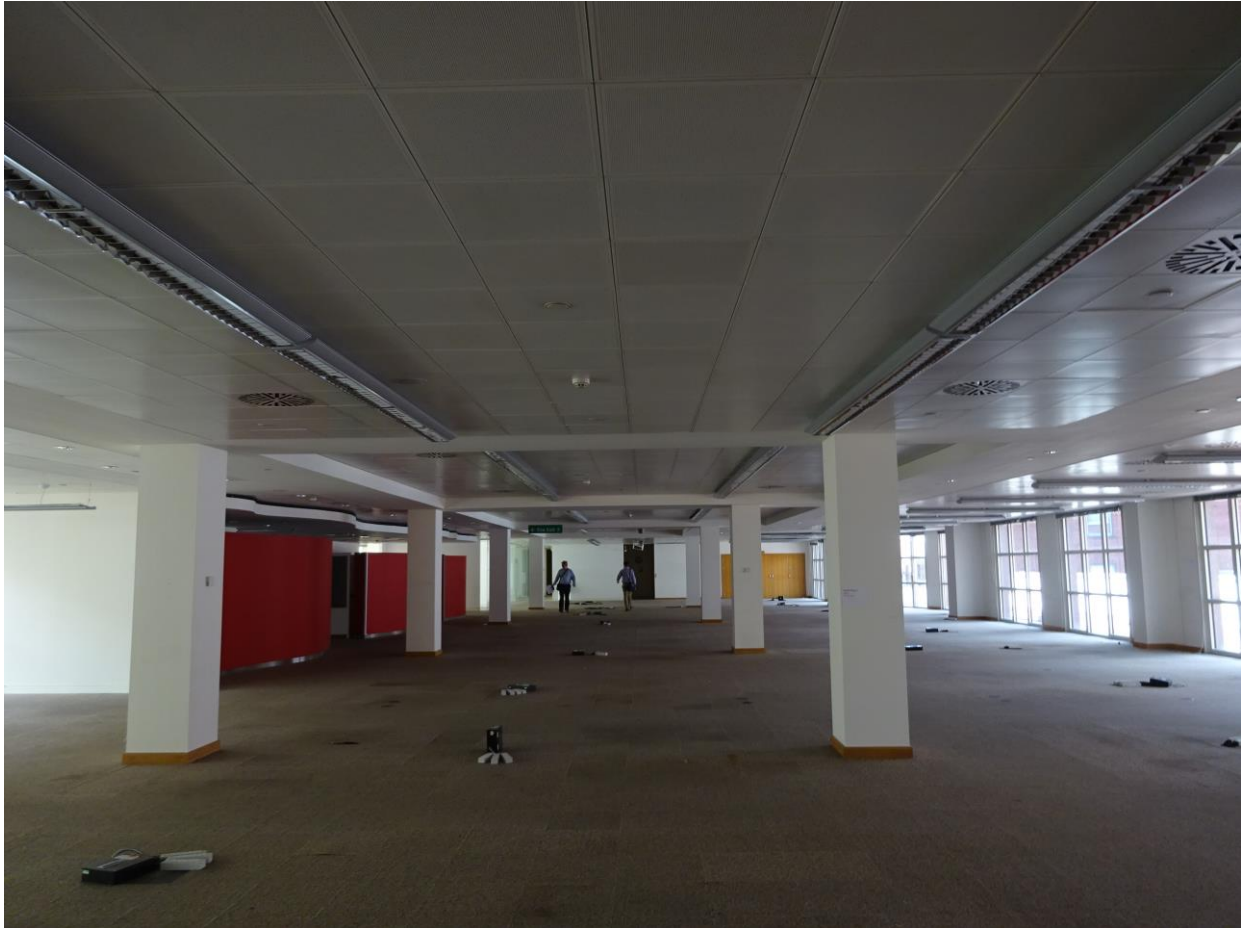
View of existing open plan space in the West Wing.

- 10.0 The creation of cellular offices, meeting rooms and additional WC toilets. New timber floor covering, painted walls, wallpaper coverings, light fittings and exposed mechanical and electrical services. Metal slab ceiling to remain as existing. Existing plasterboard edges made good. See below photo for current interior condition.
