## Supplementary information and photographs

### Supplementary information

Document reference: SUPP 7222 b.  
Date: 27 01 16  
© The Tree Bureau

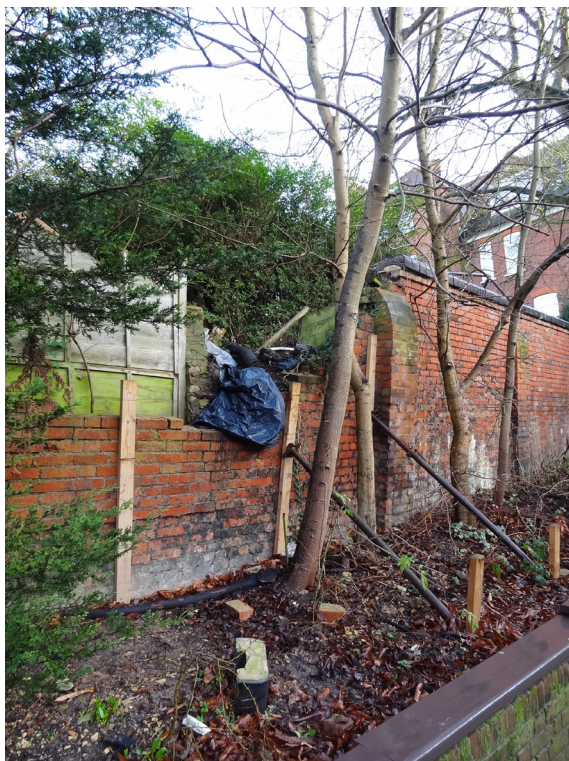
PHOTO 1: from left to right cypress (G18); Indian horse chestnut (T19) and three small self-set field maples (G19b, c and d).

Tree identification on tree location plan	Species and approximate dimensions	Tree work proposed	Observations	Reason for the proposed tree work
G18 f G18 g  see photos 1, 5 and 6 overleaf	X <i>Cuprocyparis leylandii</i> cv Leyland cypress cultivar  5-9m high Trunk diameter: 45-150mm	Crown lift northern branches to 2m.	Mostly small and dead or senescent branches. No long-term impact on tree health or structure. No impact on landscape or visual amenity. No loss of canopy cover.	To enable the building contractors to demolish and rebuild the boundary wall Section A (under permitted development rights).
G19 b G19 c see photos 1, 2, 3 and 4 overleaf	<i>Acer campestre</i> field maple  10.5m high 150mm stem diameter (G19b); 185mm diameter (G19c).	Fell to ground level, leaving stump and roots in the ground.  After wall construction complete, plant x1 <i>Magnolia grandiflora</i> 'Gallissoniere' and x3 <i>Eleagnus x ebbingei</i> (Ebinge's silverberry).	Small, young, self set. Very close to wall. Trees would need to be removed soon irrespective of the requirement to replace the crumbling wall.	To enable the building contractors to demolish and rebuild the boundary wall Section A.  To improve evergreen boundary screening and noise attenuation and provide year-round plant interest.

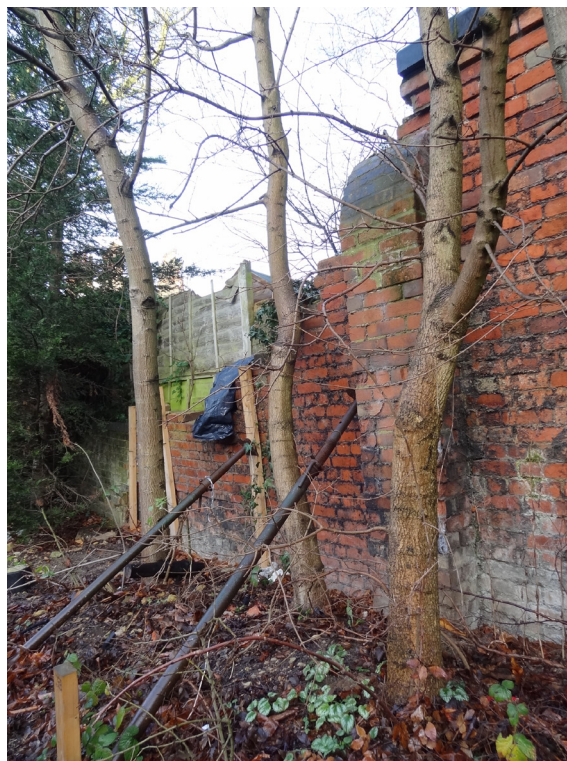
PHOTO 2: Indian horse chestnut (T19), left; and two small field maples G19b (centre) and G19c (right).

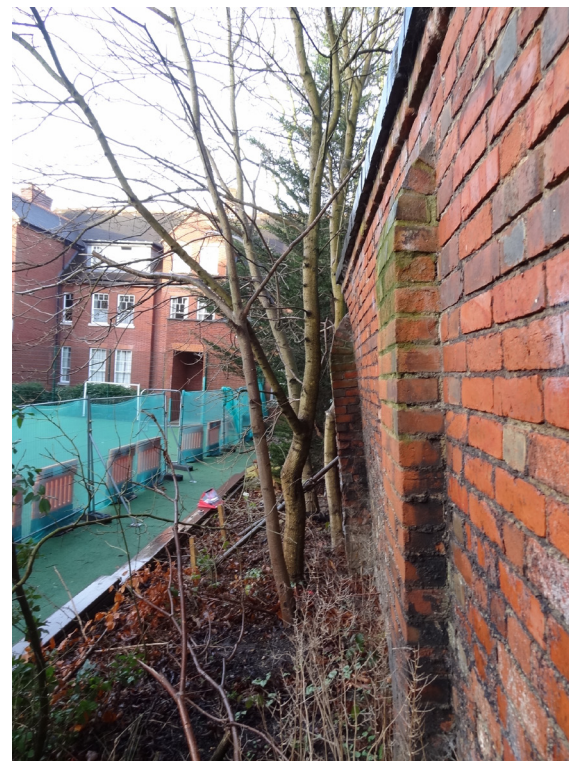
PHOTO 3: three small field maples showing their proximity to the collapsing boundary wall. From left to right: G19d, G19c, G19b.

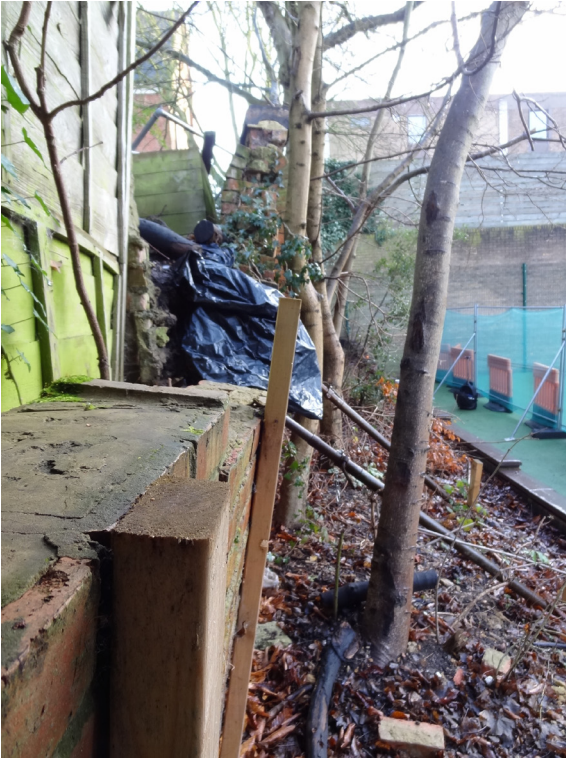
PHOTO 4: Indian horse chestnut (T19) in foreground, with field maples G19 behind.
