DESK STUDY & BASEMENT IMPACT ASSESSMENT REPORT

26 Rosecroft Avenue
London NW3

J15226

December 2015

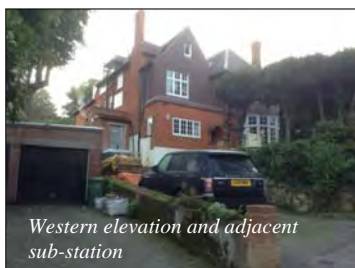
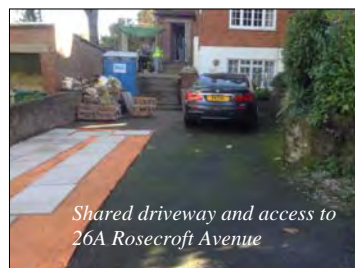
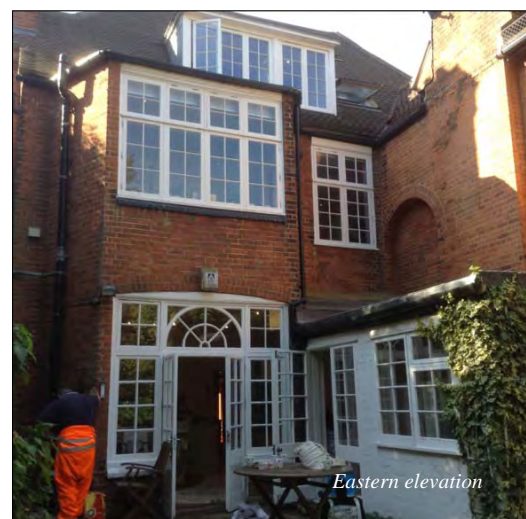
A walkover of the site was carried out by a geotechnical engineer from GEA on 23 September 2015. Selected photographs are included below.

The local topography slopes down towards the northwest and west. The site generally slopes down to the southwest and there are a number of changes in ground level across the site to accommodate the change in slope. The site is currently occupied by a two-storey detached brick house with roof accommodation and two single storey rear extensions. A lower ground floor extending to a level of 47.56 m TBM is present beneath the northwestern corner, measuring 10 m by 4 m in plan and extends 2.44 m below existing ground floor level. It is understood that this was formerly a garage, prior to its conversion. The house is divided into two self-contained flats; the lower ground floor and ground floor is owned by the client and the first floor and second floor forms 26A Rosecroft Avenue, along with the driveway, northern passageway along the house and a private rear garden, located at a higher level.

The site has its own front garden located at roughly 48 m TBM. The front garden comprises a gravel area with shrub borders and a central brick paved path, lined with five Bay trees, 6 m high. Steps lead up to a raised ground floor level, located roughly 2 m above the level of the front garden at 50 m TBM. Steps lead down from the front garden to the driveway at roughly 47.2 m TBM.

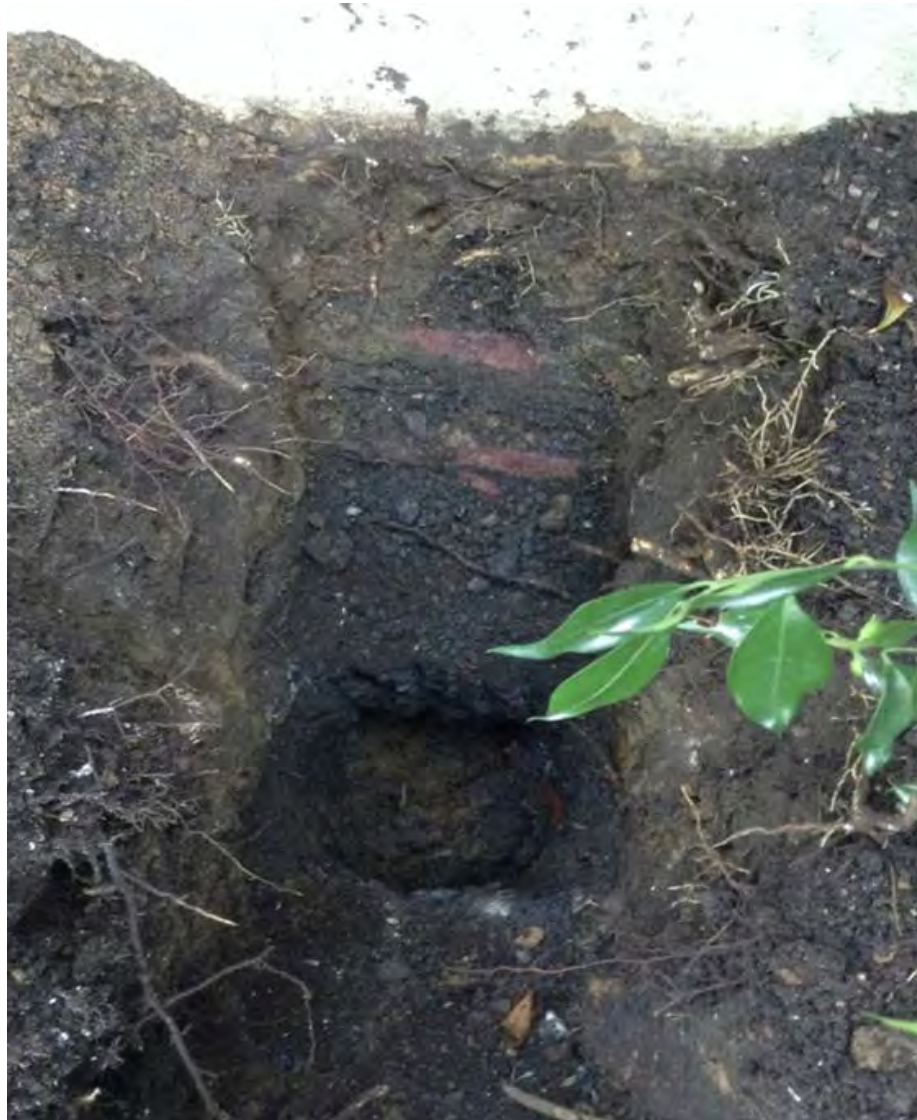
Sheet
9/20

GEA Geotechnical & Environmental Associates		Widbury Barn Widbury Hill Ware Herts SG12 7QE	Site 26 Rosecroft Avenue, London NW3 7QB	Trial Pit Number 3
Excavation Method Manual	Dimensions 400 x 400 x 650	Ground Level (mTBM) 49	Client Vipul Panchal	Job Number J15226
	Location	Dates 09/10/2015	Engineer Hestia Developments	Sheet 10/20
<div> <p><u>PLAN</u></p> <p>Concrete or brick</p> <p>Earthing rod, 0.10 m from face of wall at a</p> <p>Brick wall</p> <p>120</p> <p>180</p> <p>100</p> <p>400</p> <p>Black pipe, 0.30 m from face of wall at a depth of 400 mm</p> <p>A</p> <p>A'</p> </div>				
Remarks: All dimensions in millimetres Sides of trial pit remained relatively stable during excavation Groundwater: Not encountered				Scale: 1:10 Logged by: HD

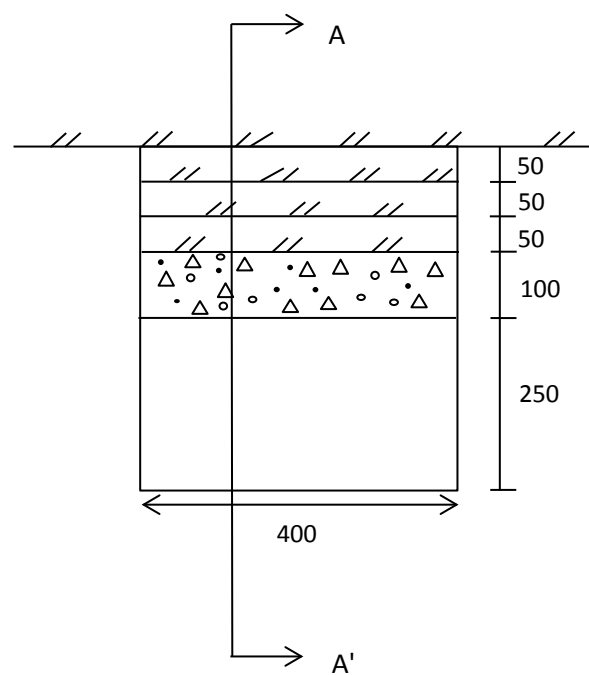
PLAN

Widbury Barn Widbury Hill Ware Herts SG12 7QE		Site 26 Rosecroft Avenue, London NW3 7QB	Trial Pit Number 5
Excavation Method Manual	Dimensions 400 x 500 x 900	Ground Level (mTBM) 50.03	Client Vipul Panchal	Job Number J15226	
	Location	Dates 09/10/2015	Engineer Hestia Developments	Sheet 16/20

Remarks: All dimensions in millimetres Sides of trial pit remained relatively stable during excavation Groundwater: Not encountered	Scale: 1:10
	Logged by: HD
