# GRESHAM · COLLECTIVE

## Design, Access and Heritage Statement

Property details: 94 Haverstock Hill, London, NW3 2BD

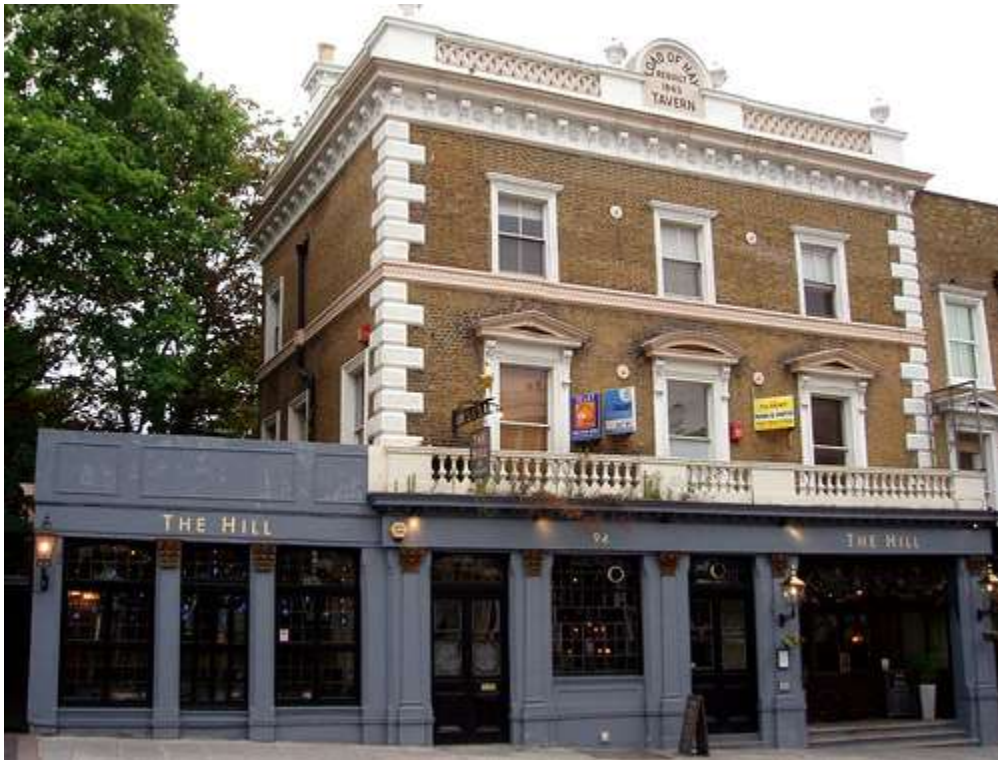
The exterior is of yellow stock brick with stucco dressings and ground floor; vermiculated stucco quoins.

Ground floor and basement is a public house frontage with Corinthian pilasters carrying entablature with modillion cornice and fascia.

Recessed main entrance to right with engraved glass to doors and screens (some of this has been replaced over the years and is clear and not etch engraved); with elaborate wrought-iron grille of foliate and scroll design forming arch over main entrance.

Segmental-arched openings to ground floor, windows and half glazed double doors with small panes. Top of building round-arched centre piece inscribed "Load of Hay Tavern rebuilt 1863"; urns on dies flanking centre piece and at angles. Left hand return with panel in balustrade inscribed "The Load of Hay Tavern".

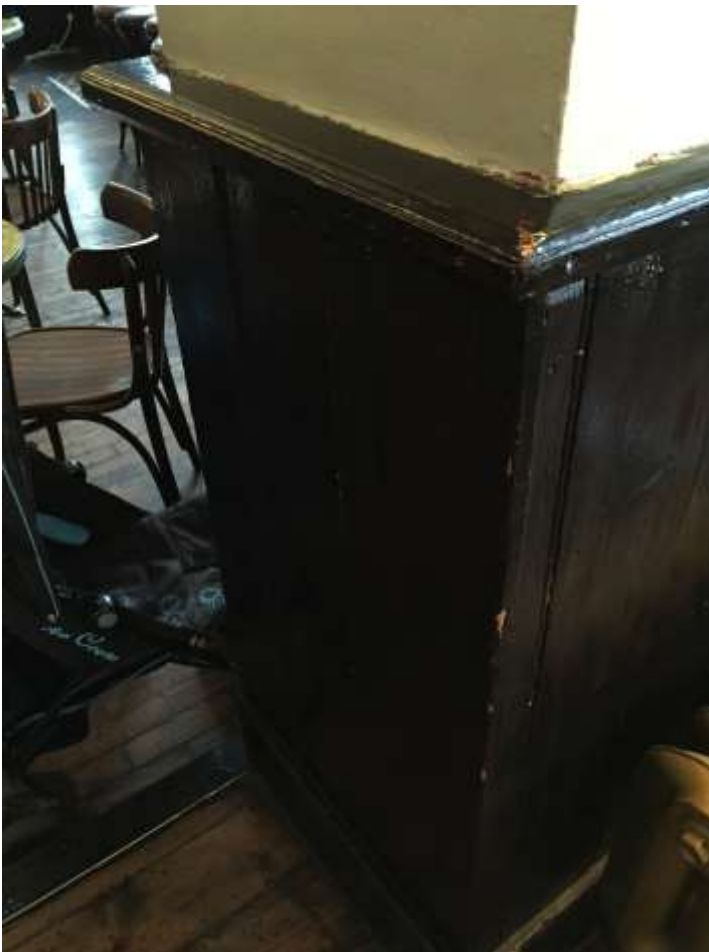
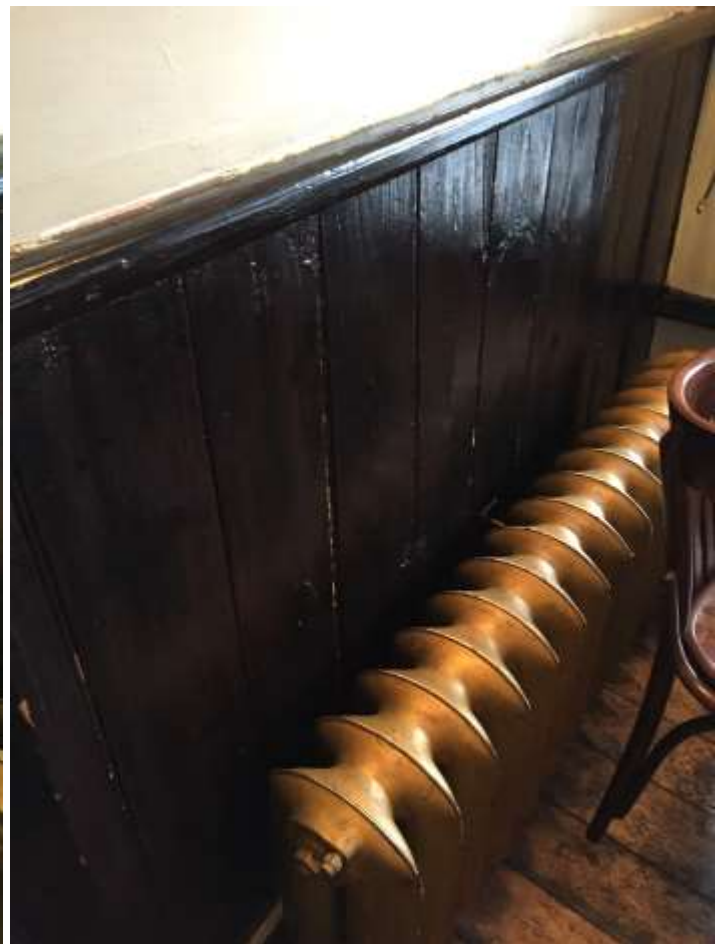
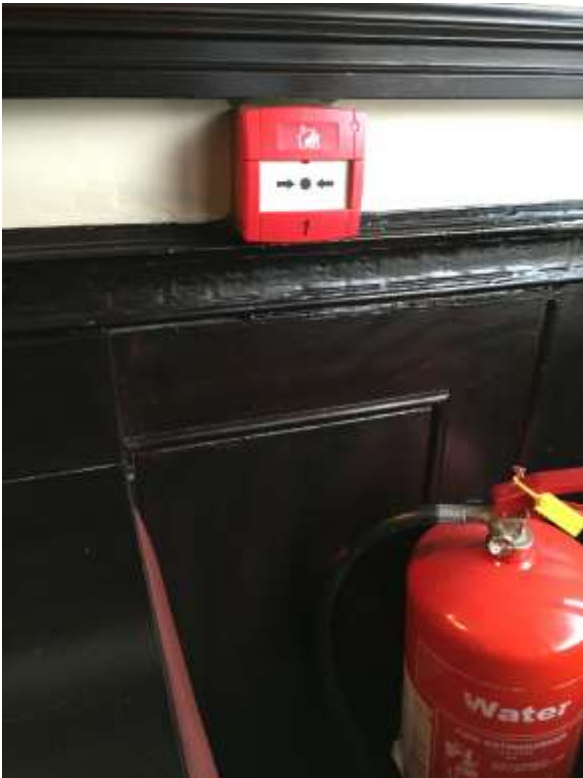
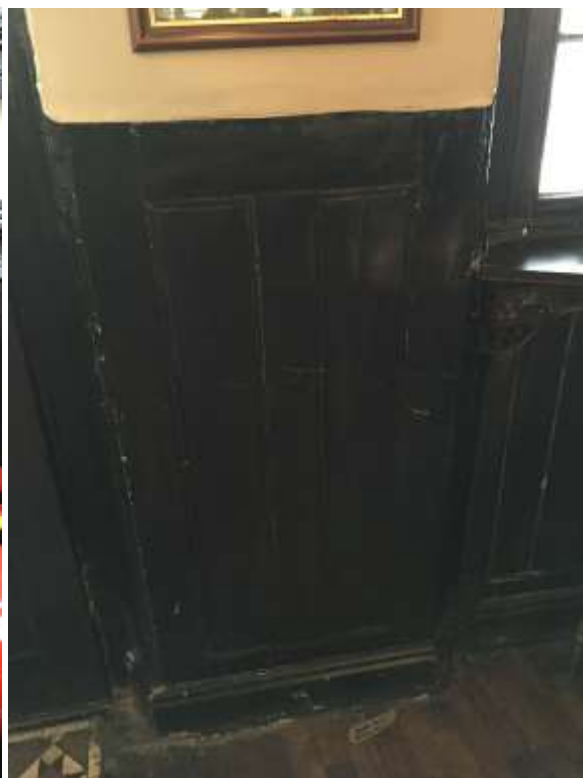
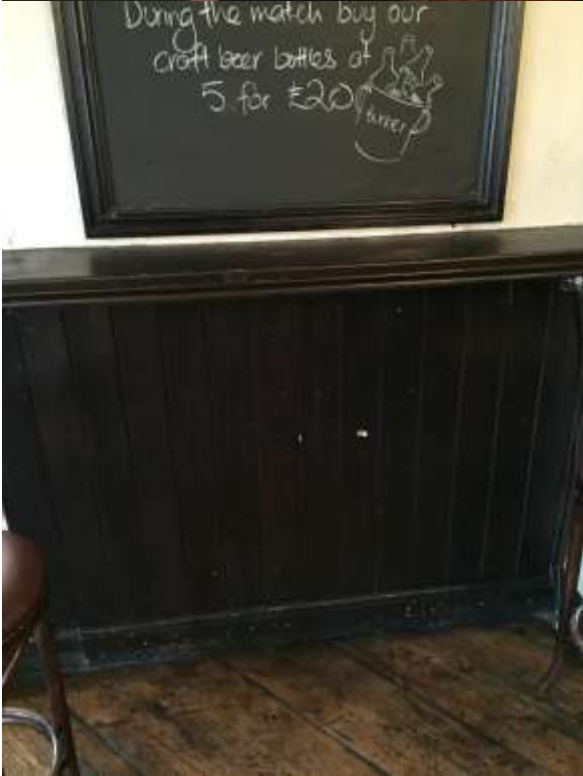
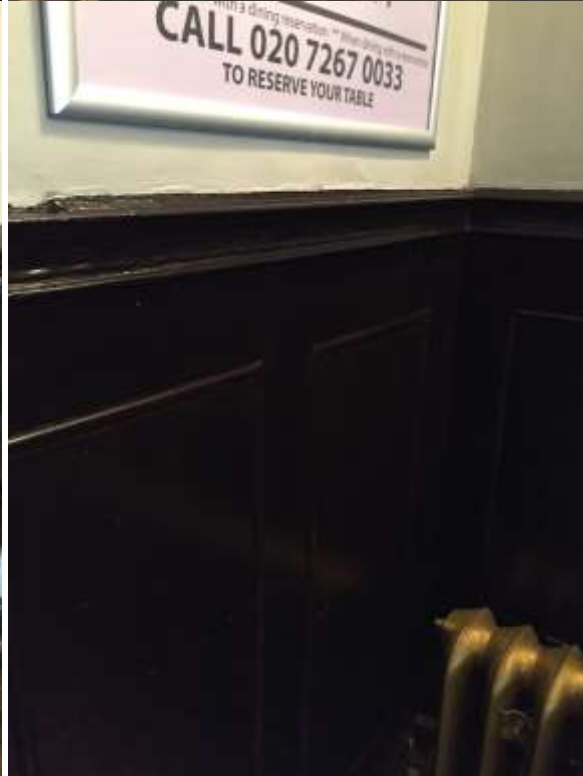
The interior bar area has wood paneling throughout to dado level. The paneling is different in various areas and suggests that this is not original and/or has been added, repaired or replaced. It is our intention to remove all wood paneling, re-plaster walls and decorate.

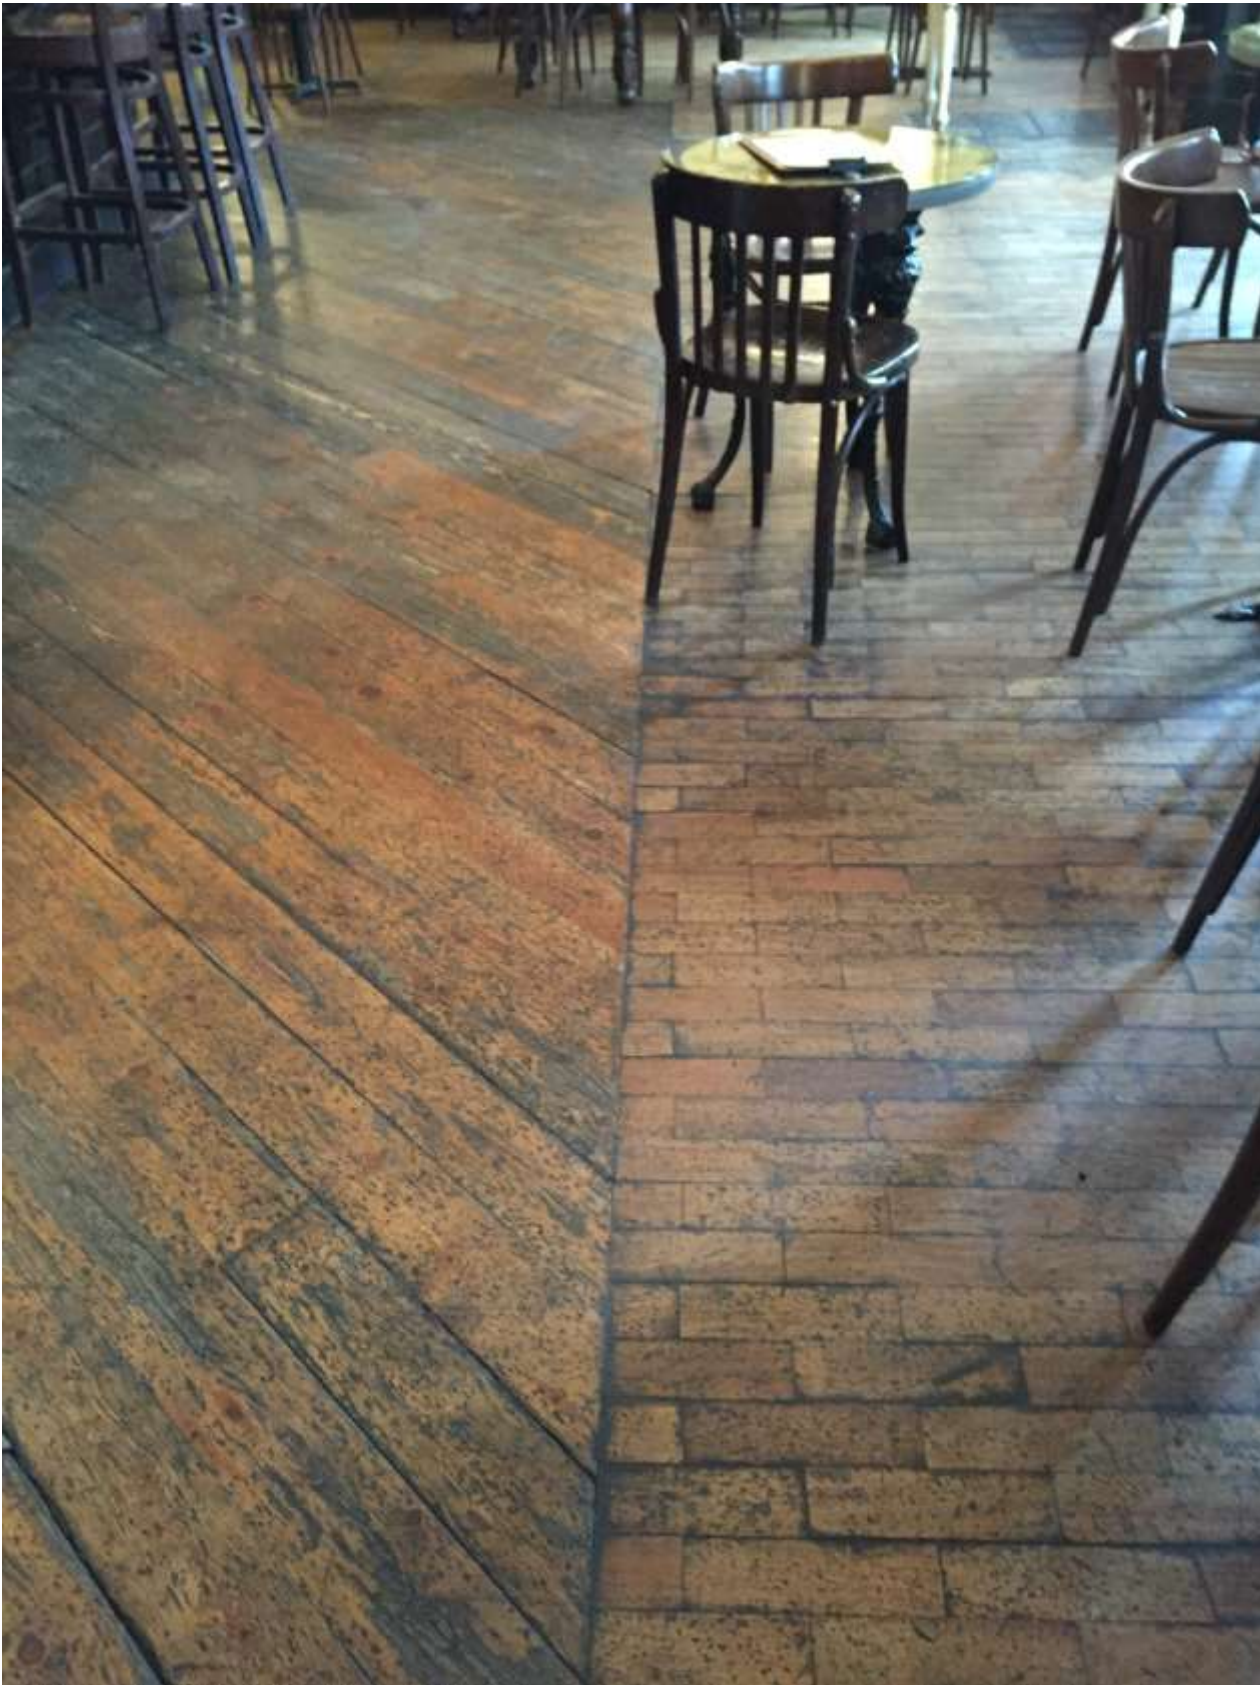
The flooring is mixed in styles and finishes. We have no intention of removing any of the flooring, but we will be sanding and restoring finish with clear lacquer.

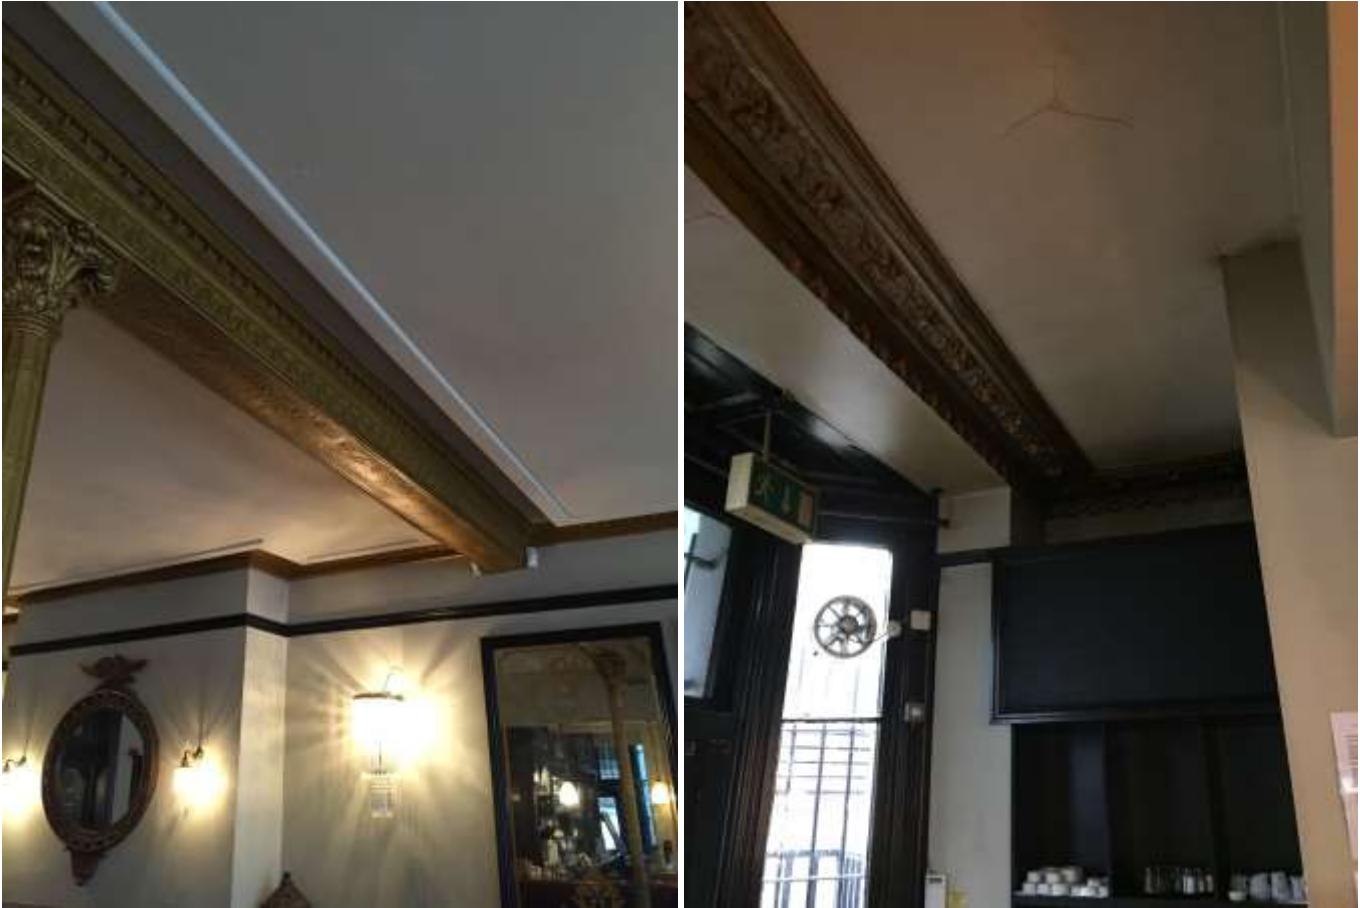
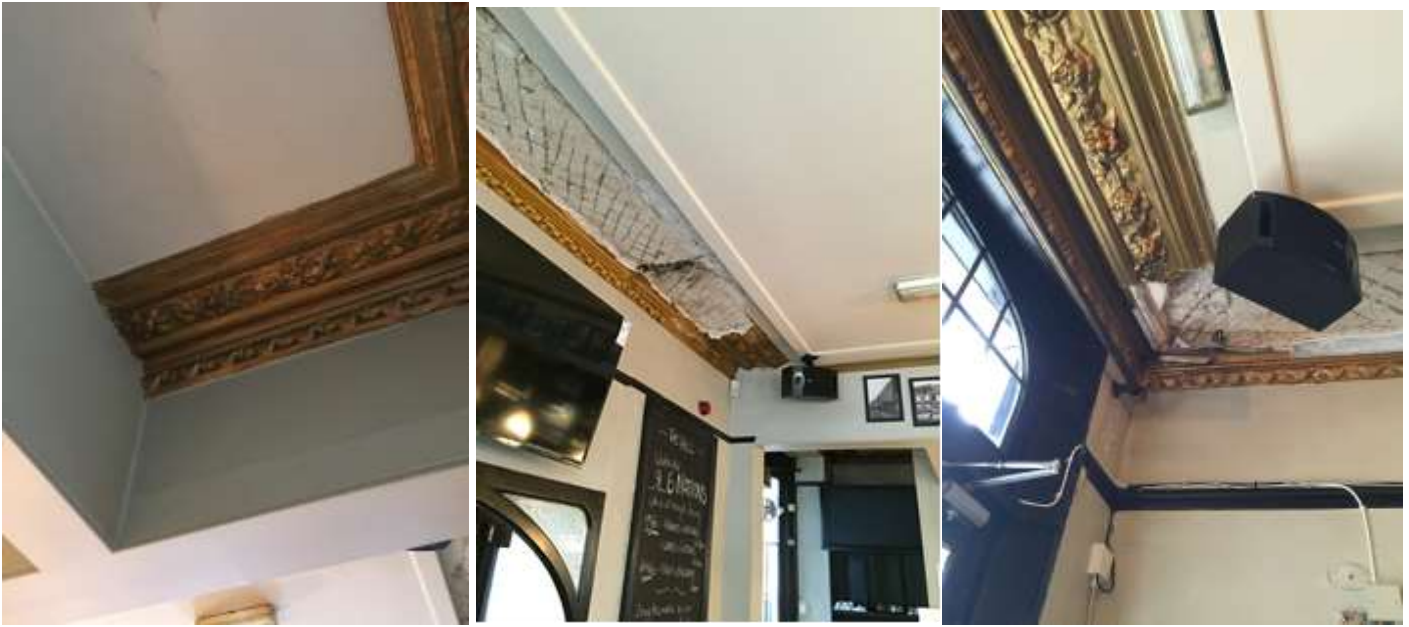
The cornice is different in various parts of the bar area and it is difficult to put an age to any of it. Big cornice was very popular in pubs in the 1960's and 1970's and it is possible that some of the cornice was installed then. In addition some of the cornice has been cut to make way for boxing and some has fallen down and has never been replaced. This was like this when we bought the premises and according to locals it has been like it for years after water damage and was seen as a something quirky. In the picture below you can also see the slightly lowered false ceiling feature as well which our builders think is a recent addition. It is our proposal not to remove any of the cornice but to install a drop ceiling to come level with the bottom of the middle beam, throughout the entire ground floor.

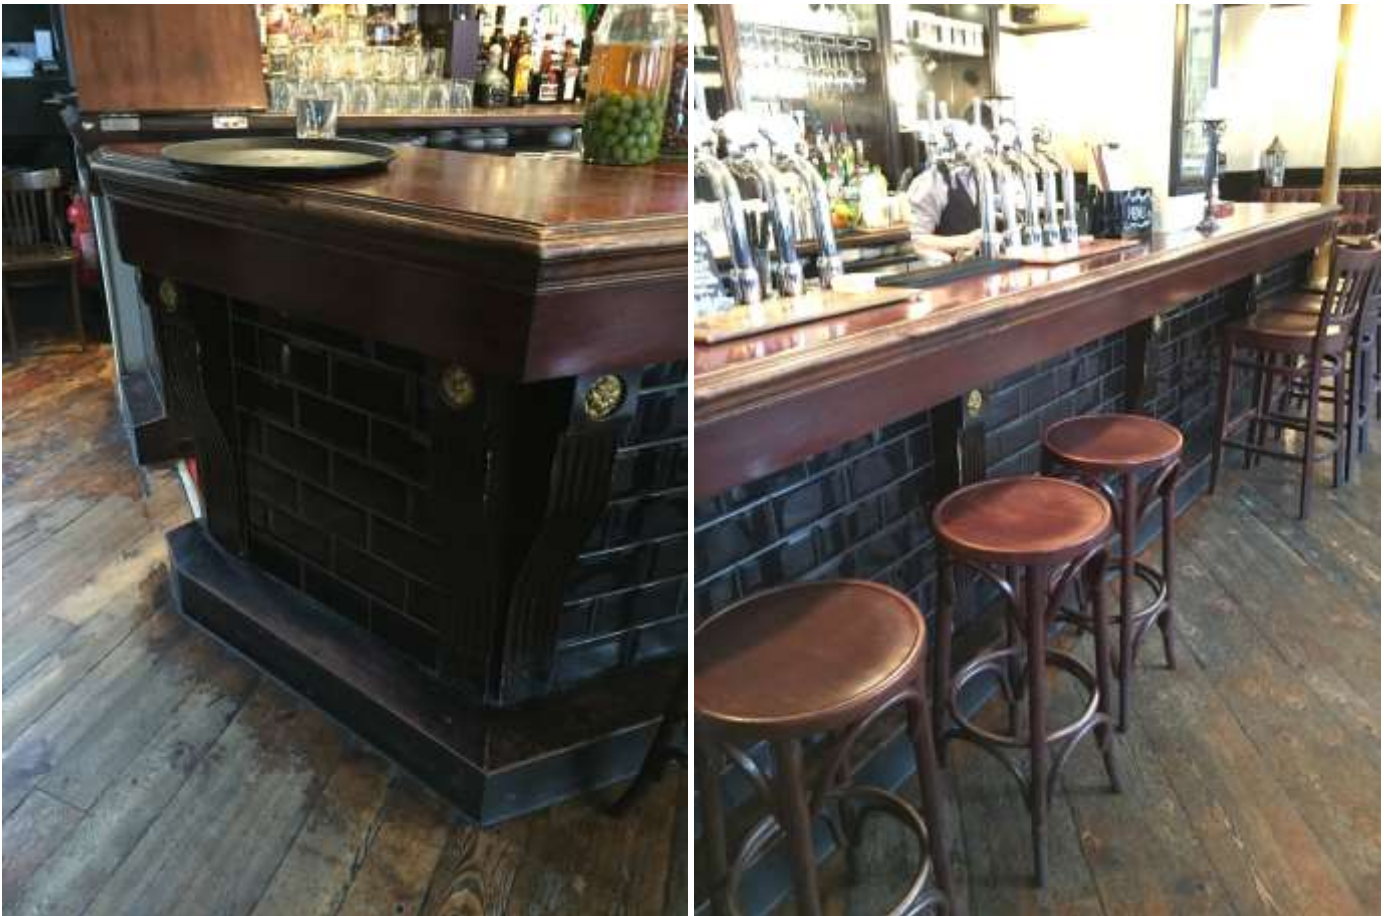
We have been led to believe that the bar was moved forward in early 2002 when a small kitchen was installed behind the bar area. The front tiles of the bar were replaced in 2010 by the previous landlord. We will be re-polishing the bar woodwork and replacing the tiling to fit with our soft furnishings.
