11A GLOUCESTER CRESCENT NW1 7DS

## Design and Access Statement

11A Gloucester Crescent  
London  
NW1 7DS

**Michael Dowd Design**

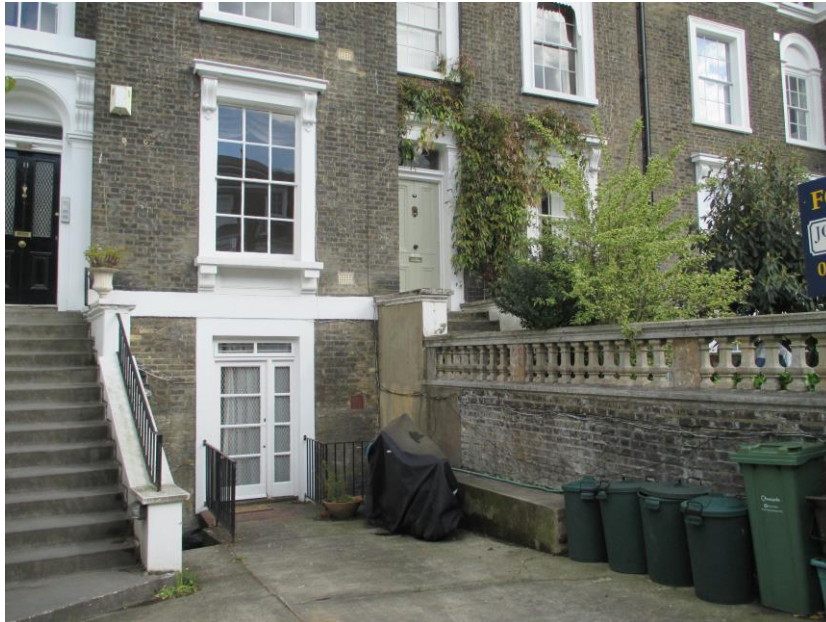
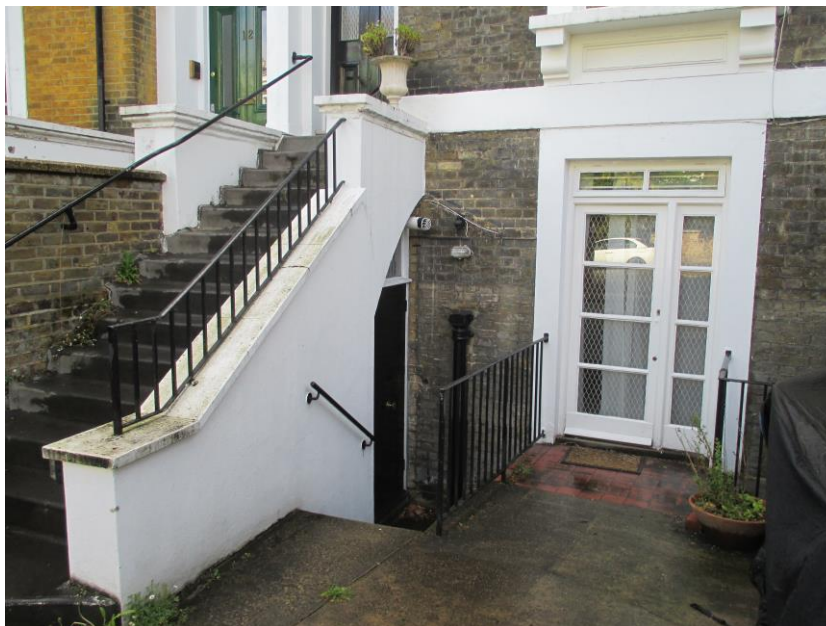
## EXISTING FORECOURT

The ground floor window is a full height French door whereas all other windows facing Gloucester Crescent have a much lower sliding sash window, which were common at the time building commenced in 1840. The forecourt uniquely slopes towards the building and not towards the road. Apart from being a possible flood risk, this slope changes the appearance negatively of the whole building.

By excavating and sloping the ground away from the road, the unsightly underpinning concrete of the adjoining wall to number 10 is exposed. Below the concrete balustrade party wall.

There is no patio area in front of the ground level room, an essential element of neighbouring building and an essential component of late Victorian London residential architecture.

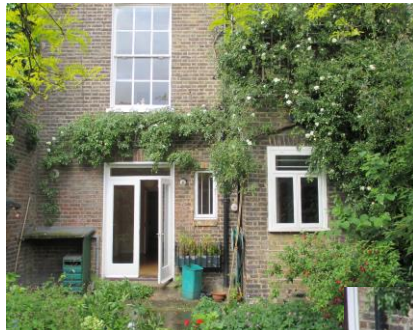
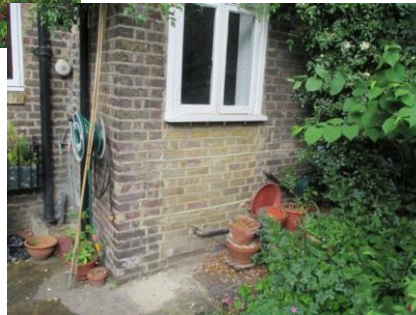
## REAR ELEVATION DOOR REPLACEMENT

To the rear of the building a recent window will be replaced by an access door to the garden, to fit the original opening size and in the original architectural vernacular.

The existing rear casement window was previously a door. Markings on the existing brickwork show the position and size of this original white painted wood framed door.

.As well as being an original asset of the building, a replacement door would add to the convenience of today's occupants allowing access to the garden without passing through a habitable room.

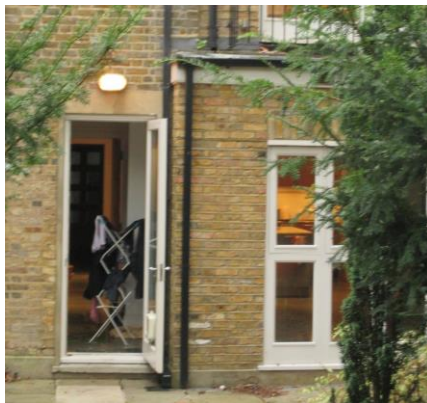
Adjoining property on Gloucester Crescent showing similar door to proposed new replacement door

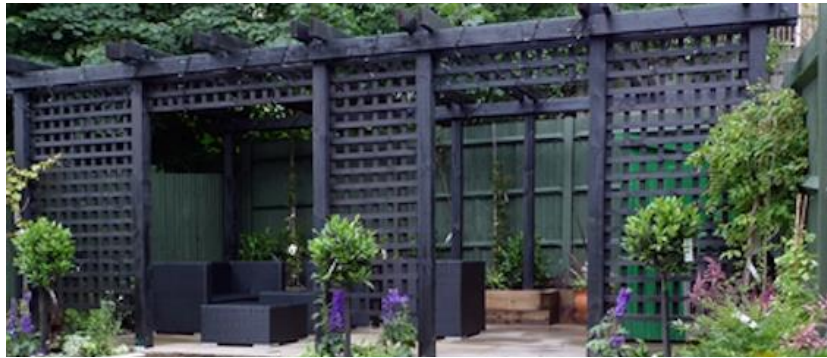
Pergola for reference

The trellis will be adapted to create a Pergola to complete the garden composition.

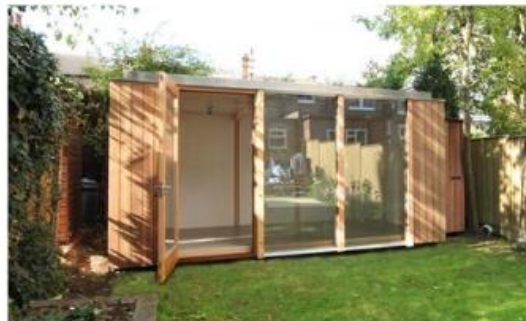
The existing garden will be given new life using mainly plants that could have been found at the time of the celebrated Victorian gardener William Robinson. There will be a small informal grass area in the garden center surrounded with herbaceous borders, bushes, climbers and trees.

The existing trellis will incorporate a discrete garden shed integrated into the existing and also new wood trellis to allow for climbing plants.

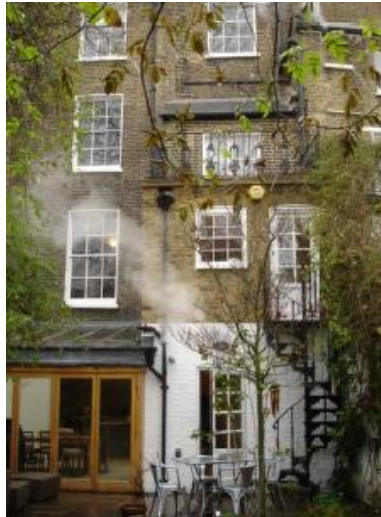
Proposed elevation to rear of existing building

A south facing sun lounge will be added to the rear of the building facing the garden. This will provide an all-weather relaxation zone for appreciating the garden.

The construction and aesthetic will be different from the existing rear of the building to mark the fact that it is a recent addition.

The addition will have double glazed windows, thermally insulated roof and zinc cladding panels.

The construction is kept clear of the building side walls so that existing drainage pipework is not interfered with and also to allow for installing scaffolding if necessary.

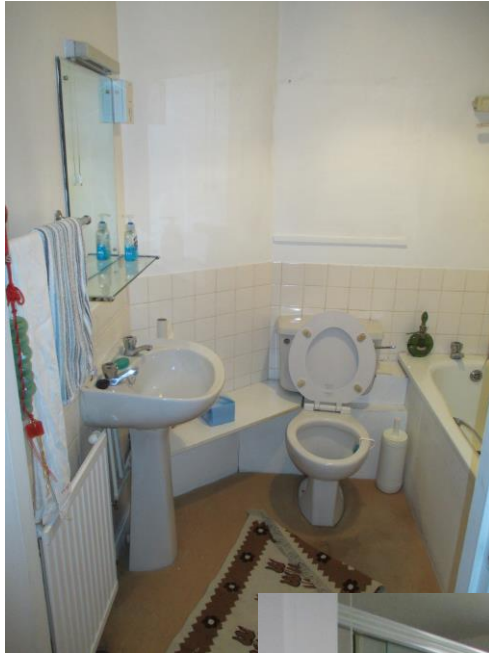
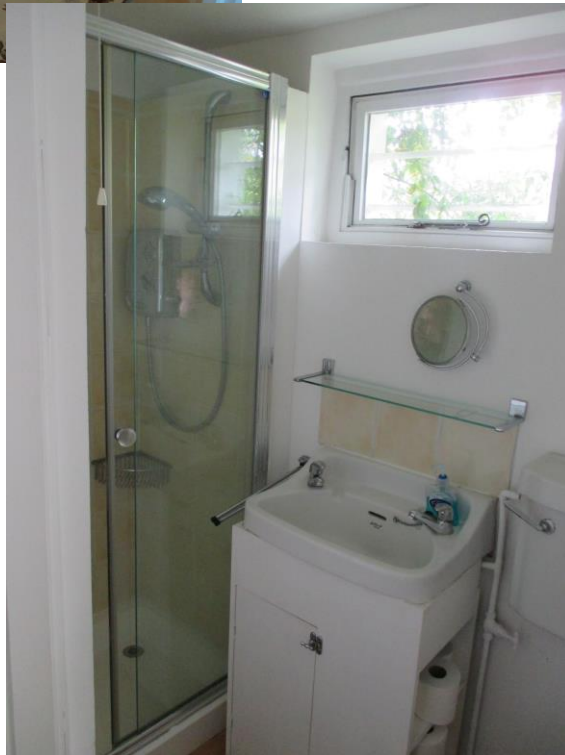
## AUDIT: BATHROOMS

The attached images are included in this report for audit purposes.

Both bathrooms and bedrooms are at ground level. At this level there are no discernable heritage assets, The ceilings are low, the floor solid, partially with glued cork tiles.

The access staircase, formally used to serve the first floor from the lower garden floor is possibly the original staircase but is in poor condition and has been subject to excessive poor quality paint over the past decades

It would appear that the current interiors could date from 1980 when the property last changed ownership.

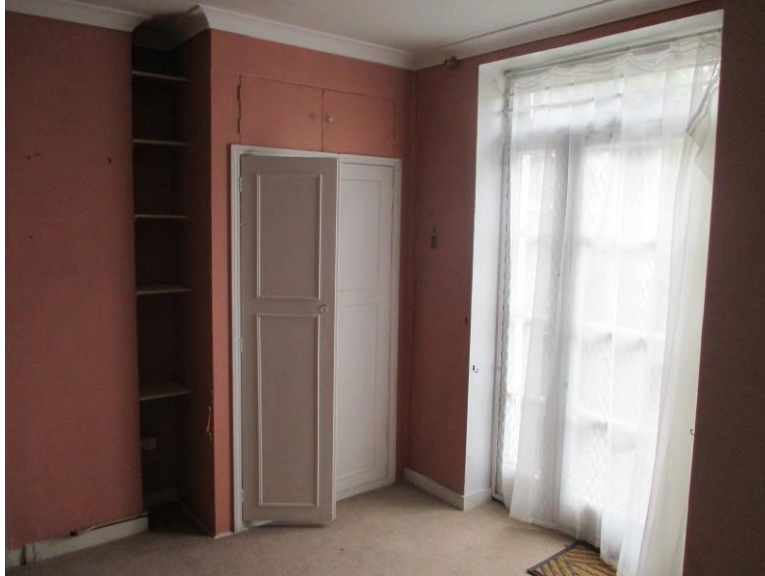
## AUDIT: BEDROOM

The attached images are included in this report for audit purposes.

Both bathrooms and bedrooms are at ground level. At this level there are no discernable heritage assets, The ceilings are low, the floor solid, partially with glued cork tiles or glued carpet to concrete sub floor.

The access staircase, formally used to serve the first floor from the lower garden floor is possibly the original staircase but is in poor condition and has been subject to excessive poor quality paint over the past decades

It would appear that the current interiors could date from 1980 when the property last changed ownership.

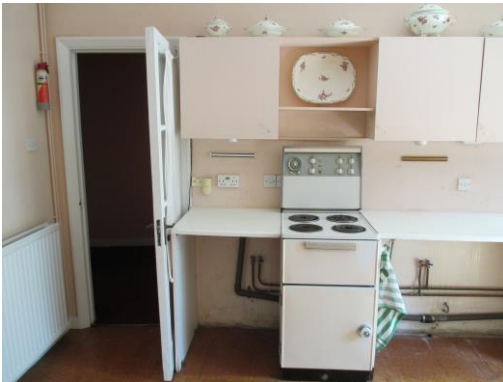
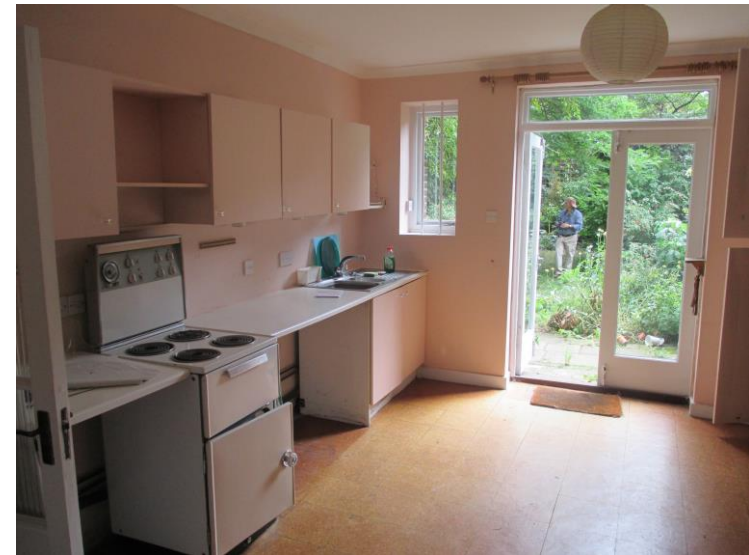
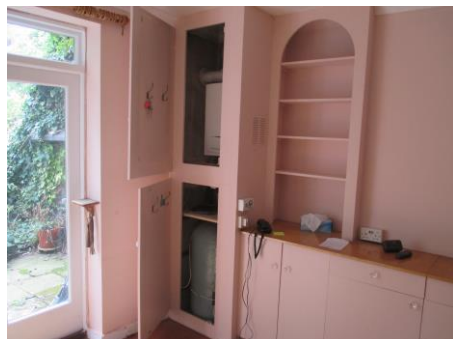
Both bathrooms and bedrooms and kitchen are currently at ground level. At this level there are no discernible heritage assets, The ceilings are low, the floor solid, partially with glued cork tiles.

The access staircase, formally used to serve the first floor from the lower garden floor is possibly the original staircase but is in poor condition and has been subject to excessive poor quality paint over the past decades

It would appear that the current interiors could date from 1980 when the property last changed ownership.
