GROUND INVESTIGATION REPORT

14 ROSECROFT AVENUE, HAMPSTEAD, LONDON NW3 7QB

VINCENT AND RYMILL

Report Reference: GWPR1540/GIR/March 2016		Status: DRAFT
Issue:	Prepared By:	Verified By:
V1.01 March 2016

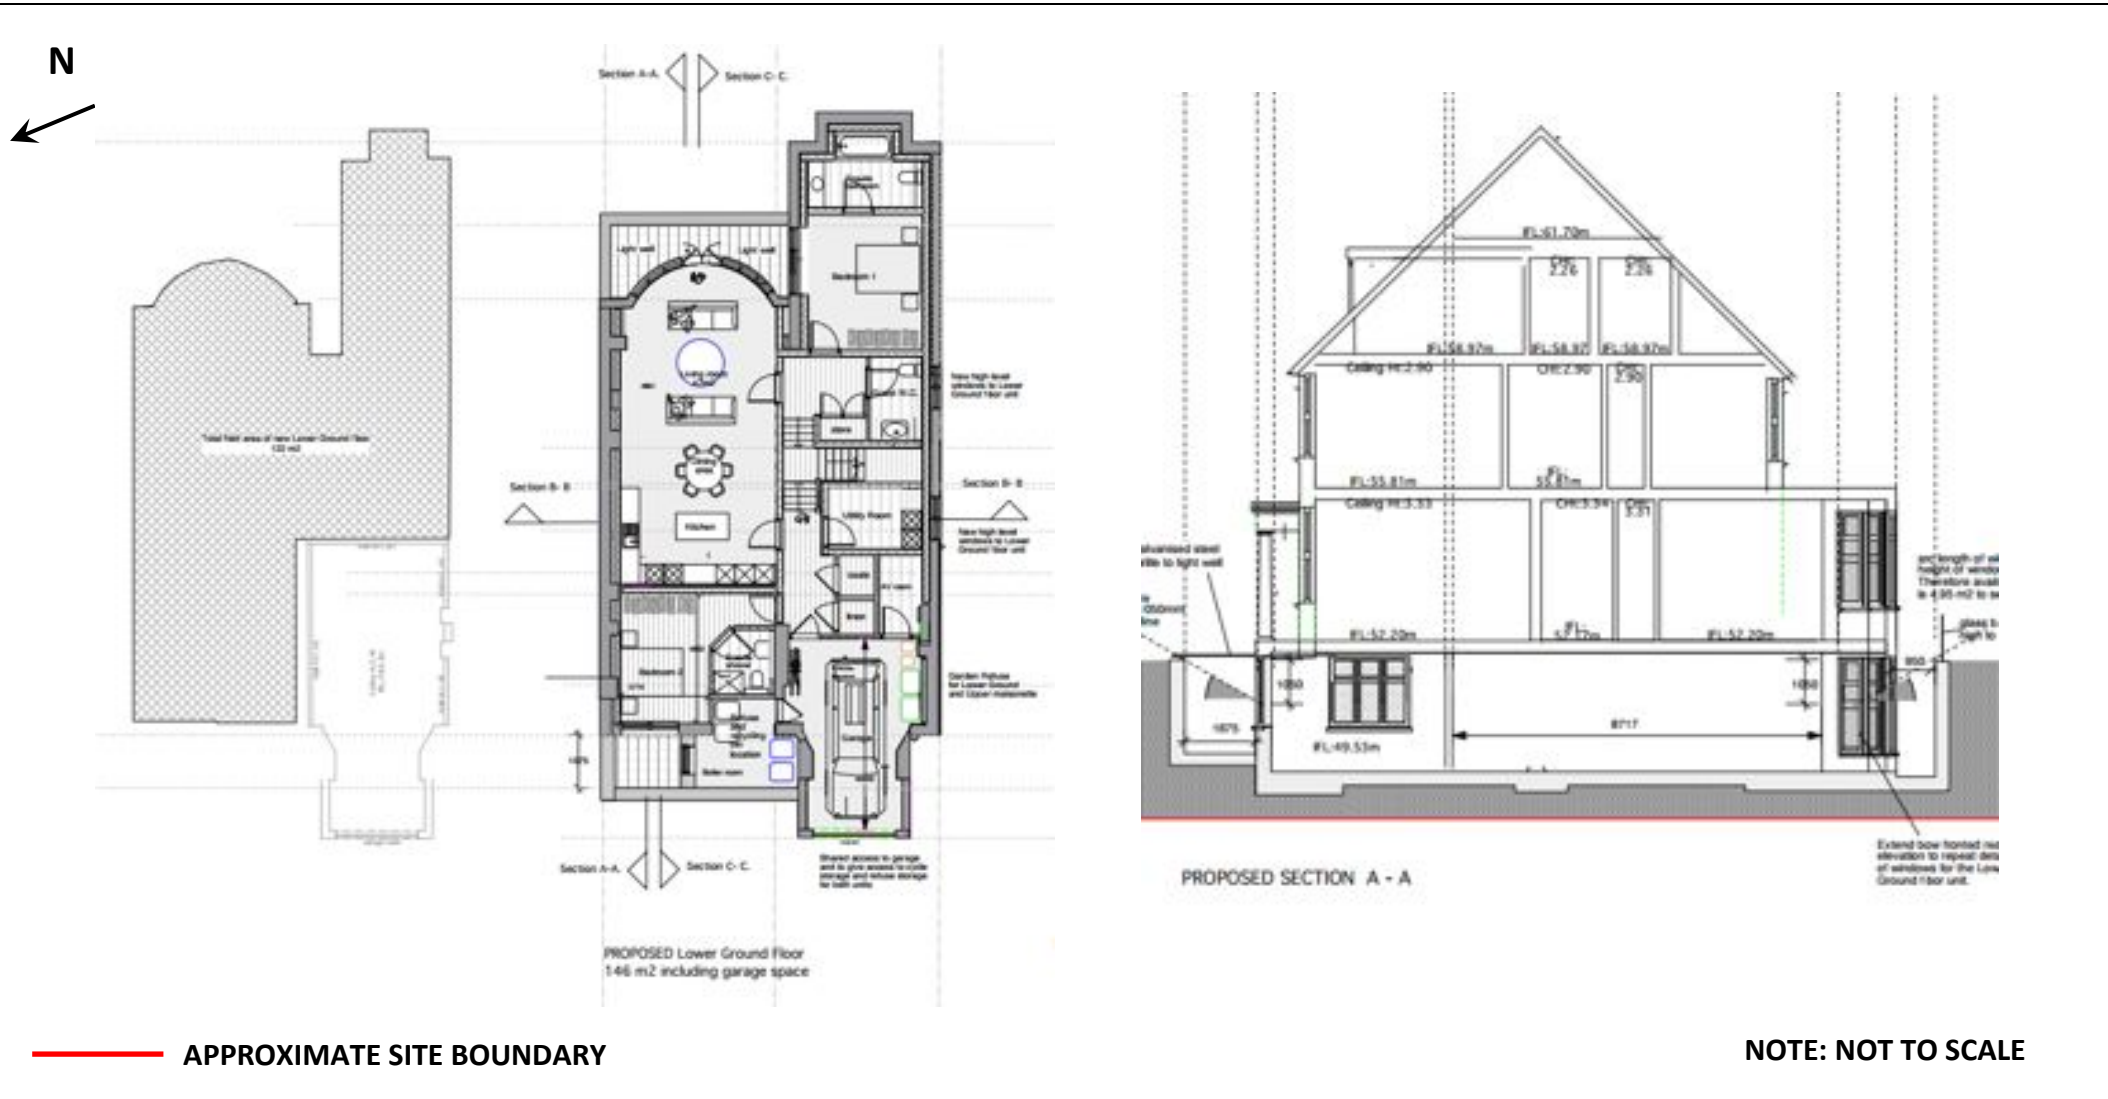
Figure 4

Project:	14 Rosecroft Avenue, Hampstead, London NW3 7QB	
Client:	Vincent and Rymill	Date: March 2016
	Proposed Development Plan	Ref: GWPR1540

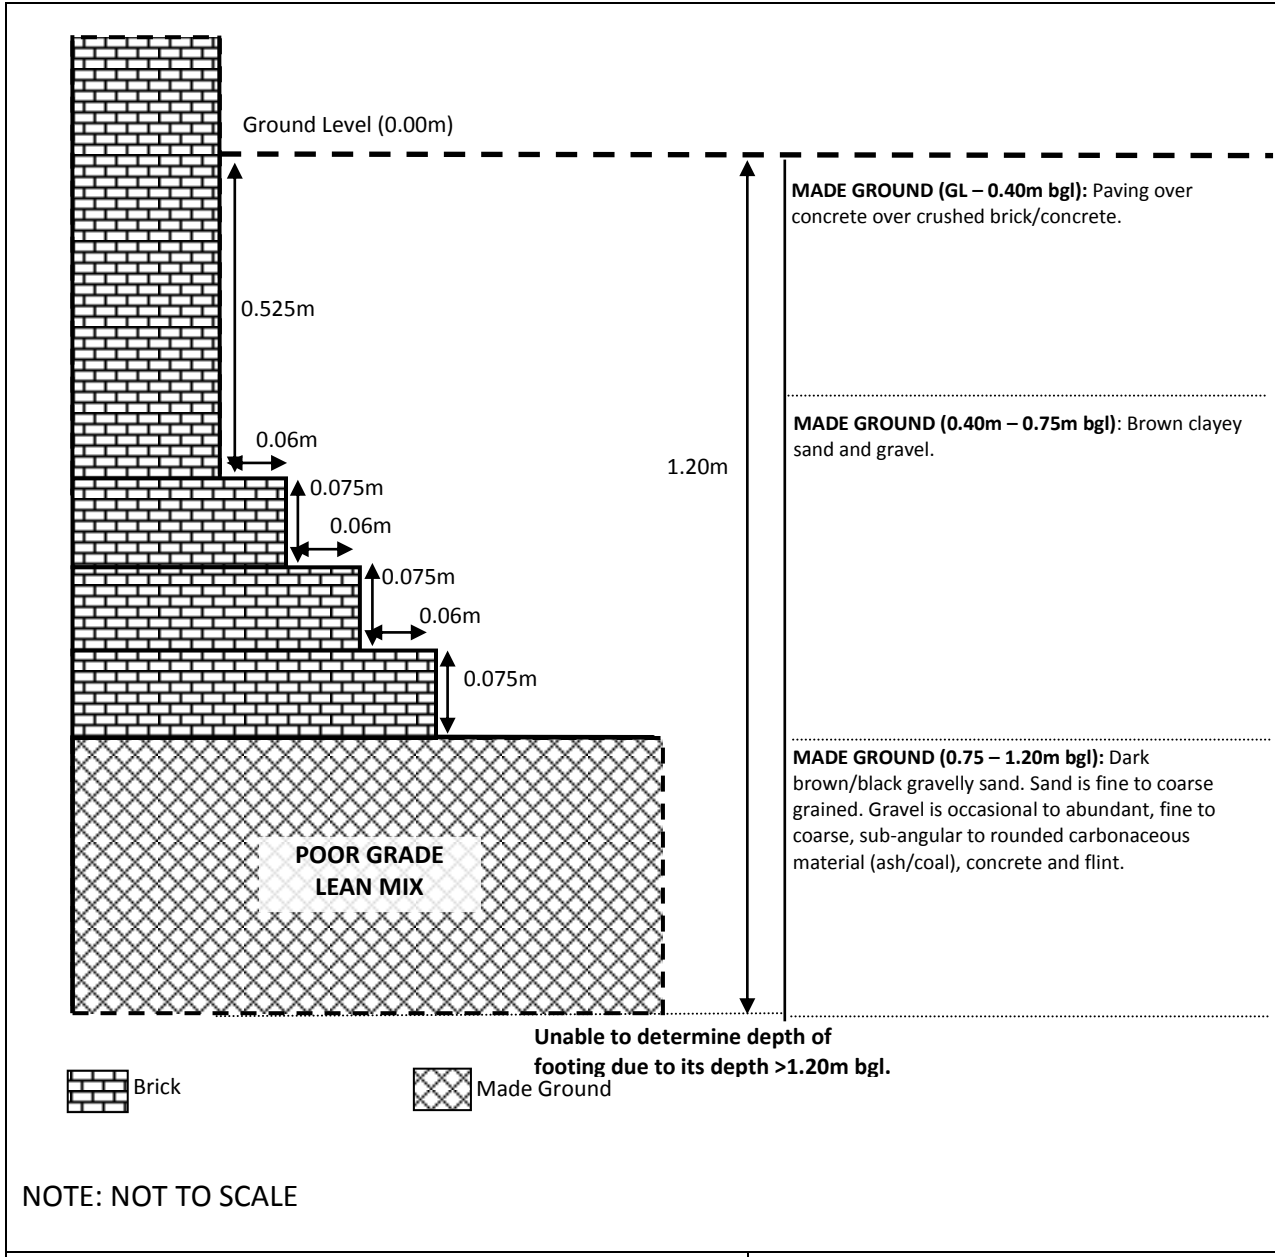
The foundation layout encountered consisted of a brick wall to ground level. The brick wall continued from ground level to a depth of 0.525m bgl and was noted to rest upon three brick steps which were 0.075m in thickness and stepped out by 0.06m. The brick steps rested upon a poor grade lean mix at 0.75m bgl. The extent of the poor grade lean mix could not be determined due to its depth (>1.20m bgl). The ground conditions encountered directly surrounding the foundation are shown in Figure 6 and described in Section 4.1.

Section Drawing: Foundation Exposure TP/FE1

Trial pit foundation exposure TP/FE1 was hand excavated from ground level at the front of the property. The exact location of the trial hole can be seen in Figure 5 with a section drawing of the foundations encountered in Figure 6.

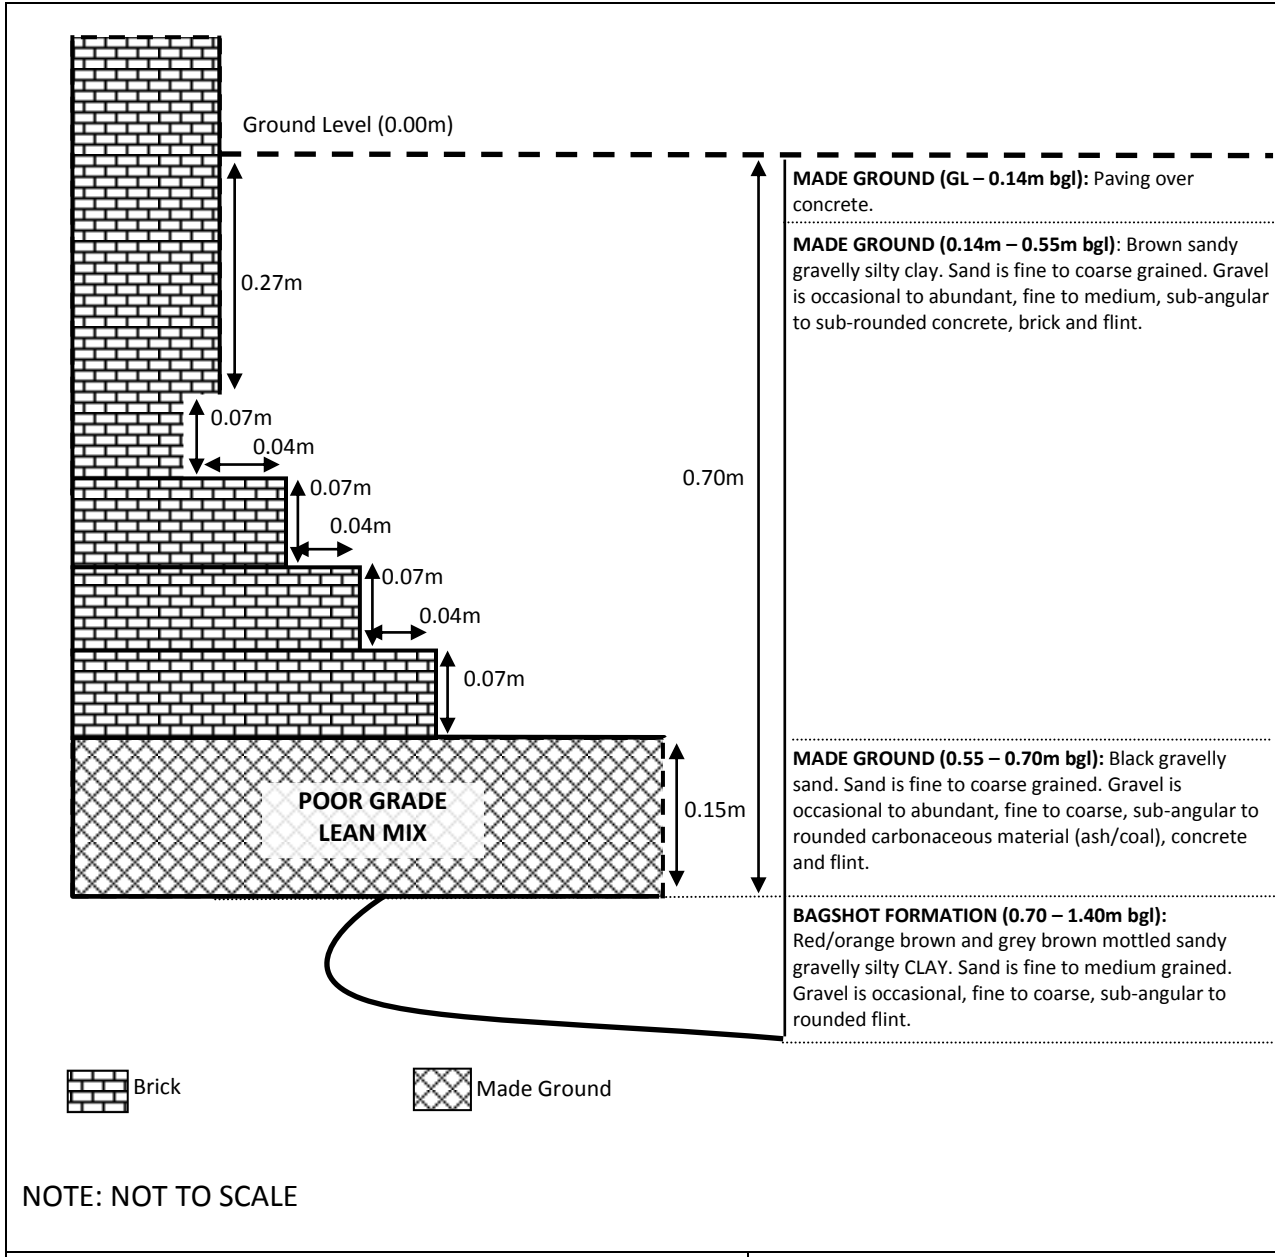
Figure 3

The foundation layout encountered consisted of a brick wall to ground level. The brick wall continued from ground level to a depth of 0.34m bgl and was noted to rest upon three brick steps which were 0.07m in thickness and stepped out by 0.04m. The brick steps rested upon a poor grade lean mix at 0.55m bgl. The poor grade lean mix extended to 0.70m bgl. The ground conditions encountered directly surrounding the foundation are shown in Figure 7 and described in Section 4.1.

Project: 14 Rosecroft Avenue, Hampstead, London NW3 7QB	
Client: Vincent and Rymill	Date: March 2016
Section Drawing: Foundation Exposure TP/FE2	Ref: GWPR1540

Trial pit foundation exposure TP/FE2 was hand excavated from ground level at the rear of the property. The exact location of the trial hole can be seen in Figure 5 with a section drawing of the foundations encountered in Figure 7.

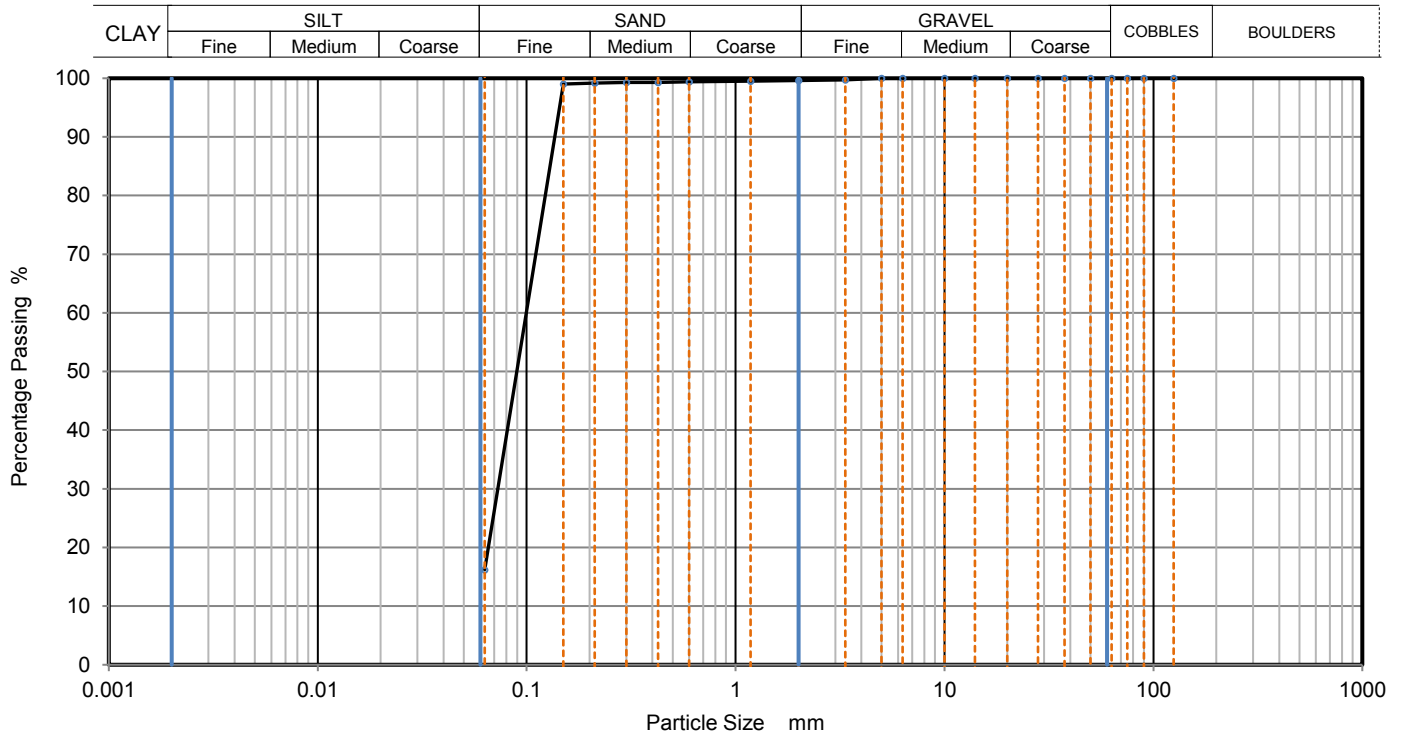
Job Ref	20362
Borehole/Pit No.	WS1
Sample No.	
Depth	3.00 m
Sample Type	D
Samples received	12/02/2016
Schedules received	12/02/2016
Project started	15/02/2016
Date tested	26/02/2016

Site Name	14 Rosecroft Avenue, Hampstead		
Project No.	GWPR1540	Client	Ground and Water Ltd
Soil Description	Orangish brown clayey SAND		
Test Method	BS1377:Part 2: 1990, clause 9.0

Sieving		Sedimentation	
Particle Size mm	% Passing	Particle Size mm	% Passing
125	100		
90	100		
75	100		
63	100		
50	100		
37.5	100		
28	100		
20	100		
14	100		
10	100		
6.3	100		
5	100		
3.35	100		
2	100		
1.18	100		
0.6	99		
0.425	99		
0.3	99		
0.212	99		
0.15	99		
0.063	16

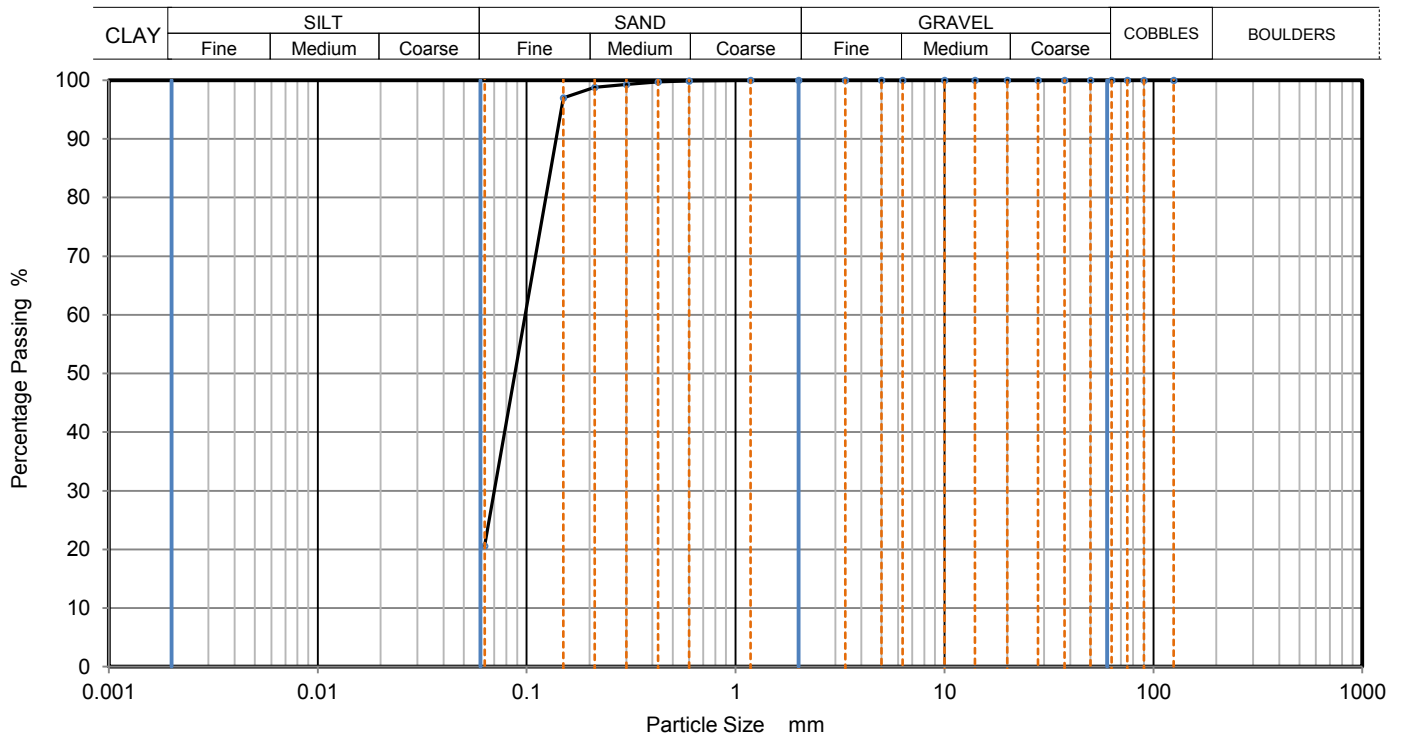
Job Ref	20362
Borehole/Pit No.	WS2
Sample No.	
Depth	6.00 m
Sample Type	D
Samples received	12/02/2016
Schedules received	12/02/2016
Project started	15/02/2016
Date tested	26/02/2016

Site Name	14 Rosecroft Avenue, Hampstead		
Project No.	GWPR1540	Client	Ground and Water Ltd
Soil Description	Brown very clayey SAND		
Test Method	BS1377:Part 2: 1990, clause 9.0

Sieving		Sedimentation	
Particle Size mm	% Passing	Particle Size mm	% Passing
125	100		
90	100		
75	100		
63	100		
50	100		
37.5	100		
28	100		
20	100		
14	100		
10	100		
6.3	100		
5	100		
3.35	100		
2	100		
1.18	100		
0.6	100		
0.425	100		
0.3	99		
0.212	99		
0.15	97		
0.063	21
