# **Land Contamination and Geotechnical Assessment**

**Nos. 1-6 Regent House**

**Pratt Mews**

LBH4398 Ver 2.0

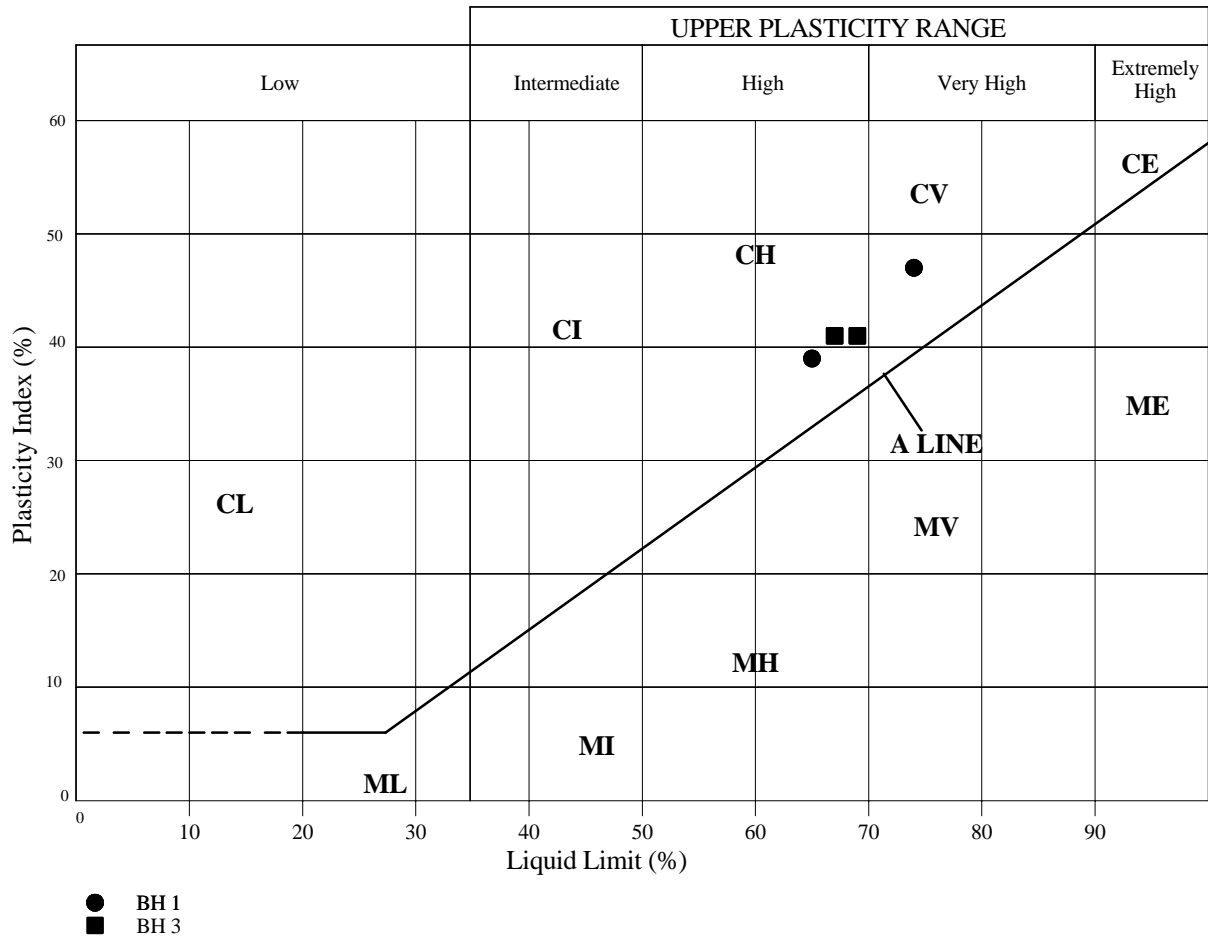
Lab. Ref. 16.03.004

**PLASTICITY CHART**

The results of plasticity index testing have confirmed the London Clay underlying the site to be of high shrinkability.

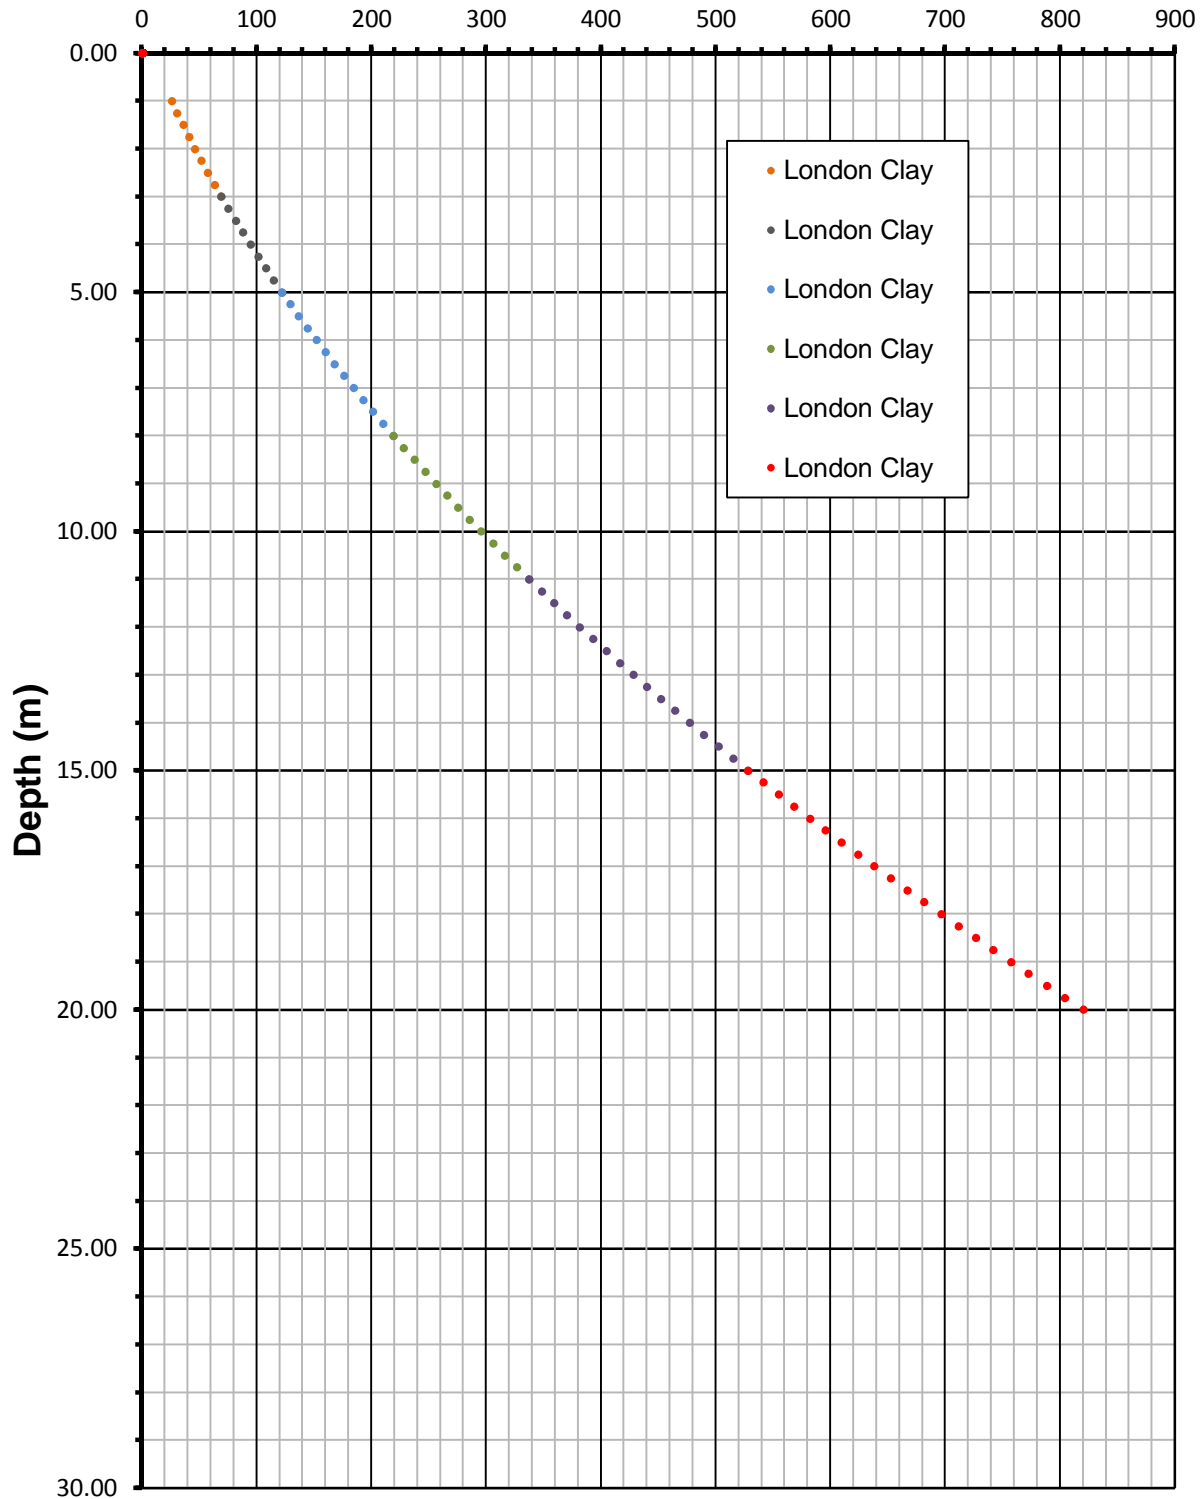
### Combination 2 ULS analysis (GEO loading)

#### Calculated PILE SWL (kN)

Preliminary graphs of Pile Safe Working Load (SWL) based on Combination 2 ULS GEO are appended for 300mm and 450mm diameter piles. It should be noted that these graphs are based upon an  $\alpha$ -value of 0.5,  $N_c$  of 9 and conservative geotechnical parameters (for these calculated capacities, a clay strength profile of  $50\text{kN/m}^2$  rising by  $7.5\text{kN/m}^2$  per m depth has been assumed).

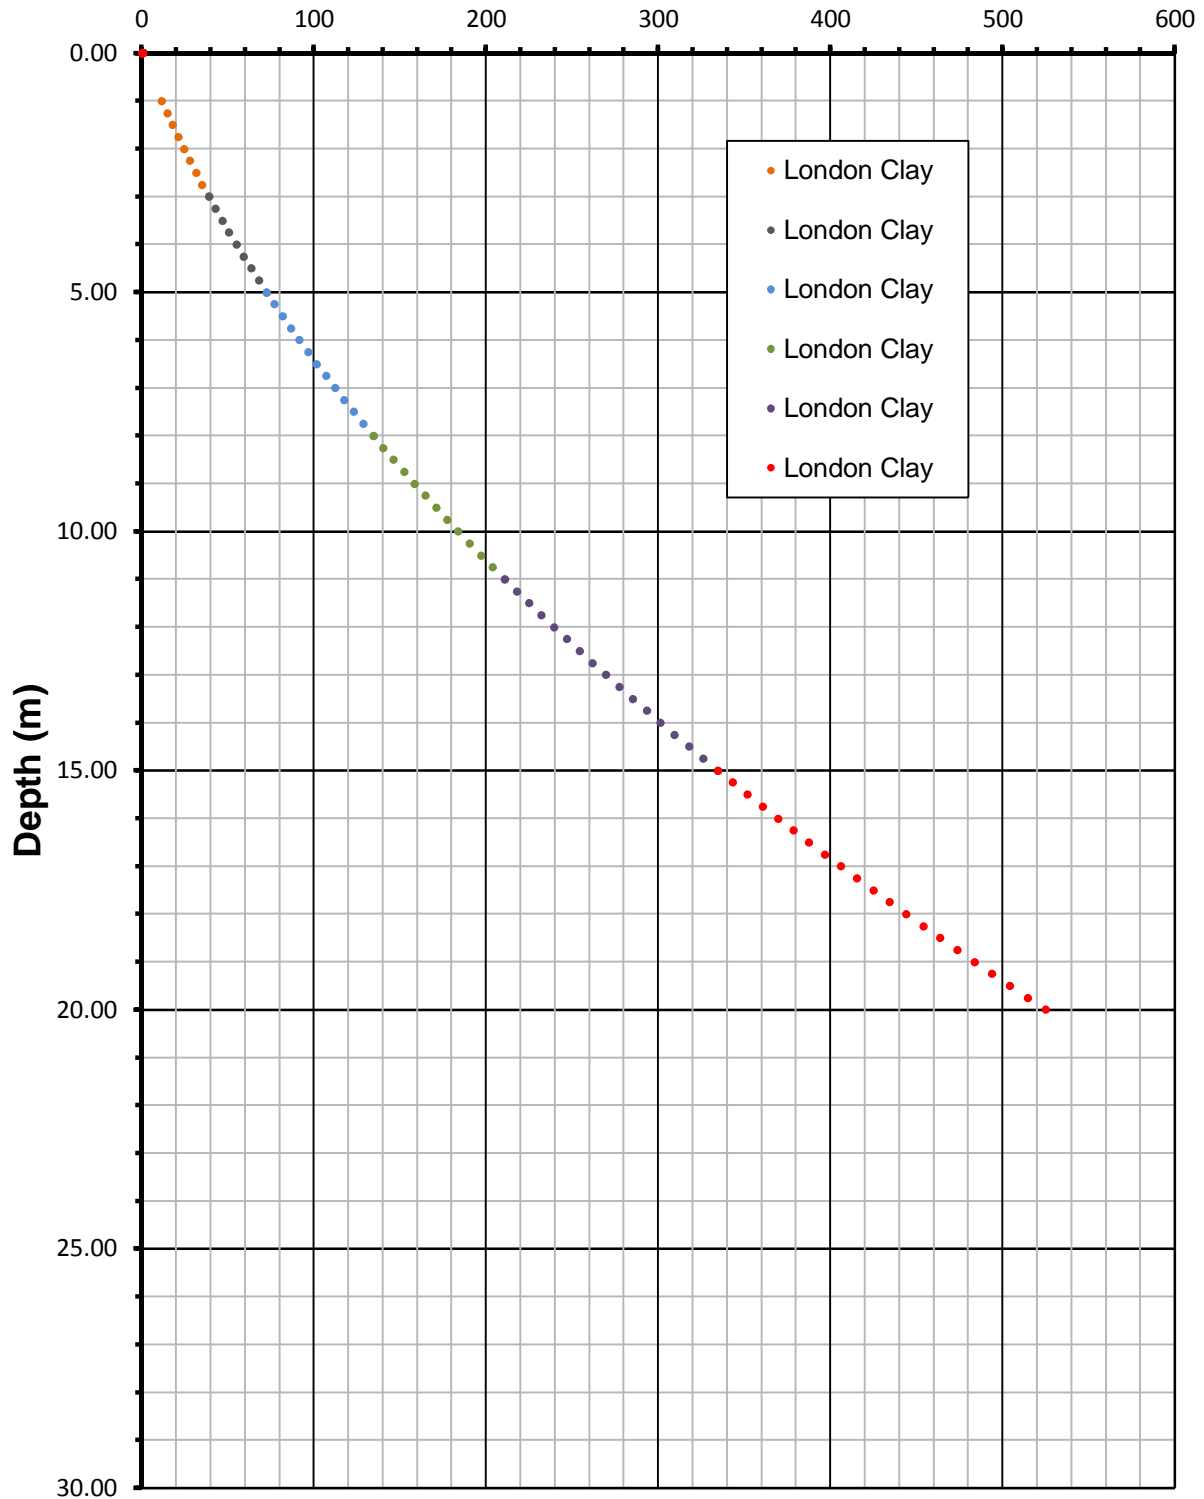
## Combination 2 ULS analysis (GEO loading)

### Calculated PILE SWL (kN)
