Pegasus Life Limited

**79 Fitzjohn's Avenue,
Camden, London**
*Basement impact assessment –
Revision 1*

March, 2016

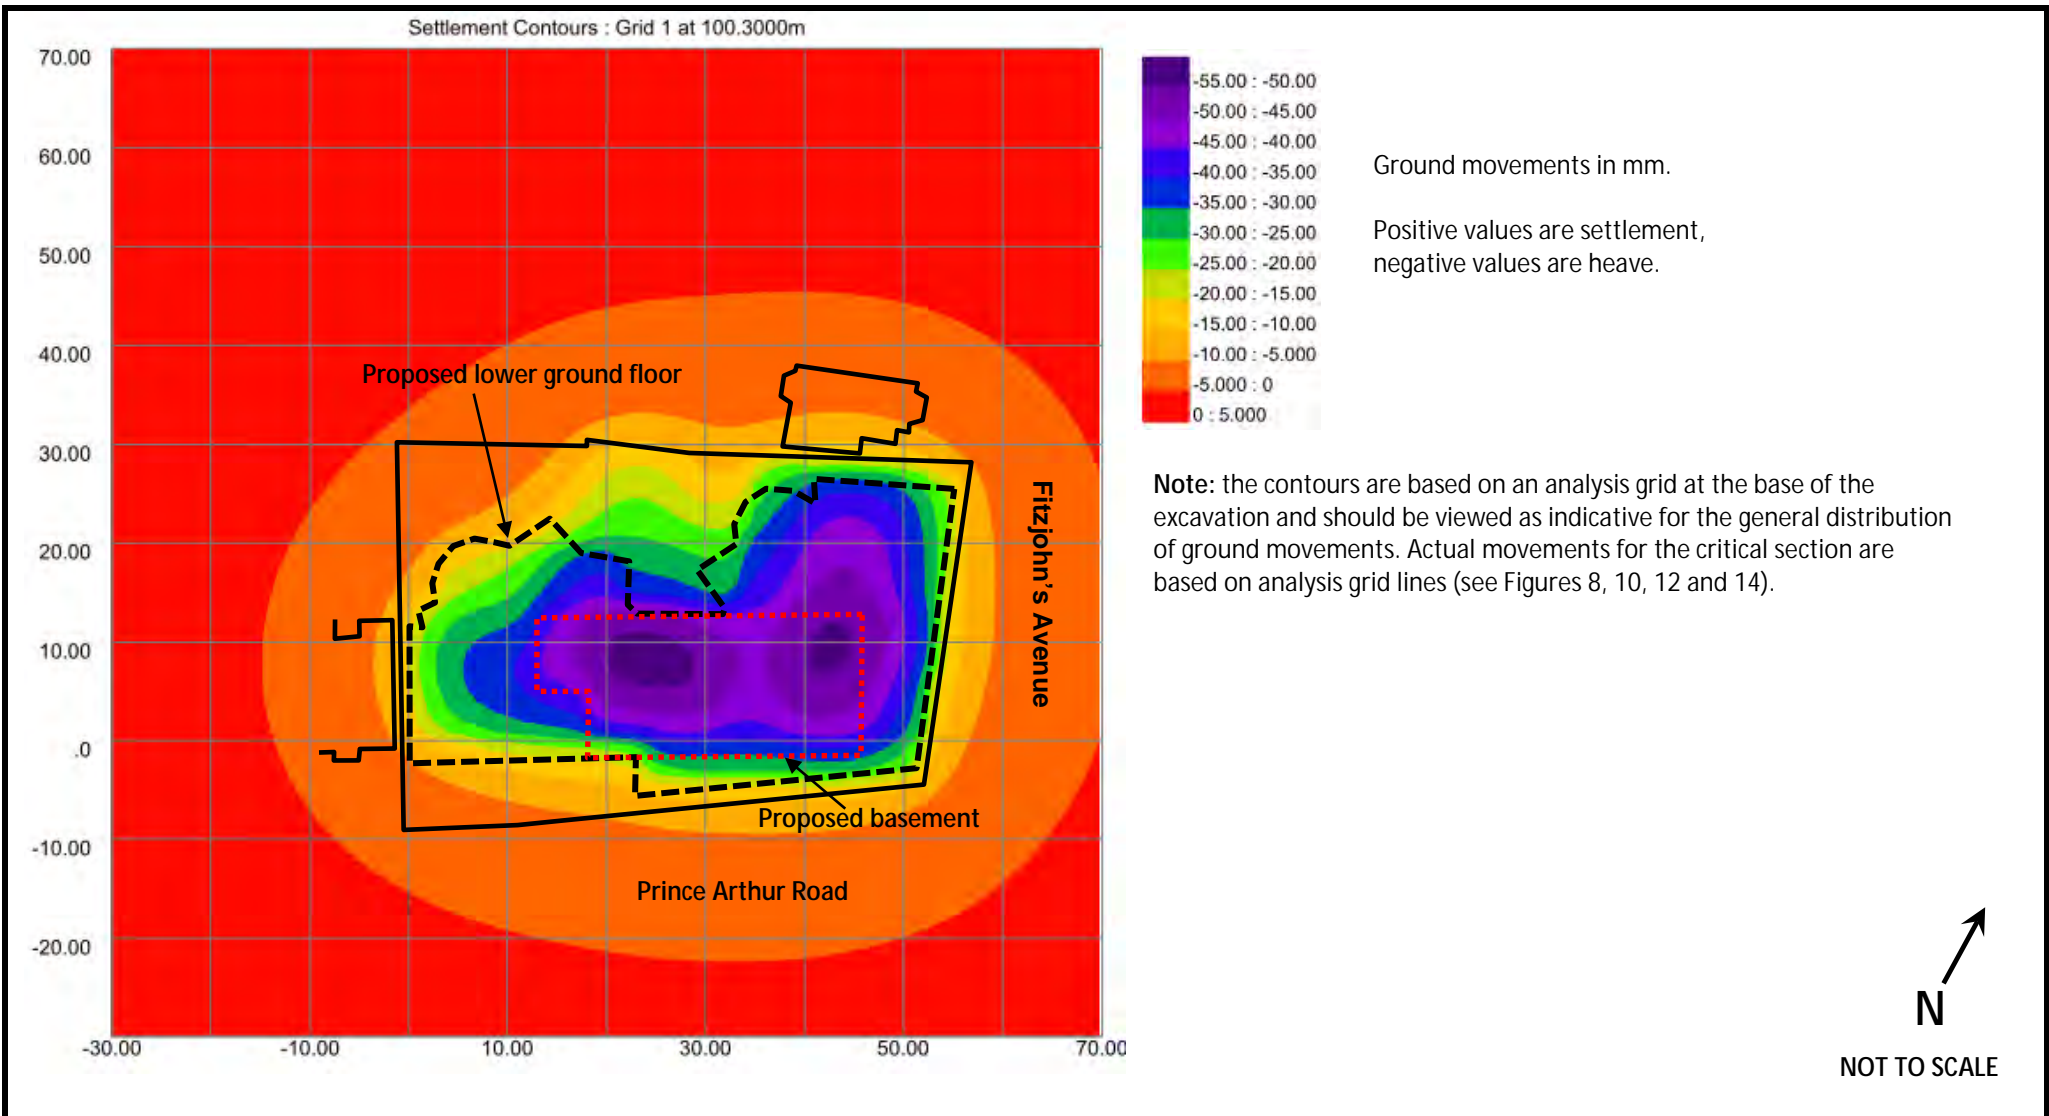
Title Short term ground movement contour plot	Figure 6

Total heave is predicted to be approximately 85mm, occurring beneath the central region of the proposed basement, reducing to around 10mm to 15mm around the basement perimeter and 10mm at the nearest foundation of the adjacent property on Prince Arthur Road.

There is potential for up to 5mm to 10mm of undrained heave within the London Clay around at the basement perimeter, reducing to around 5mm at the nearest foundation of the adjacent property on Prince Arthur Road.

A contour plot showing the short-term ground movements caused by the demolition of the existing buildings on site and the basement excavation within Figure 6 and the long-term

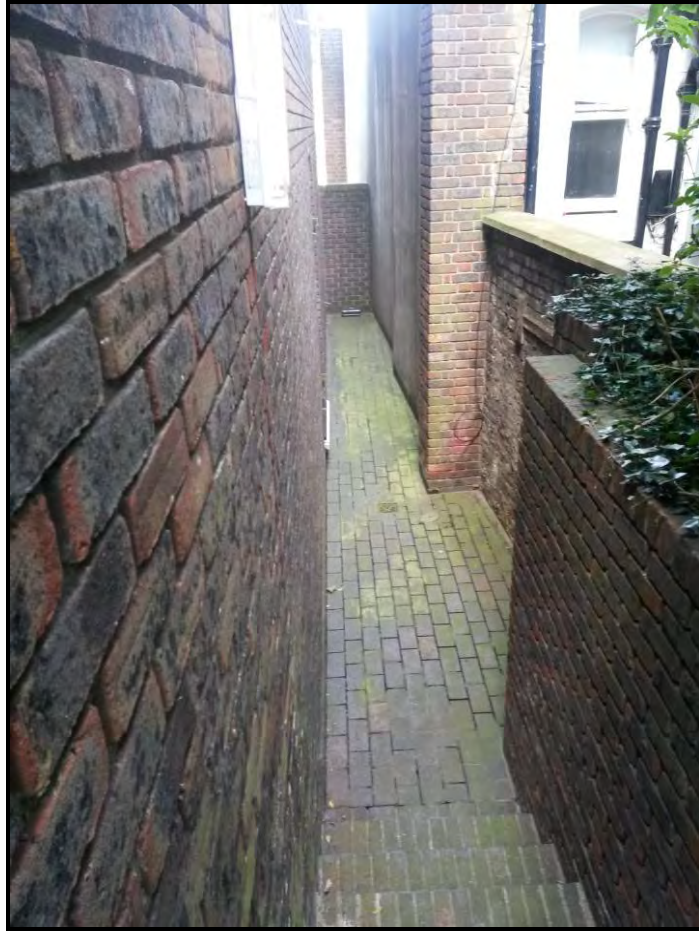
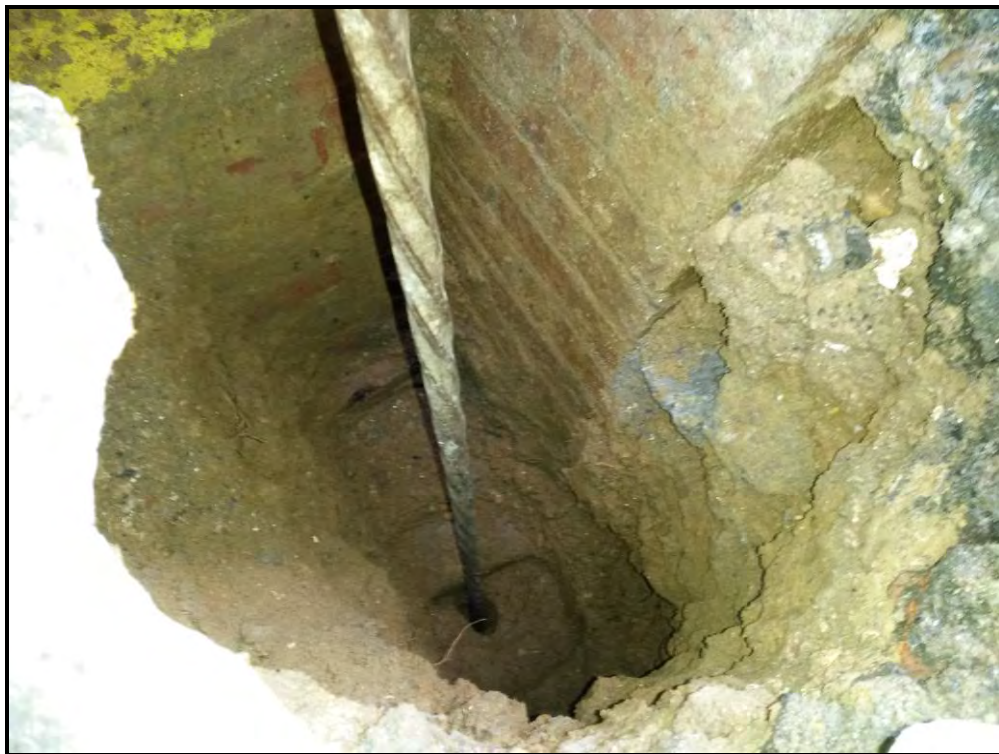
Trial pit 1

Three inspection pits were excavated on the north-western site boundary to expose and record the existing foundations. The foundations are likely to be consistent with those of the neighbouring properties and the details have been used with the land stability assessment.
