# Heritage Statement

**20 – 21 King’s Mews, Holborn,  
London, WC1N 2JB**

This Heritage Statement was commissioned by Marek Wojciechowski Architects on behalf of clients in October 2015 to accompany a pre-application consultation and was prepared by Esther Robinson Wild and Neil Burton of The Architectural History Practice Ltd.

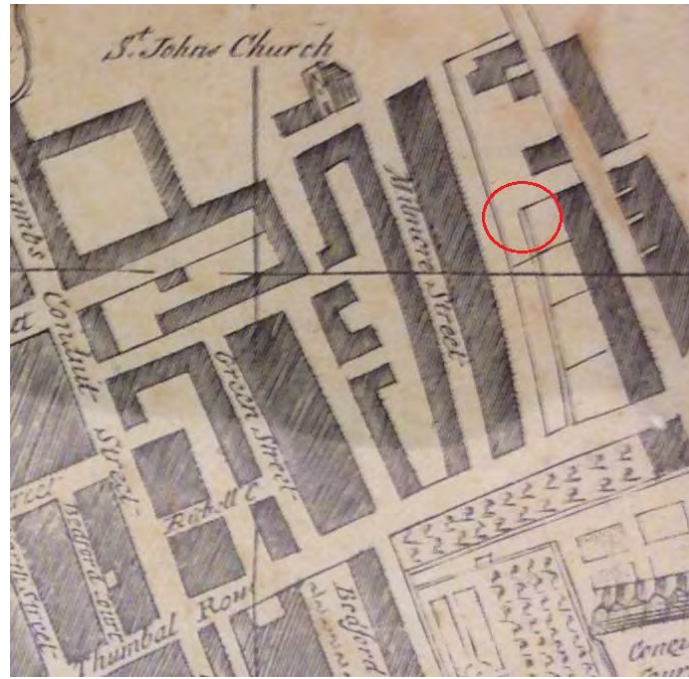
Fig.2 A detail from “A new and exact plan of the city of London and suburbs thereof, with the addition of the new buildings, churches & co.,” 1736 (British Library, ref: Maps CC.6.a.44)

A slightly rough and not wholly reliable map of 1736 (fig.2) does show a track or lane on the line of Kings Mews, but with no buildings. A parish map of 1755 (fig.3) shows buildings exactly as they were shown on the 1720 map, but with some further development along The **King's Way** or **King's Road** (now **Theobald's Road**) which provides the southern access to the mews. There is no obvious explanation for these inconsistencies, but it is clear that King's Mews did exist in some form from the 1720s.

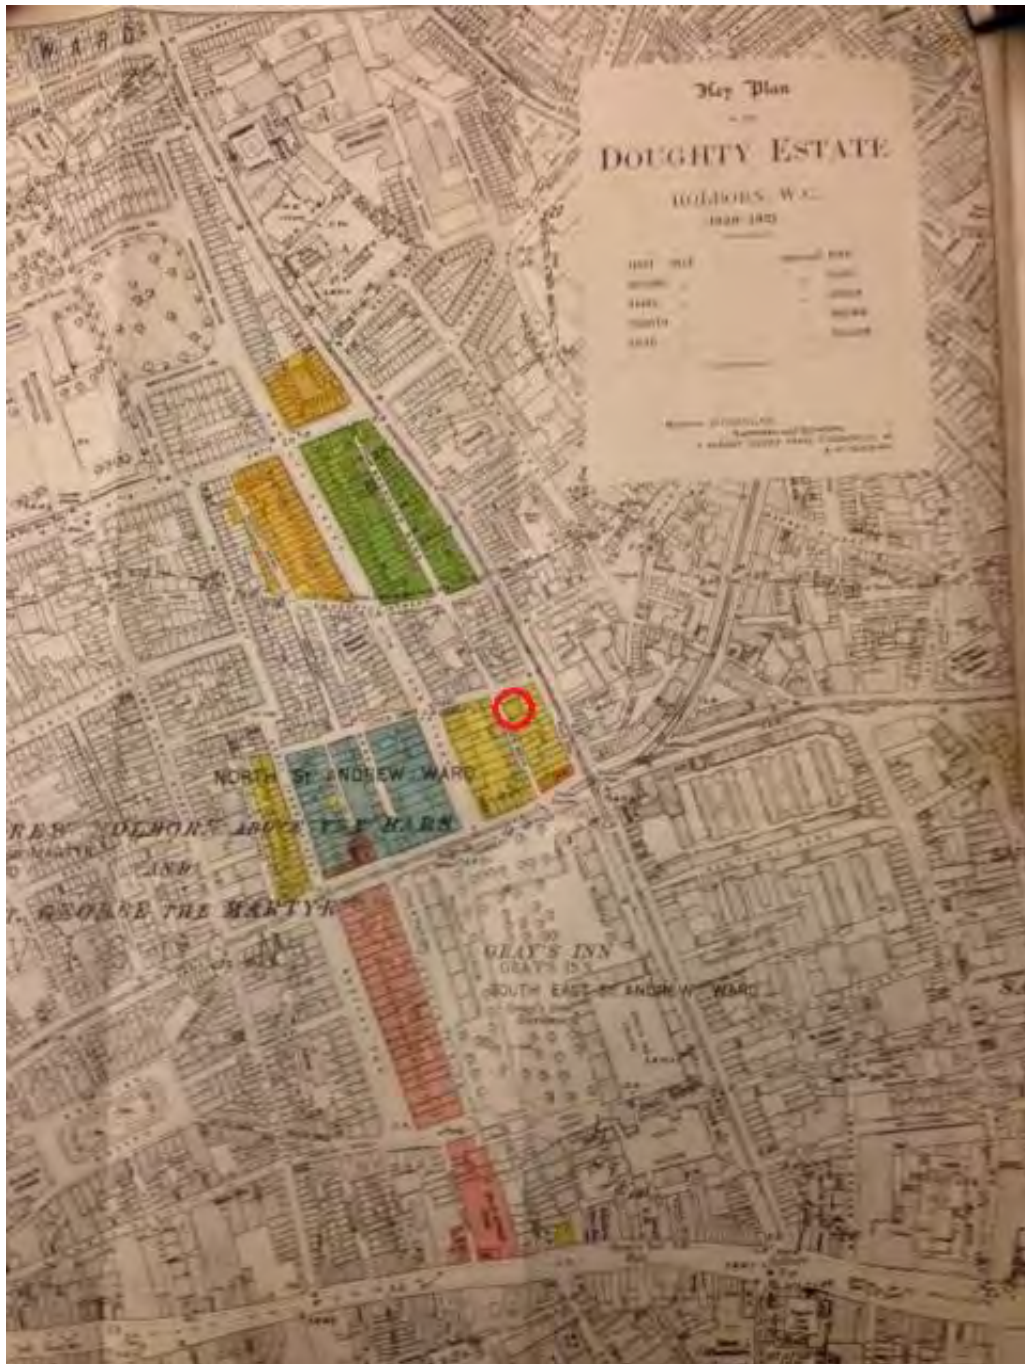
Fig.9 A plan of the Doughty-Tichborne Estate, 1921 (Doughty-Tichborne, London: Doughty-Tichborne)

In 1921, the Doughty-Tichborne family put their entire London estate (fig.9) up for auction. **King's Mews was included in the fifth sale.** Unfortunately, only the sales particulars for the fourth sale are available and so it is not possible to find particular information about the building at this time.

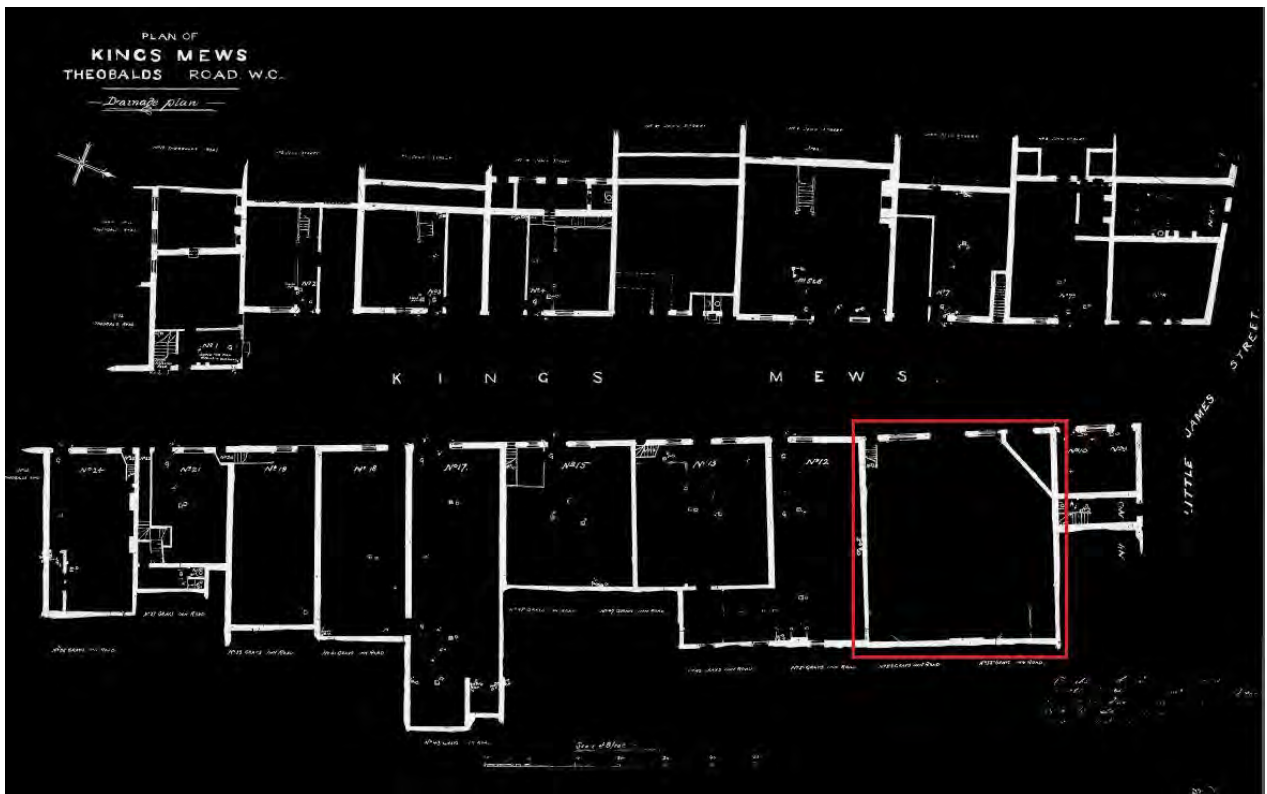
Fig.10 1901 block plan attached to a drainage application of 1936  
(Camden Archives, ref: Drainage Application for 1, 1A, 2-7, 7a, 9, 10, 12, 13, 15, 17-19, **21, 24 King's Mews, October 1936, plate 1**)

A drainage application of 1936 (figs.10-11) (Camden Archives, ref: Drainage Application for 1, 1A, 2-7, 7a, 9, 10, 12, 13, 15, 17-19, **21, 24 King's Mews, October 1936**) suggests that with the introduction of sanitary services the Mews was coming back into use for both commercial and residential services. A block plan attached to the application is dated 1901 and shows the present numbers 20 and 21 as having one main access point to what appears to be the open plan ground floor. Where there are garage doors currently, which also lead into the open space, a doorway leads into a small separate area, the use of which cannot be ascertained from the plan.

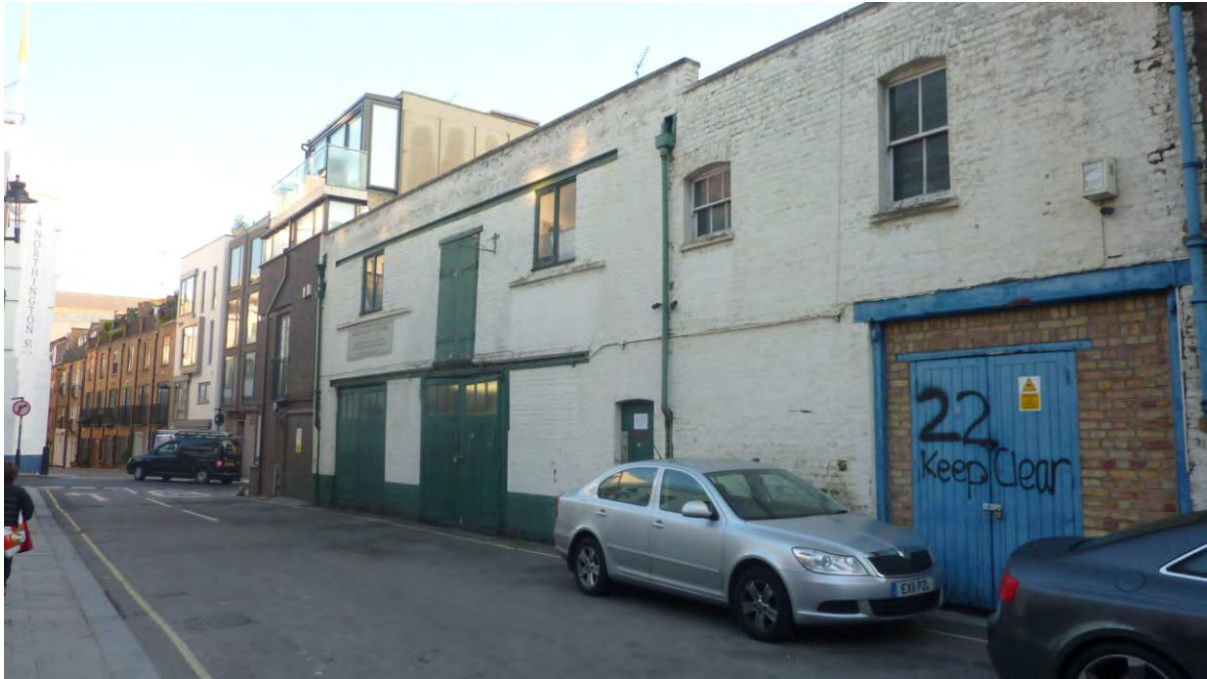
The building has a simple utilitarian façade dominated by large garage doors, is two storeys high and fronts directly onto the mews. It is constructed of brick and the front elevation is painted white with a green painted band at the bottom of **the building's façade**. The brickwork is laid in English bond with later stock brick alterations laid in stretcher bond

(fig.13). The ground floor has two large timber and part glazed double garage doors giving direct access into the garage. These are likely to be in the place of the original openings and where the coach house and stable doors once stood. Three of the doors are of a plank and batten style with the fourth door on the far right incorporating a small door. The planks are regular and appear to be machine sawn and are probably of twentieth century date. The doors appear to **have Collinge's** strap hinges (fig.16) which were used on the majority of mid to late-nineteenth century stable and coach house doors and it is likely that these have been re-used.

Fig.13 Front elevation to King's Mews

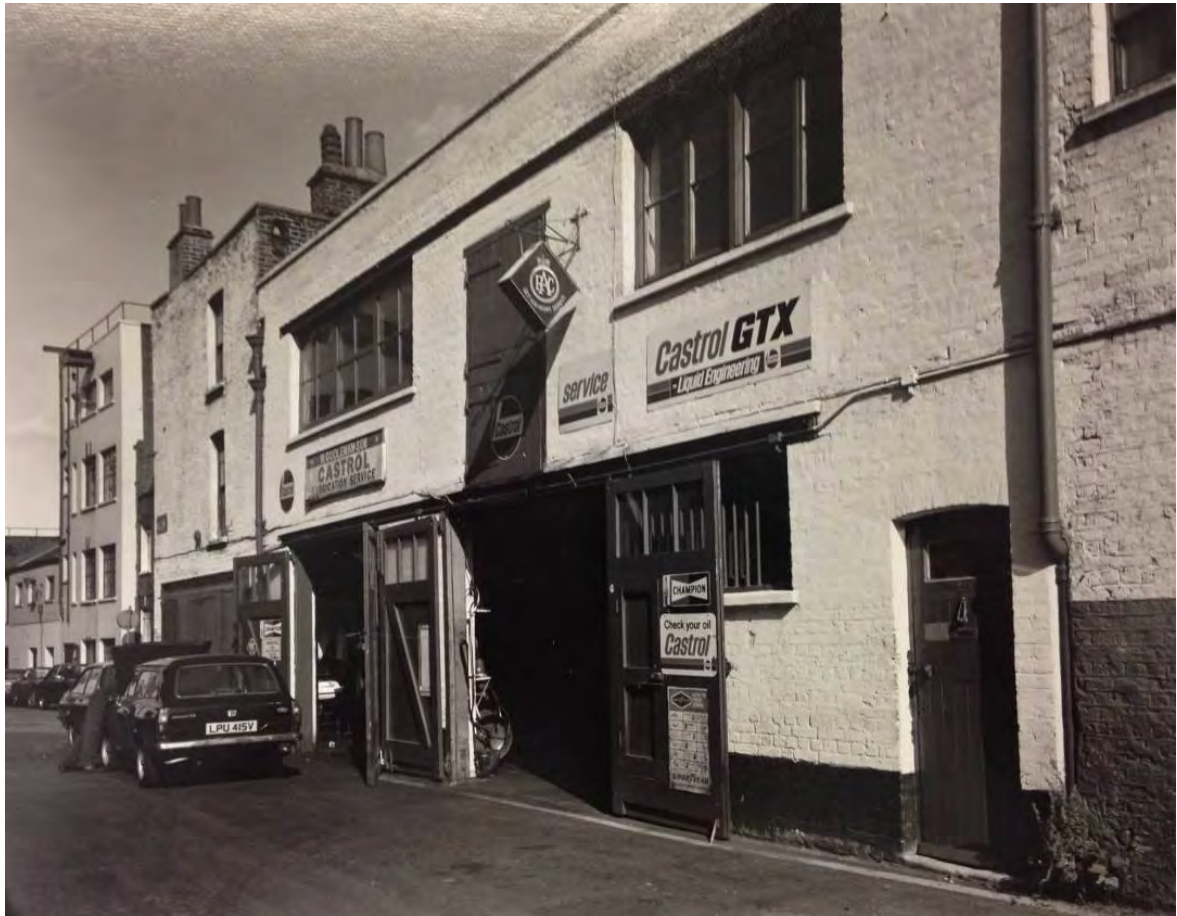
The first floor has two timber casement windows above which there is also a single steel beam running along the centre of the facade. The windows date from after 1980 as the photograph (fig.15) shows larger window apertures and now evidenced by the large sills and the slightly recessed stretcher bond brickwork. The original windows would probably have been timber sashes. The first floor retains the original winch-door opening which gave direct access to the hayloft.

Fig.15 A photograph of the building in 1980  
(Camden Archives, ref: 89.3 KM, 032325, Neg.755. P.D. Barkshire)

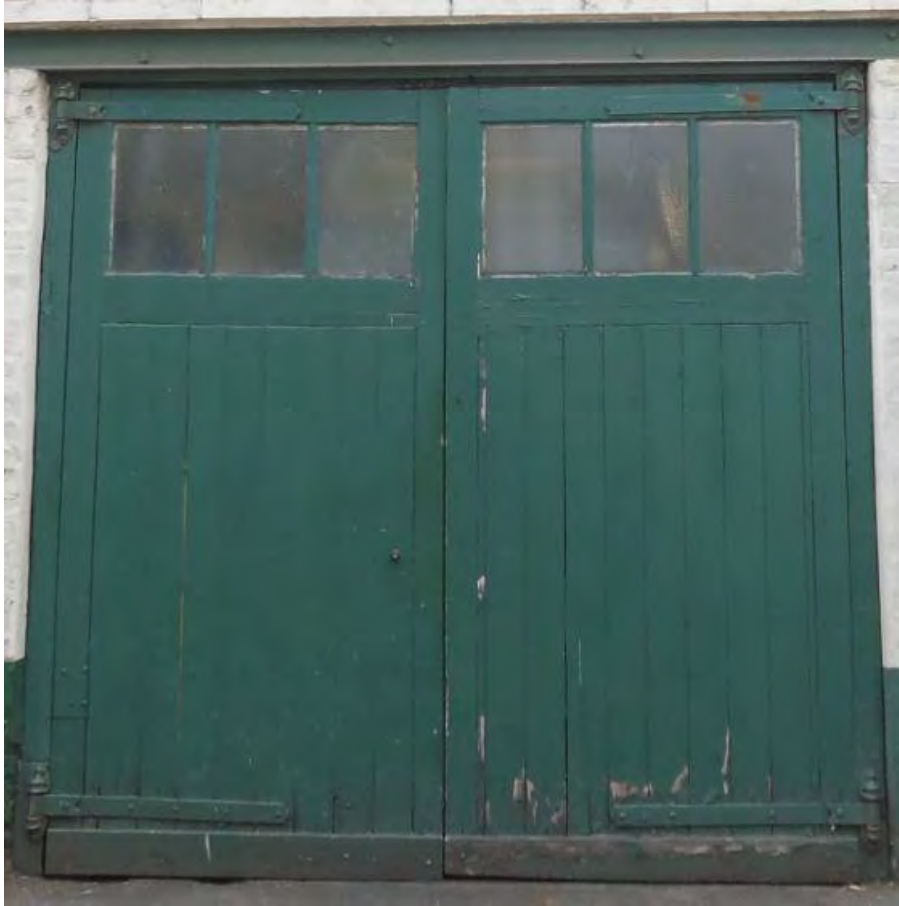
Fig.16 Detail of **Collinge's** hinges

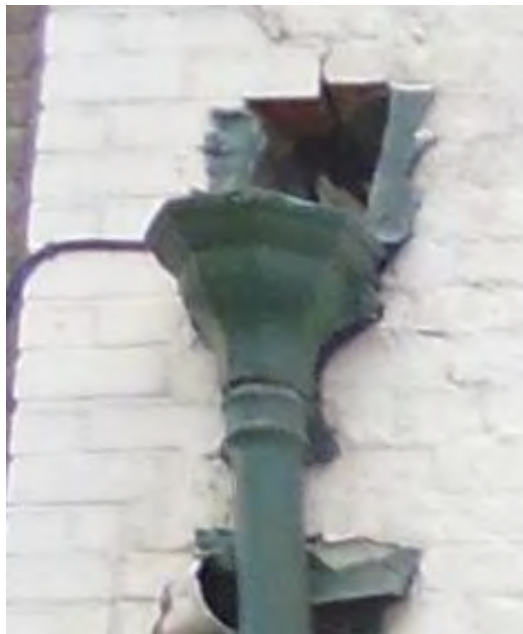
The building has a modern double hipped roof now covered with corrugated sheets, possibly containing asbestos and lead flashing (figs.18-20) behind a plain parapet. The hipped roof to the left has two skylights. The building does not retain any of the architectural details associated with its original use. However, it does retain a single nineteenth century cast iron hopper head located above the right downpipe (fig.17).

Fig.17 Detail of cast-iron hopper head

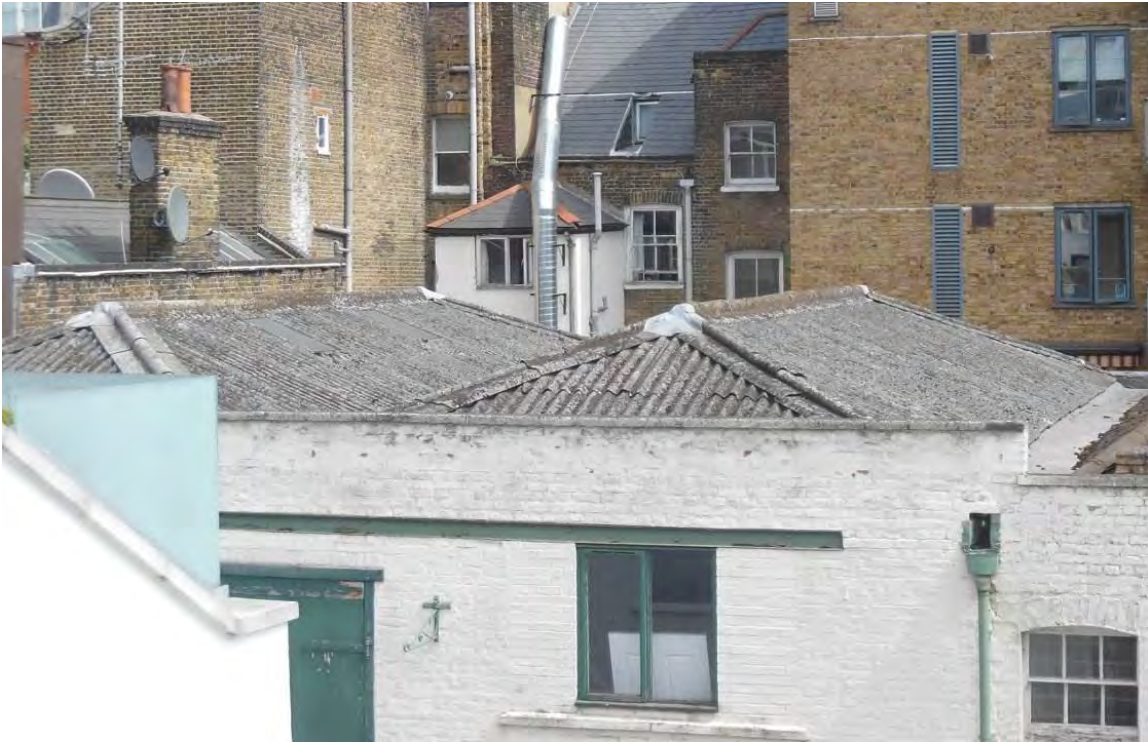
Fig.18 Detail of roof

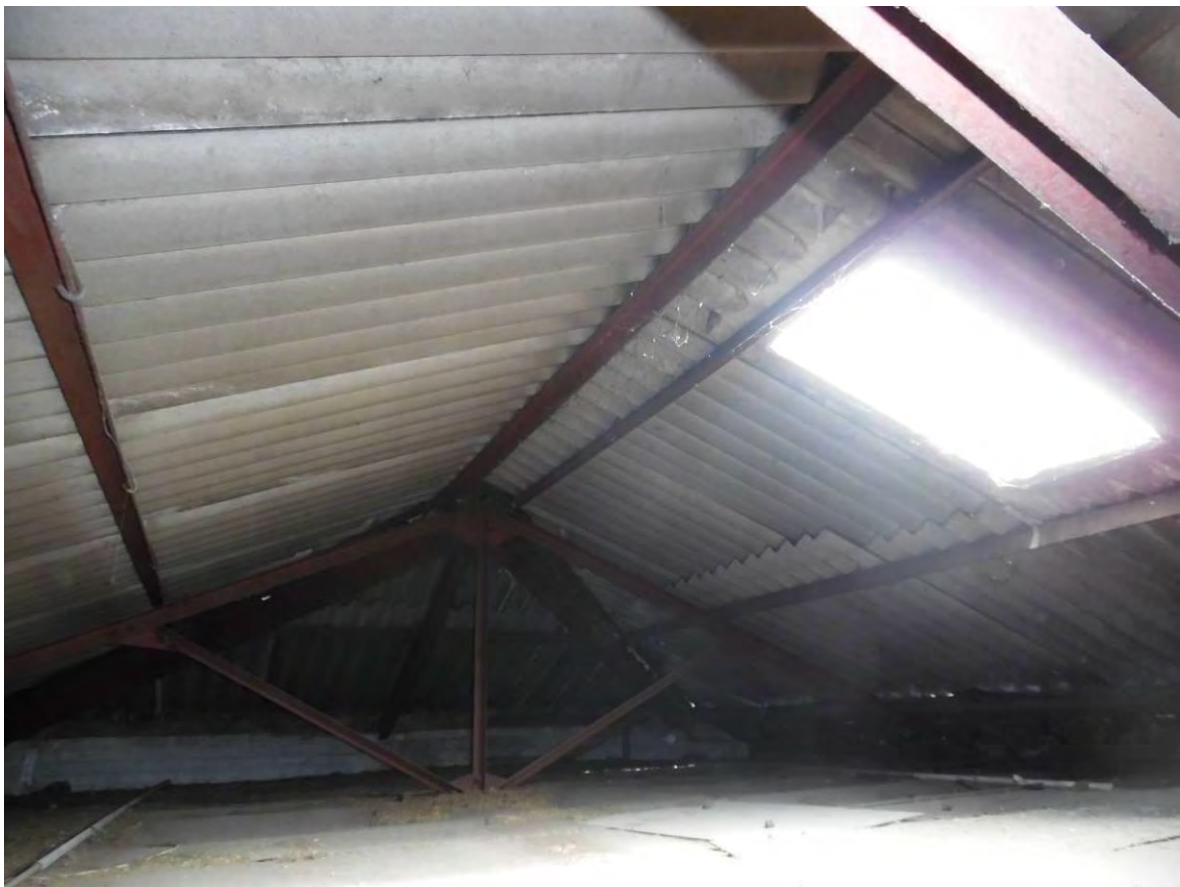
Fig.19 Detail of roof interior (1)

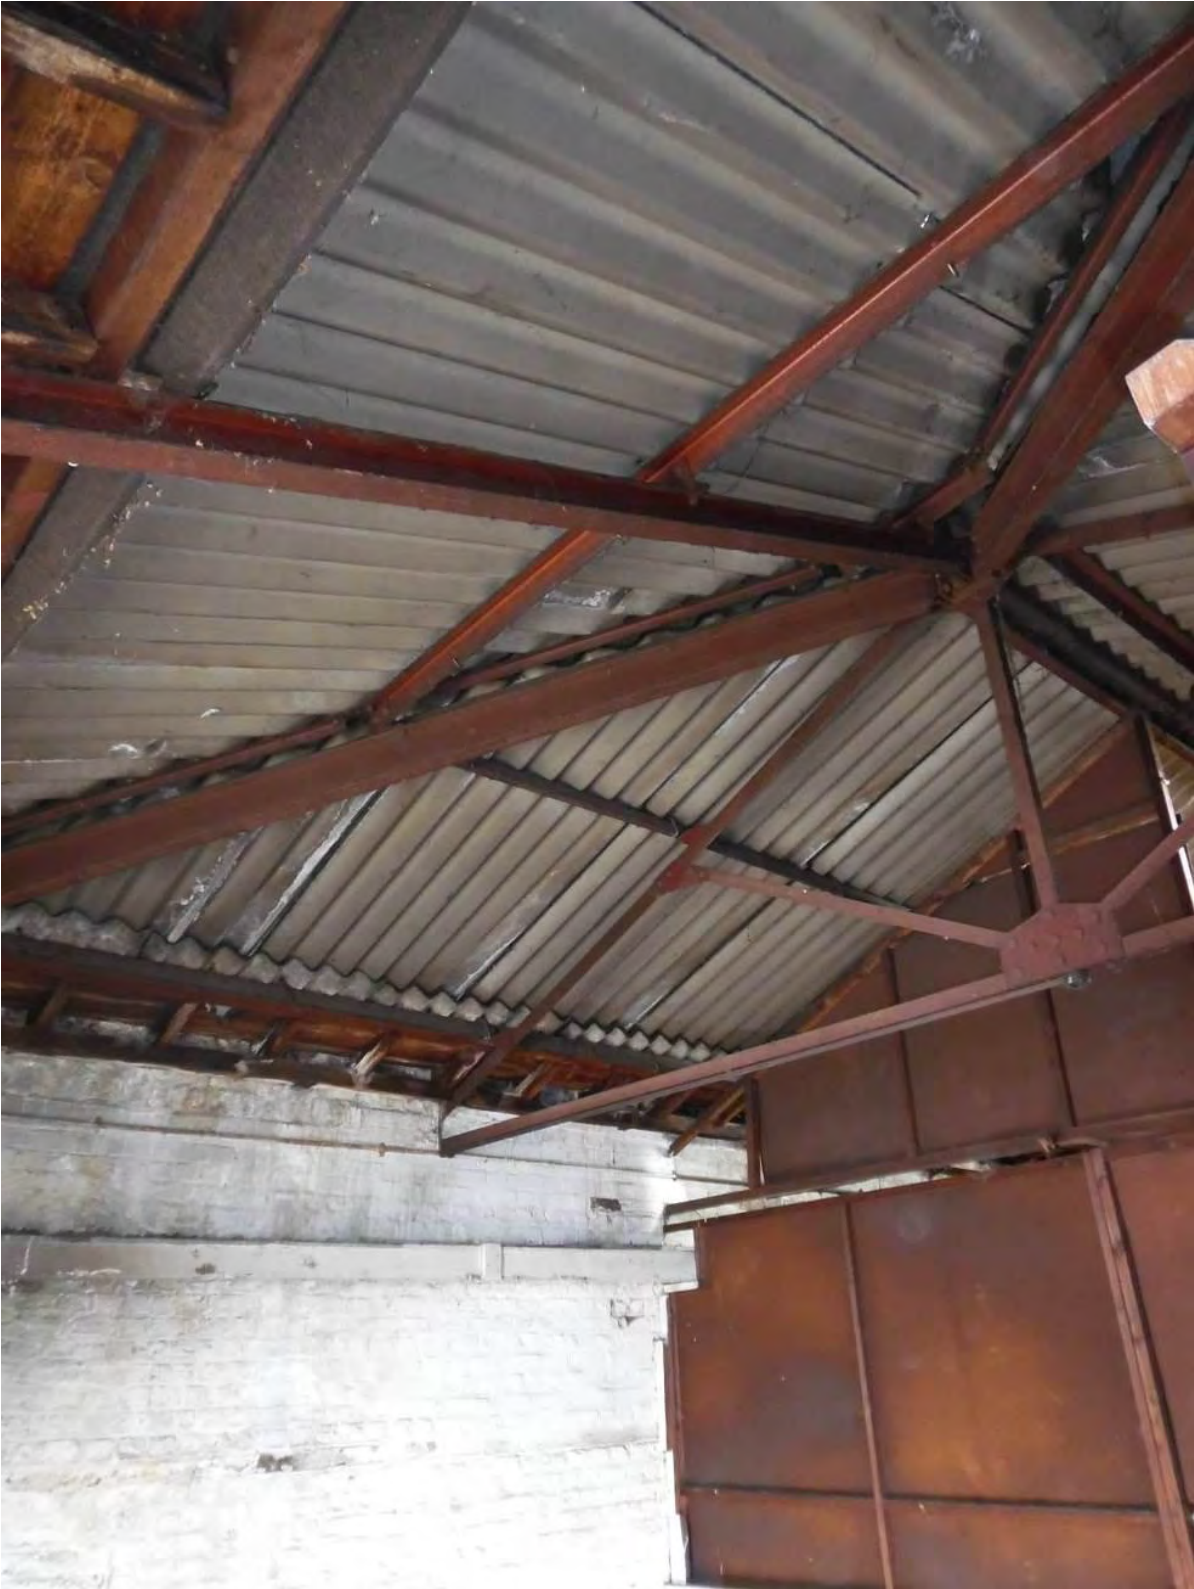
Fig.20 Detail of roof interior (2)

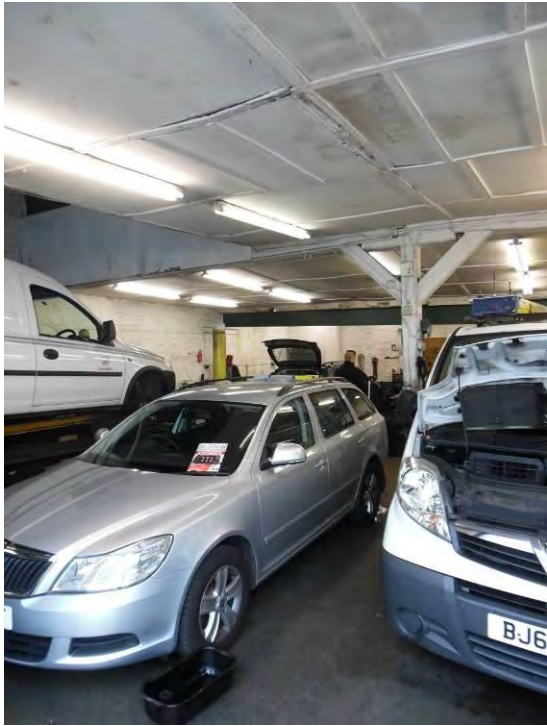
Fig.21 Ground floor interior looking north east

The ground floor is formed of a large open plan space interspersed in the centre by two posts, one timber post to the front of the garage and one modern metal post to the rear (figs.21-22). The front timber post also has a spine beam and braces and is probably of nineteenth century date. The metal post has a metal beam above (fig.24). The ceiling is of modern plasterboard and is coming away in parts. The walls are painted brick and follow the colour scheme of the exterior. The party walls appear to be original to the early to mid-nineteenth century building (fig.25) although the paint covering impedes proper and close assessment of the brickwork. The floor is of modern concrete.

The ground floor has been heavily altered to accommodate motor garage use in the mid twentieth century and extant original fabric appears to be limited to the brick party walls, and the timber spine beam, post and braces.

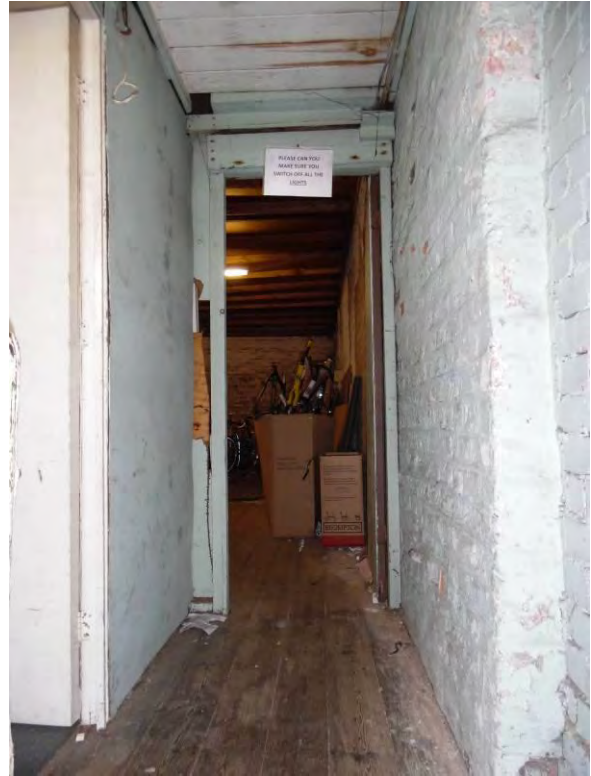
Fig.28 First floor landing looking east

Two doorways lead off the staircase landing. Both doors are modern with the door to the left at the top of the stairs leading to the front partitioned section of the building and the door directly in front of the stairs leading to the open plan rear section (fig.32). The front section has a timber bead and butt partition to the staircase. The ceiling is of timber planks. The walls are of painted brick and there is a slightly recessed blocked opening in the party wall to number 22 at the top of the stairs (fig.31). The enlarged windows inserted when the building was converted to a garage have been partly in-filled with Fletton bricks (figs. 29 and 31)

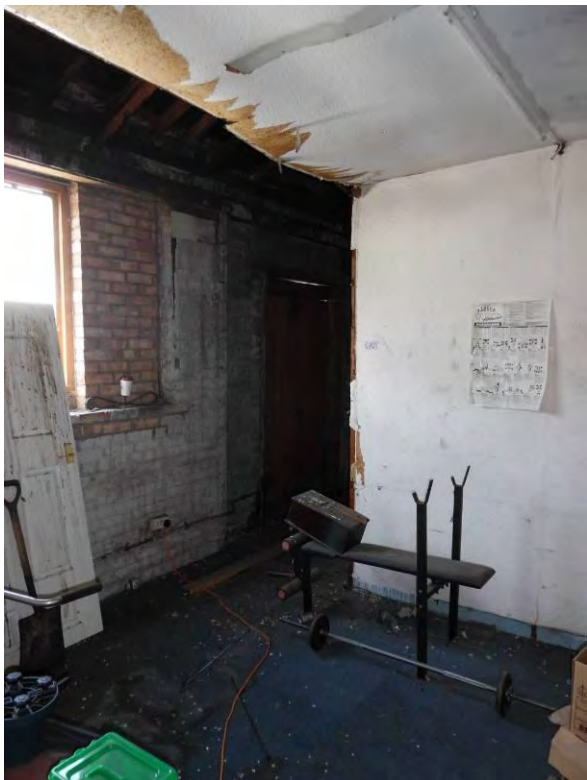
The front left section of the building contains three partitioned spaces. The first space is separated from the right side of the floor by partition boards with a plasterboard false ceiling (figs.29-30). The partitioned section has a felt floor covering. It is possible to clearly see where the post-1980 timber casement window has been inserted (fig.29) in this front area. The new brickwork has not been painted white as with the original brickwork. This section of the floor does not appear to be in use and is in a poor state of repair.

Fig.29 First floor partitioned space at the front of the building looking south east

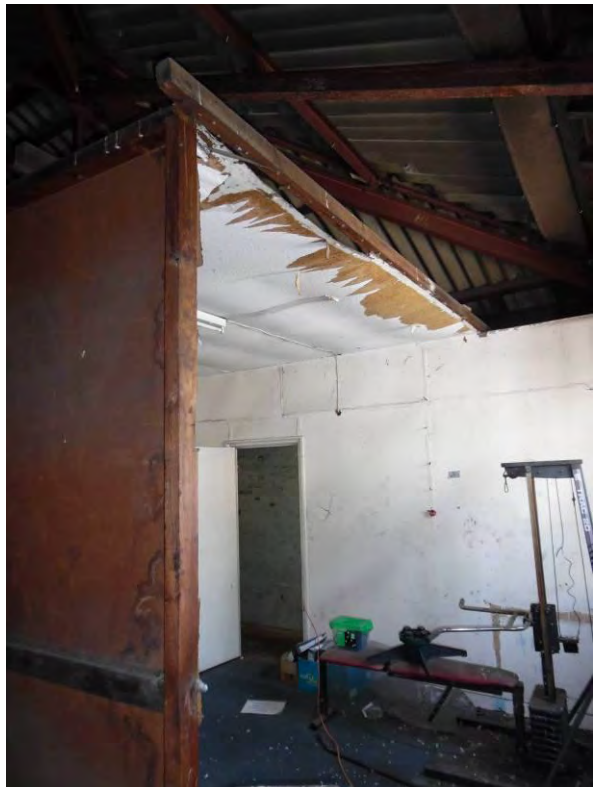
The second central space is delineated by partition boards to the left and the right (figs.30 & 32) and it has exposed floorboards. As with the third far right section which is full height from the ground it is open to the roof (figs. 31-32). All of the beams and roof structure are modern.

Fig.30 First floor partitioned space at the front of the building looking north-west

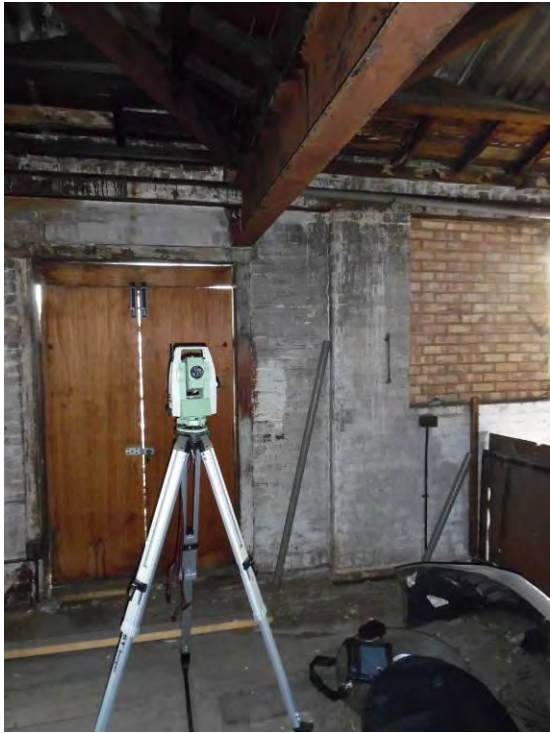
The original first floor plan would have consisted of two spaces, one given over to the hayloft at the front and the other accommodating the Mews staff which dealt with the horses. The hayloft was accessed directly from the Mews below through the winch-doors (fig.31).

The timber winch-door lintel and jambs are exposed and these appear to be original to the building. The doors are faced with modern plywood boards (fig.31).

Fig.31 First floor part partitioned space at the front of the building looking west

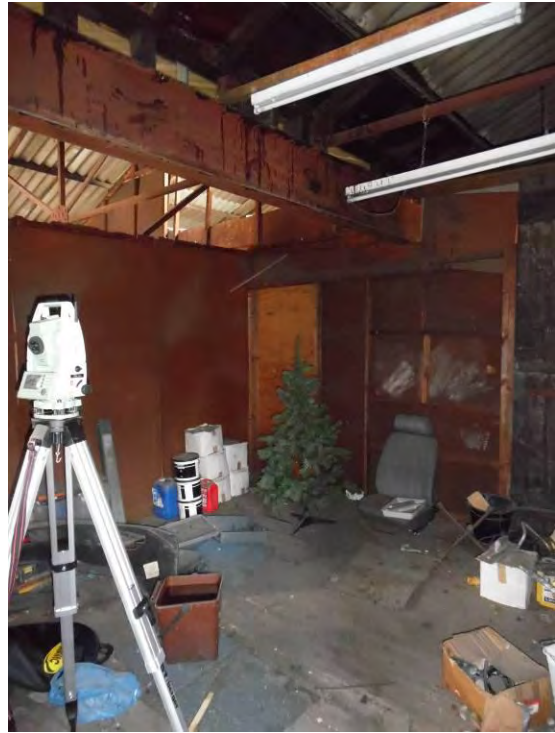
Fig.32 First floor part partitioned space at the front of the building looking north east

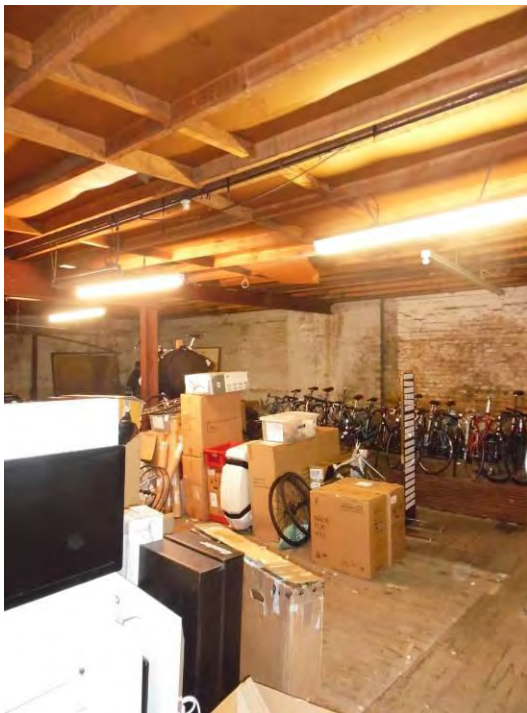
Fig.33 First floor rear open plan space looking north east

The rear open plan section runs the width of the building. It has exposed red brickwork (fig.34) in parts. The ceiling of boards and timber beams appears to be relatively new (fig.33-36). As with the front section, the exposed supporting beams and posts are modern and the floor is of exposed timber floorboards. It also appears to contain a trapdoor (fig.33). The space is used for storage and is in a relatively good state of repair.

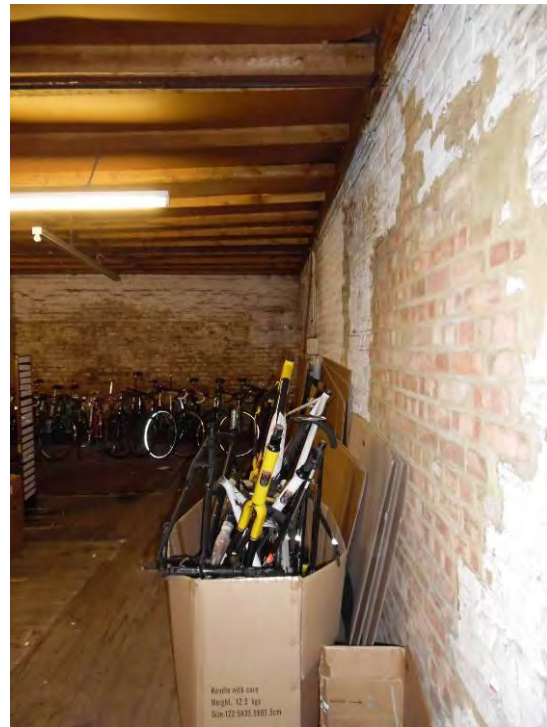
Fig.34 First floor rear open plan looking east
