35 Gloucester Crescent front boundary wall details: Notes from Primrose Hill Conservation Area Advisory Committee

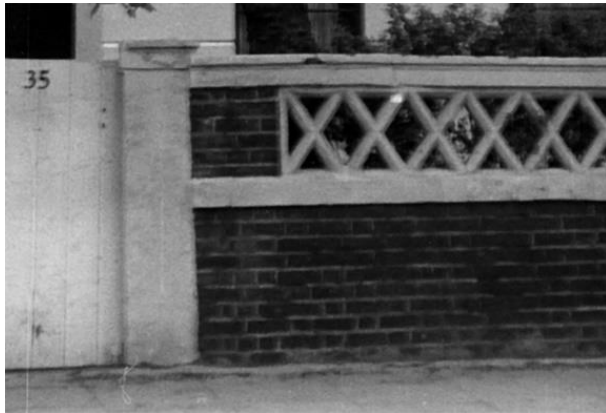
In 1972

35 Gloucester Crescent

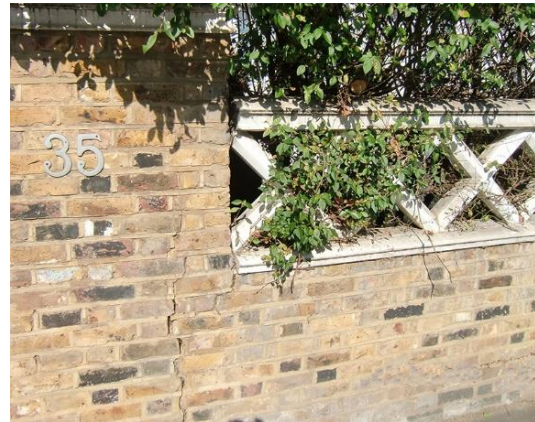
In 2016

Note that the form of the cross is too long in the modern replacement, while the upper and lower mouldings are also incorrect.

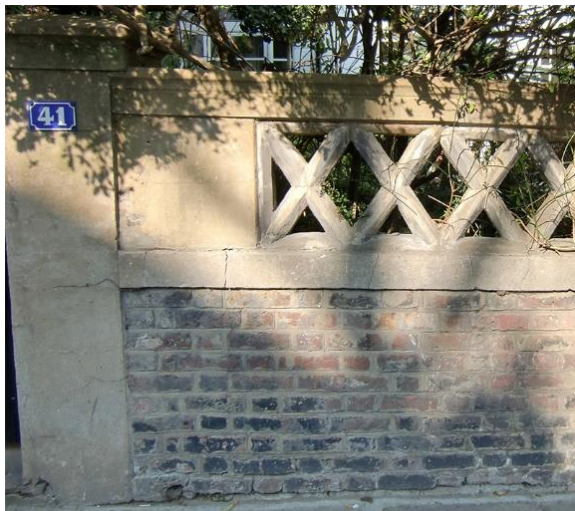
No. 41 Gloucester Crescent

Example of original detail form, note angle of saltire cross and upper and lower junctions with horizontal mouldings
