**PHASE I AND PHASE II GEOTECHNICAL ASSESSMENT**

**3 BELSIZE CRESCENT, LONDON, NW3 5QU**

**Title:** PHASE I AND PHASE II GEOTECHNICAL ASSESSMENT

**Reference:** LS 1985

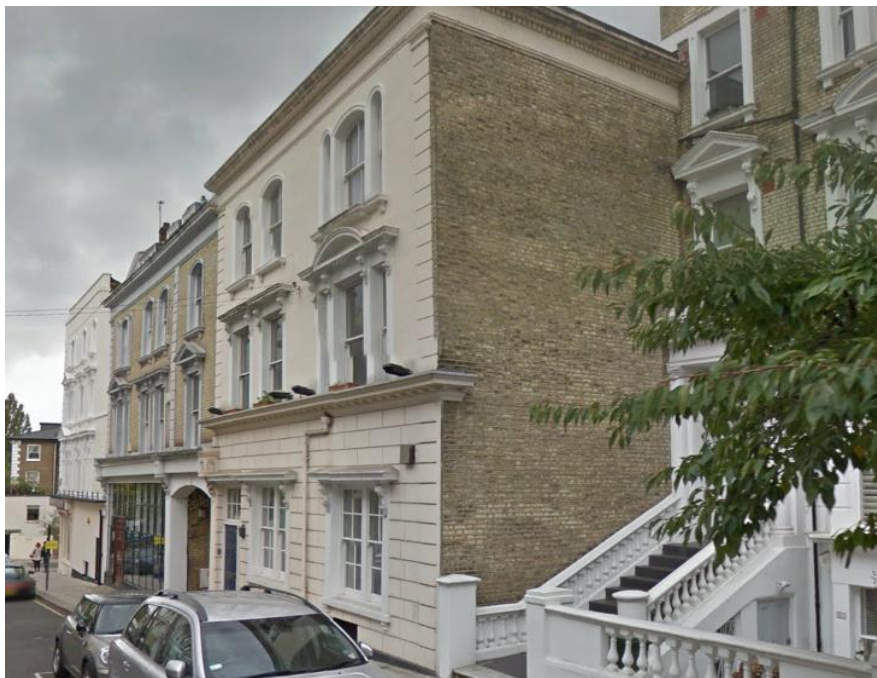
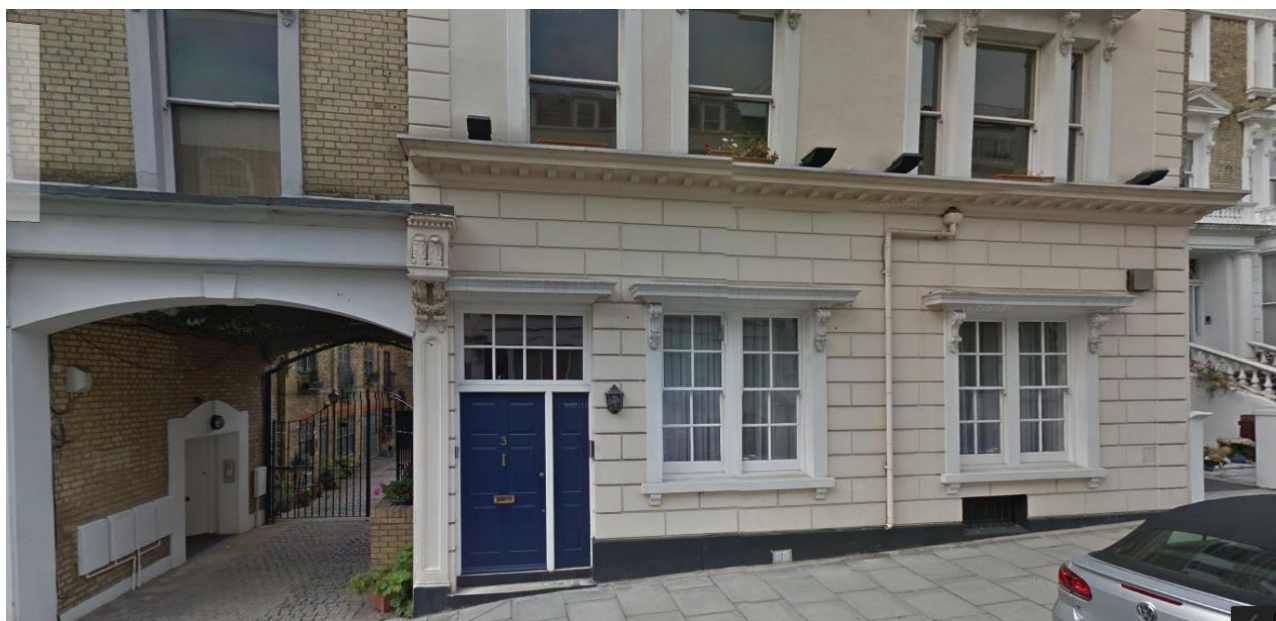
<b>TITLE:</b> Photographs			<b>REF:</b> LS1985
<b>PROJECT:</b> 3 Belsize Crescent, London, NW3 5qu			<b>VERSION</b> v1
<b>CLIENT:</b> David Templer			<b>Photos</b> 1 to 2
<b>PREPARED:</b> JB	<b>CHECK:</b> MR	<b>DATE:</b> 15/01/2016	<b>SHEET No:</b> page: 1 of 2

**Photograph 1 and 2** - View of the north eastern elevation of No 3 Belsize Crescent

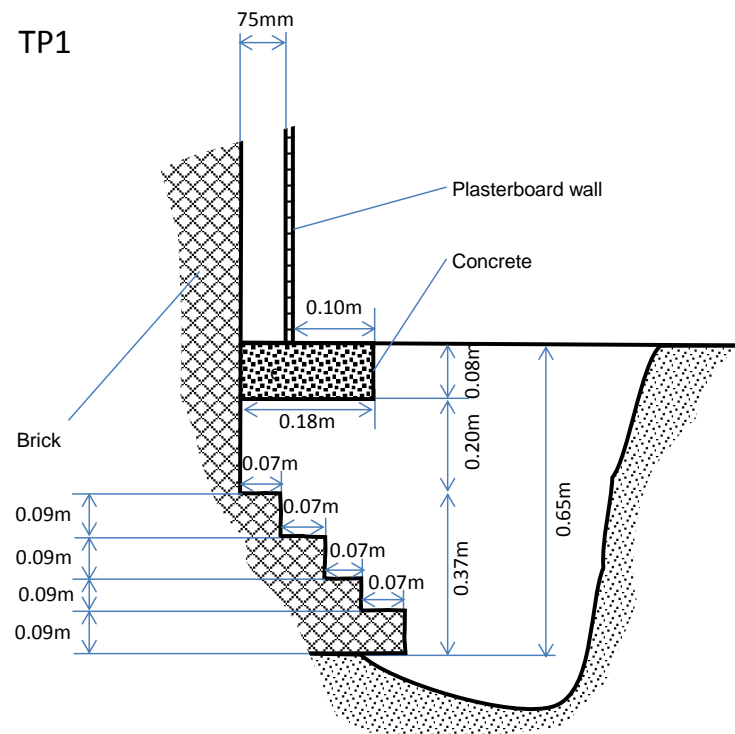
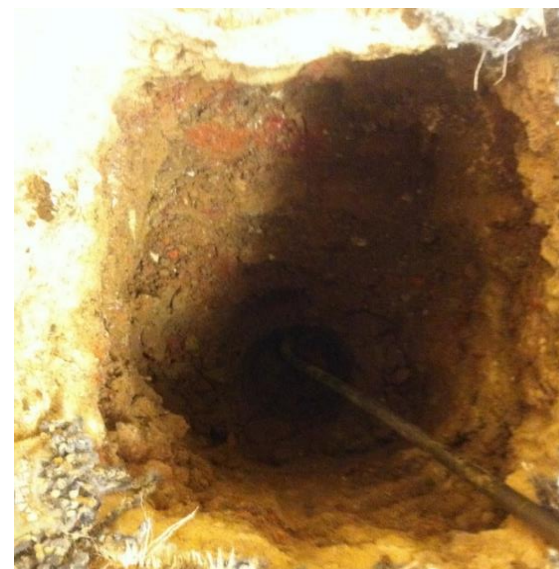
<b>TITLE:</b>	Foundation Exposures	<b>REF:</b>	LS1985	<b>PREPARED:</b>	JB
<b>PROJECT:</b>	3 Belsize Crescent, London, NW3 5QU	<b>VERSION:</b>	v1	<b>CHECKED:</b>	MR
<b>CLIENT:</b>	David Templer	<b>FIGURE:</b>	TP1	<b>DATE:</b>	15/01/2016

Unable to prove foundation depth

A summary of the excavations made to expose and log existing foundations is presented below. Sketches are shown in Appendix B.

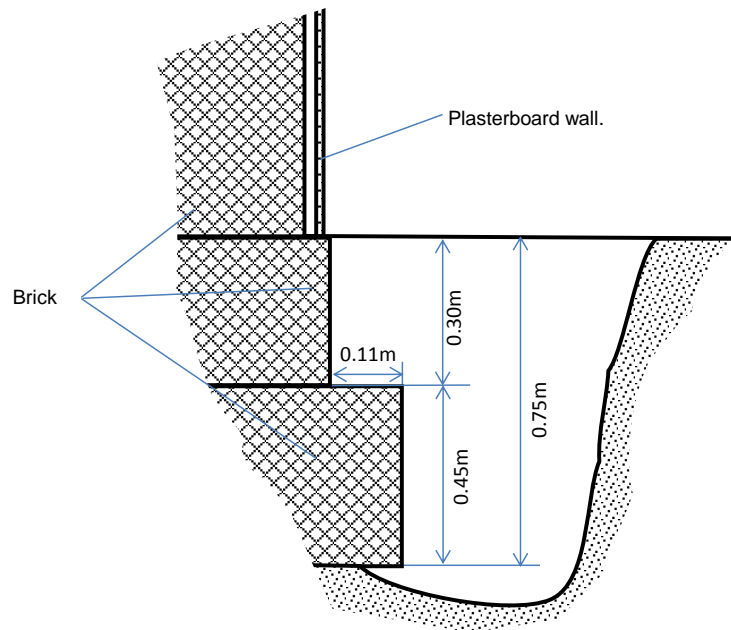
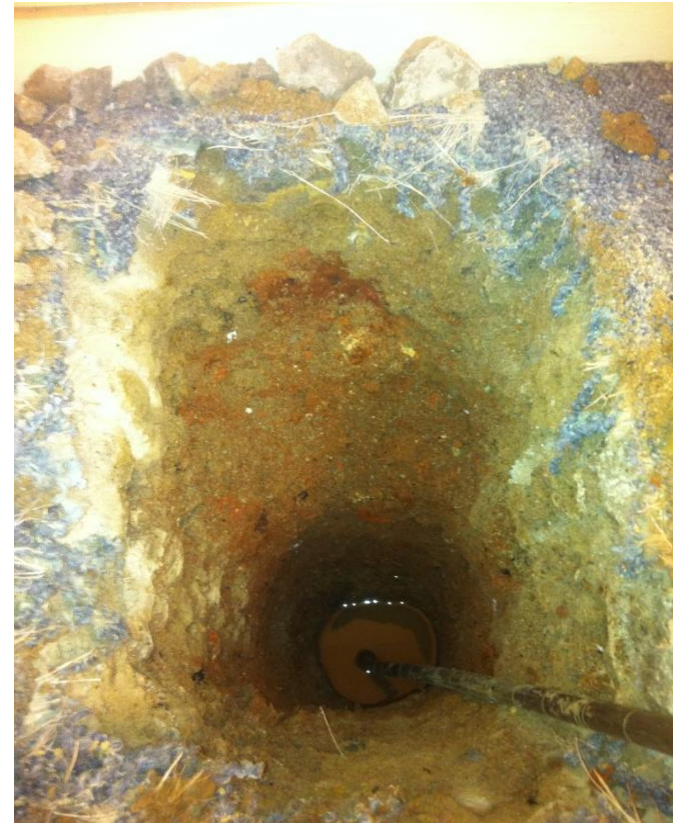
<b>TITLE:</b>	Foundation Exposures	<b>REF:</b>	LS 1985	<b>PREPARED:</b>	JB
<b>PROJECT:</b>	3 Belsize Crescent, London, NW3 5QU	<b>VERSION:</b>	v1	<b>CHECKED:</b>	MR
<b>CLIENT:</b>	David Templer	<b>FIGURE:</b>	TP2	<b>DATE:</b>	15/01/2016

0.00-0.10 Carpet over concrete. (MADE GROUND)

0.10-0.28 Grey very gravelly SAND. (MADE GROUND)

... Slow water seepage, standing at 0.73m

0.75-0.80 Brown mottled grey/orange silty CLAY, rare fine selenite crystals. (LONDON CLAY)
