**19 FORTRESS ROAD, CAMDEN, LONDON, NW5**  
**Contaminated Land Assessment – Revision A**

**Contaminated Land Assessment**

**Reference:** JM/HB/P14-708/03 Rev A

**Date:** June 2014

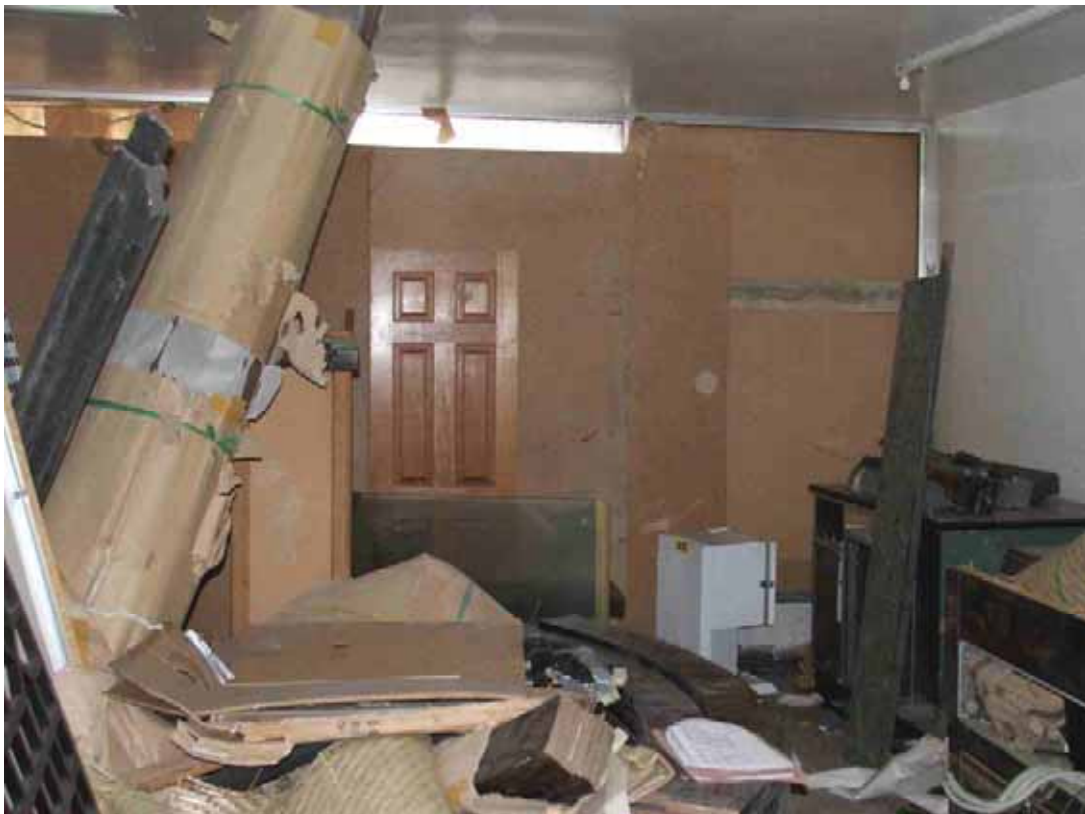
- 3.3 The building was most recently in use as a retail unit, with a small yard and external lean-to/outbuilding to the rear. Domestic waste, furniture and scrap wood was present in the retail shop area (see Figure 3.2). An internal stairwell led down to the basement floor (not considered as part of this application). Within the small yard area, a rectangular open lightwell was present, revealing an access door and window for the basement (at a lower elevation). Ground cover in the yard was noted to be concrete (see Figures 3.3 and 3.4).

Figure 3.2: View of former shop (boarded shop-front windows)

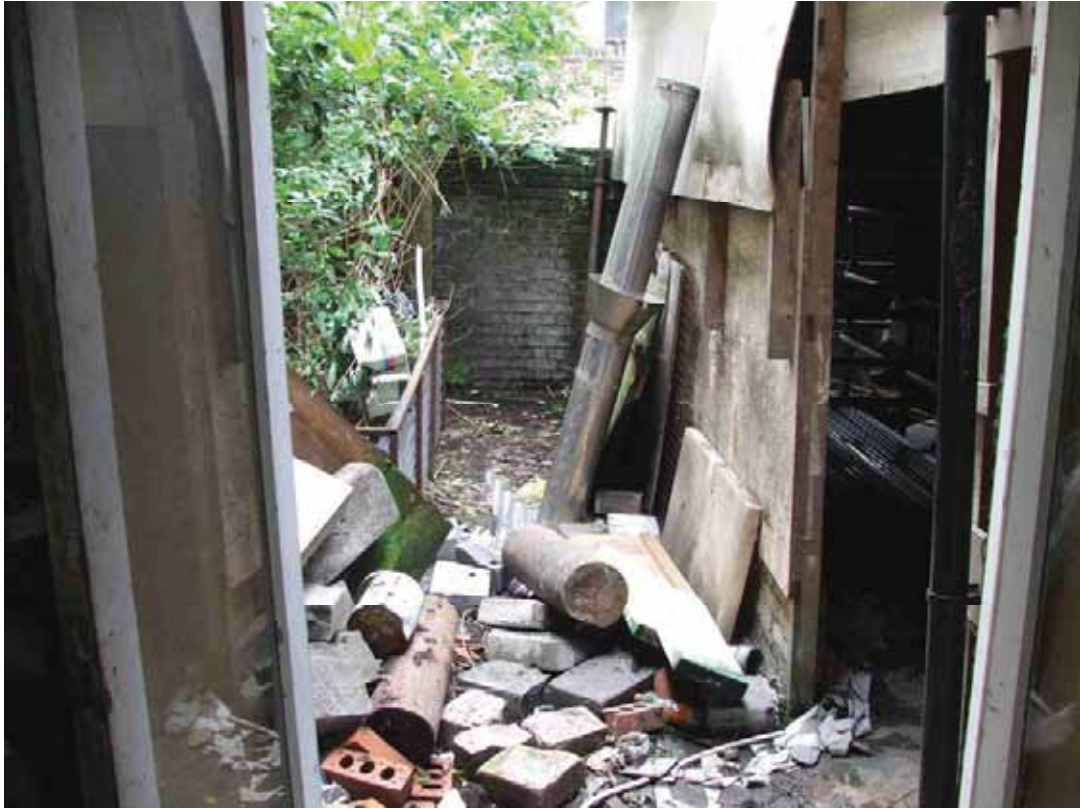
Figure 3.3: View of yard area with lightwell to left, outbuilding to right

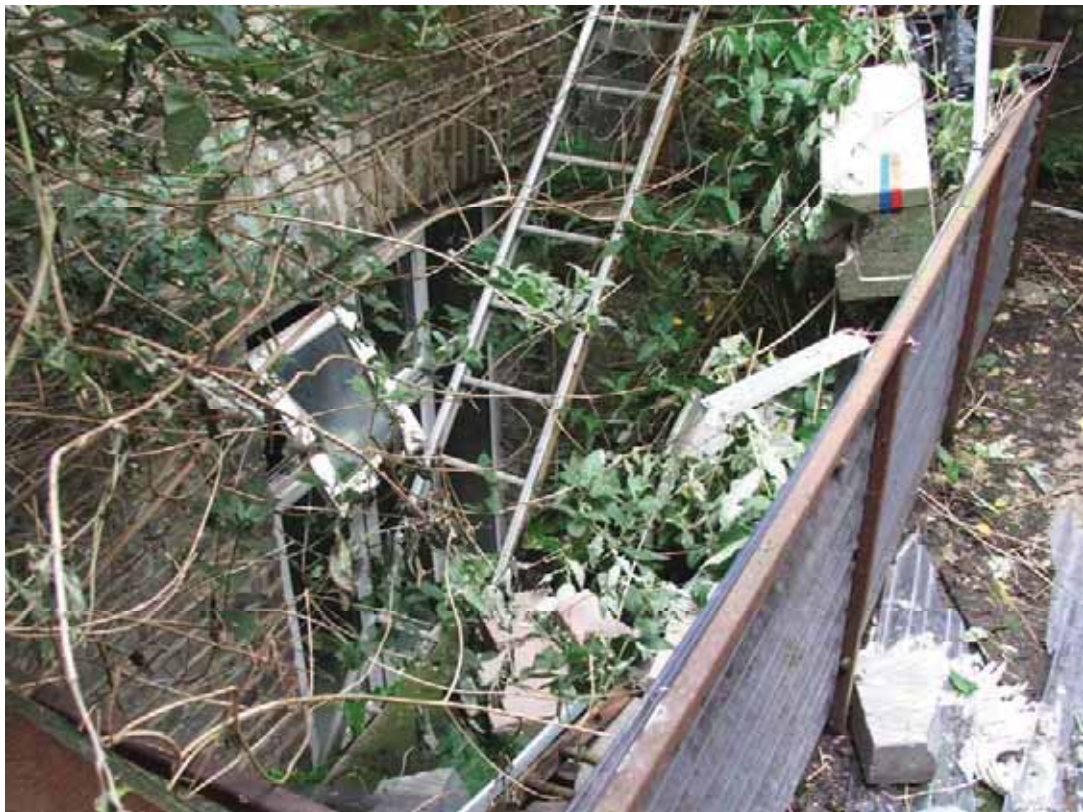
- 3.8 A surface water drain was noted within the floor of the storage/workshop area to rear of the site, along with a foul and surface water drain at the bottom of the lightwell. In addition, a damaged and corroded manhole cover was observed in the workshop area.

Figure 3.4: Lightwell to basement area (in yard)

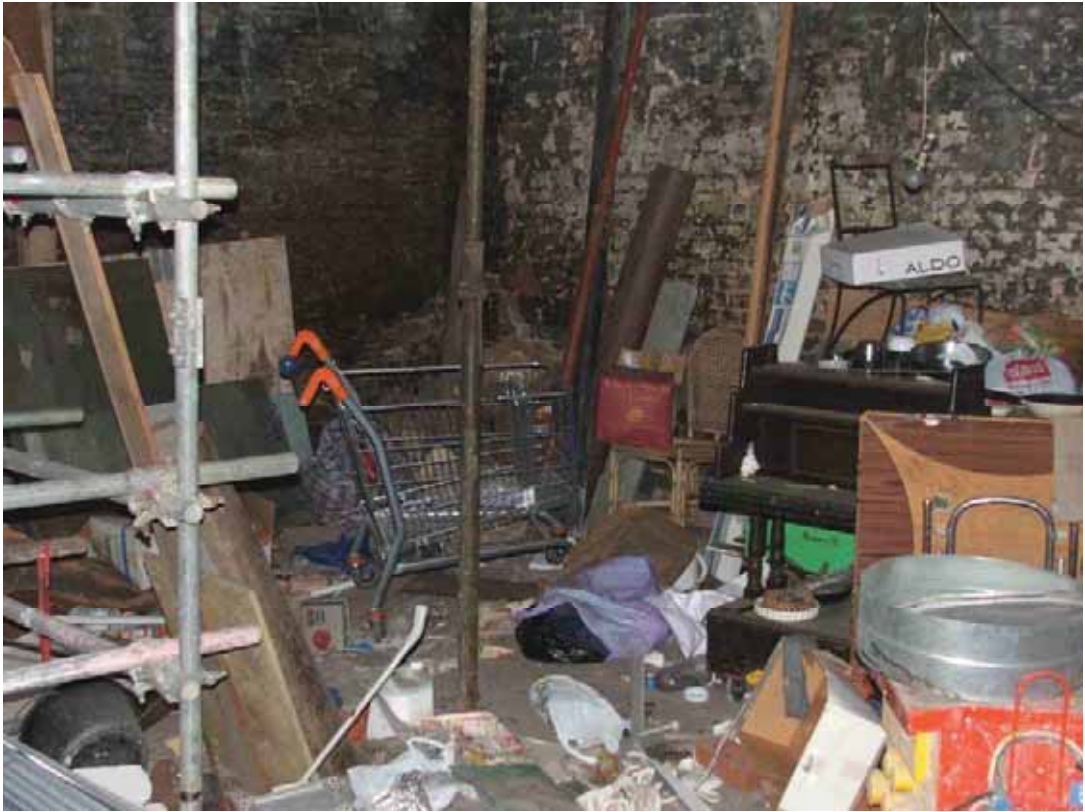
- 3.5 The outbuilding at the rear of the property is a single storey lean-to type structure, was noted to be in a poor state of repair. Domestic waste, general rubbish, dilapidated furniture and scaffold poles were present in the outbuilding (see Figure 3.5).

Figure 3.5: Internal view of outbuilding

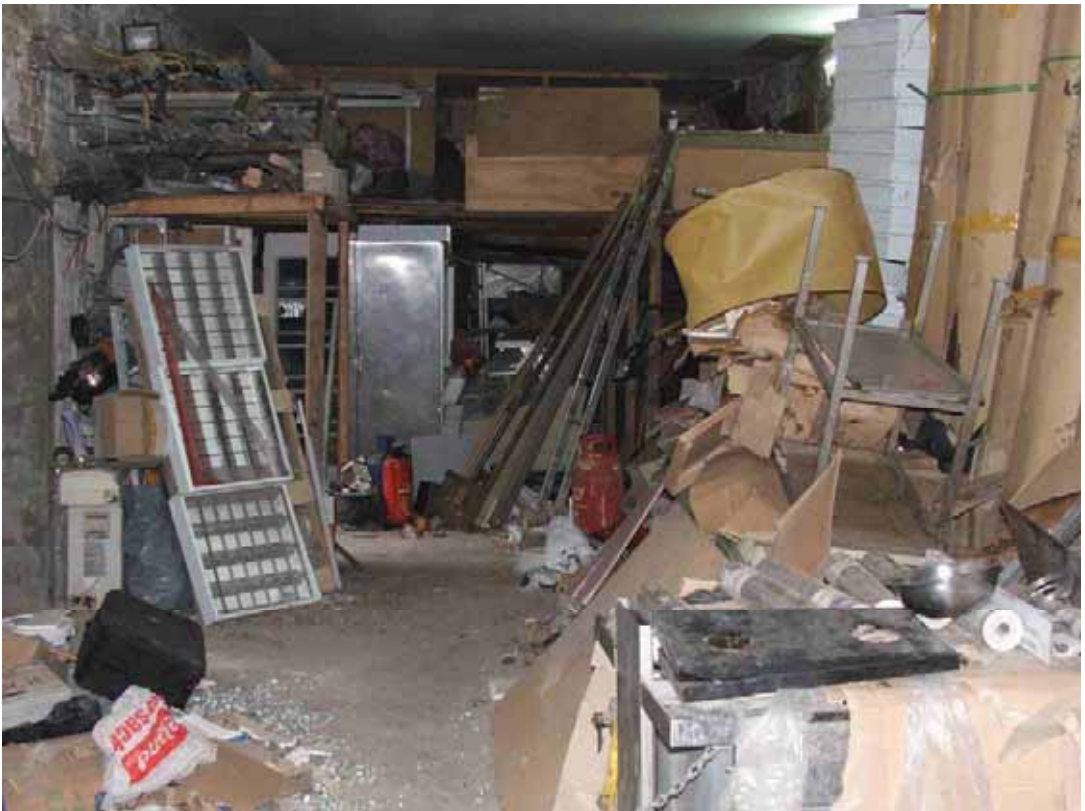
- 3.6 The northern part of the building, appears to have been constructed at a later date, and is of similar construction type but with a flat roof. The eastern elevation of the property has a roller shutter/garage door, to a storeroom at the rear. Both the garage and the store contained general waste (including paint), commercial cooling equipment, gas canisters and building materials etc (see Figure 3.6). Ground cover in the garage was noted to be of concrete in poor to fair condition.

Figure 3.6: Internal view of store

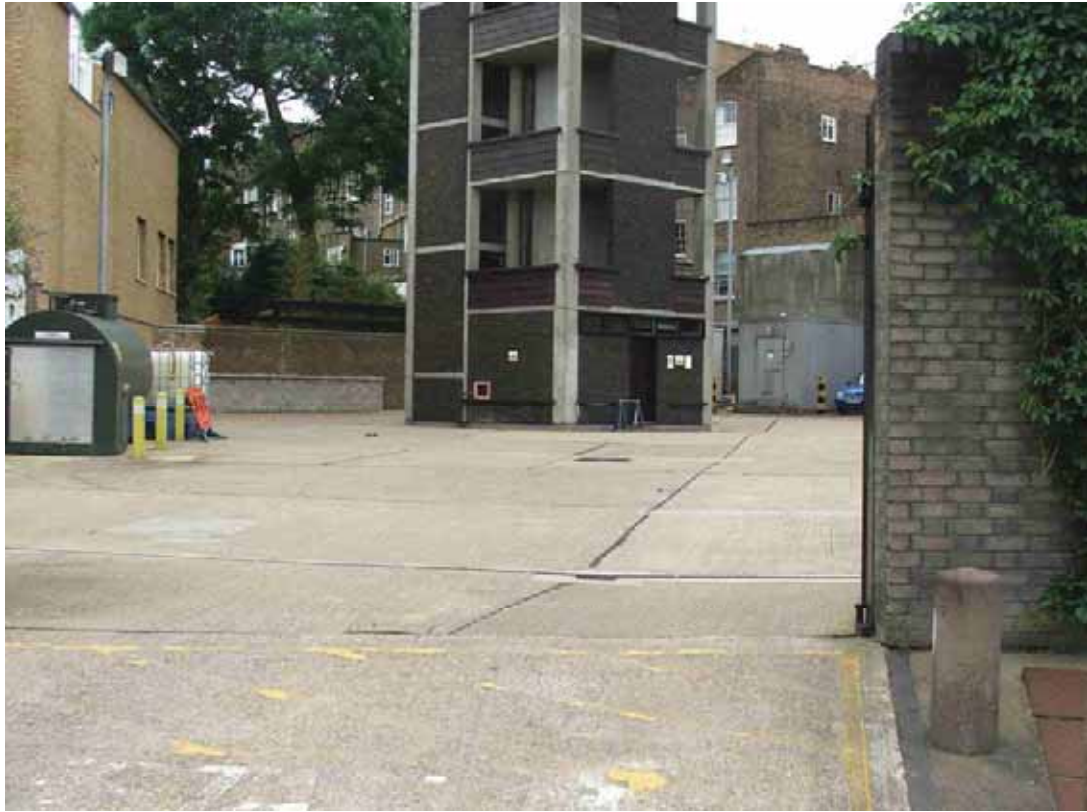
- 3.13 The fire station is present immediately west situated between the western site boundary and Highgate Road further west. From a roadside inspection of the fire station site, an above ground fuel tank was visible along the north-western wall of the fire station, approximately 35m west of the site (see Figure 3.7). In addition, an industrial generator housing or similar was observed adjacent to the eastern site boundary of the fire station (i.e. located immediately adjacent to the retaining wall which forms the western boundary of the subject site). Hardstanding across the fire station was noted to be formed of jointed concrete slabs.

- 3.20 Information relating to below ground fuel tanks at the adjacent fire station were also obtained from the planning records, presented in Appendix B. An application for the siting of the currently present above ground 5,000l fuel tank at the fire station site dated July 2006 was found. This indicated, that as part of the application for the new DERV fuel tank, former below ground fuel tanks were being decommissioned due to their age and condition. From the historic photograph provided in the application, a former fuel pump was located on the north-western boundary wall, approximately 35m west of the site. Although no formal certificate of decommissioning was available in the planning records, it is considered likely that these tanks were suitably decommissioned.

**Figure 3.7: Off-site Fire Station, with fuel tank (LHS), practice tower (C) and generator (RHS)**

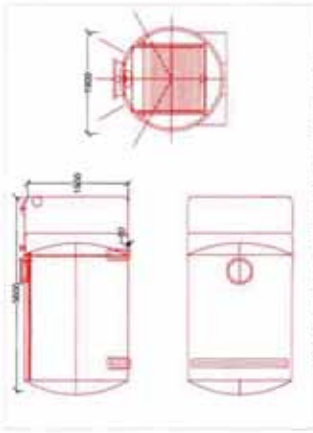
PROPOSED NEW TANK (ABOVE GROUND) SCALE 1:50

The provision of a small above ground tank is such, that it can be easily located in the station yard with little impact and can be subsequently removed with little impact when decommissioned. It is constructed to comply with current British Standards and Environment Regulations etc. The inclusion of modern leak detection and the ability to visually inspect these tanks externally significantly enhances the early identification of a leak and thus greatly reduces the risk of environmental impact, when compared to the installation of a replacement underground tank.

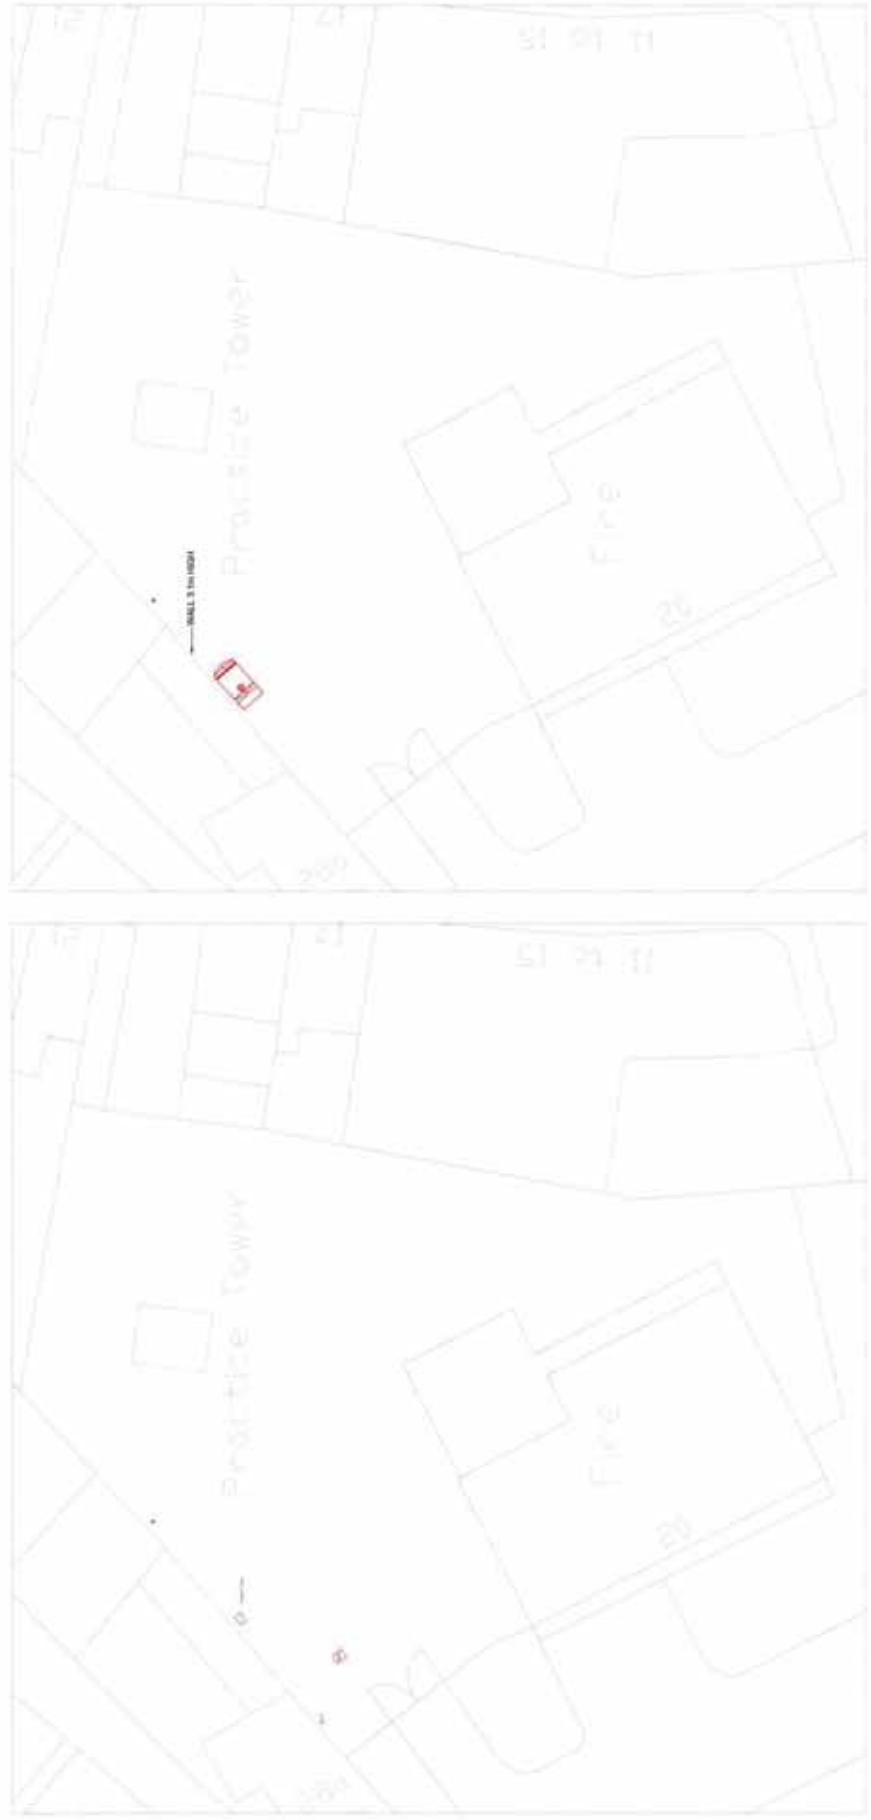
EXISTING LUBRICANT INSTALLATION TO BE DECOMMISSIONED SCALE 1:200

1. The current below ground fuel tanks generally [including this particular site] are being decommissioned due to their age and condition with the result that

- The Fire Brigade vehicle fleet will predominantly utilise Public Petrol Stations.
  - Most importantly any potential risk to the environment caused by accidental leakage of the existing tank facility will be negated.
