GROUND INVESTIGATION REPORT

43 BURGHLEY ROAD, KENTISH TOWN, CAMDEN, LONDON NW5 1UH

ELI NATHENSON C/O MARTIN EVANS ARCHITECTS

| Report Reference: GWPR1599/GIR/March 2016 | | Status: FINAL |

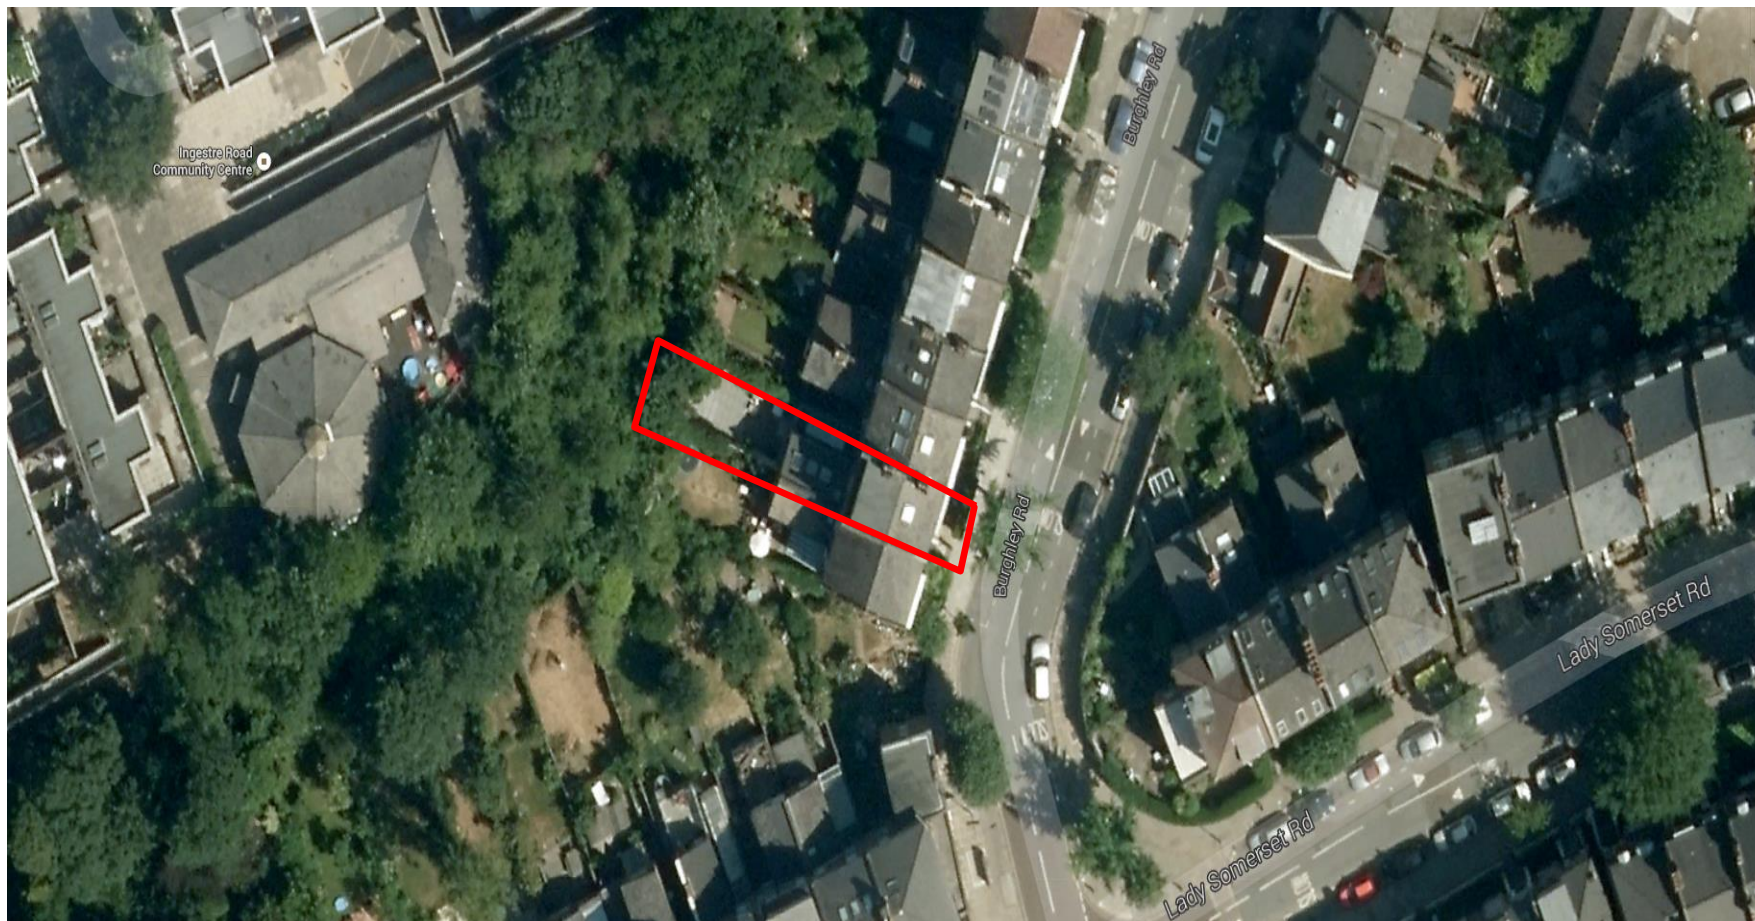
Figure 2

— Approximate Site Boundary

The national grid reference for the centre of the site was approximately TQ 28770 85704. A site location plan is given within Figure 1. A plan showing the site area is given within Figure 2.
