Site Investigation Report

Site: 77 Lawn Road, London NW3 2XB

Report Date: March 2016

Project Reference: J12507

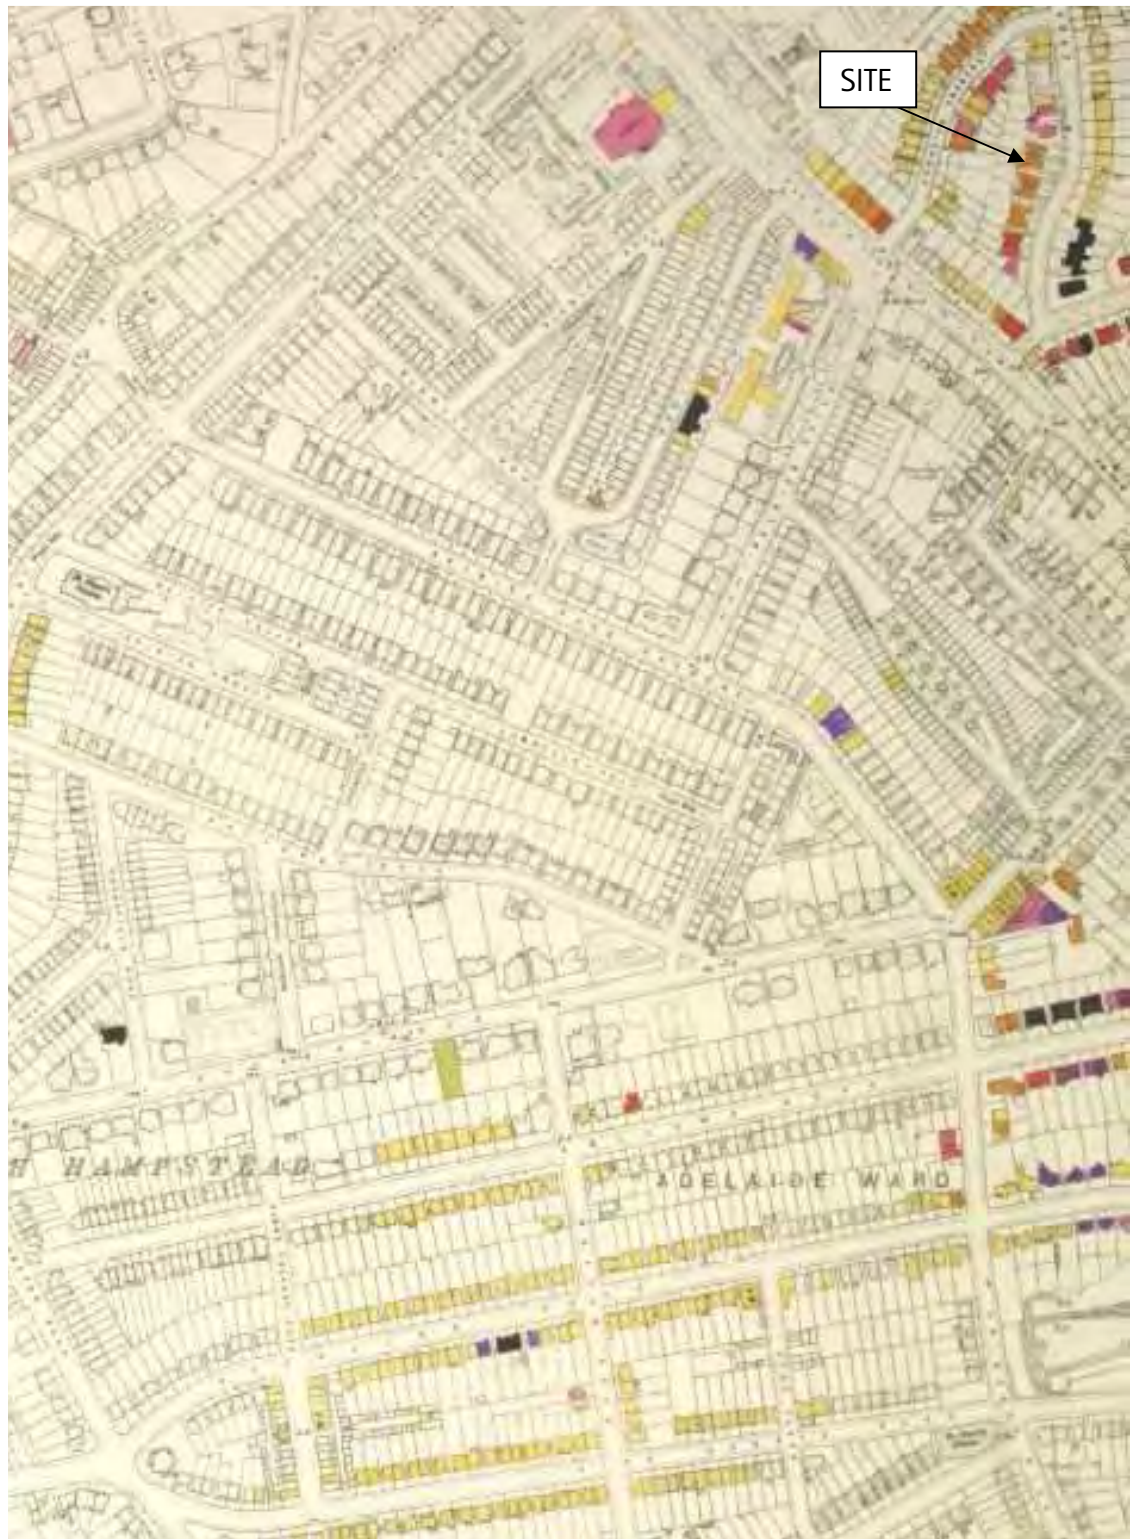
The published bomb map for the area (map No. 37), shows the site suffered general blast damage-not structural (shown in orange). The map also shows a building to north suffered damage beyond repair (shown in purple) and a series of buildings to the south east suffered total destruction (shown in black), please refer to Figure A in Appendix E.

General blast
damage – not
structural

The maps have been reviewed for information purposes only and should not be perceived as part of a formal UXO desk study or risk assessment as detailed in CIRIA C681 "Unexploded Ordnance (UXO) – A guide for the Construction Industry".
