150 HOLBORN ECOLOGICAL APPRAISAL

DAH REAL ESTATES SARL

APRIL 2016

150 HOLBORN – PRELIMINARY ECOLOGICAL APPRAISAL

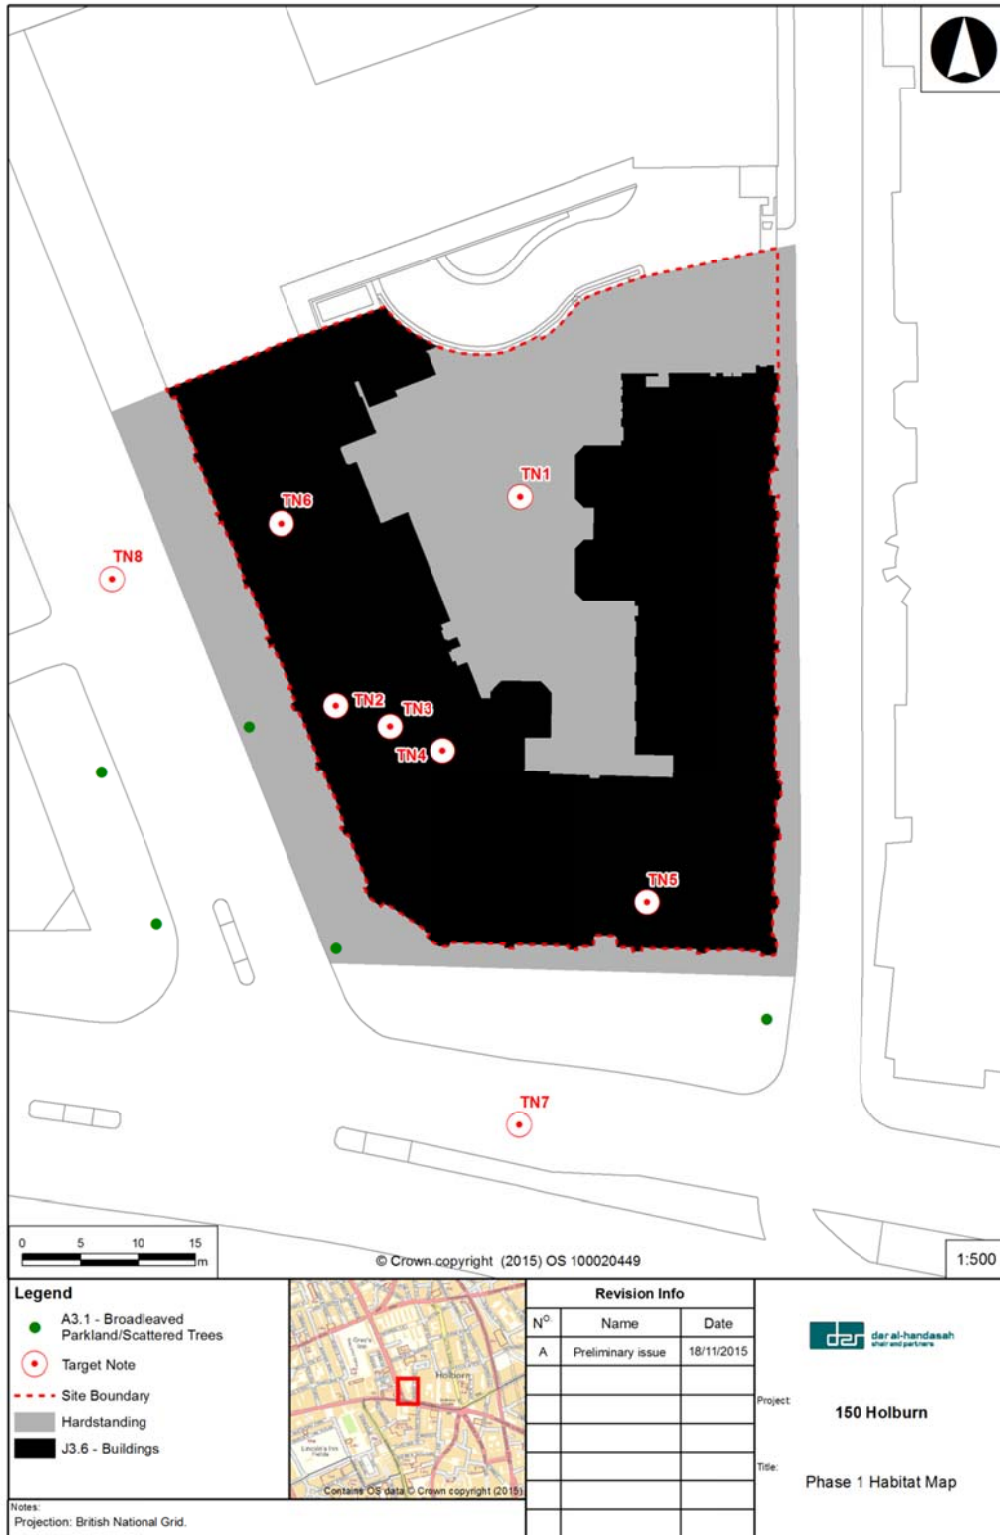
Figure 3-1 Phase 1 Habitat Map

The site is currently comprised of hard standing and buildings, with no landscaping or vegetation within the site itself. There are a number of mature London Plane trees located on Gray's Inn Road directly adjacent to the site, however these are not anticipated to be affected within the plans for the site as they fall on the public highway beyond the site boundary.

The locations of these habitat types and features were presented in Figure 3-1 and each habitat type is described below. In addition, consideration is given to the offsite broadleaved trees situated adjacent to the western Site boundary on Greys Inn Road.

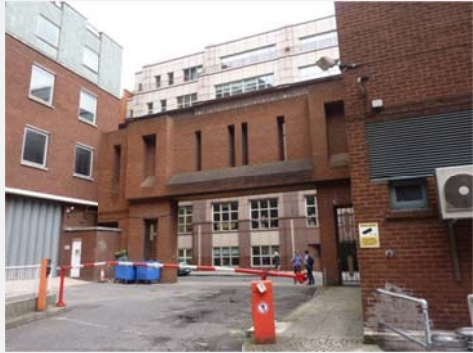
Target Note	Comment	Image
1.	Central courtyard at ground level. Hardstanding, no vegetation or planting. Waste storage areas and loading bays for retail units.

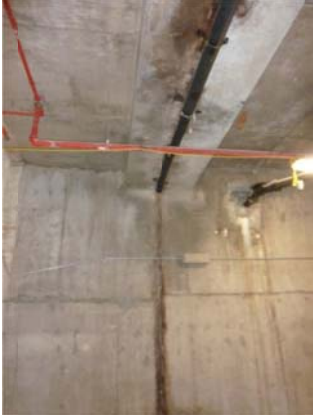
2.	Basement – storage area. Presence of expansion joints with small voids, however these were generally damp suggesting low suitability for roosting bats. No evidence of bats was observed (staining, feeding remains etc).

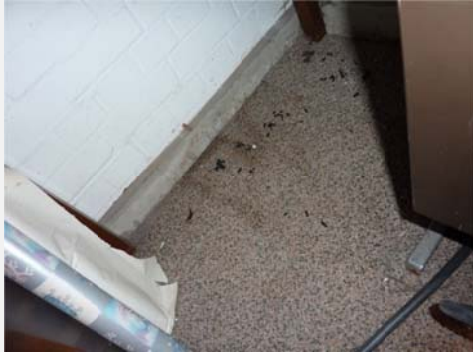
3.	Basement - office rooms. Evidence of rats and mice was observed, large numbers of droppings and characteristic odour.

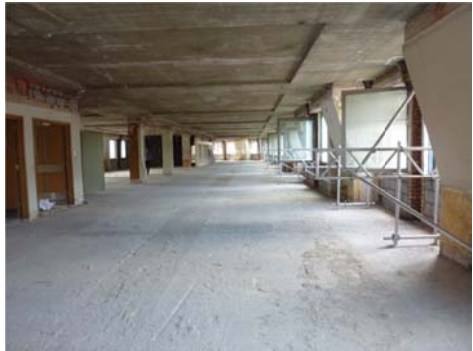
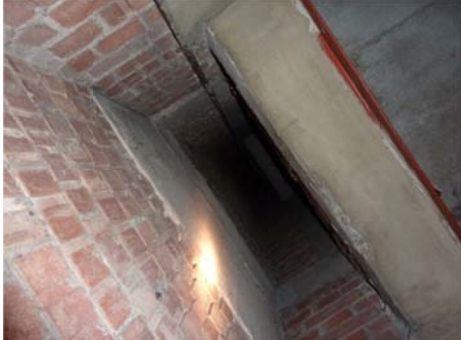
4.	Office floors 2 to 6. All fixtures and fittings have been removed from the office areas, toilets, kitchens, etc. The building is currently empty (except for occupied retail units on the ground floor). Some floors have open windows and other potential access points (such as utility shafts) for bats adjacent to the tree canopy along Gray’s Inn Road. The interior of the building is generally dry and subject to very little disturbance (limited to daily security inspection, occasional visits for building maintenance, and temporary lighting). A number of potential roosting locations were observed, such as disused storage cupboards, cracks in brickwork, and other voids. No evidence of bats was found, with the exception of some suspected droppings in a cupboard located on the 2 nd floor. On discovery, advice

Target Note	Comment	Image
	<p>was sought from a licensed bat worker who confirmed the droppings to be rodent.</p>

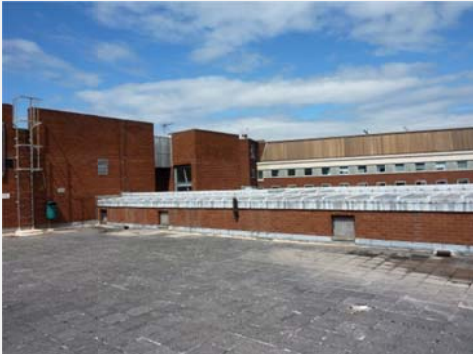
<p>5.</p>	<p>Roof of building. Open and generally exposed, with large areas of lead flashing. No evidence of wildlife.</p>

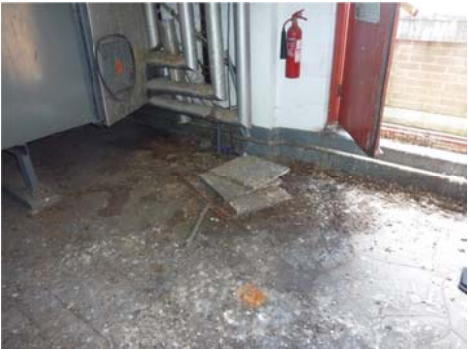
<p>6.</p>	<p>Roof voids and service areas were observed to be used as roosting areas by a large number of Feral Pigeon (<i>Columba livia</i>), as evidenced by large amounts of droppings, feathers and presence of birds.</p>

The Feral Pigeons currently using the roof area of the building should be managed in accordance with the Wildlife and Countryside Act 1981, and the Animal Welfare Act 2006. It is recommended that DEFRA Guidance is adhered to in the potential removal of Feral Pigeons, whereby an authorised person should be engaged to install deterrents or scaring devices to preclude the birds from the roof areas. Future access should be prevented prior to the demolition of the building.

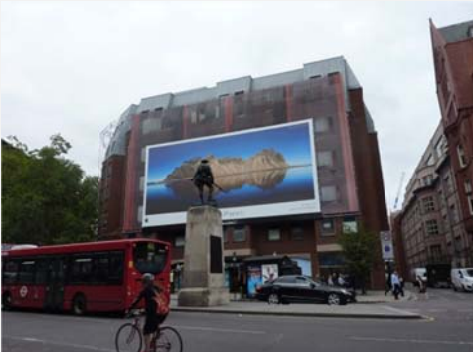
<p>7.</p>	<p>Exterior view from Holborn towards the Project Site. Advertising hoarding and scaffolding covers the front of building.</p>

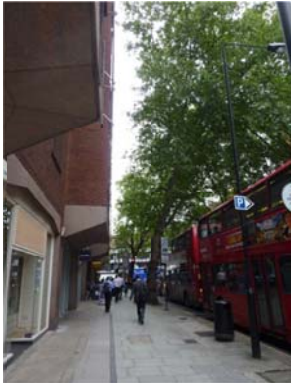
Target Note	Comment	Image
8.	Exterior view from Gray's Inn Road. Avenue of mature London Plane (<i>Platanus x hispanica</i>) trees directly adjacent to the Site.

The two mature London Plane trees directly adjacent to the site should be accounted for in the project design to prevent their removal or damage – although this is not anticipated based on the current plans. Should they be affected by the works, the London Borough of Camden Tree Team should be consulted. Protection measures such as the adoption of root protection zones should be included in a Construction Environmental Management Plan.

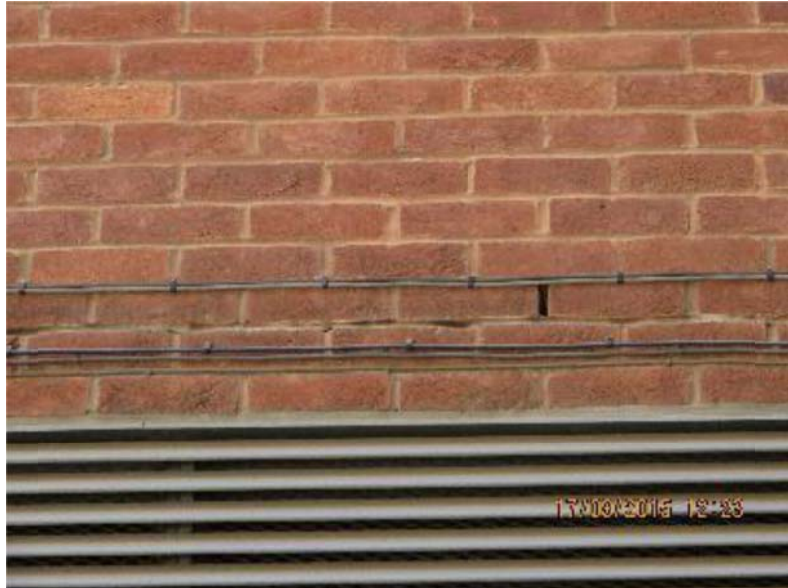
Figure 3-2: Weep holes in brickwork leaving crevices provide potential roosting and/or access for bats

No evidence of bats was recorded during the external inspection of the buildings, however a number of features were noted as providing potential bat roosting opportunities, for example weep holes in brickwork leaving crevices (Figure 3-2), and gaps where the lead flashing meets the brick wall on the roof (Figure 3-3).

It is recommended that the works to 150 Holborn proceed with caution, and works to the areas identified as having the potential to support roosting bats be undertaken by hand, for example the stripping of the lead flashing around the top floor of the building. In the unlikely event a bat is found during this process, all works must stop and an ecologist contacted.

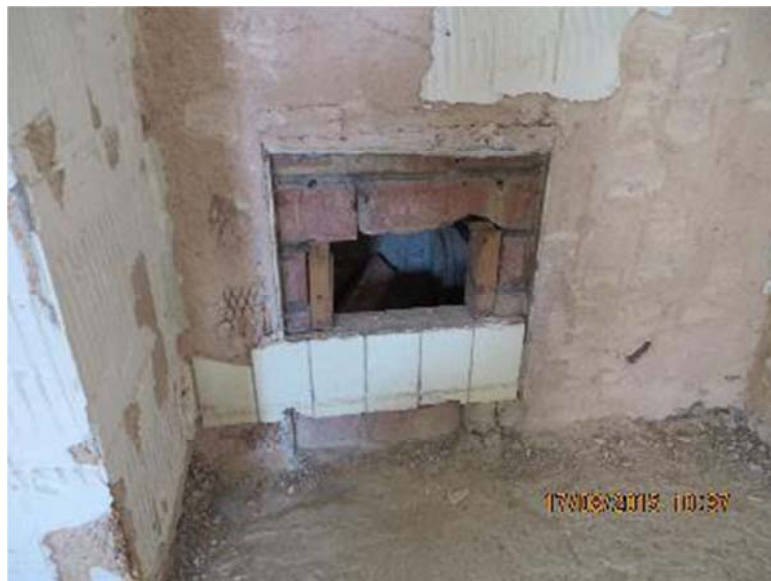
Figure 3-4: Typical holes/cracks/crevices in brickwork observed during the internal inspection.

No evidence of bats was recorded during the internal inspection of the building. Droppings were found at the same location as droppings previously found and reported to be bat droppings; however, the droppings found on the occasion of the current survey were identified as mouse droppings. A number of features were noted as providing potential bat roosting opportunities, such as holes/cracks/crevices in the brickwork (Figure 3-4).

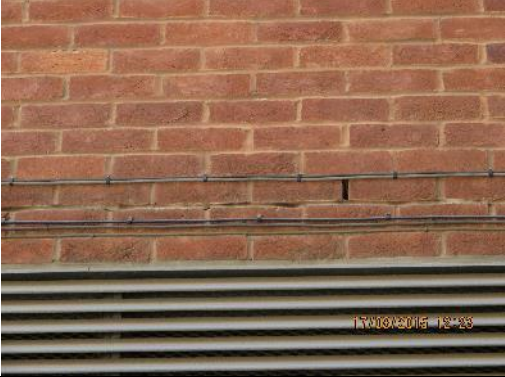
Description	Photographs of the Feature	Bat Roosting / Access Point
Weep holes in brickwork leaving crevices

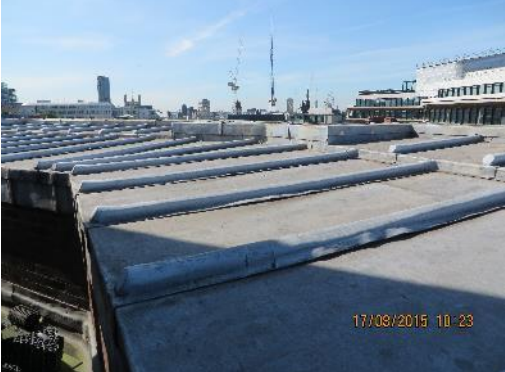
Roosting/Access
Lead flashing covered the top storey of the building

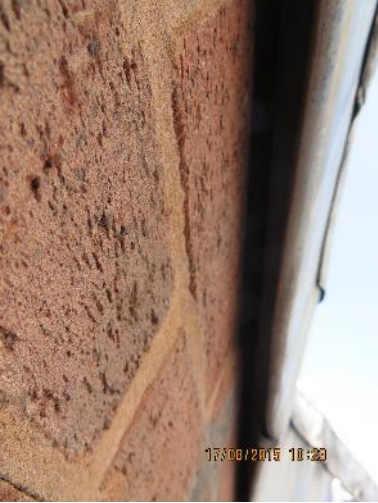
Roosting
Gap where lead flashing meets the brick wall on the roof

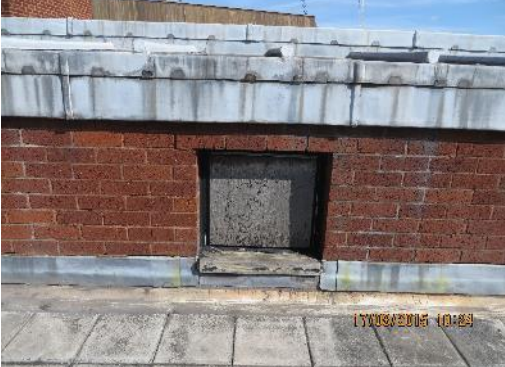
Roosting
Gaps behind boarding to pipework on roof areas

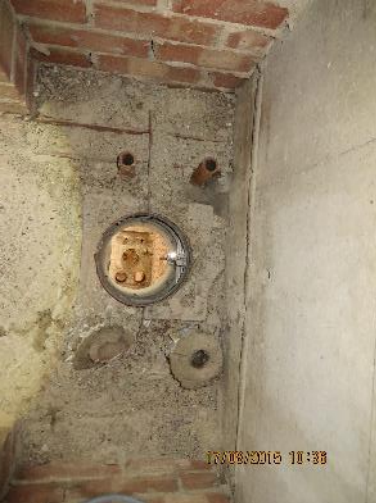
Description	Photographs of the Feature	Bat Roosting / Access Point
<p>Pipework running through the floor on each storey provided connectivity between the floors – note the pipes on the floor below visible within the centre of the circular pipe.</p>

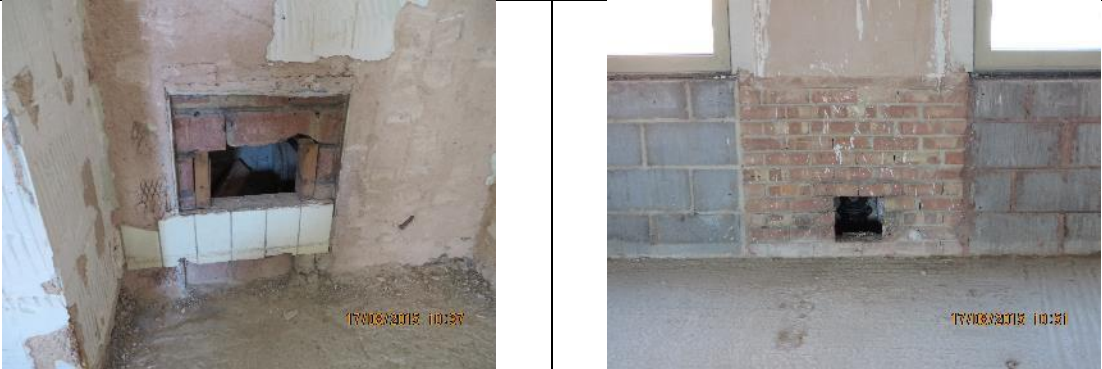
<p>Access</p>
<p>Holes/cracks/crevices in the brickwork</p>

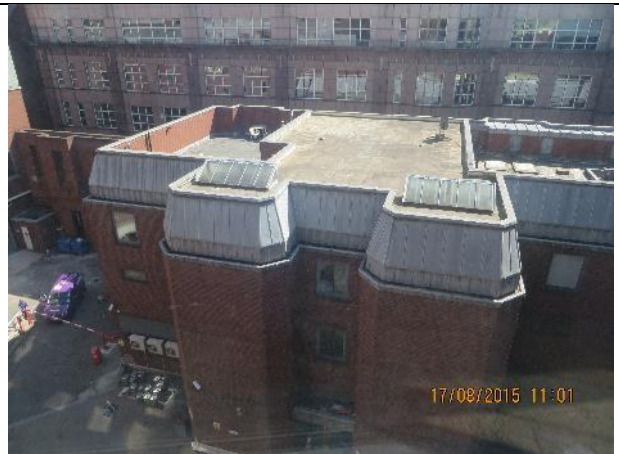
Photograph 6: Roof of eastern arm of the building, taken from inside the western section

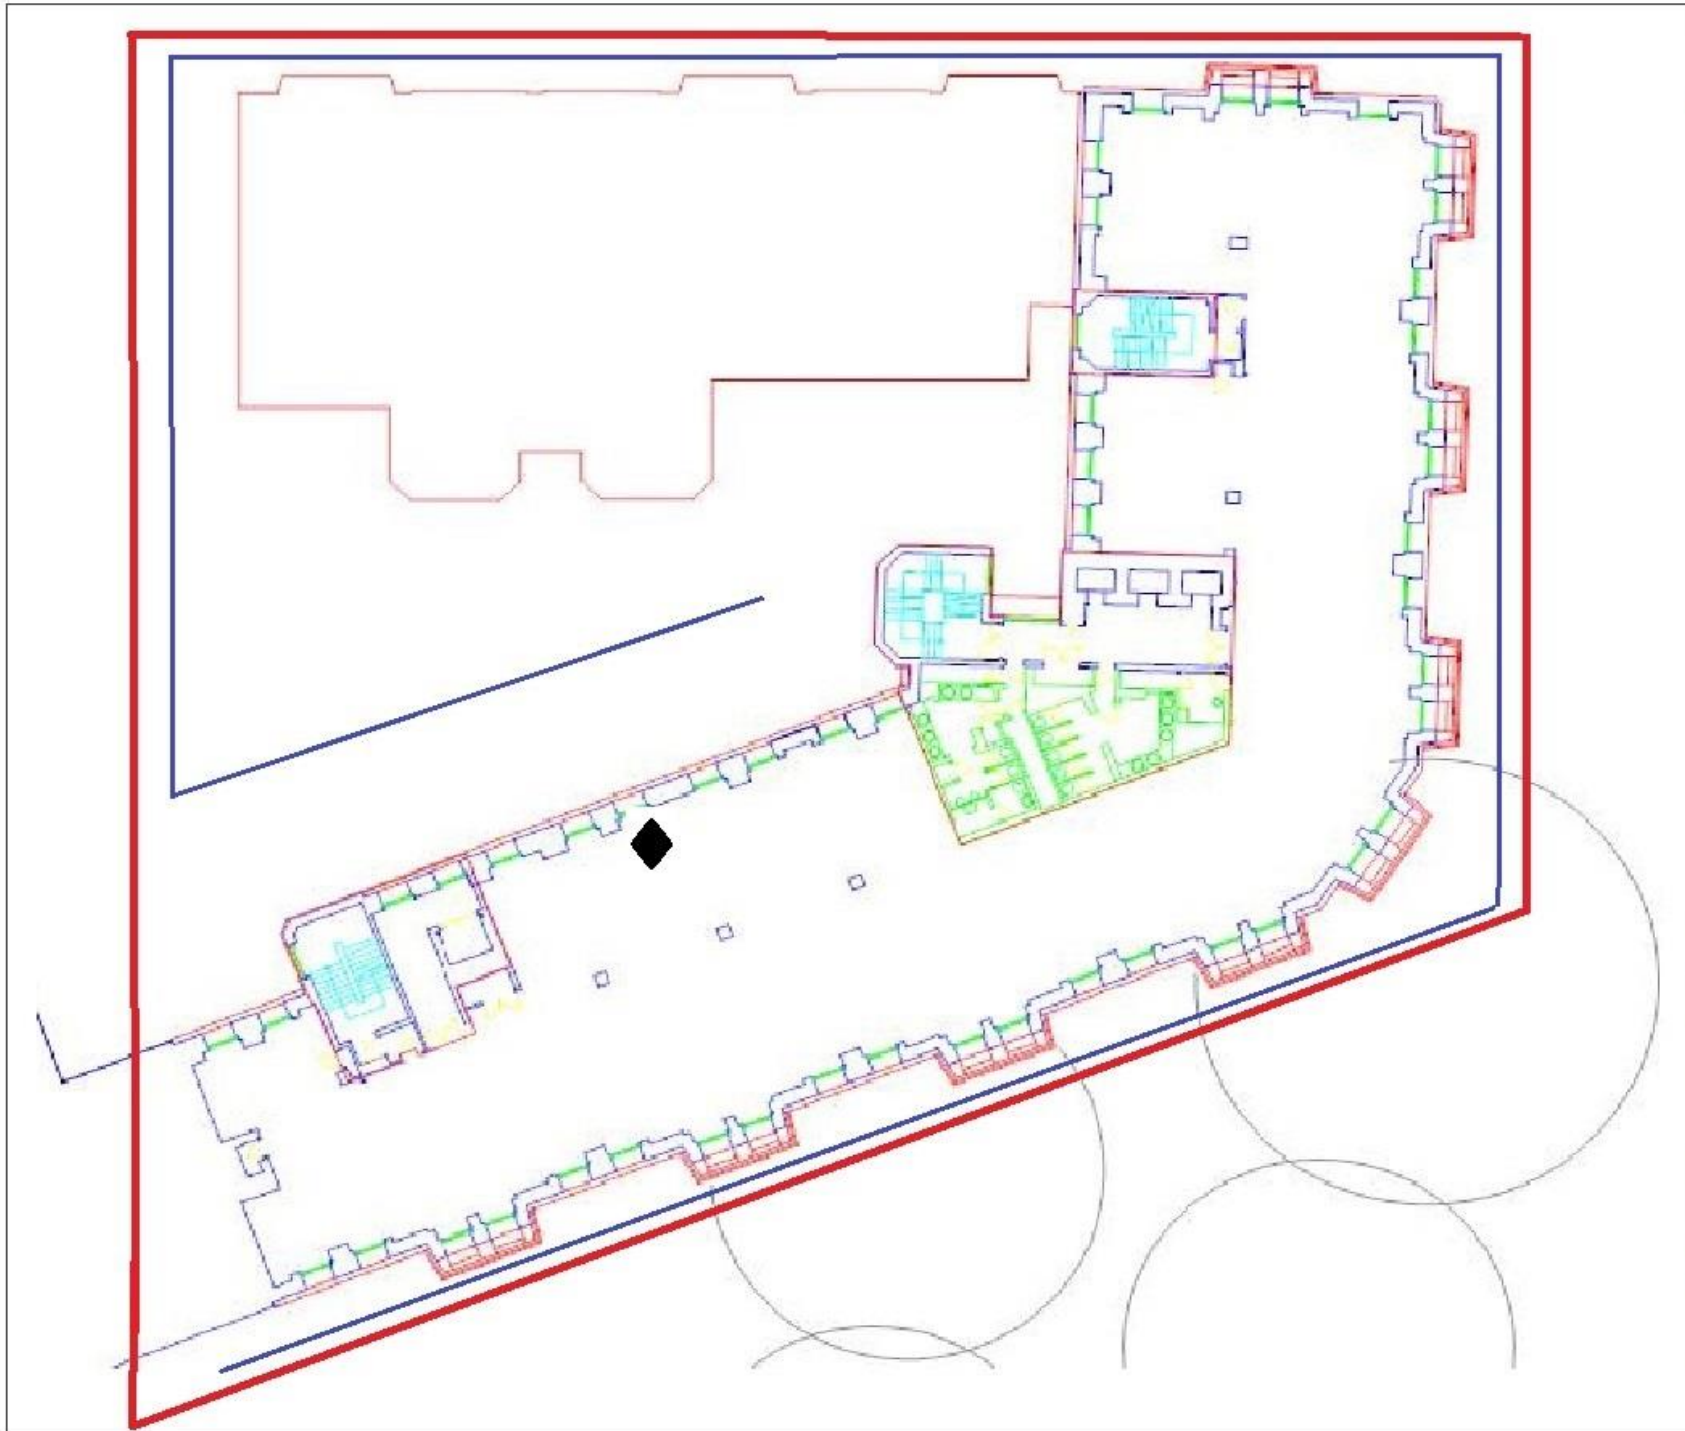
Figure 1: 150 Holborn – Bat Activity Survey Transect and Location of Static Detector

- Approximate redline boundary
- ◆ Location of Static Detector - 6th Floor
- Transect Route
