## GROUND INVESTIGATION REPORT

18 ORNAN ROAD, LONDON NW3 4PX

SOUTHFIELDS PROPERTY LTD

Report Reference: GWPR1313/GIR/August 2015		Status: FINAL
Issue:	Prepared By:	Verified By:
V1.01 August 2015

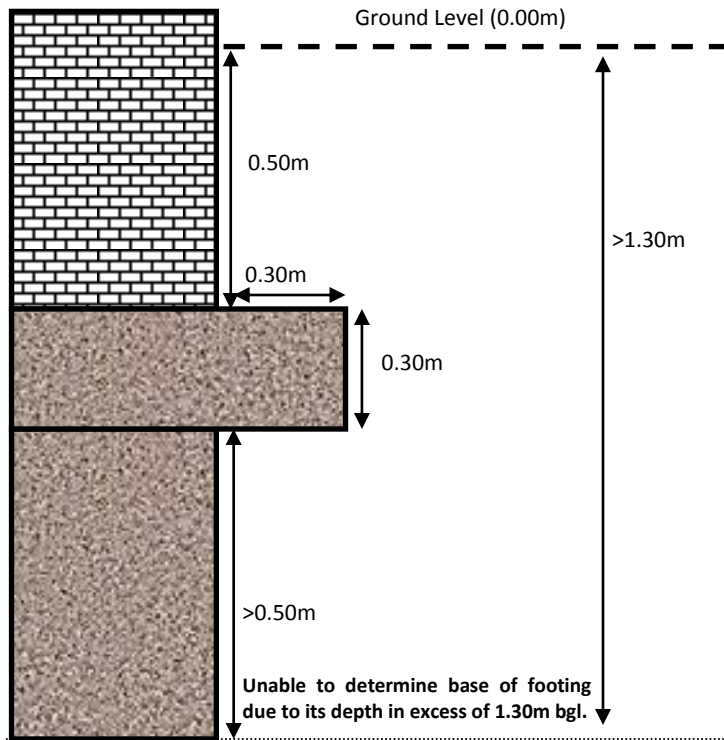
**Figure 6**

Trial pit foundation exposure TP/FE1 was hand excavated from ground level at the front of the existing property. The exact location of the trial hole can be seen in Figure 5 with a section drawing of the foundation encountered in Figure 6.

The foundation layout encountered consisted of a brick wall to ground level. The brick wall continued from ground level to a depth of 0.50m bgl. The brick wall was noted to rest upon a concrete footing which stepped out by 0.30m and was 0.30m in thickness. The concrete footing was noted to step back in, towards the property, and was noted to extend to a depth beyond 1.30m bgl. The base of the foundation was not determined due to its depth. The ground conditions encountered directly surrounding the foundation are shown in Figure 6.

**MADE GROUND:** (GL - >1.30m bgl): Light to dark brown clayey gravelly sand to silty sandy gravelly clay. Sand is fine to medium grained. Gravel is occasional to abundant, fine to coarse, sub-angular to sub-rounded flint, brick, concrete and ceramic fragments.

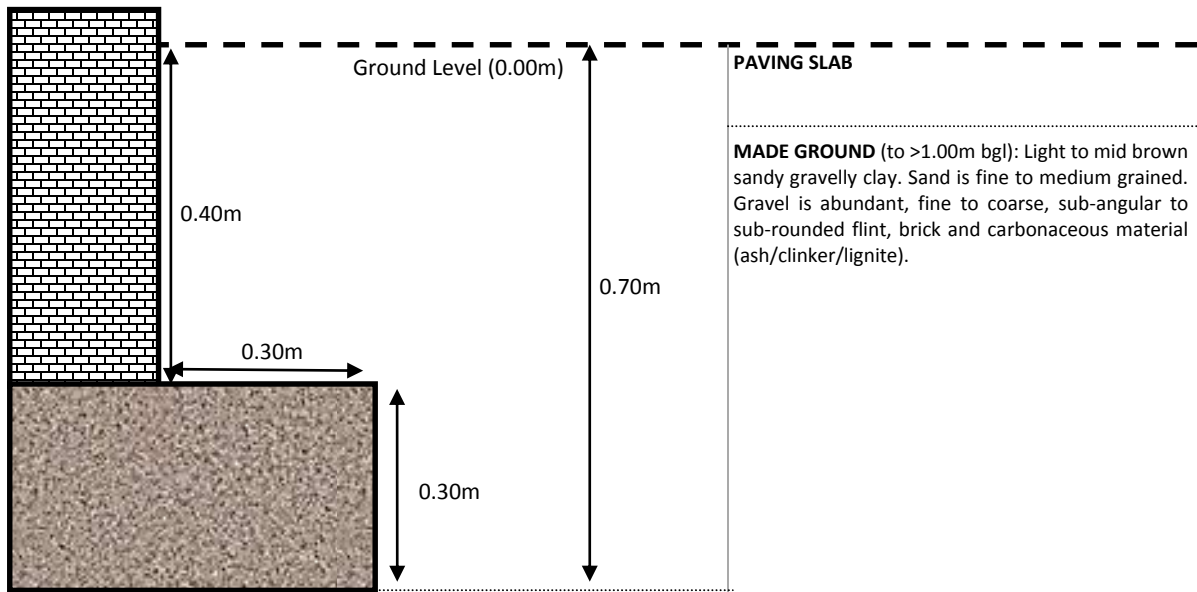
Trial pit foundation exposure TP/FE2 was hand excavated from ground level to the rear of the existing property. The exact location of the trial hole can be seen in Figure 5 with a section drawing of the foundation encountered in Figure 7.

The foundation layout encountered consisted of a brick wall to ground level. The brick wall continued from ground level to a depth of 0.40m bgl. The brick wall was noted to rest upon a concrete footing which stepped out by 0.30m and was 0.30m in thickness. The foundation was noted to rest on Made Ground comprising a light to mid brown sandy gravelly clay. The ground conditions encountered directly surrounding the foundation are shown in Figure 7.

Brick

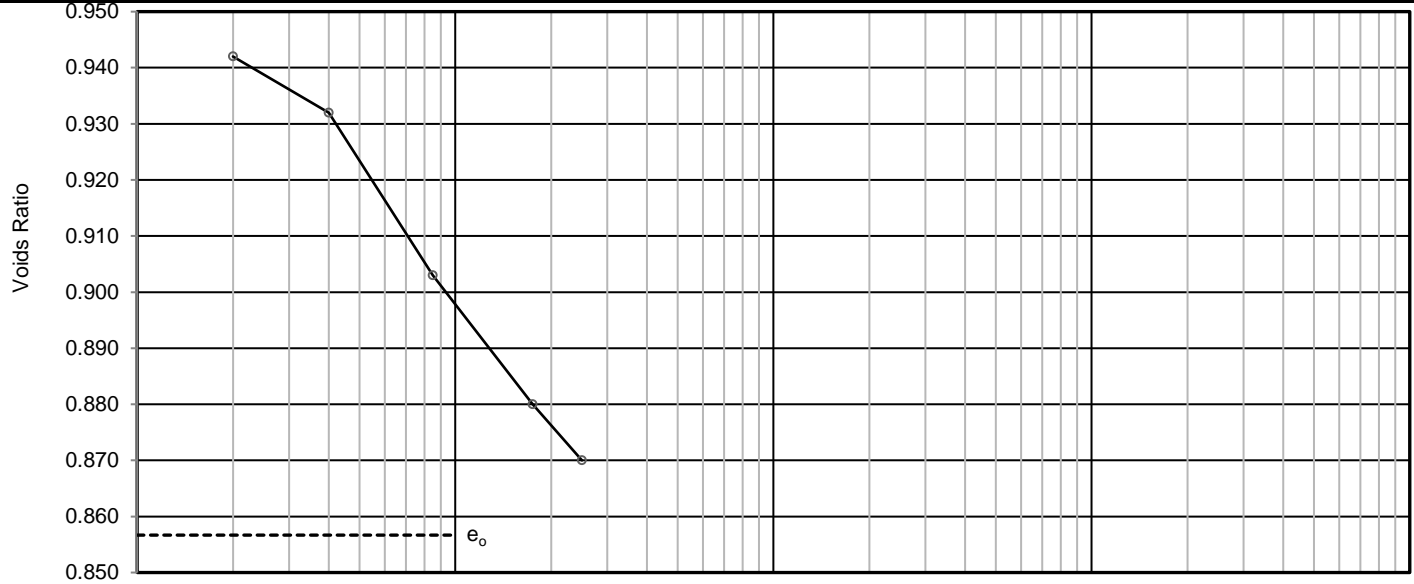
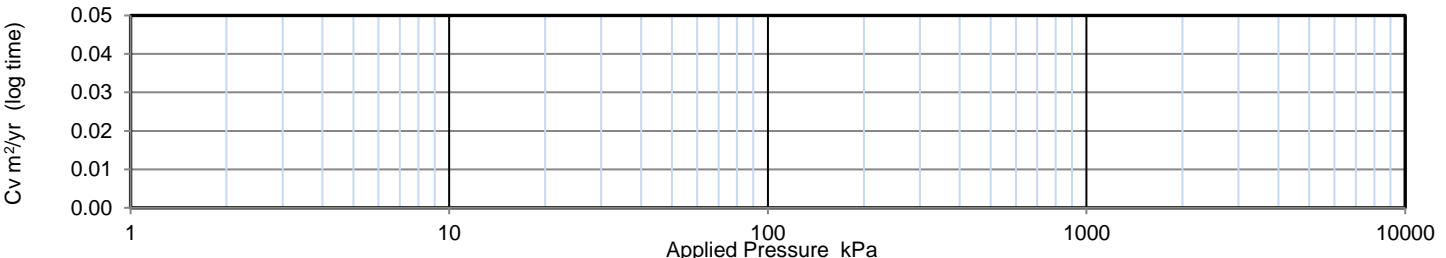
Job Ref	19103
Borehole/Pit No.	WS1
Sample No.	-
Depth	3.50
Sample Type	D
Sample Received	29/06/2015
Schedule received	26/06/2015
Project Started	29/06/2015
Date Test started	08/07/2015

Site Name	18 Ornan Road, London, NW3 4PX		
Project ID	GWPR1313	Client	Ground and Water Ltd
Soil Description	Orangish brown silty CLAY with brown and yellow silt pockets		
Test Method	BS1377:Part 5:1990, clause 3

Applied Pressure kPa	Voids ratio	M <sub>v</sub> m <sup>2</sup> /MN	C <sub>v</sub> (t <sub>50, log</sub> ) m <sup>2</sup> /yr	C <sub>v</sub> (t <sub>90, root</sub> ) m <sup>2</sup> /yr	C <sub>sec</sub>
50	0.857	-	-	-	-
25	0.870	0.28			
18	0.880	0.70			
8.5	0.903	1.4			
4.0	0.932	3.4			
2.0	0.942	2.7

One Dimensional Consolidation Test - Swelling									
Stratum/Depth		Height (mm)	Moisture Content (%)	Bulk Density (Mg/m <sup>3</sup> )	Dry Density (Mg/m <sup>3</sup> )	Void Ratio	Degree of Saturation (%)	Particle Density (Mg/m <sup>3</sup> )	Swelling Pressure (kpa)
London Clay Formation WS1/3.50m bgl (Brown silty CLAY)	Initial	15.90	29.9	1.89	1.45	0.857	94	2.70	50
	Final	16.63	37.1	-	-	-	-	-	-

It must be noted that the sample was remoulded and this must be taken into account in final design.
