36 Lancaster Grove NW3

Heritage Assessment

Proposed conversion of the former Belsize Fire Station
into residential accommodation

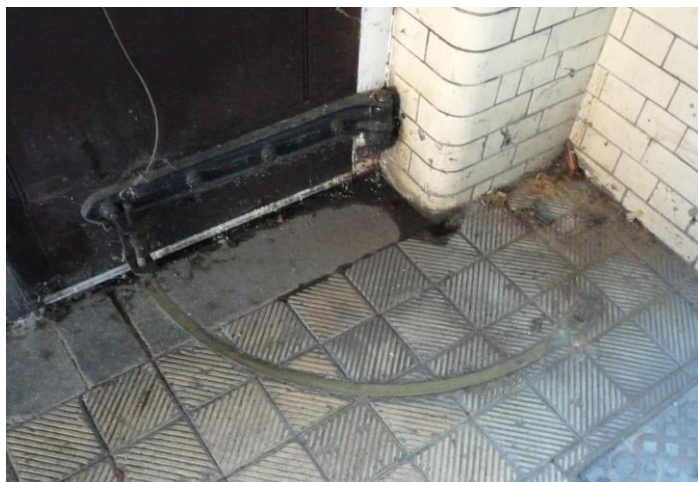
1. Wall tiling. The white wall tiling here, in the stair well and in the wash room will all be retained with only minor repairs carried out where essential.
2. Flooring. The existing flooring falls towards the north. This will be retained and a new level floor will be placed over the existing tiles. This will end with a step where the floor comes close to the main doors allowing these to open and a view to be had of both the flooring and the brass runners for the large doors.

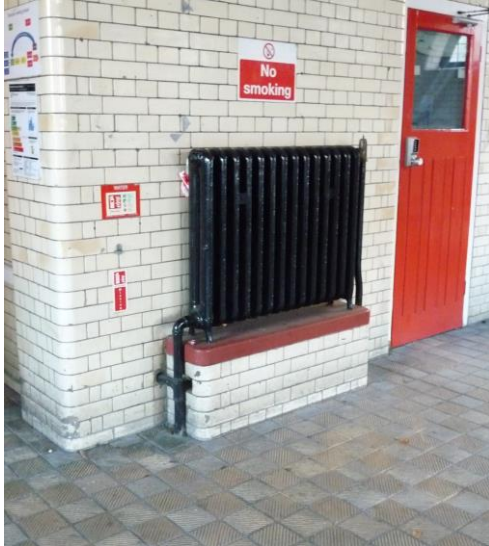
3. Radiators. There are four radiators mounted on brick plinths around the appliance room. Three are on white glazed bricks and the other beside the watch room is on a brown brick plinth which it is assumed was rebuilt when the watch room window was changed to a shallow bay.

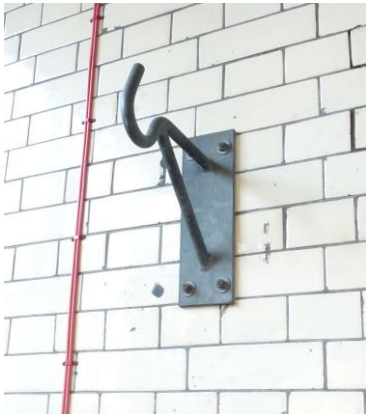
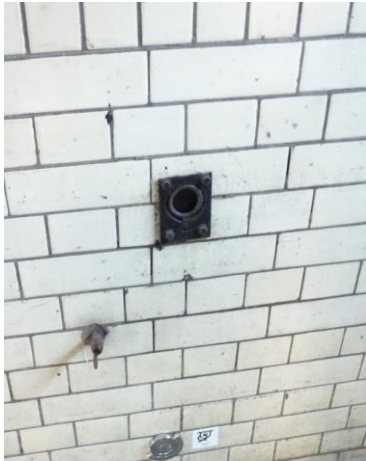
4. Main doors. The main doors all remain unchanged and capable of being opened. Inner doors will be provided inside the line of the outer doors swing to the appliance room.
5. Hold back devices and hooks

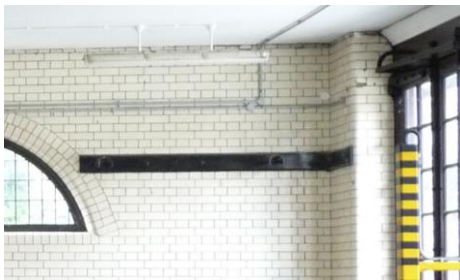
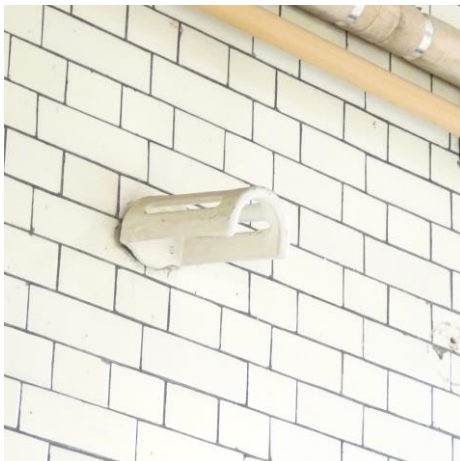
6. Hanging racks north west corner of appliance room. A similar rack exists in the washroom on the eastern side and there is evidence of two other fittings having been fixed to the wall in that space. These are similar to harness racks however since this was never intended to have horse drawn appliances and there no evidence of stabling or hay storage it appears more likely that this may have had a more general support role.

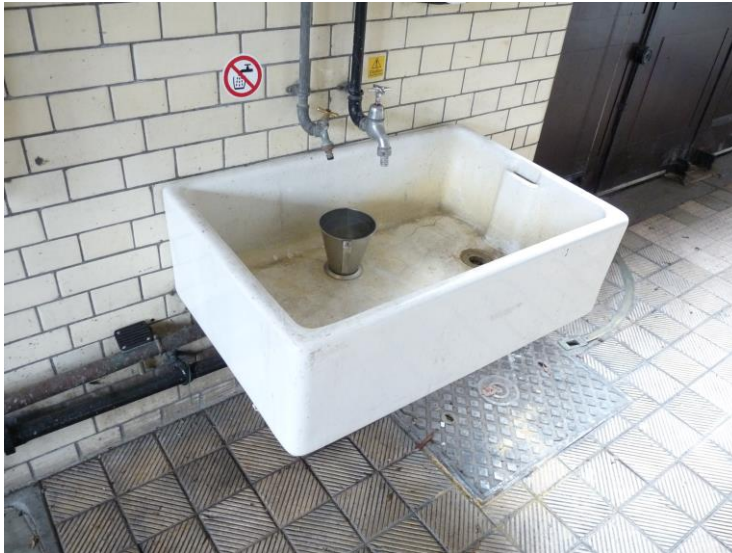
7. Belfast sink on the eastern wall of the appliance room. There is no sink shown on the original drawings nor any drainage point. The taps are modern fittings and it is not considered that the sink itself is of any special interest.

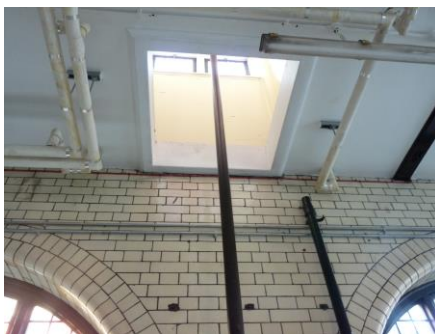
8. Pole access. The two poles in the appliance room and the single pole in the stairwell will be retained. The floor will be infilled over the appliance room and the surrounding enclosure at first floor level will be retained. In the stairwell the gates providing access to the pole will be secured and retained in position.

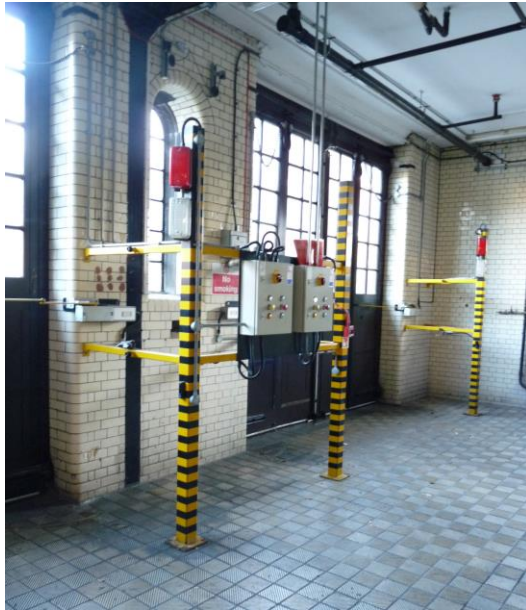
9. Modern protective metal structures and services on soffit of floor above the appliance room. The structures either side of the main doors support control equipment and are of no historic significance. Drainage and heating runs for services installed at various stages can be seen suspended below the floor for the single mens dormitory above.

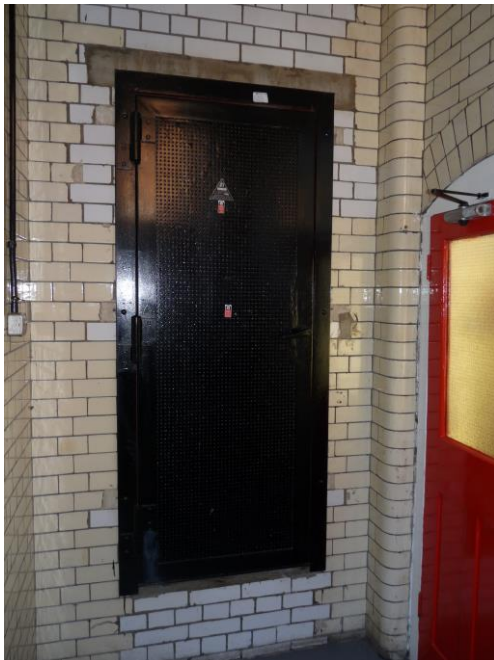
5. The entrance to the flat uses the door from the corridor linking to the main staircase. This leads to steps to a lower level and originally was the stokery situated at the the same level as the boiler since removed. The room to the right on entering was the coke store which will now provide access to bedroom 1. The existing fire door will be retained for access but relocated at floor level. As can be seen from the tiling this door was moved, probably when its use as a coke store ended.

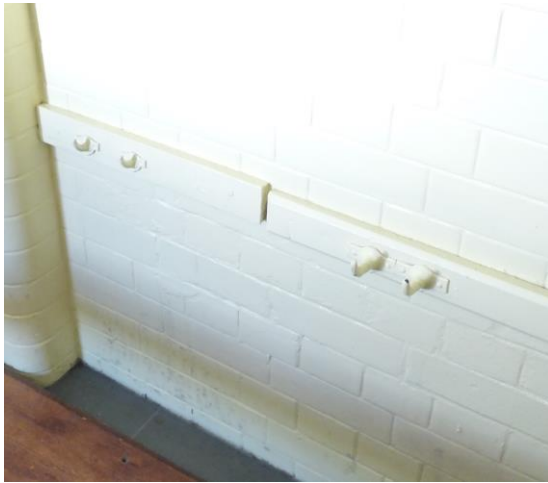
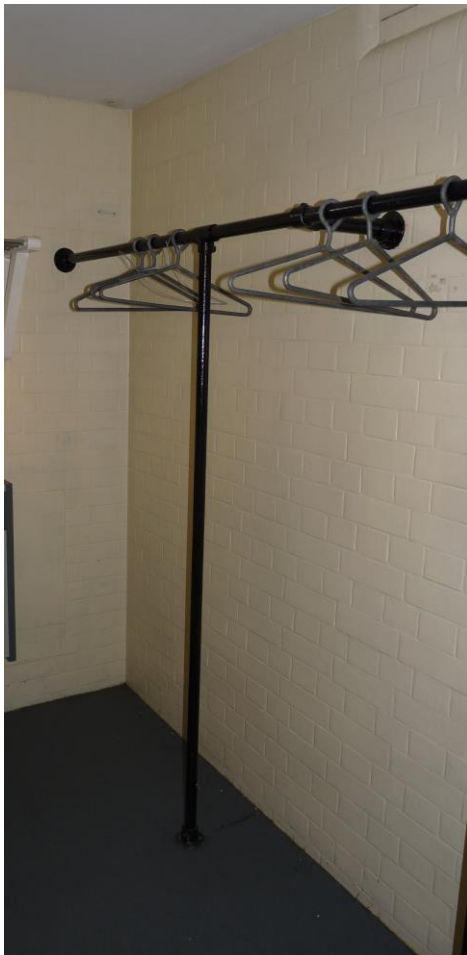
- 6 The wash room was originally a simple single space with coppers along the western wall and sinks along the southern wall. The walls are tiled but most of this has been painted over. It is proposed to remove the paint. The area has been subdivided into three separate spaces with light weight partitioning. Where there had been coppers there are now

rows of hooks. These are clearly not original but it is intended to retain a number as they appear to be part of the evolving use as a washroom.

The above coat racks were a later addition and formed out of standard metal tube. They are not of special architectural or historic interest, however it is proposed to reuse these within the apartment as being of general interest.

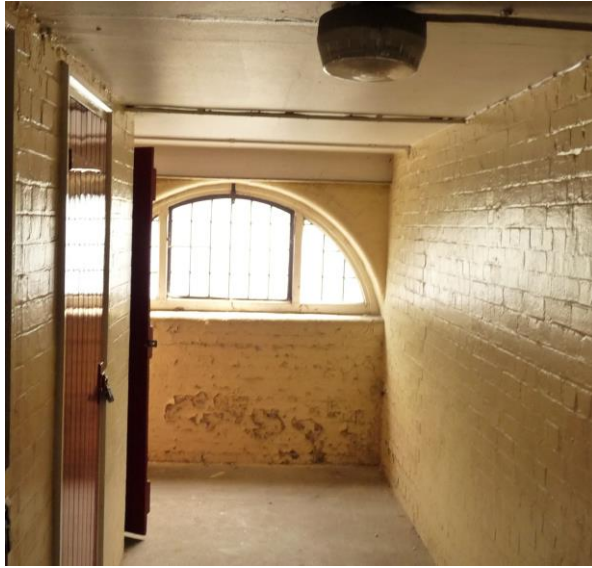
1. Existing windows

These windows will be dropped to floor level to provide access to the outside and increased natural light. A single door will be provided in the centre with fixed lights on either side thus respecting the form of the existing windows.

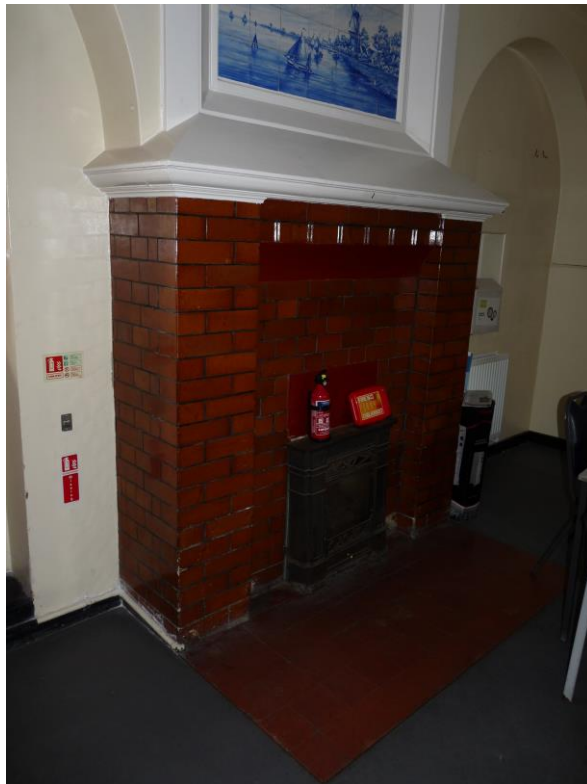
1. Fire places in original single mens mess room

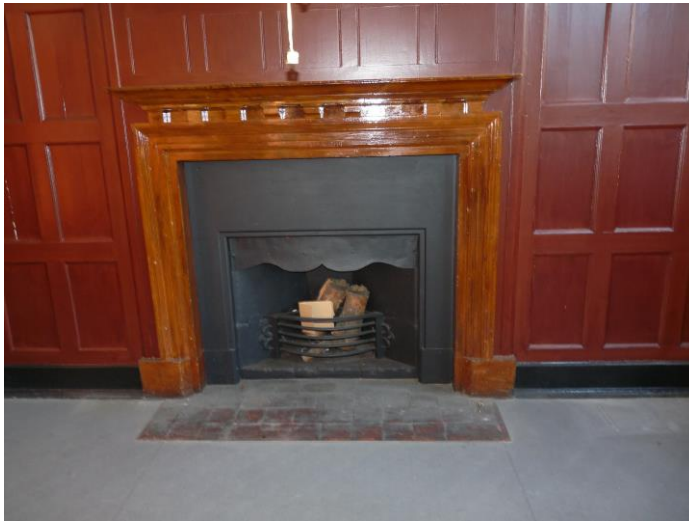
2. Fire place in original recreation room set into panelling which is also to be retained.

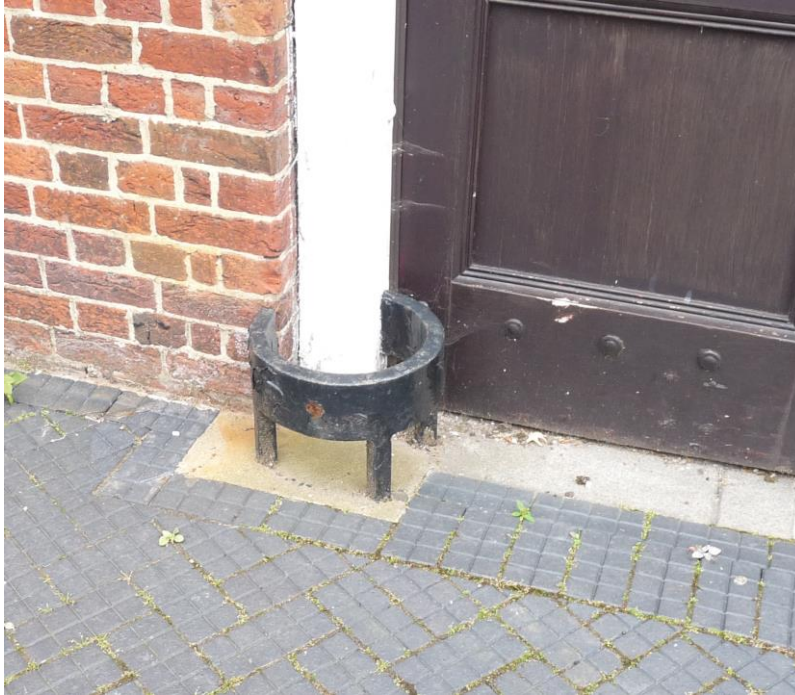
1. Corner protection. Three quarter round steel protection guards are provided to most of the brickwork corners in areas designed for vehicular traffic. These will all be retained.

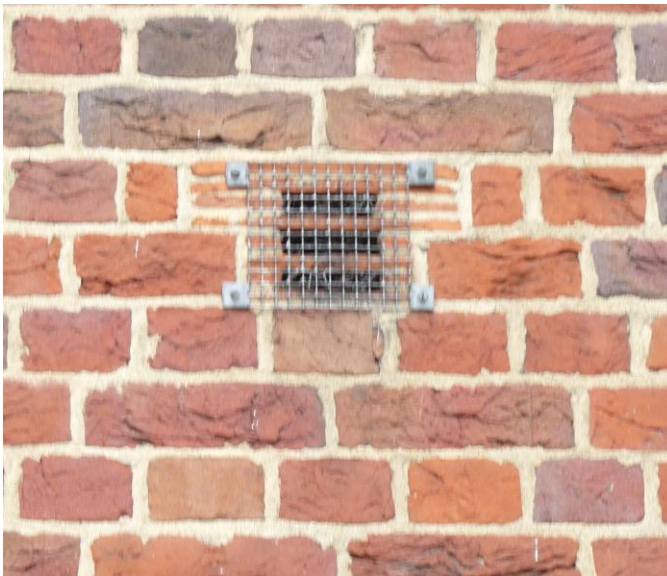
2. Tile ventilators. There are a number of small ventilators formed with tiles spanning across an opening. Fly screens have been added probably as a later detail.

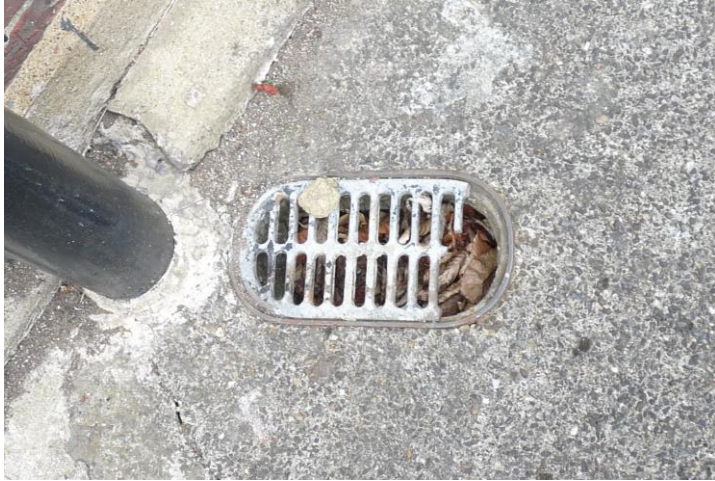
3. Rainwater gully cover plates. These will be retained.

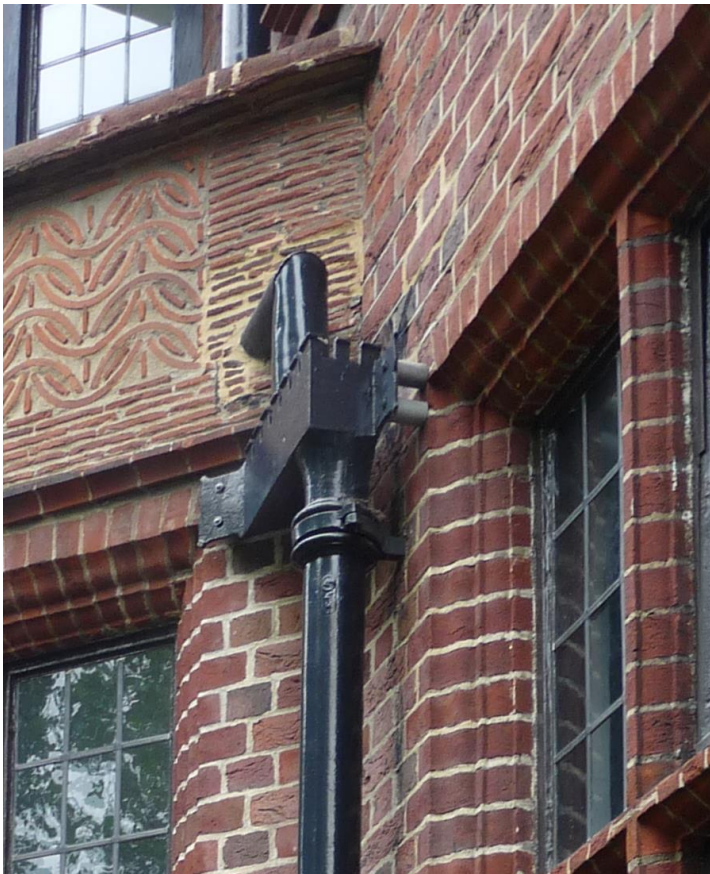
4. Rainwater hopper heads. Castellated design will be retained.

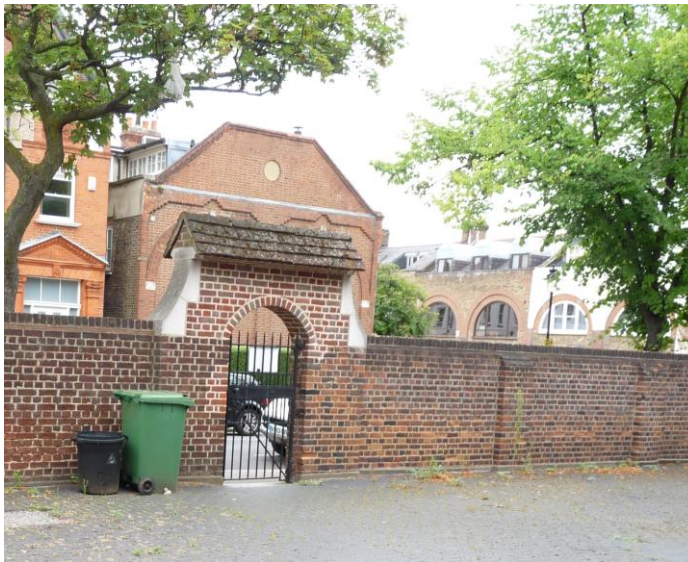
7. Pedestrian gate. This gives a view enclosed yard with tiled finish to be retained.

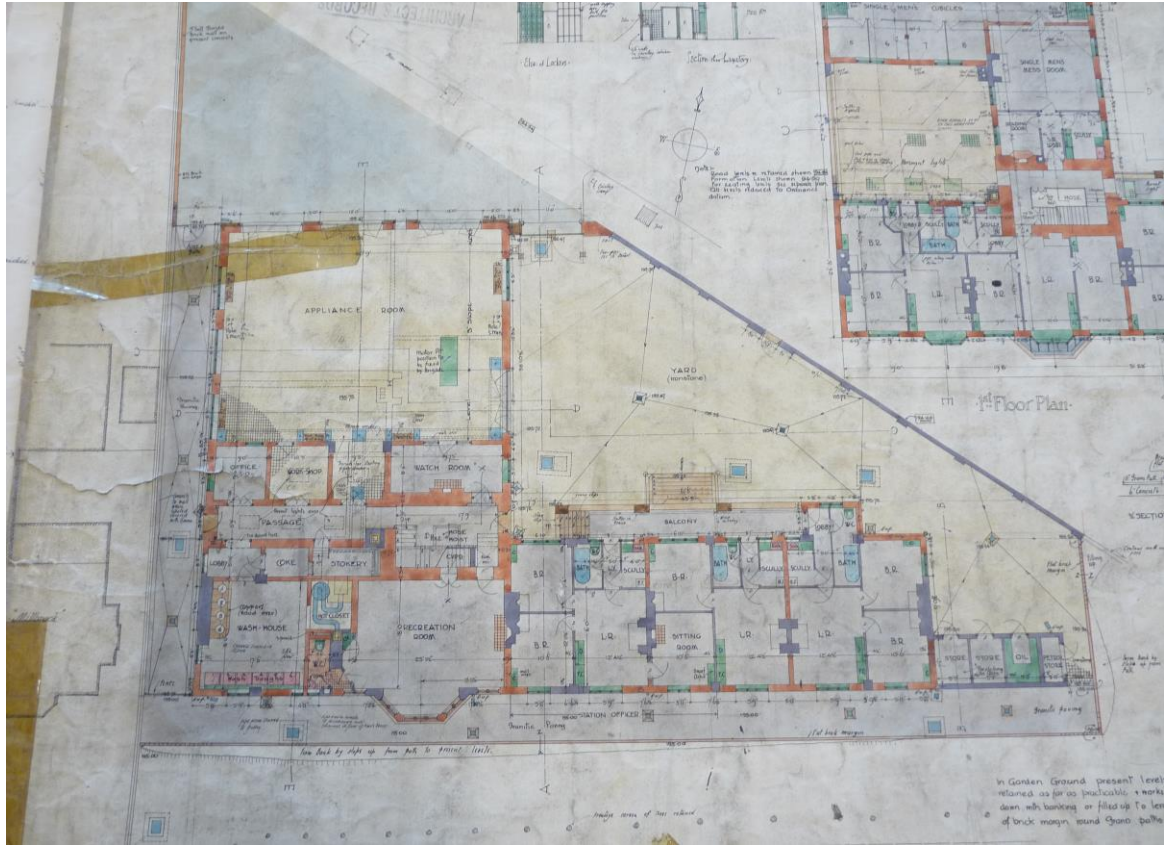
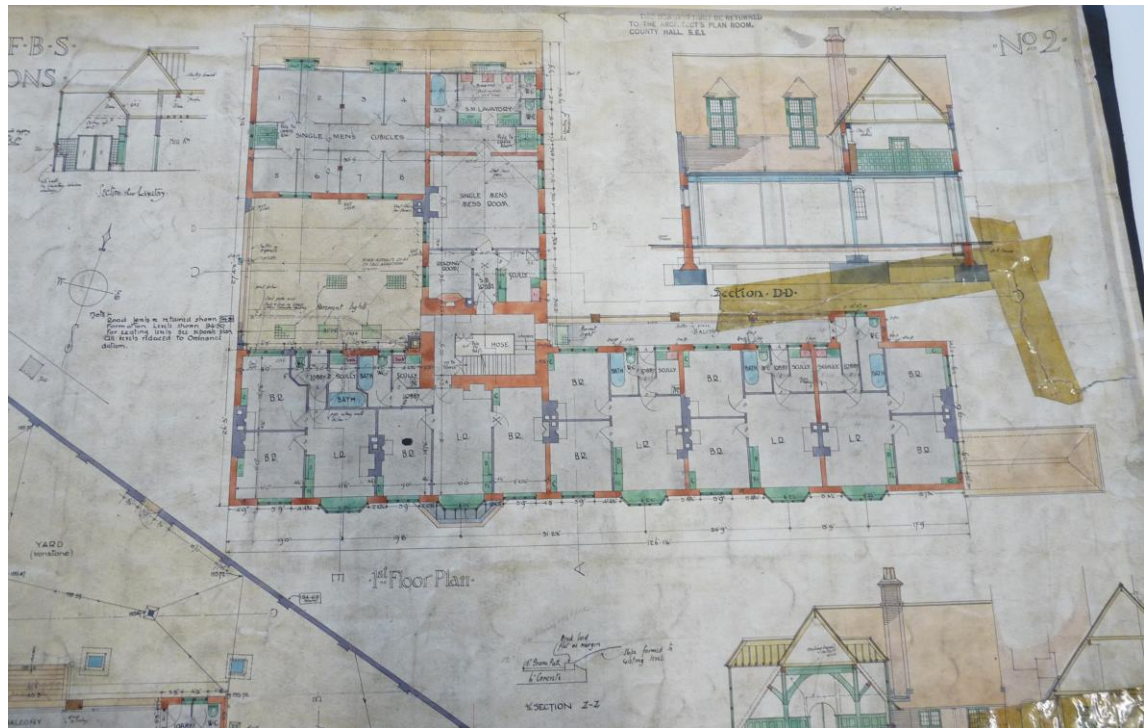
APPENDIX G
1913 Ground and first floor plans
By courtesy of the London Metropolitan Archive City of London

- 3.9 The London Metropolitan Archive has plans of the original building from 1913 and some with later alterations. A summary of the key features and alterations which have occurred is set out below.

- 3.11.3 Watch room. The original room had a flat wall overlooking the appliance hall with a glazed screen divided into three bays; the central bay provided an access door from the appliance room. See Appendix G for original layout of watch room.

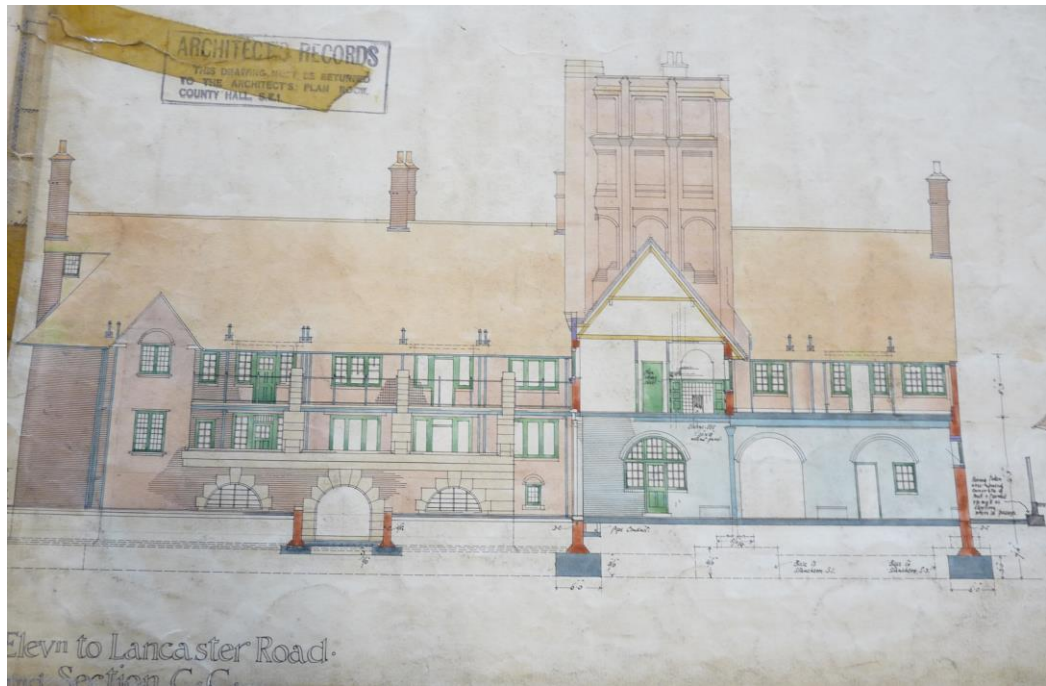
APPENDIX H

1913 North elevation of eastern wing and section through main building.
By courtesy of the London Metropolitan Archive City of London

- 3.10.1 The residential wing has a basement, a raised ground floor with a balcony accessed from steps up from the western end, and the first floor above it, again with a balcony access but this time from the central staircase. There is further residential accommodation at first floor level in the main block which is considered in 13.12. At the far end of the eastern wing is a single storey oil and petrol store.

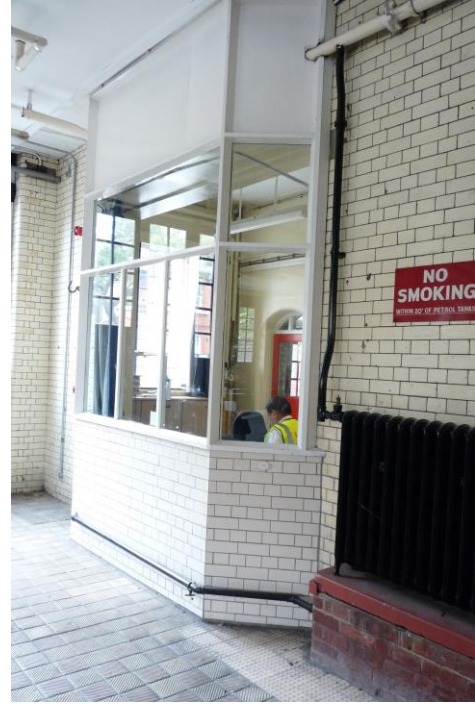
APPENDIX K

Altered watch room bay window as it exists today, plan showing original layout and detail through corridor and stoker.

The use is significant in that it was an essential part of the functioning of the station however the room itself has been through considerable change. Most of the wall facing the appliance room has been replaced and although it is clad in white tiles these do not match the originally tiling in any way. A new door has been formed in the western wall and the fire place has been removed.

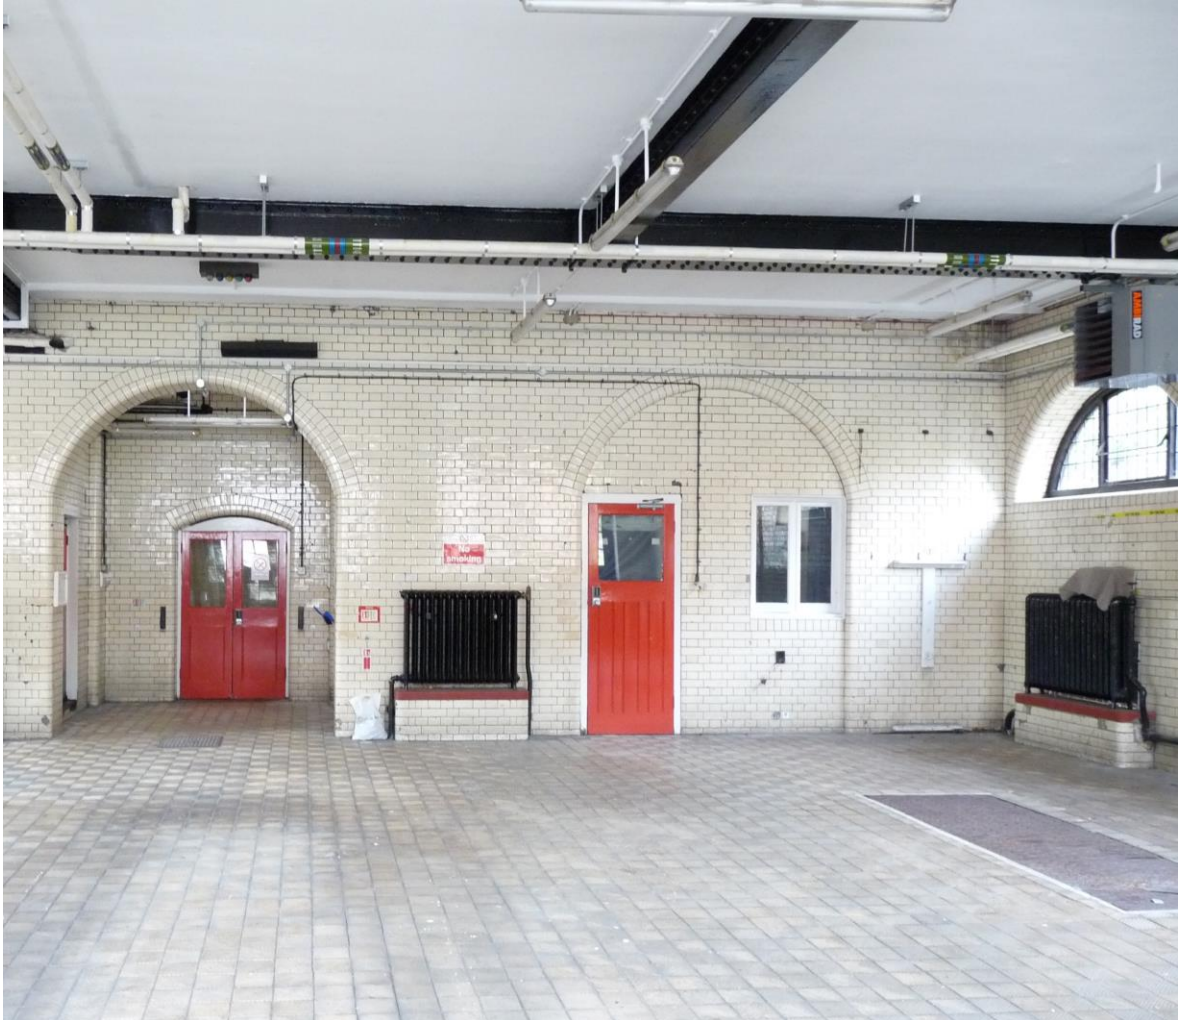
APPENDIX L

Photographs of office and workshop adjacent to appliance room also showing radiators on plinths in the appliance room.

- 3.11.4 Office and workshop. These are two simple rooms. The office has no direct door to the appliance room although there is a window. The workshop does have a door and its location possibly explains the pit having been moved from the location shown on the original drawings

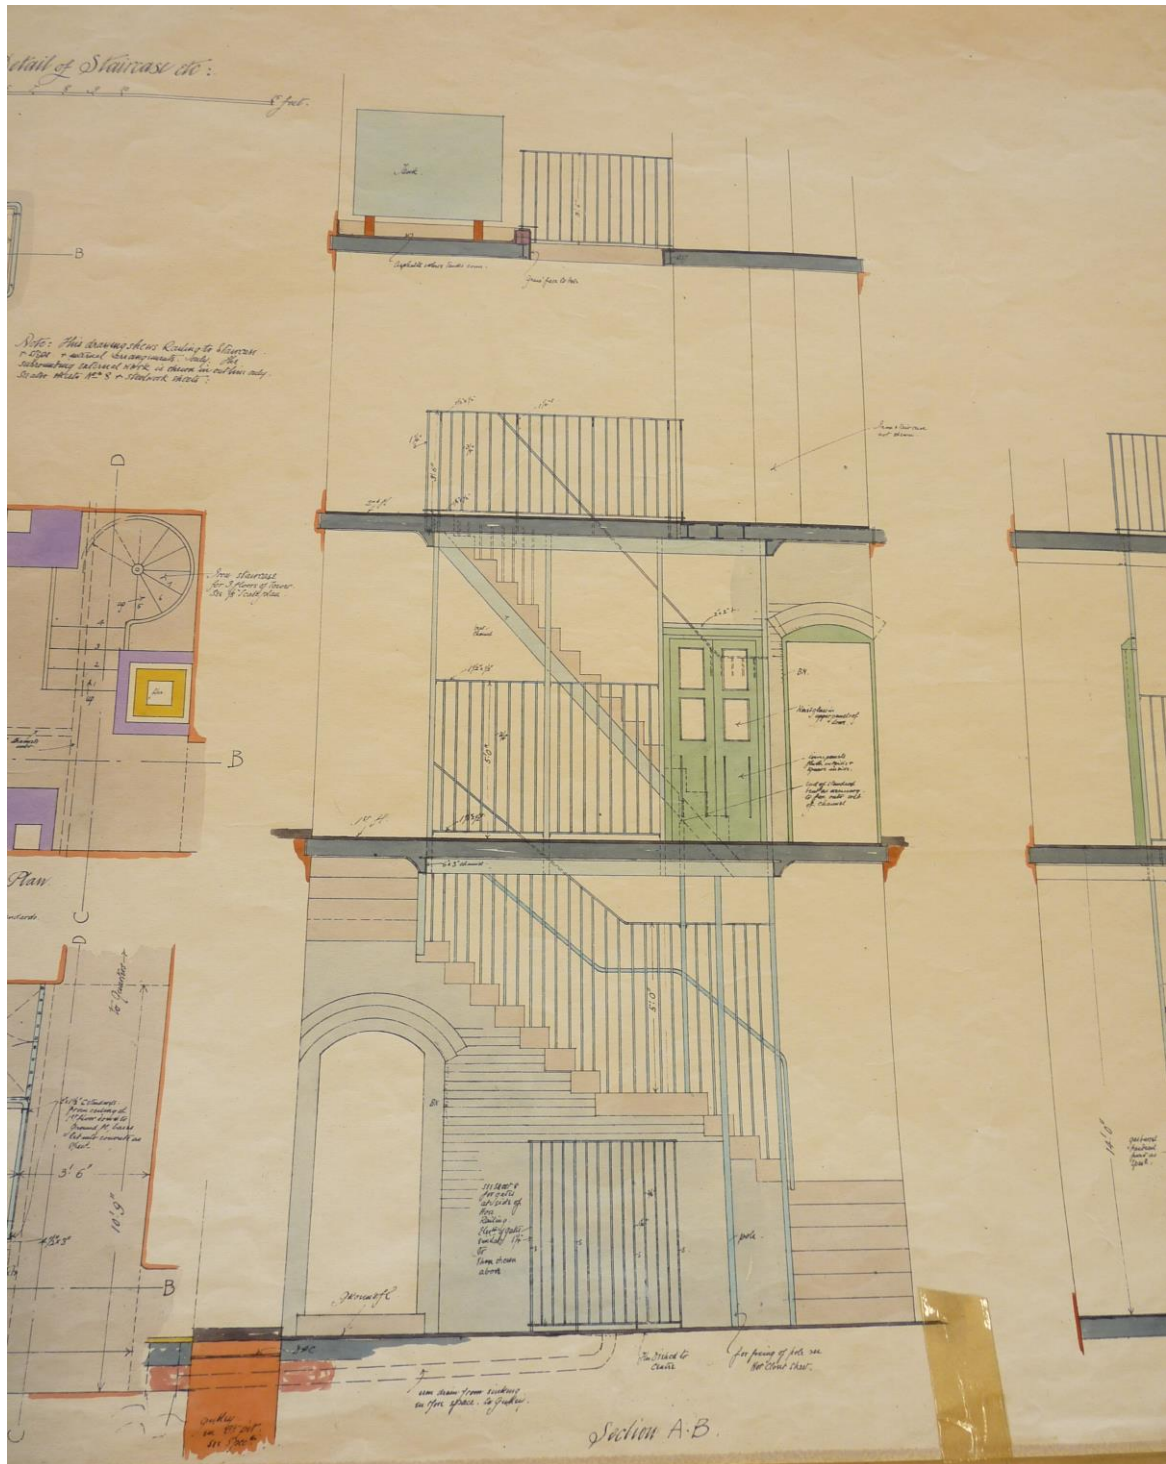
APPENDIX M

Central staircase

- 3.12.5 Corridor and staircase. The staircase consists of a steep metal framework around a narrow well which is labelled on the ground floor as housing a hose hoist and pole. The stair well and smaller openings above in the tower were to allow hoses to hung up to dry. The staircase now has doors leading out to the terrace on the western side at first floor and to the access balcony also at first floor level to the east however these do not appear on the original plans and it appears that this was originally an open space.

1. The main staircase rises in the centre of the building initially with treads supported on masonry and then from the first floor with precast concrete supported on steel strings.
2. A rapid access pole is located at the western end of the stairwell with a door access from the first floor landing.
3. The balustrade is a simple metal handrail on square section balusters with intermediate supporting u section channels spanning between floors.
4. A gate with two leaves gives access to the flight leading to the second floor. From that level upwards there is a small tight spiral staircase. The central opening is significantly reduced in size to allow for hoses to hang down the centre but no longer accommodating the stair flights. The view between floors is significantly reduced

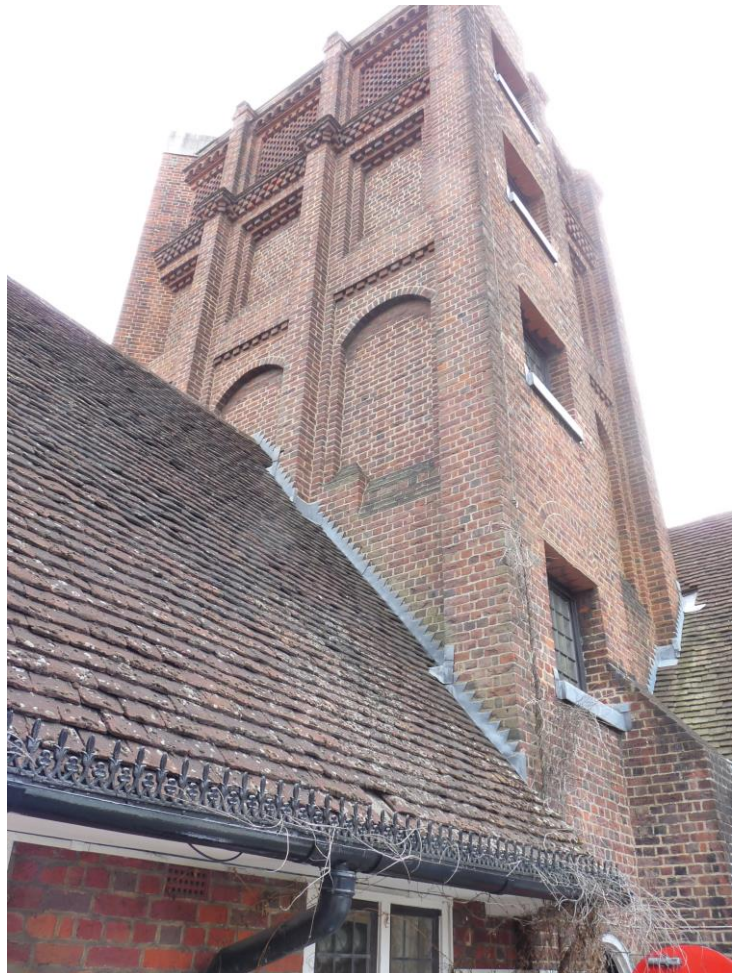
APPENDIX P
Tower as it is today

3.14.1 The tower rises in the centre of the complex. From the third floor upwards access is by a tight spiral staircase and there is an open void in the centre of the small floor which is lit at each level by a west-facing window. The opening aligns with the opening and drainage point below and presumably allowed the maximum length of hose to be suspended.

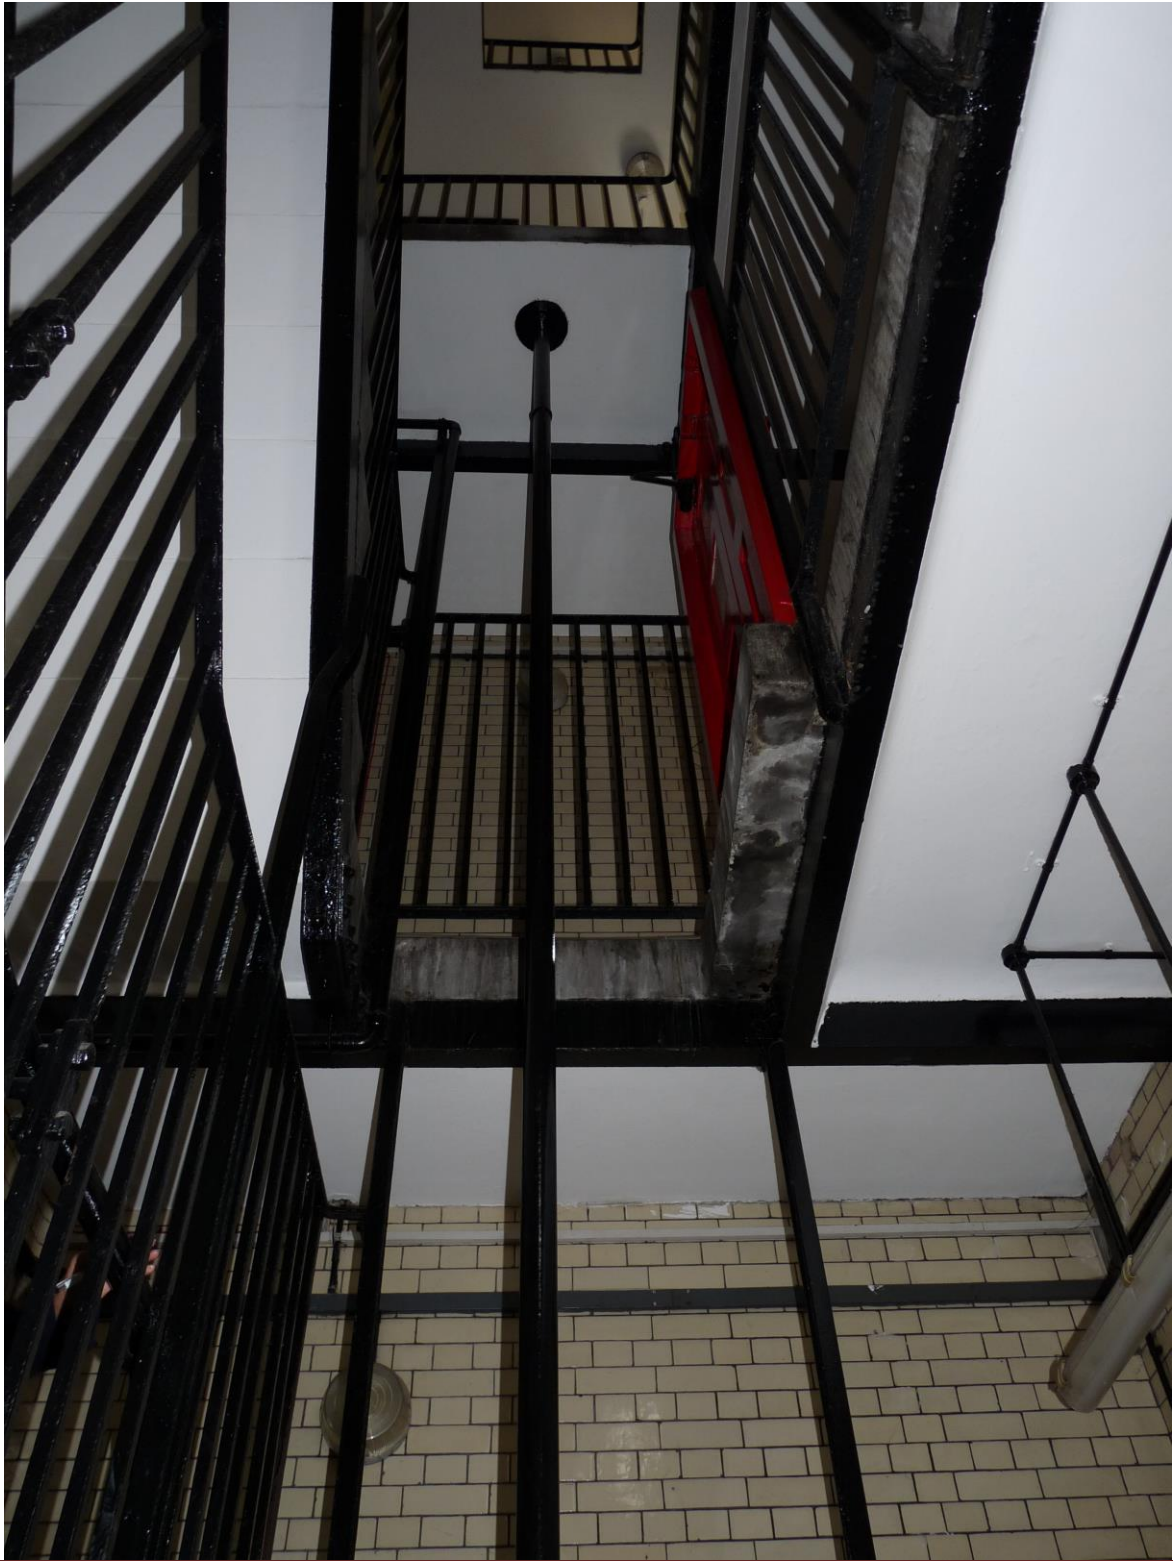
APPENDIX Q

Photograph of stair tower interior showing open stairwell with increased sense of enclosure at upper levels

3.14.2 Central staircase. This is an impressive central feature which is both visually striking and is at the heart of the functional activity in the building. It was used for hose drying and the drainage point in the floor is a reminder. It was a steep staircase and use in the case of an incident was supplemented by a third pole located at the western end of the well. This has now been removed. The balustrade to the well is a simple metal rail, supported on square section balusters. The walls are lined with tiles reflecting the functional use and, in contrast to the panelled walls of the recreation room on the south side and those of the mess room to the north, have been retained.

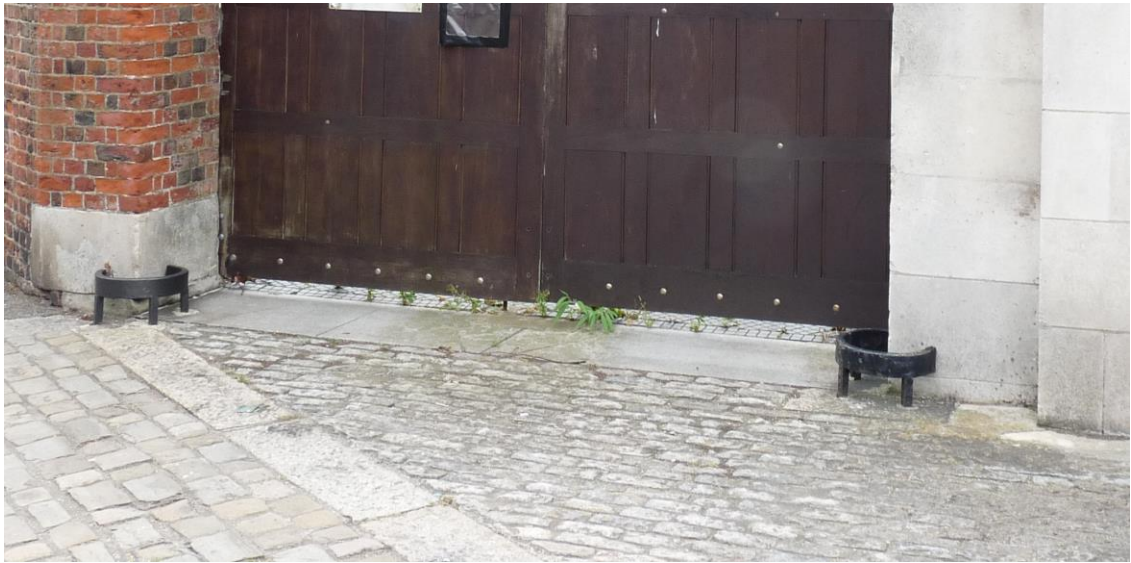
APPENDIX S
Photographs of doors and corner protection

3.15.2 The large-scale doors for the appliances and the open courtyard in front create a different character for the building and are in contrast to the general character of the area. Curved metal guards are provided to vulnerable corners.

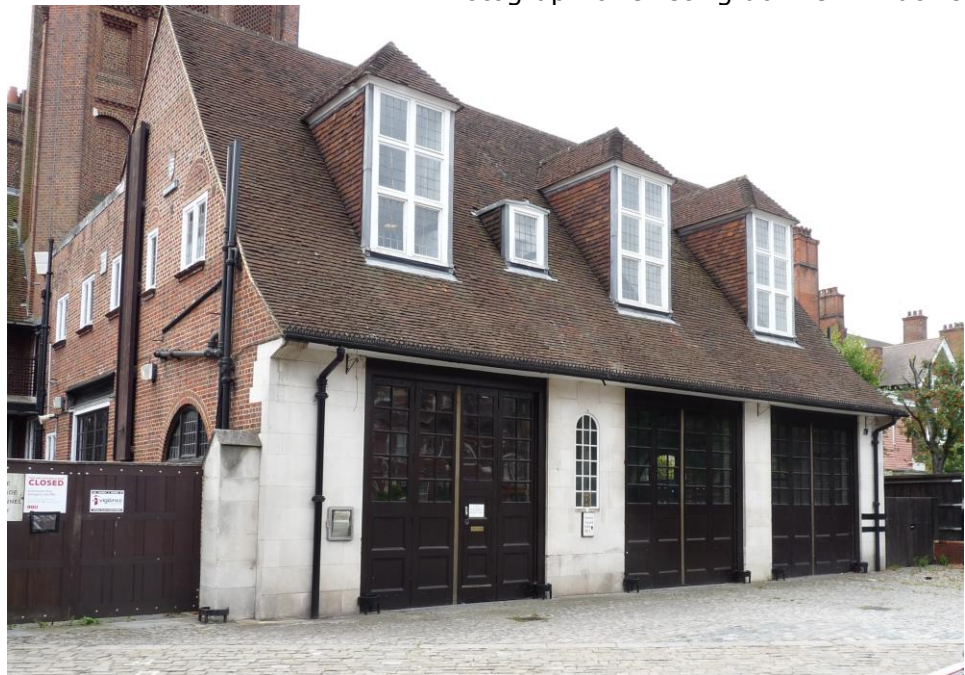
APPENDIX T
Photograph of existing dormer windows

3.15.3 The scale of the northwest wing due is markedly different from that of the majority of the building and is accentuated by the tall dormer windows lighting the dormitory, between which a small dormer has been inserted as a later addition.

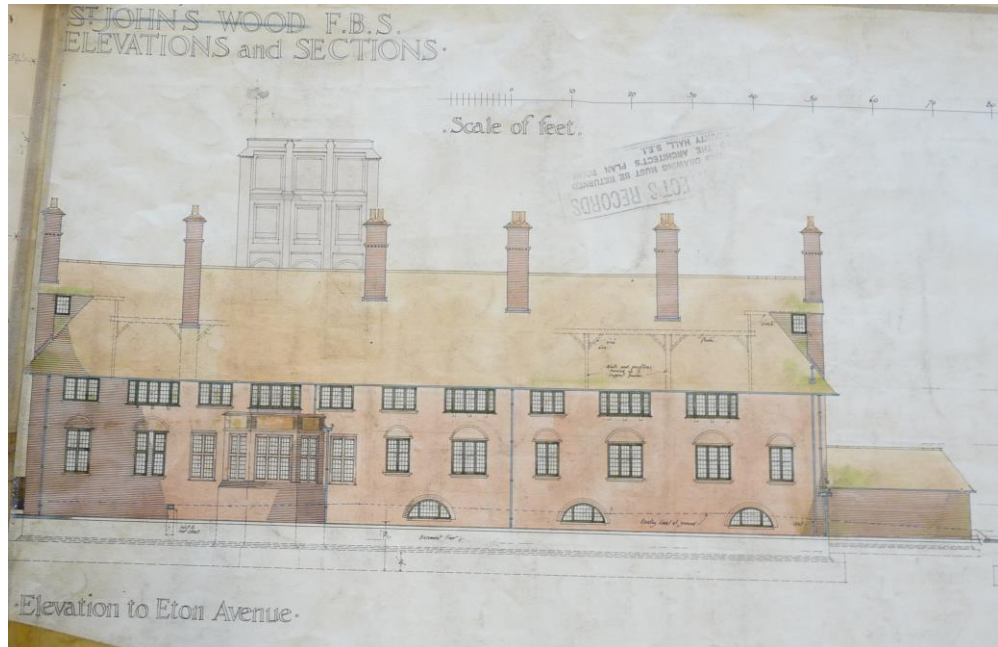
APPENDIX U

1913 Elevation to Eton Avenue

3.17.1 The south façade presents a long, low building range dominated by the substantial roof. At the eastern end there are the three semi-circular windows lighting the cross corridors in the basement of the eastern residential wing. This sets the level for what is, in effect, the range of ground floor windows along the whole façade of the residential wing at the eastern end and the recreation room with its bay window; then at the western end is that which started as further residential accommodation but was later converted to administrative use. Below this is the wash room with high-level windows.

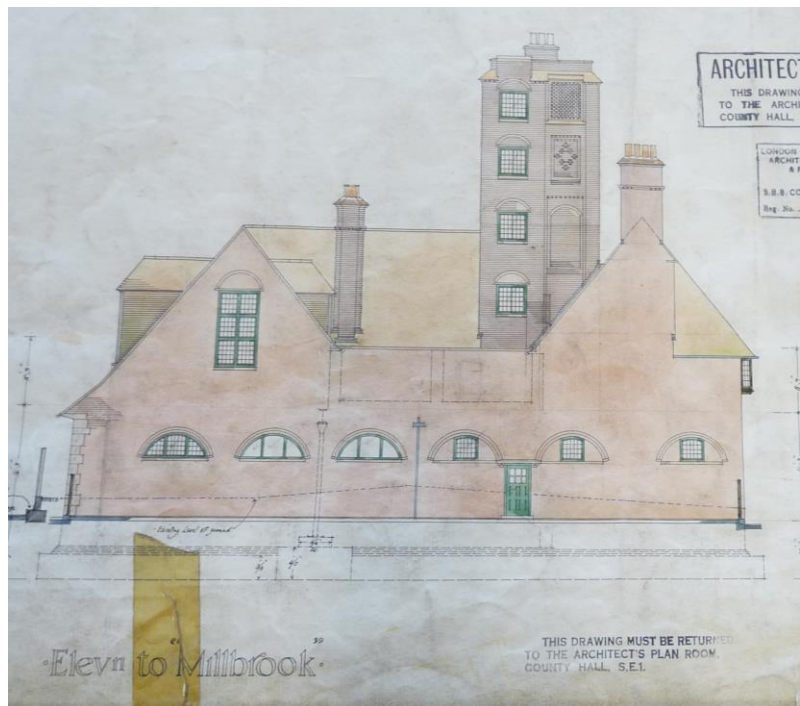
APPENDIX V

1913 West Elevation facing adjoining house Millbank.

3.18.1 The designers were always aware of the need for a change of level to the adjoining site and allowed for a small retaining wall. The fire station is screened by the fence between the two properties. A range of semi-circular windows provides light to the appliance room and the wash room. There is a single door giving access from the corridor leading to the central staircase. This is clearly a space which was used but it has a 'left-over' feel about it.
