Greenwood Place Community Centre

Preliminary Land Quality Statement

London Borough of Camden

11167

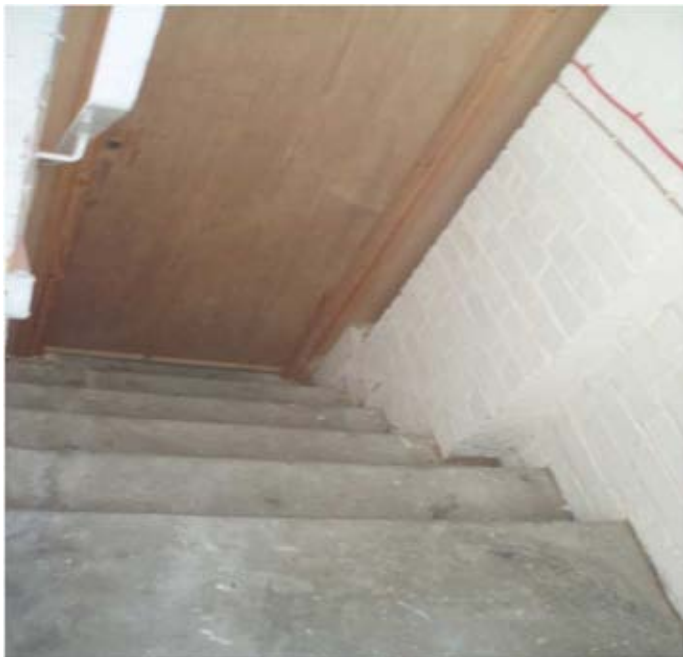
Image 7: Steps Leading down to store in active part of Greenwood Place

- COSHH Store building (Image 6);
- A below ground store, approximately 4x4m in plan and 1.00 to 1.50 m bgl (Image 7);
- Boiler Room (Image 8) located towards the bottom of the 'Mail Out' community space which covers part of the ground floor footprint of Deane House (see Figure 2 for photograph). Staining on the floor of the boiler room was noted (Image 9) suggesting possible leakages during past operation;

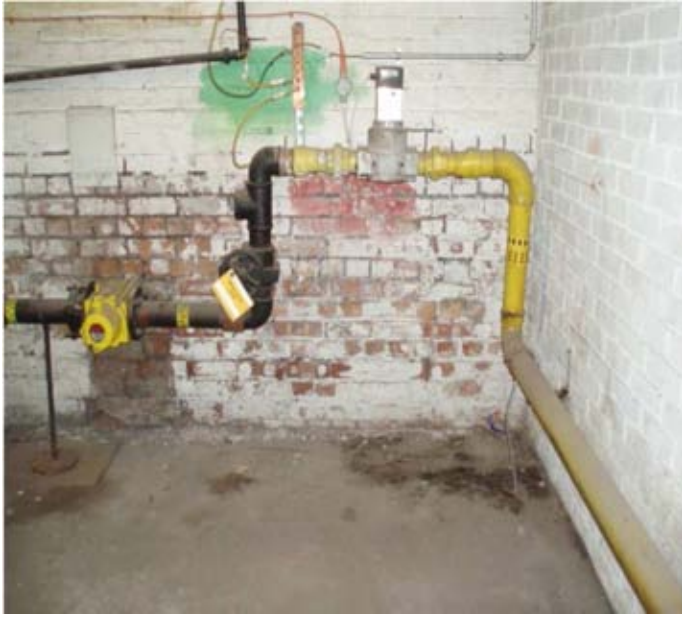
Image 9: Staining in Boiler Room

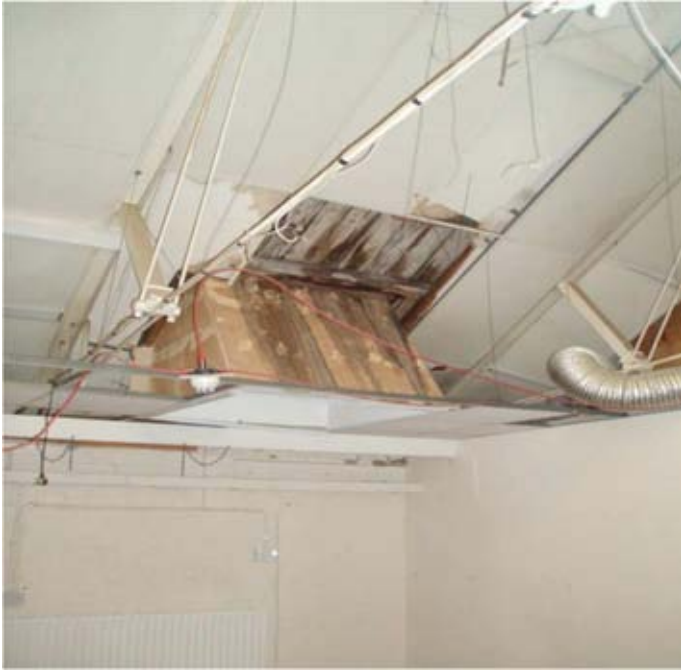
Image 13: Roof in Poor State of Repair (Disused Building)
