HISTORIC DEVELOPMENT

3.2 HISTORY OF NOS. 1-8 ST.ANDREWS PLACE

3.2.8 HISTORIC DEVELOPMENT PLANS

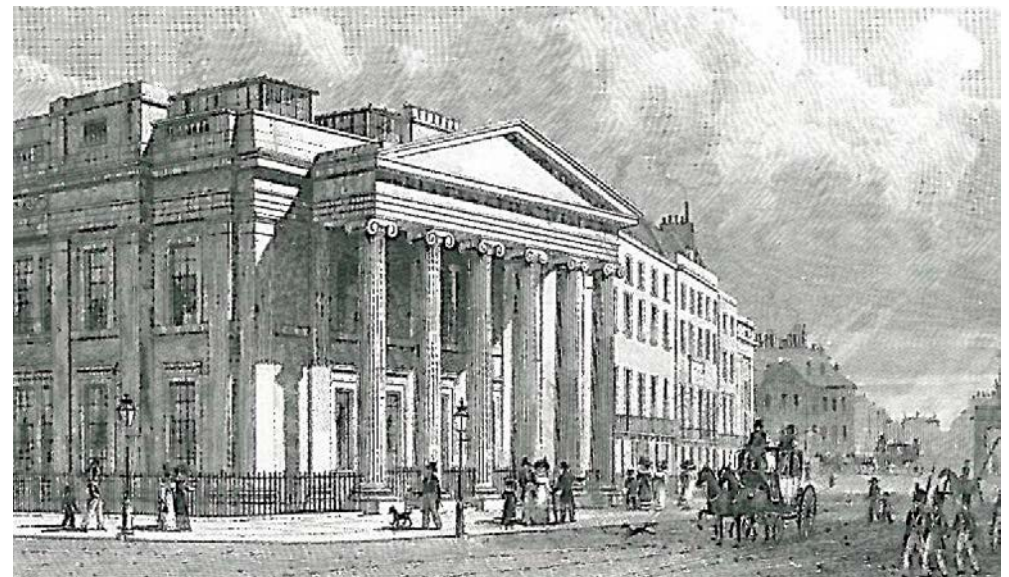
The Royal College of Physician's premises on Pall Mall East, 1828

The College moved into a building on Pall Mall East, originally designed as the Union Club by Sir Robert Smirke. (See photograph of this building, bottom right.)

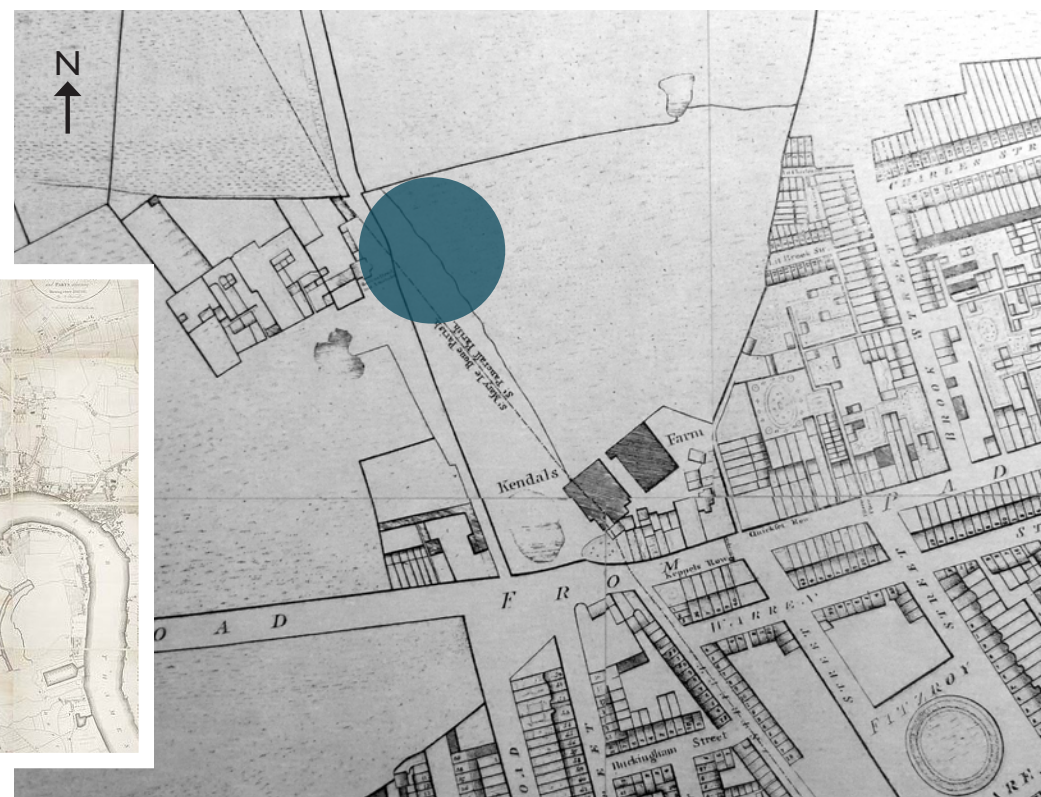
Horwood's Map of London, 1794-99. The detailed map shows the approximate location of St. Andrews Place before development

the Crown Estate since. During the Tudor period the large open area was a well-stocked deer park, known as Marylebone Park. In the mid-17th century the parkland was divided into a series of small holdings for the growing of hay and grazing of livestock. By the late 18th century London had gradually expanded north-west and was by this time bordering Regent's Park. The development of London can be seen on Horwood's map of 1794-99.

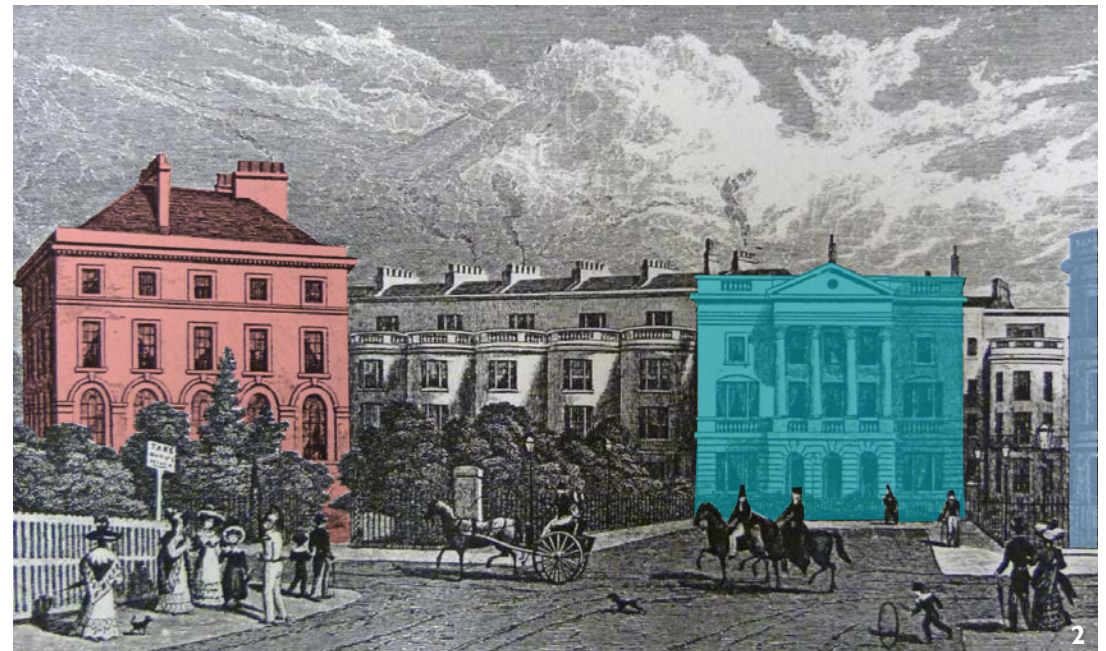
2 St. Andrews Place, 1828

Nos. 1-8 St. Andrews Place were constructed as part of the Regent's Park development in c1823. They were designed by John Nash but built under the supervision of George Thompson. Someries House on the north side of the street (on the site of the Lasdun building) followed in 1824 and Nos. 9-10 at the east end were built in c1826. The completed buildings were depicted in an engraving two years later (reproduced bottom right). Someries House is the three storey detached building on the left, while Nos. 9-10 is the building with the portico at the end of St. Andrews Place. One of the bay windows of Nos. 1-8 can just be seen on the right hand side of the image.

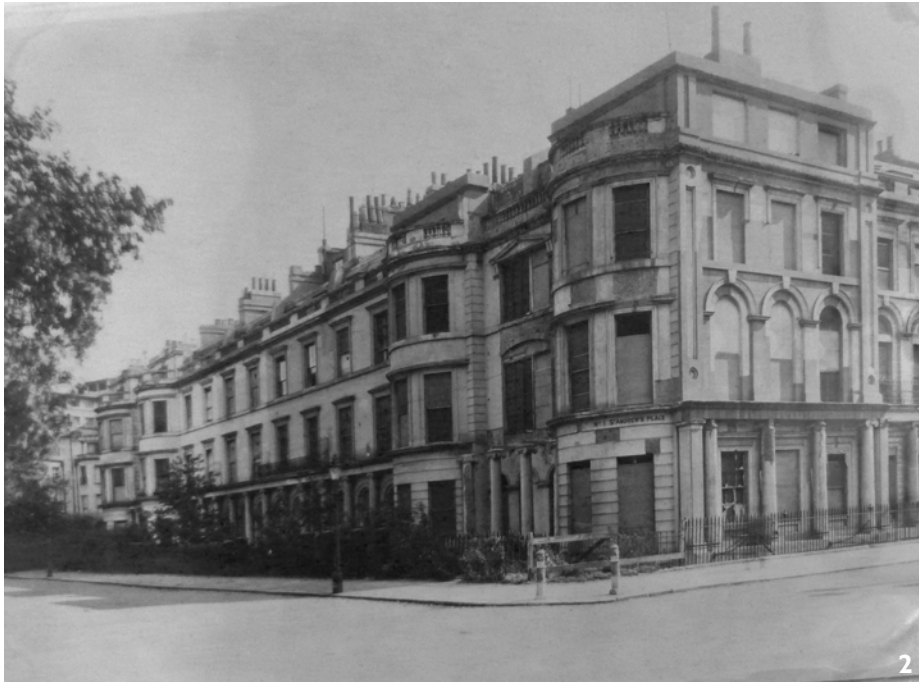
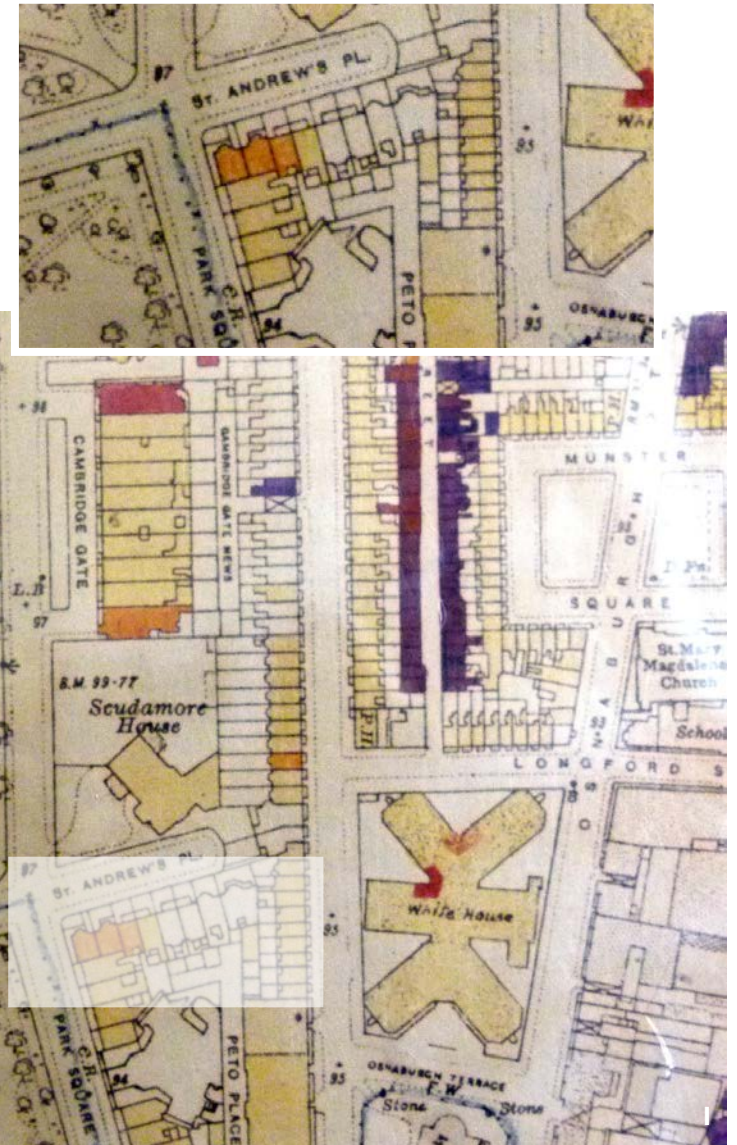
1 Bomb damage map 1940s
 2 1946 photograph of bomb damage to Nos. 1-4 (LMA, SC/PHL/01/053) RCP
 Internal use only.

A bomb damage map drawn up in the mid-1940s following World War II which shows the extent of destruction to property. Nos. 1-3 St. Andrews Place is coloured orange which represented 'General Blast Damage, Minor in Nature', while No.4 and Someries House (labelled on this map 'Scudamore House') are shown as yellow for 'Blast Damage, Minor in Nature'. The damage is also seen on a photograph from 1946 which shows boarded up windows, broken glass, damaged plaster revealing brick underneath and damage to the railings at the corner of the two streets.

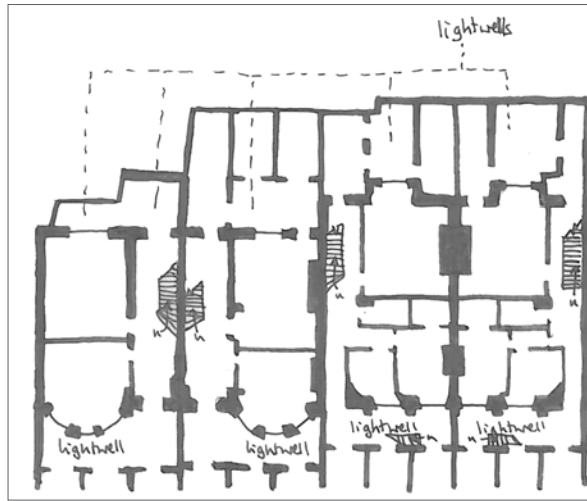
BASEMENT

-   **A** Opening created early 20th Century, blocked up 1980s
-   **B** Wall removed early 20th Century, replaced later 20th Century
-   **C** Staircase removed mid 20th Century, replaced 1980s
-   **D** Opening created late 20th/early 21st Century

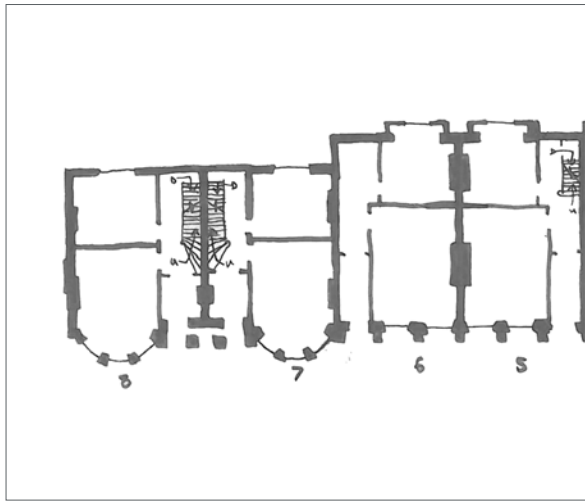
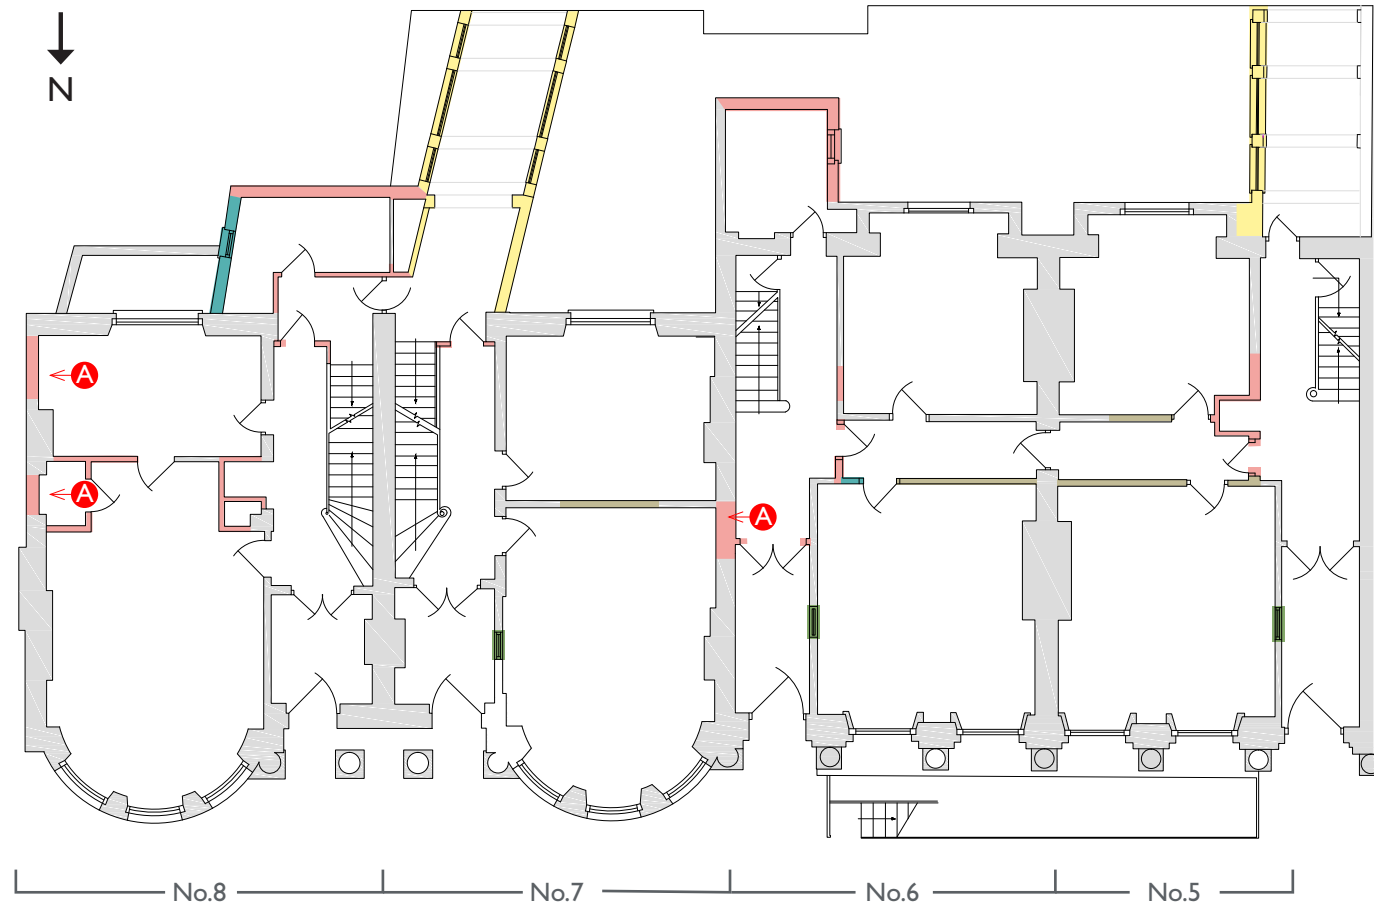
GROUND FLOOR

- A** Opening created early 20th Century, blocked up 1980s
- B** Wall removed early 20th Century, replaced later 20th Century
- C** Staircase removed mid 20th Century, replaced 1980s
- D** Opening created late 20th/early 21st Century

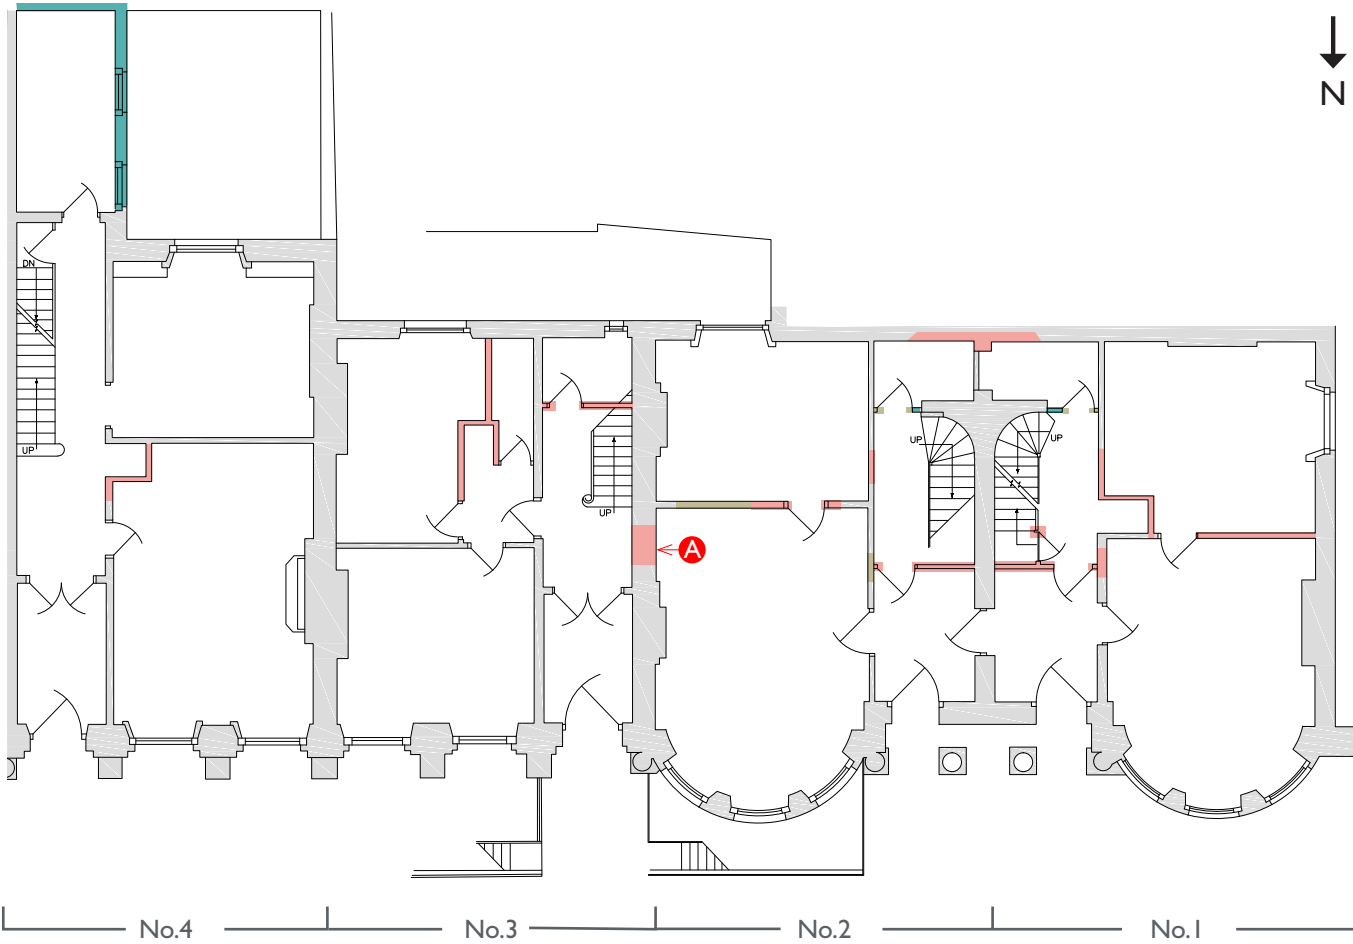
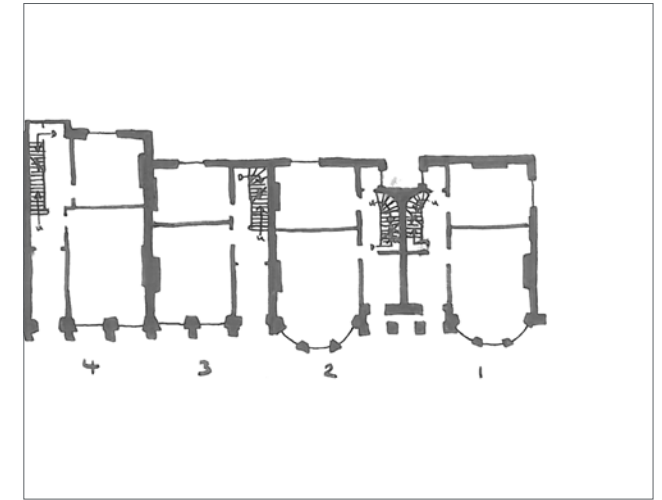
GROUND FLOOR

- A Opening created early 20th Century, blocked up 1980s
- B Wall removed early 20th Century, replaced later 20th Century
- C Staircase removed mid 20th Century, replaced 1980s
- D Opening created late 20th/early 21st Century

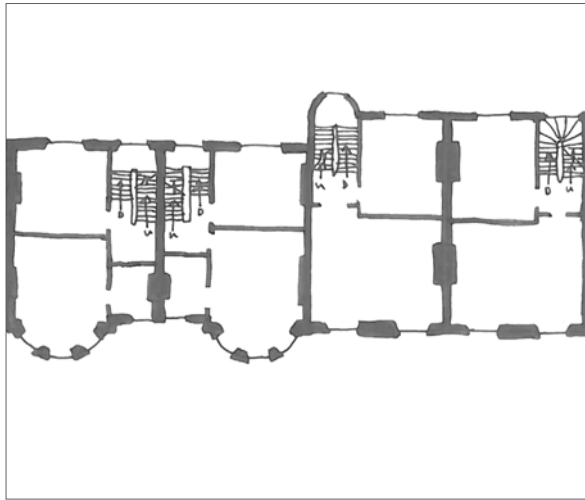
FIRST FLOOR

- A** Opening created early 20th Century, blocked up 1980s
- B** Wall removed early 20th Century, replaced later 20th Century
- C** Staircase removed mid 20th Century, replaced 1980s
- D** Opening created late 20th/early 21st Century

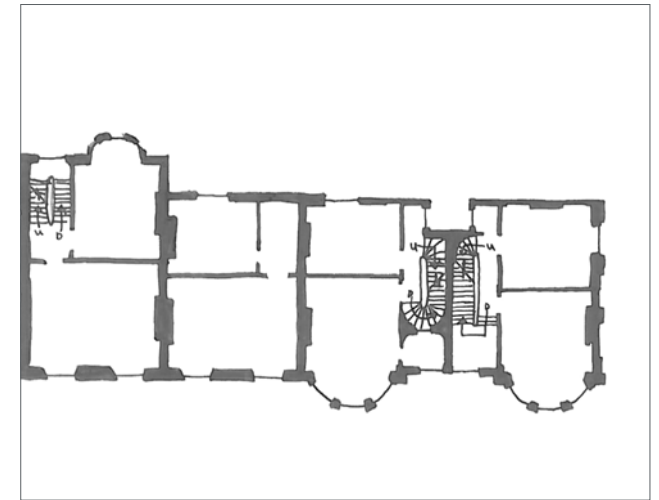
FIRST FLOOR

- Ⓐ Opening created early 20th Century, blocked up 1980s
- Ⓑ Wall removed early 20th Century, replaced later 20th Century
- Ⓒ Staircase removed mid 20th Century, replaced 1980s
- Ⓓ Opening created late 20th/early 21st Century

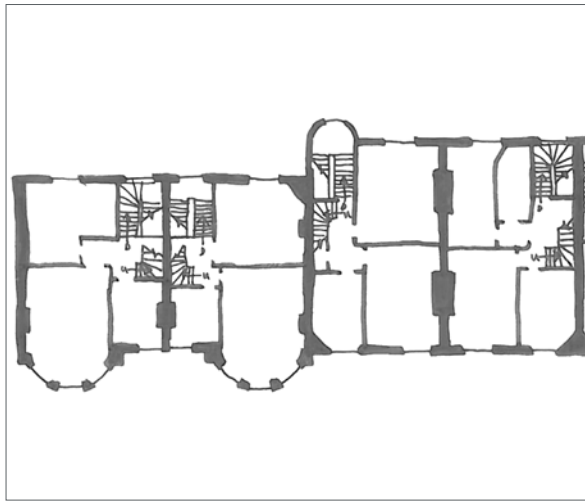
SECOND FLOOR

- A** Opening created early 20th Century, blocked up 1980s
- B** Wall removed early 20th Century, replaced later 20th Century
- C** Staircase removed mid 20th Century, replaced 1980s
- D** Opening created late 20th/early 21st Century

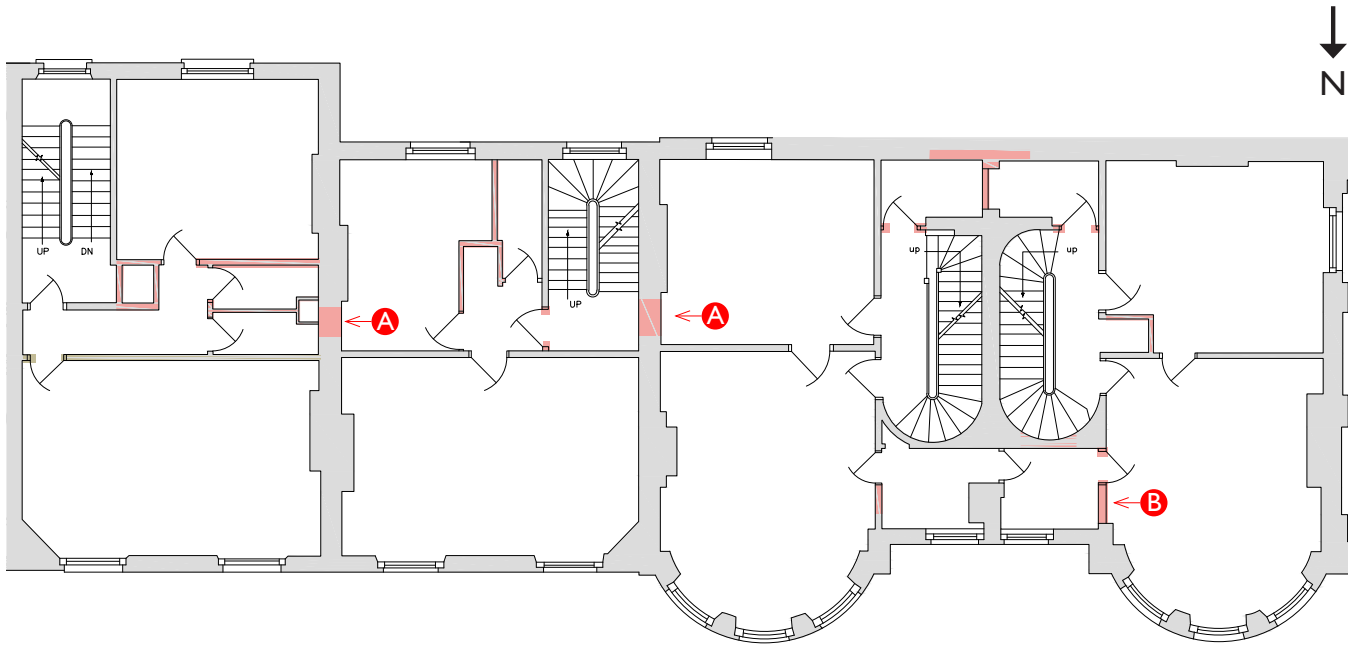
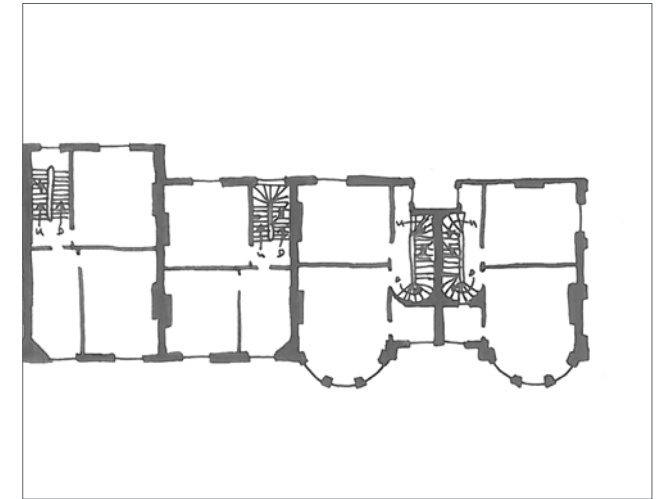
SECOND FLOOR

- A** Opening created early 20th Century, blocked up 1980s
- B** Wall removed early 20th Century, replaced later 20th Century
- C** Staircase removed mid 20th Century, replaced 1980s
- D** Opening created late 20th/early 21st Century

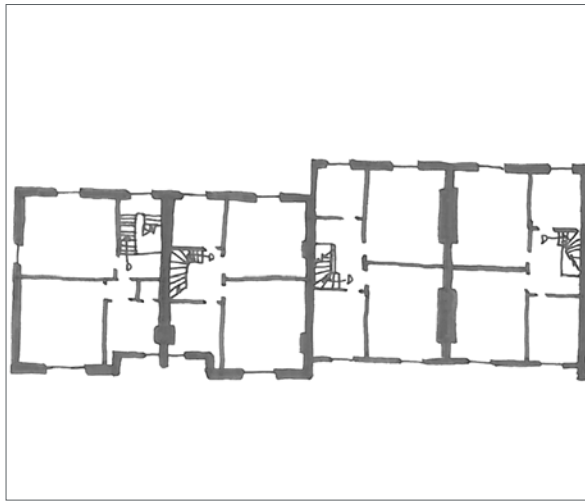
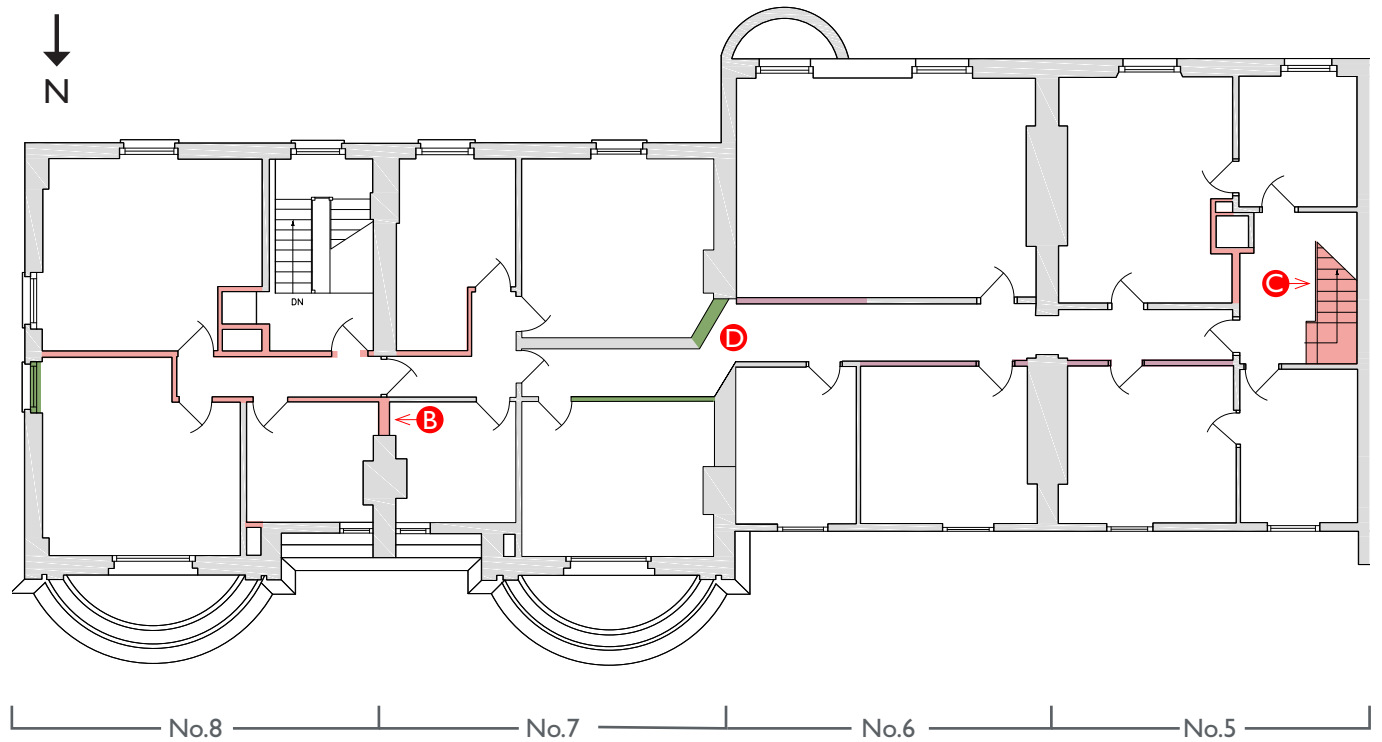
THIRD FLOOR

- A** Opening created early 20th Century, blocked up 1980s
- B** Wall removed early 20th Century, replaced later 20th Century
- C** Staircase removed mid 20th Century, replaced 1980s
- D** Opening created late 20th/early 21st Century

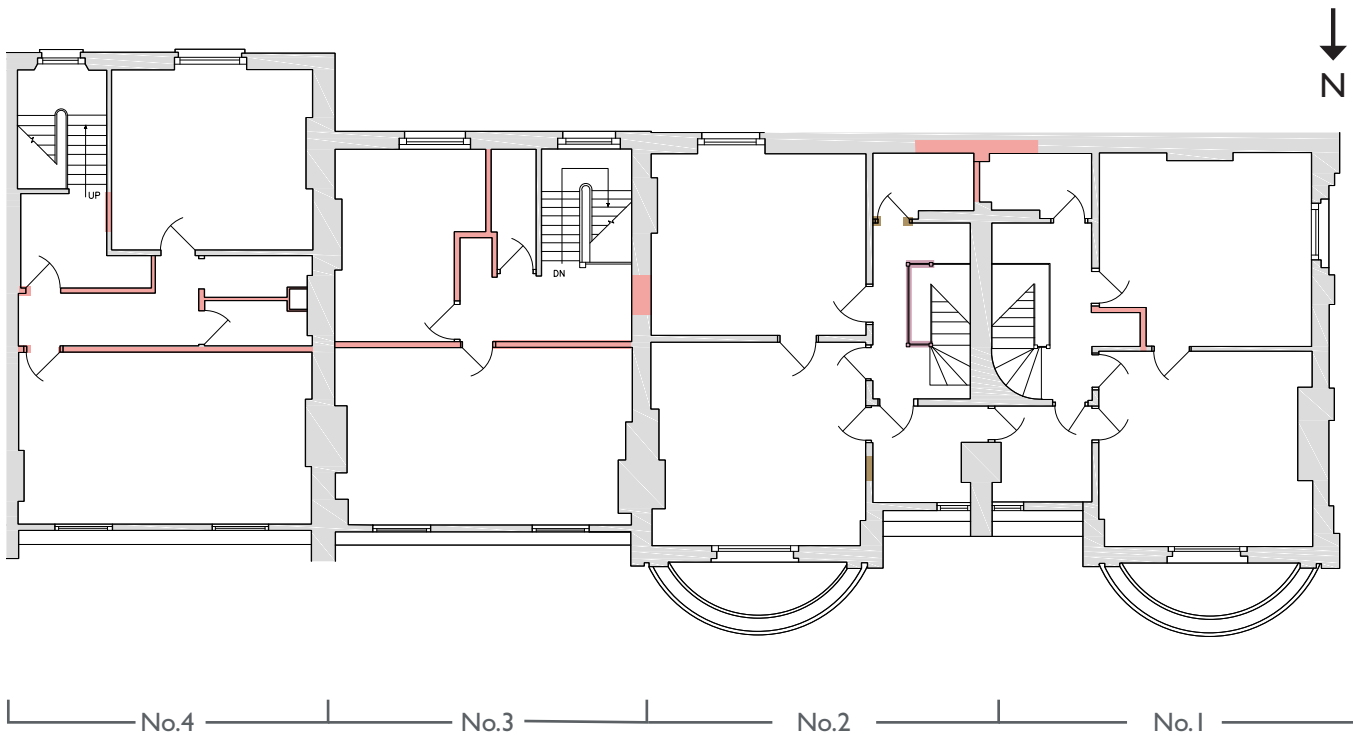
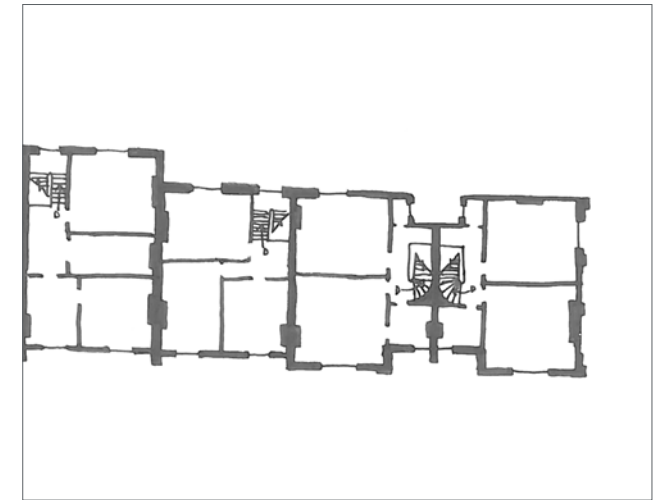
THIRD FLOOR

- A** Opening created early 20th Century, blocked up 1980s
- B** Wall removed early 20th Century, replaced later 20th Century
- C** Staircase removed mid 20th Century, replaced 1980s
- D** Opening created late 20th/early 21st Century
