Status: Stage 2
Date: 23/03/2016
Revision: A
Job no: 1387
Prepared by: Robert Mills
Approved by: Tom Steel

1 Introduction

This report has been prepared by Heyne Tillett Steel (HTS) to accompany the planning application for the proposed works to Minerva House, 26-27 Hatton Garden. The proposed development is located in the London Borough of Camden and comprises the additional of a single storey upward extension to the rear of the property, infilling of lightwells and the opening up of the internal space by replacing load-bearing partitions with steel framing. The extent of the existing basement is not proposed to change.

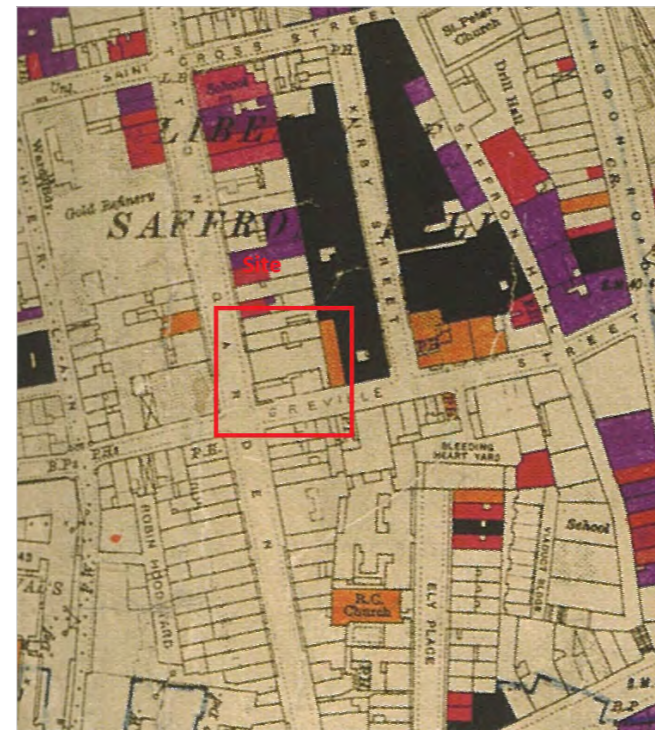
Bomb map indicating no damage to site during WWII

Historically the site is understood to have been used by the Royal Orthopaedic Hospital until 1907 when the hospital building was demolished and the current building was constructed. The building is thought to have been designed for the jewellery industry, with showrooms on the lower floors and workshops above. Bomb maps indicate that the site escaped damage during World War 2.

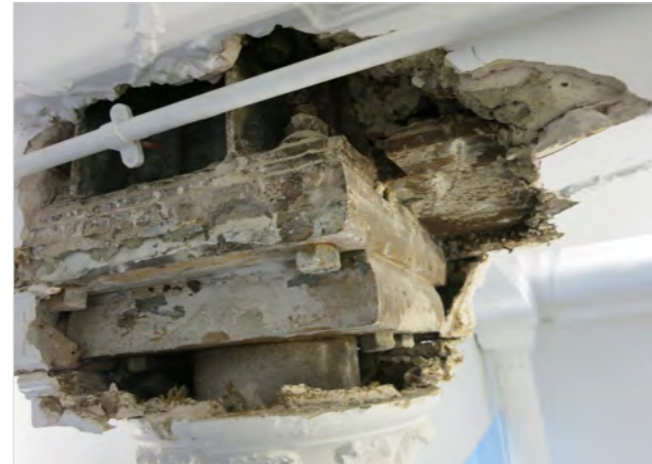
Column head detail at first floor

The existing building dates from around 1908 and comprises of 6 storeys fronting Hatton Garden and 4 storeys behind, over a basement. The floor structure generally appears to be of solid concrete construction, most likely formed from filler joists with concrete infill. At the lower levels the floors are supported on what appears to be an early steel frame, with the detailing suggesting that cast iron columns and wrought iron beams could have been utilised in some locations. A number of the steels appear to be concrete or masonry encased. Some chimney breasts that run up the building are also transferred on a grillage of steels at first floor level.

Detailing of the columns and beams at ground floor level appears to be consistent with early steel frames and cast iron column construction during the early 20th Century. In order to carry out a more thorough assessment of the load bearing capacity of the beams and columns, it is recommended that testing be completed to confirm the material properties of these.

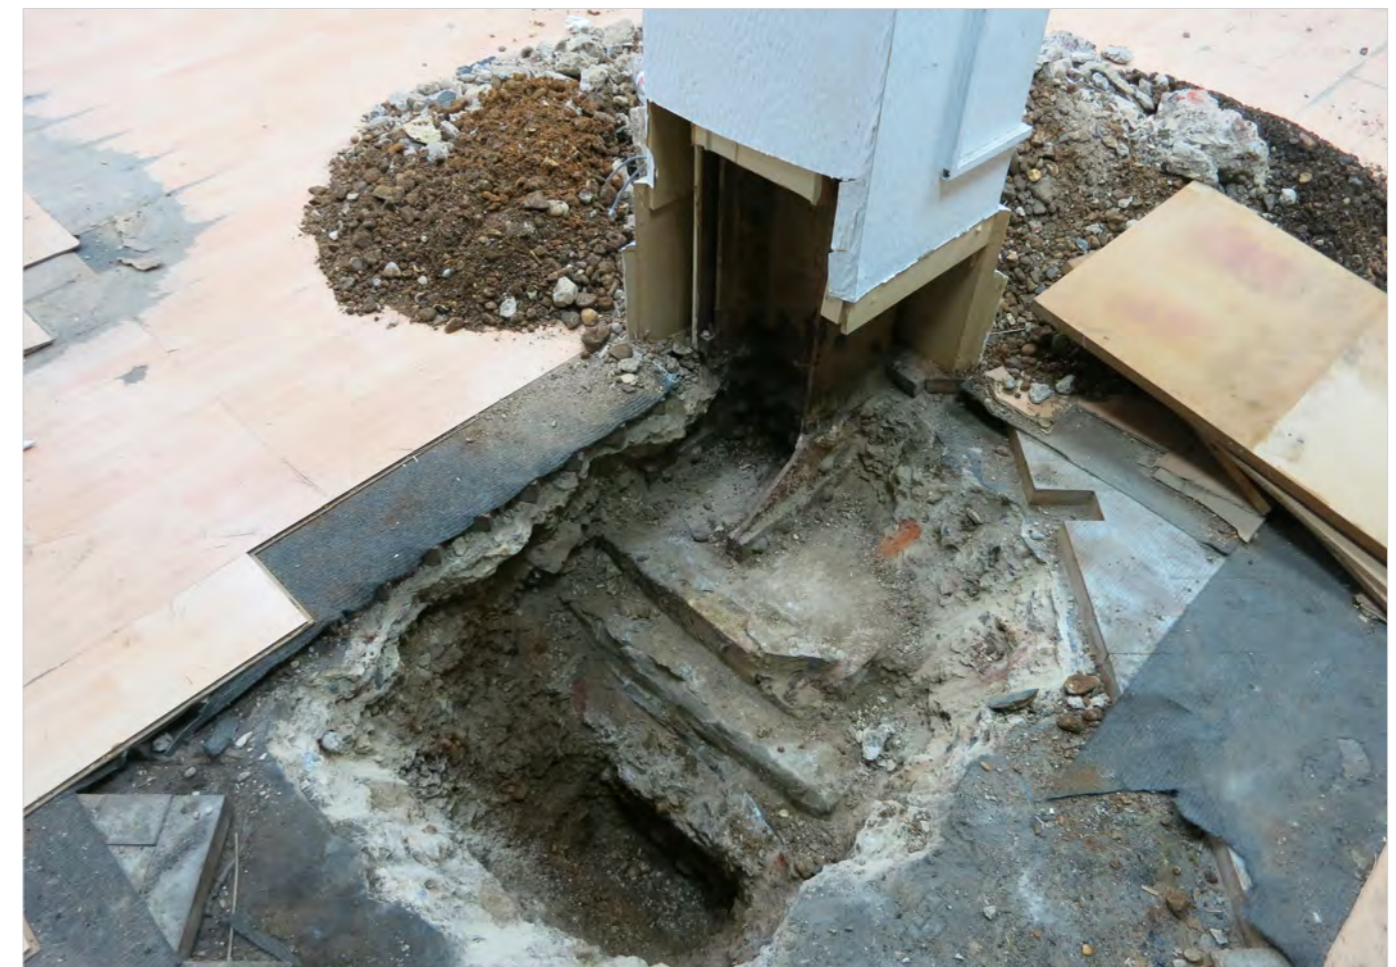
Existing pad footings under columns

A number of trial pits were completed in the basement and the results are summarised in the appendices. The pits indicated pads and strip footings below columns/walls and suggested that footings were generally founded at around 0.6-1.0m below ground onto gravelly material.

Calculations have been completed to assess the load on the existing building, based on a solid concrete floor thickness of 200mm, which would need to be confirmed. The two columns that have been assessed both have a bearing stress under the footing of around 380kPa, which is high and close to the 400kPa capacity indicated for the gravels.

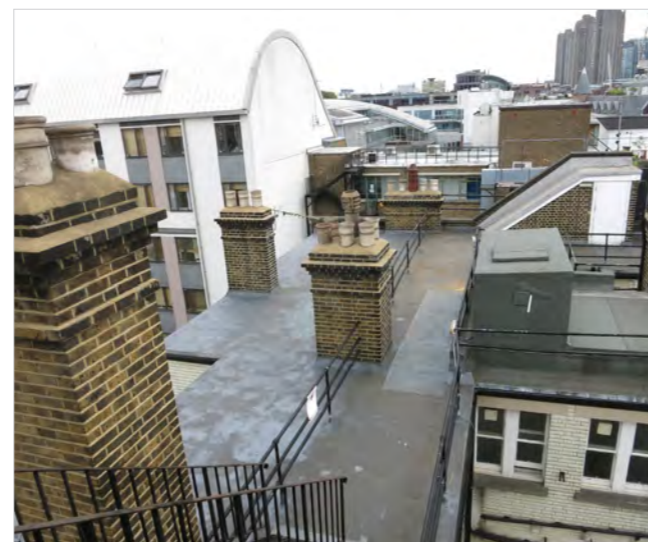
Existing Lightwells to be removed

The existing building is set out such that the building mass decreases above first floor level in order to accommodate a number of lightwells. It is proposed that three of the existing lightwells will be infilled with new floor structure up to the new roof level at 5th floor level, with the external wall line pushed out closer to the boundary. In order to form these the existing external walls adjacent to the lightwell will be demolished and new steel framing introduced to support the edge of the floor slabs and a new lightweight floor structure. A lightweight cladding system such as rendered panels, glazed curtain walling, brick slip system or metal cladding is proposed to form the new external wall line, with cross bracing to provide stability.

with column lines at basement/ground floor levels. The weight of the new floor structure approximately equates to the load from the removal of the external wall. Additional load will be transferred onto the perimeter walls of the lightwells at ground/basement levels, which will be spread evenly along the wall using spreader beams.

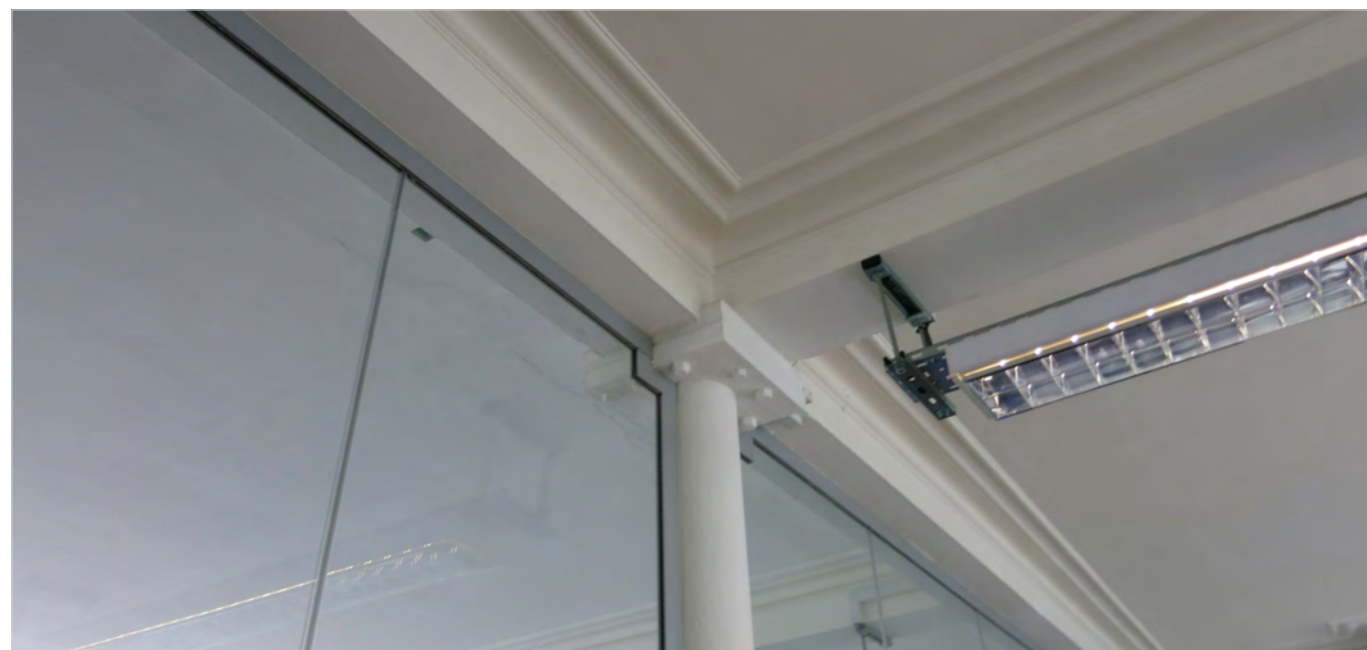
Existing beam and column junction

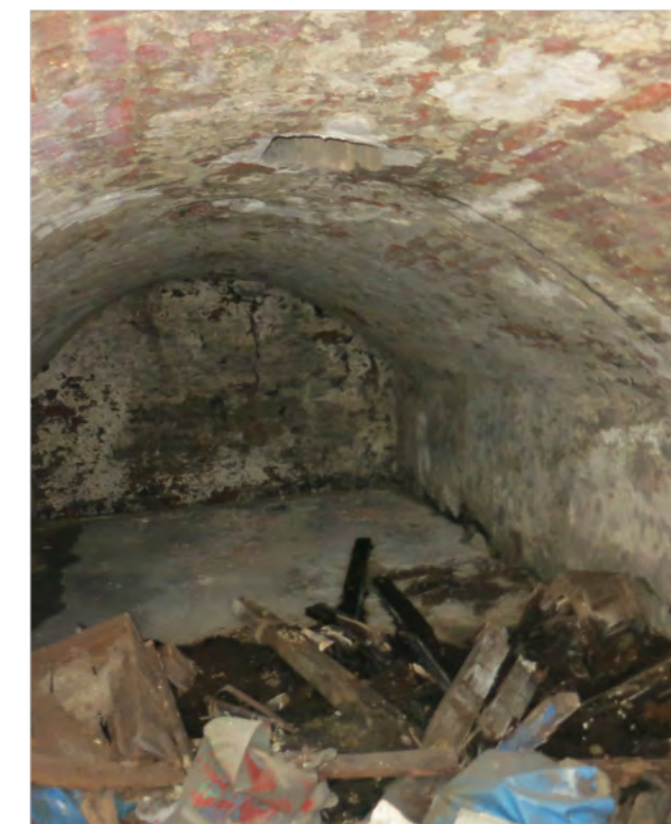
View of existing vault structure

At the front of the building are 6 No. pavement vaults formed from arched brickwork extend under the pavement and part of the Hatton Garden road. The condition of these has not been verified on site and these are expected to fall outside the scope of any proposed works.

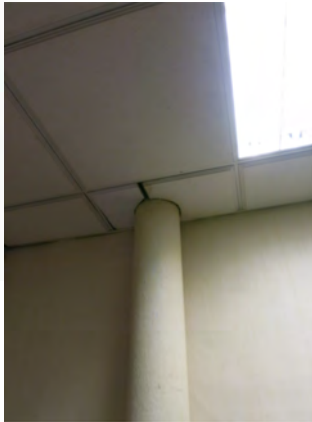
Slender circular column

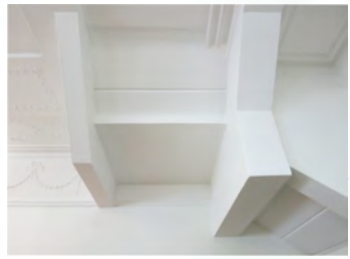
Bulk head under stair structure

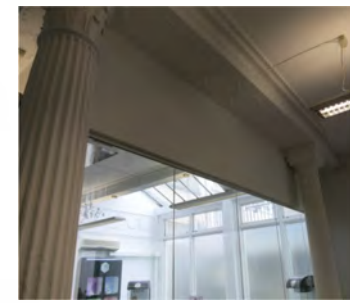
Architecturally encased column and beam. Tbc if investigations can locally remove cornice detail.

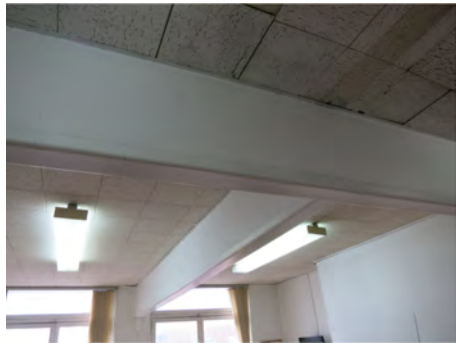
Ceiling tiles with tops of partitions left in place

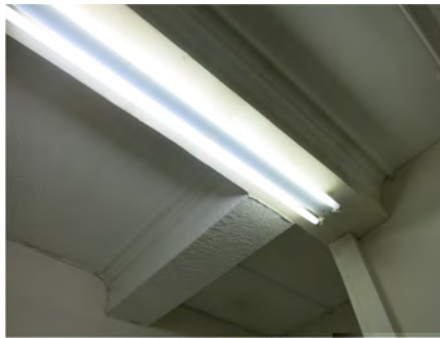
Original ceiling and downstand visible

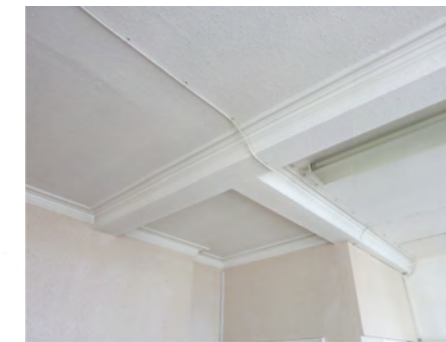
Encased downstand beams
