152-156 Kentish Town Road
Basement Impact Basement
Parmarbrook

Job No: 1599

PB-1599-BIA01 - 152-156 Kentish Town Road Basement Impact
Assessment

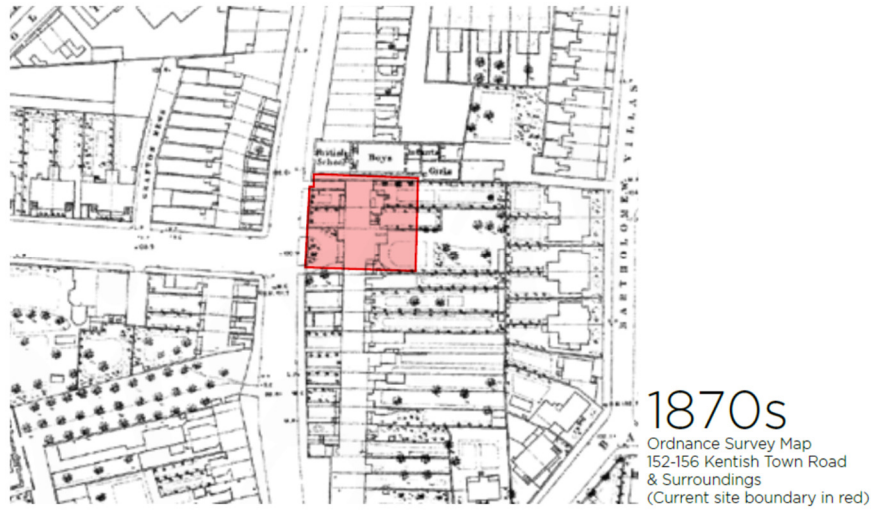
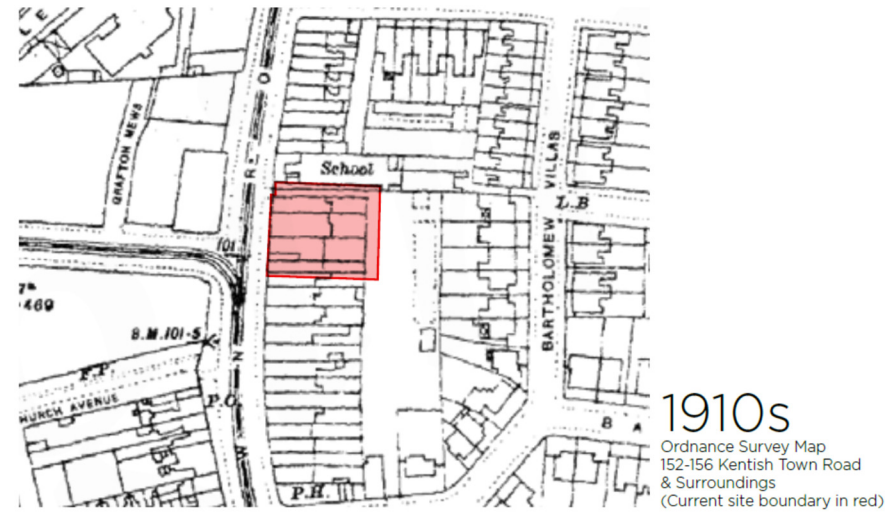
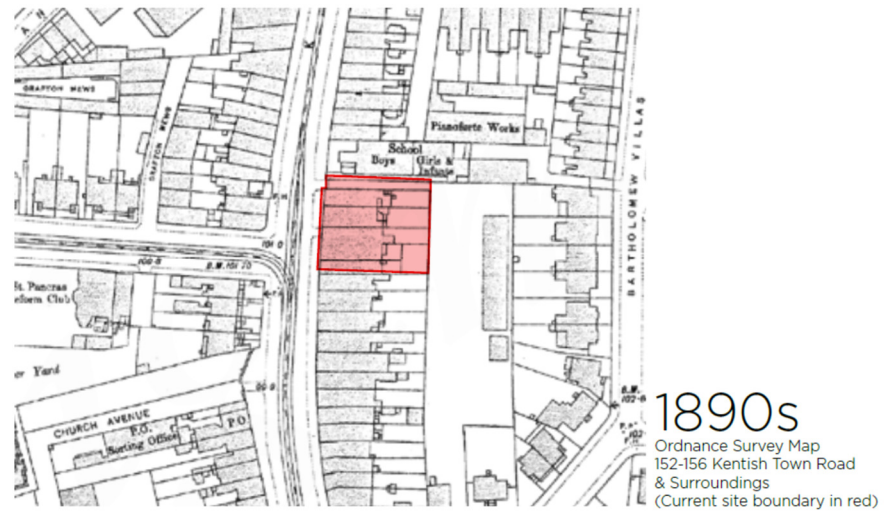
The historic Ordnance Survey Data shown left describes a distinct shift in the grain of the area over the past 150 years. Beginning as a series of smaller, predominantly residential units (such as those still surviving at nos.140-150 Kentish Town Road neighbouring) the site gave way to a larger scale development after the 1910s. This was typified by the North Western Polytechnic building opposite to the application site, which was completed in 1929.

As can be seen to the left, a number of buildings were cleared prior to the 1950s, to make way for the current property at no.152-156 Kentish Town Road.
