Revised Arboricultural Report

Arboricultural Report

Impact Assessment & Method Statement

**156 West End Lane
West Hampstead
London
NW6 1SD**

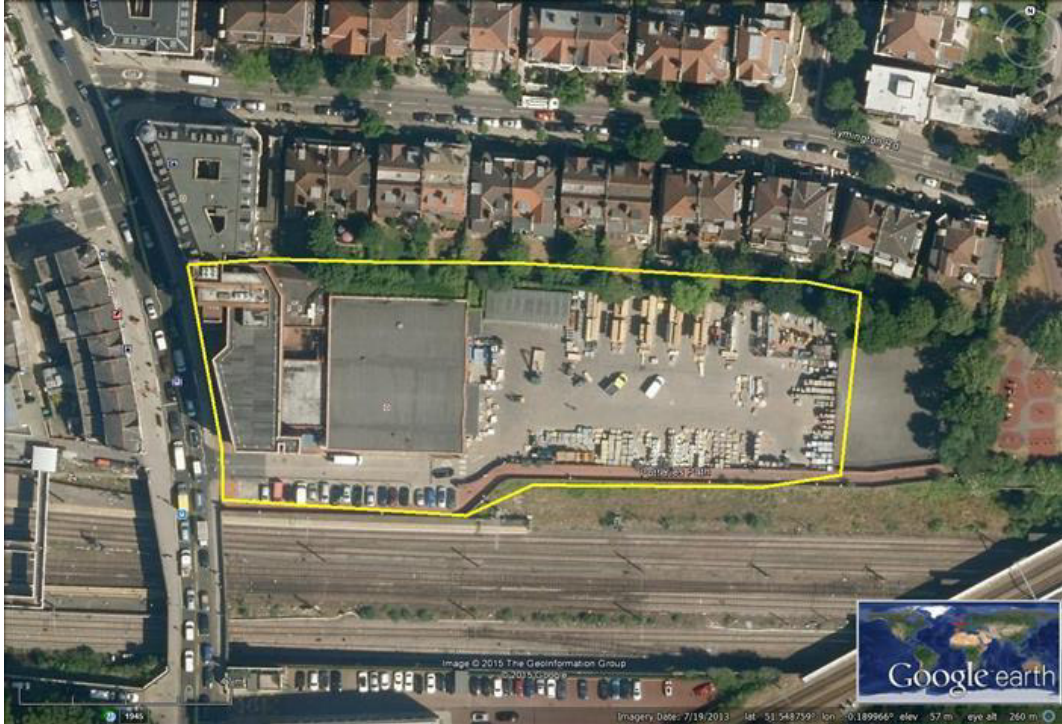
Figure 1 Extent of the survey (image is not current).

2.1.2. Our survey covered the area indicated in Figure 1.
