## **Site Monitoring Report Sheet**

Client:	The Linton Group			Planning Ref: 2012/3089		2012/3089/P	
Local Authority:	LB Camden			Date:	04/05/16		
Site Address: 29 New End, Hampstead, London NW3 1JD							
Proposal: Demolition of the existing building and replacement with residential flats with a basement and associated landscaping							
Visit Checklist		Y/N					Y/N
Tree protection barrier (TPB) in place		Υ	TPE	「PB as per approved			Υ
Ground protection (GP) in place		Υ	GP	GP as per approved			Υ
TPB breached		N	Tre	rees damaged since last visit			N
Client briefed by LT		Υ					
LT briefed by Client		Υ					
LPA informed		Υ					
Remedial action required		Υ	Add	itional Heras fencing			
Comments

## Site inspection of tree protection measures (as per Condition 11) and discussion of repair of boundary retaining wall by chestnut at the front of the site.

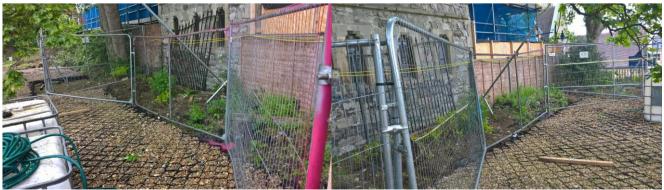
Photographs 7 and 8: Additional Heras for Boarder as suggested at the site meeting (05/05/16)

- Existing Protection Measures: Site meeting held with Tree Officer Nick Bell. Satisfied with the state of tree protection measures and pruning that had taken place to date, although requested that the exposed boarder/shrub bed at the back of the site to have heras across it. This had been undertaken (see Photographs 7 & 8 below).

Heras fencing to shrub bed.
