**Arboricultural impact  
analysis**

**195 Goldhurst Terrace  
London  
NW6 3ER**

job no.: 472

date: 15.06.16

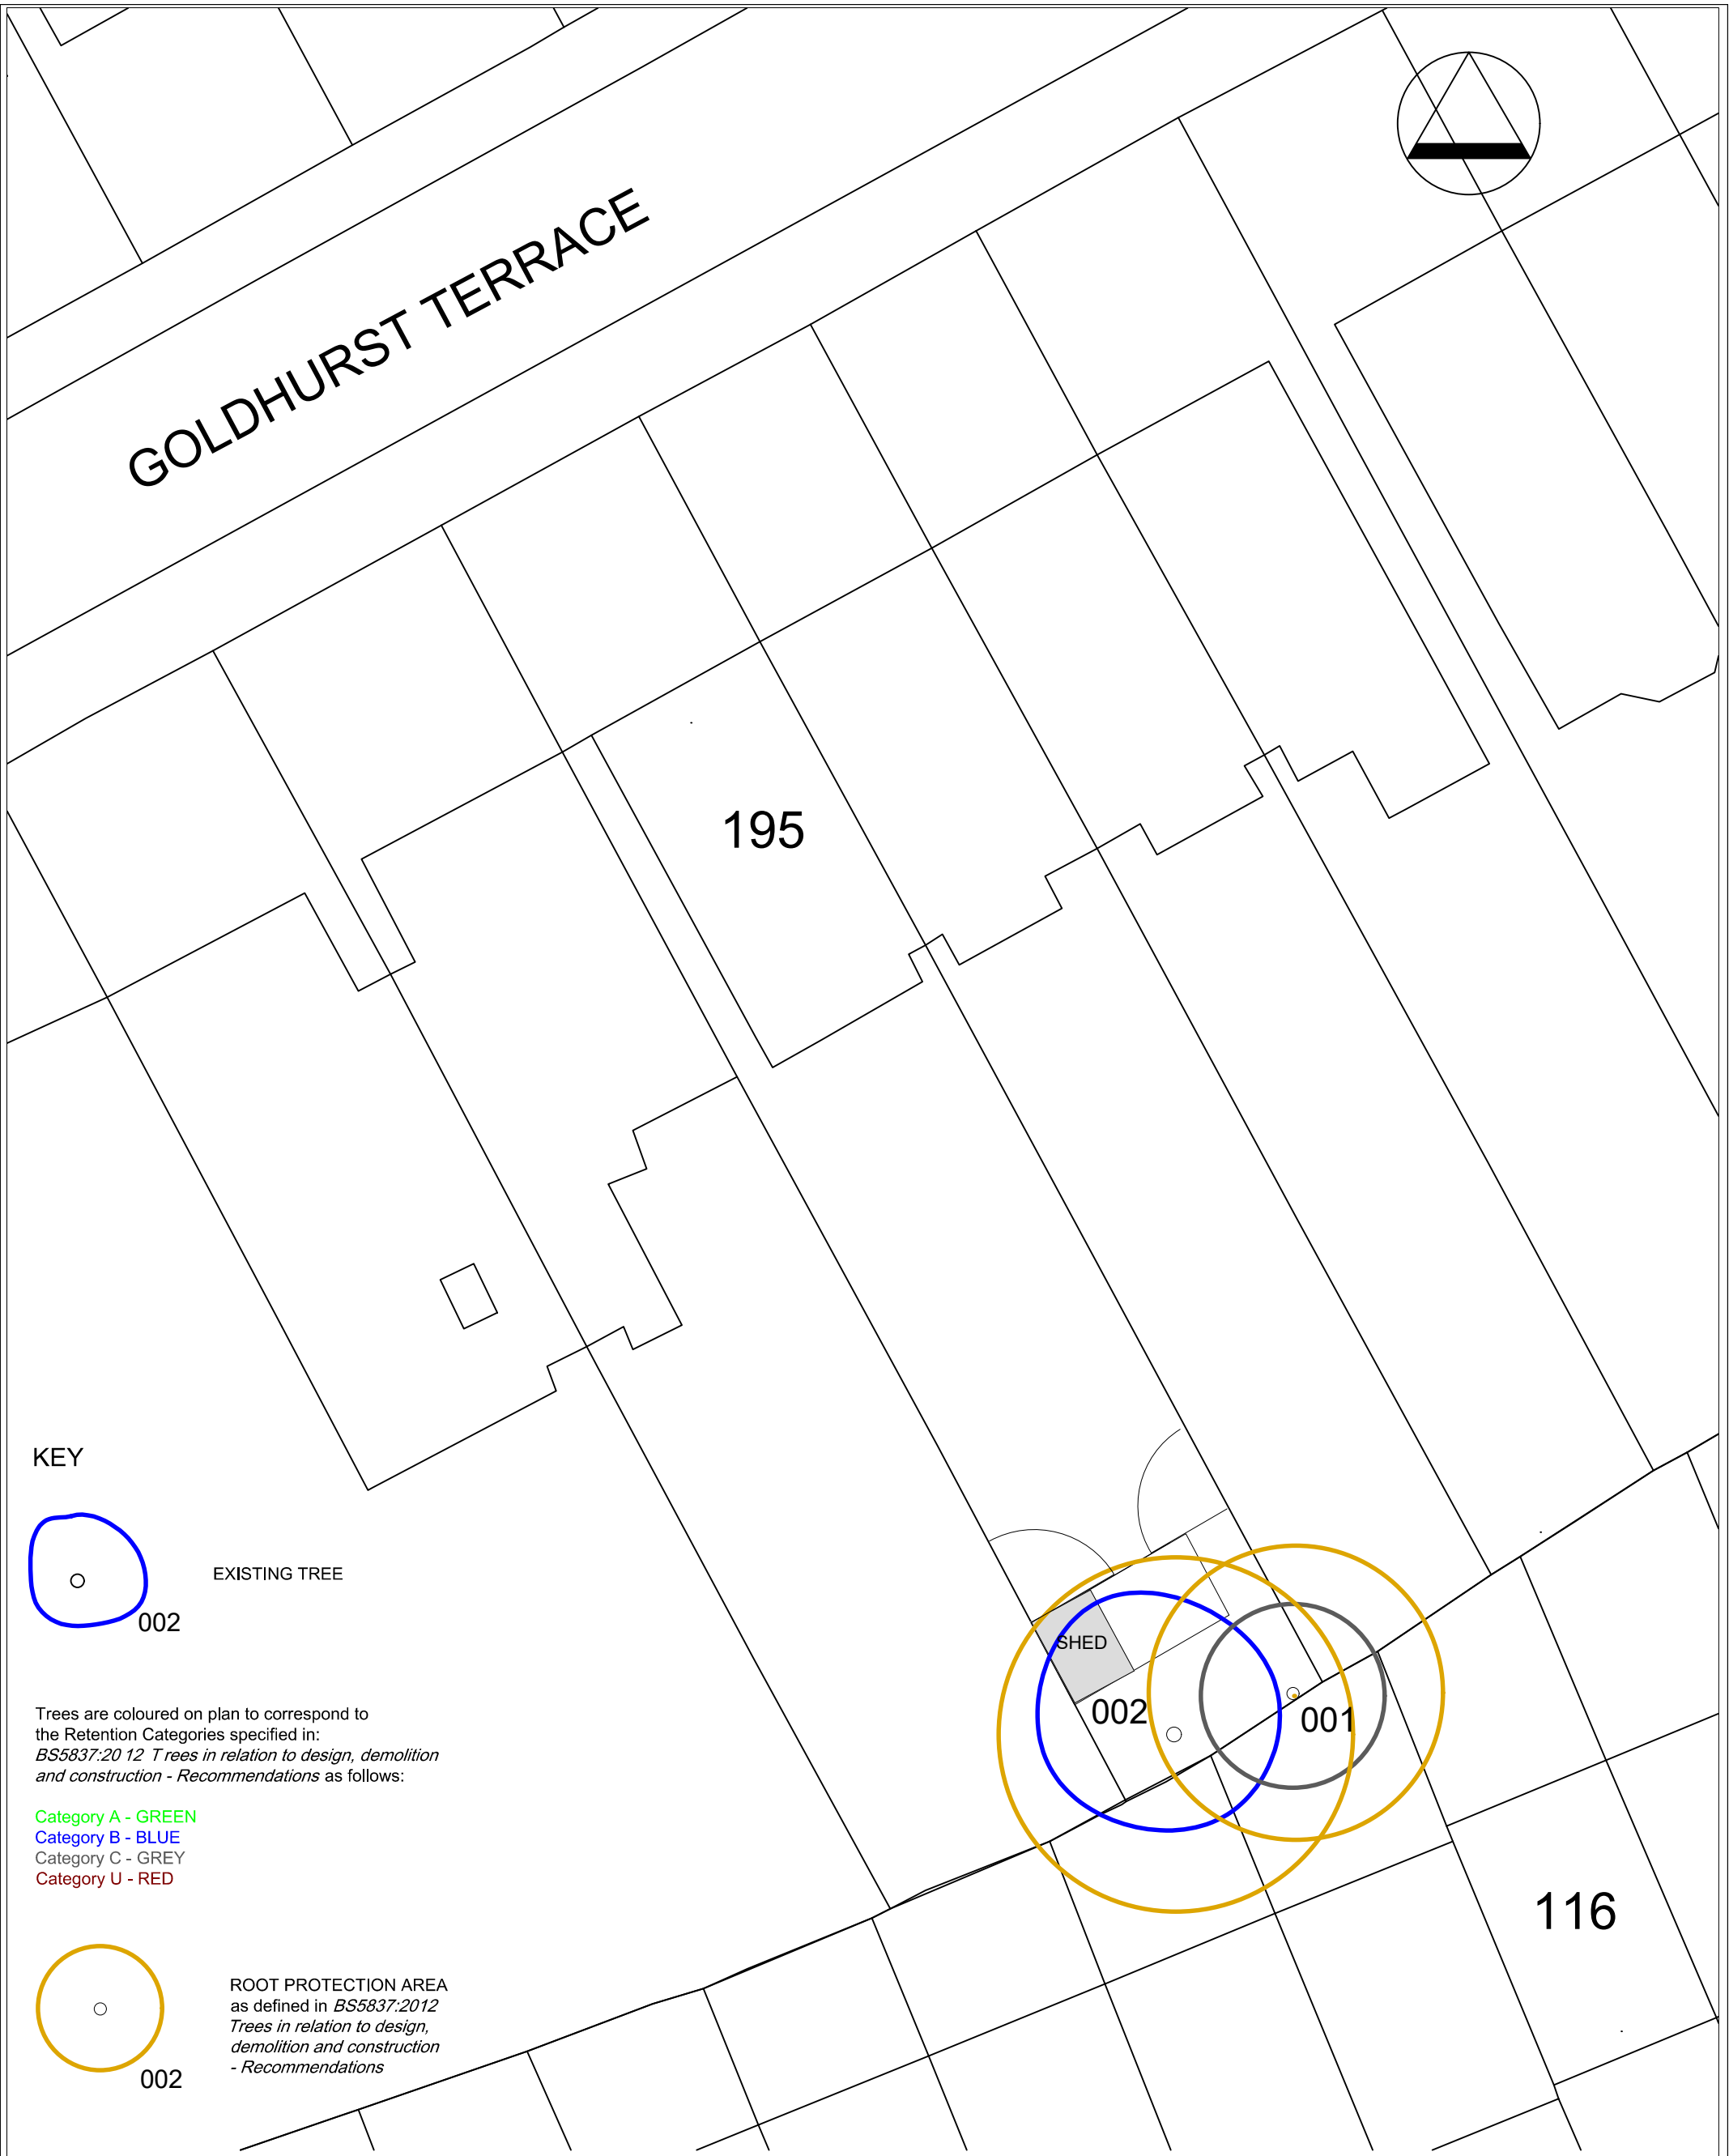
Client: MR AND MRS C. CAULDWELL	Drawing Title: TREE SURVEY PLAN		<b>Skerratt</b> arboricultural advice <hr/> 158 MALDEN ROAD, LONDON NW5 4BT +44 (0)7768 398776
Job Title: 195 GOLDHURST TERRACE LONDON NW6 3ER	Date: 15.06.16	Scale: 1:200 (A3)	
	Drawing Number: 472.01.00	Drawn by: RS

**Crown spread** - radial crown spreads in metres have been recorded at four points on the circumference of the crown (north, east, south and west). The accompanying Tree survey plan shows approximate crown shapes based on these measurements

Trees are coloured on plan to correspond to the Retention Categories specified in:  
*BS5837:2012 Trees in relation to design, demolition and construction - Recommendations* as follows:

- Category A - GREEN
- Category B - BLUE
- Category C - GREY
- Category U - RED

- David Balkind Design Drawing No. 400-200 – General Arrangement Plan (proposed)
- 1.6 The **Tree survey plan** in **Appendix a** is based on Ordnance Survey Mastermap digital data and additional on-site measurements. The **Tree constraints plan** in the same appendix is based on the same information as the tree survey plan with the footprint of the proposed structure taken from David Balkind Design Drawing No. 400-200, overlaid.

- 2.1.1 195 Goldhurst Terrace is a substantial Victorian end-of-terrace dwelling on 4 levels (lower ground, raised ground, first and second floors), standing in a long narrow rectangular plot, the longer axis of which runs roughly north-west to south-east.
- 2.1.2 The rear garden, in which the trees stand, is at lower ground floor level. Its surface is level throughout except for a shallow, narrow bank abutting the rear boundary.
- 2.1.3 The short rear and long, north-east facing side boundaries are fenced with 1800mm high timber panel fencing in good condition.
- 2.1.4 An approximately 1500mm high brick wall runs along the south-west facing side boundary.
- 2.1.5 The **Tree survey** and **constraints plans** in **Appendix a** show the existing layout and the footprint of the proposed development.

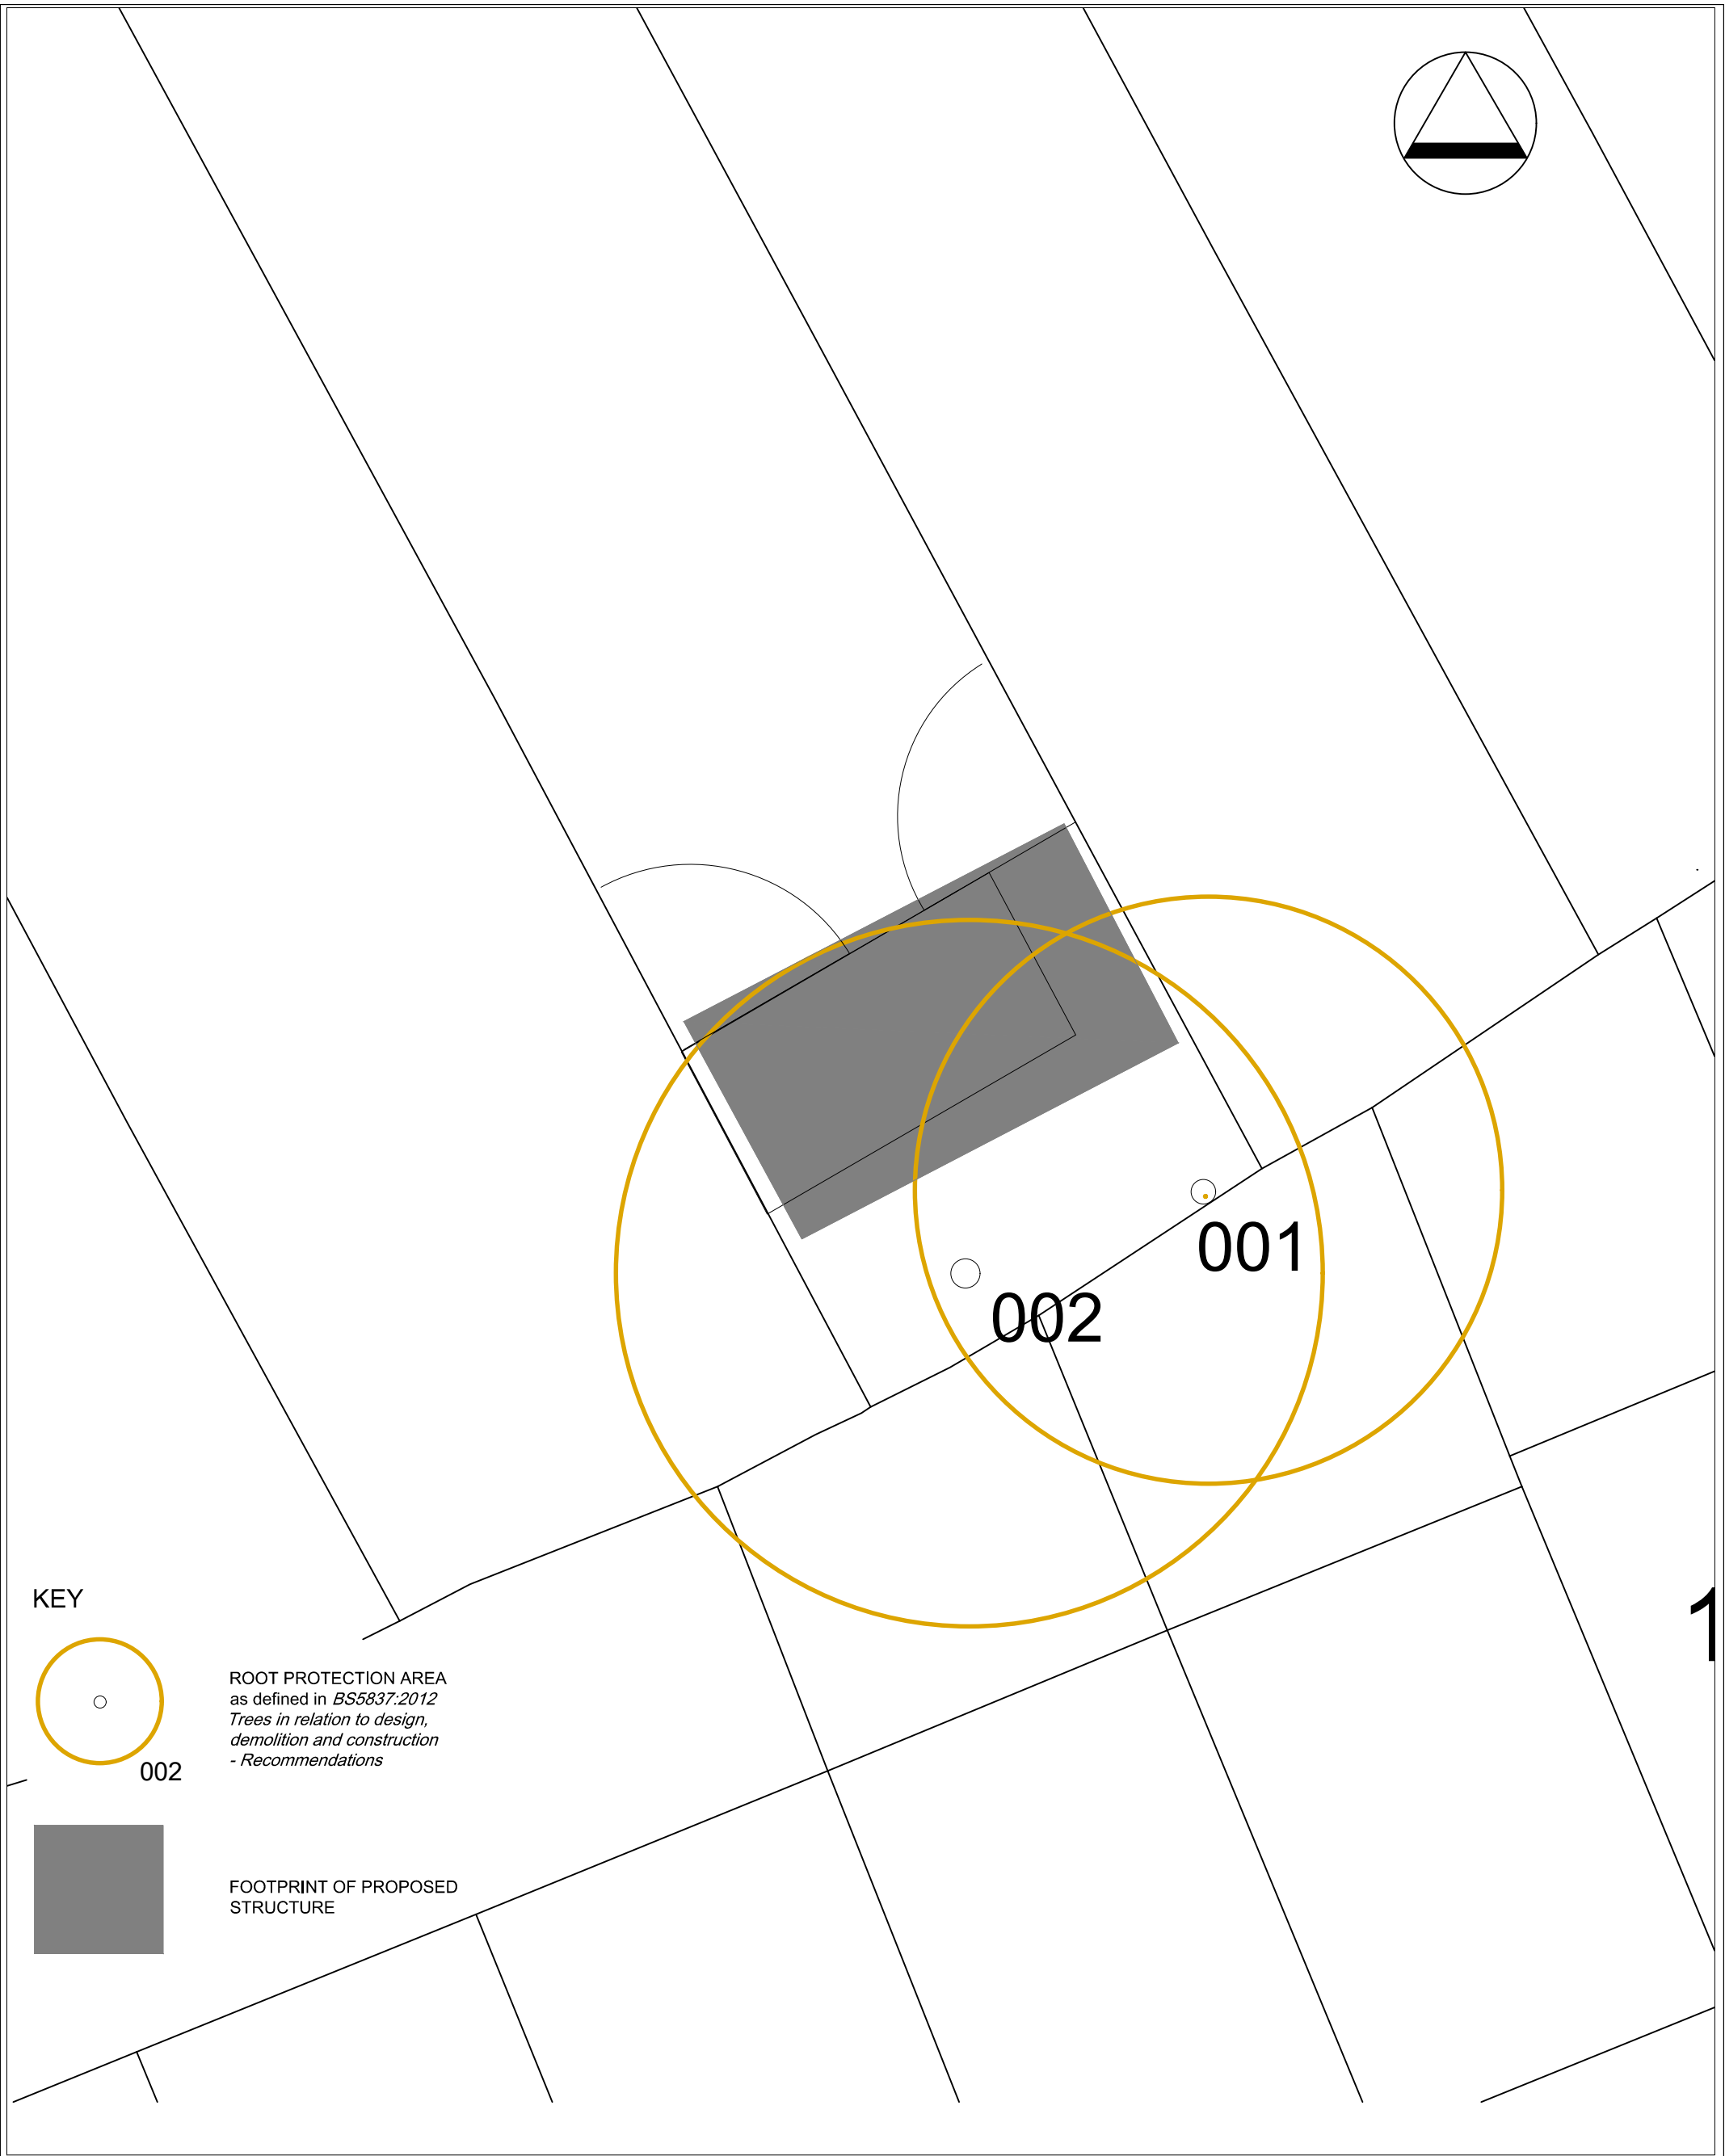
Client: MR AND MRS C. CAULDWELL		Drawing Title: TREE CONSTRAINTS PLAN		<b>Skerratt</b> arboricultural advice 158 MALDEN ROAD, LONDON NW5 4BT +44 (0)7768 398776
Job Title: 195 GOLDHURST TERRACE LONDON NW6 3ER		Date: 15.06.16	Scale: 1:100 (A3)	
		Drawing Number: 472.02.00	Drawn by: RS

3.1.1 The **Tree constraints plan** in **Appendix a** shows the RPAs of both trees arranged symmetrically around their stems. The RPAs highlight the primary potential area of conflict between proposed development and retention of existing trees, namely conflicting demands for space at and below ground level.

3.3.1 Almost the complete footprint of the proposed structure is within the RPA of Sycamore 001 or Lime 002, or both.

ROOT PROTECTION AREA  
as defined in *BS5837:2012*  
*Trees in relation to design,*  
*demolition and construction*  
*- Recommendations*

FOOTPRINT OF PROPOSED  
STRUCTURE

3.3.2 Because of this overlap, the structure's foundations have been designed to minimise disruption below existing ground level.

3.3.3 Construction details are shown on David Balkind Design Drawing No. 400-200. It is proposed to construct the new building's (timber) floor above existing ground level on 400mm deep concrete pads.

3.3.4 Judging from the drawing, the pads will be less than 500 x 500mm square in plan and will be at approximately 2000mm centres. If these assumptions are correct, approximately 15 pads will be required in total.

3.3.5 I understand that there can be some flexibility in the positioning of individual pads. For the purposes of this impact analysis I have assumed that individual pad locations may be adjusted laterally by up to 300mm.
