## 115-119 GOLDHURST TERRACE LONDON

DESIGN AND ACCESS STATEMENT DOCUMENT  
JUNE 2016

**KSR ARCHITECTS LLP**

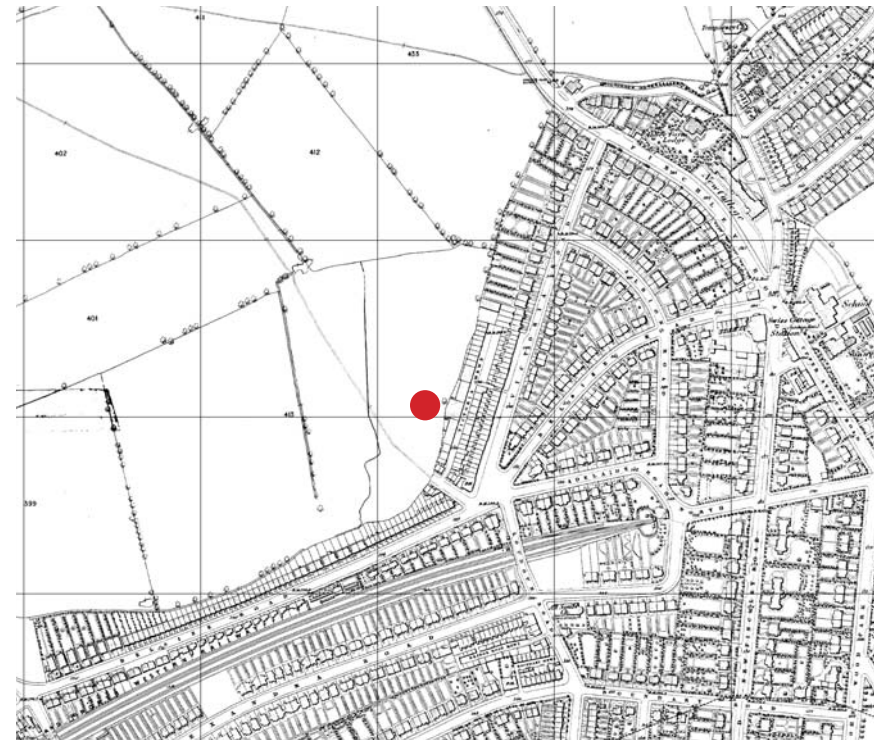
SITE PLAN 1871

The original building was a continuation of the terrace that still exist to the north of the site. The building was originally three separate plots and contained three projecting bays on the front elevation.

The original buildings projected into the rear of the garden in the same manner as the surrounding buildings today in a form that was typical of the architectural typology of the time.

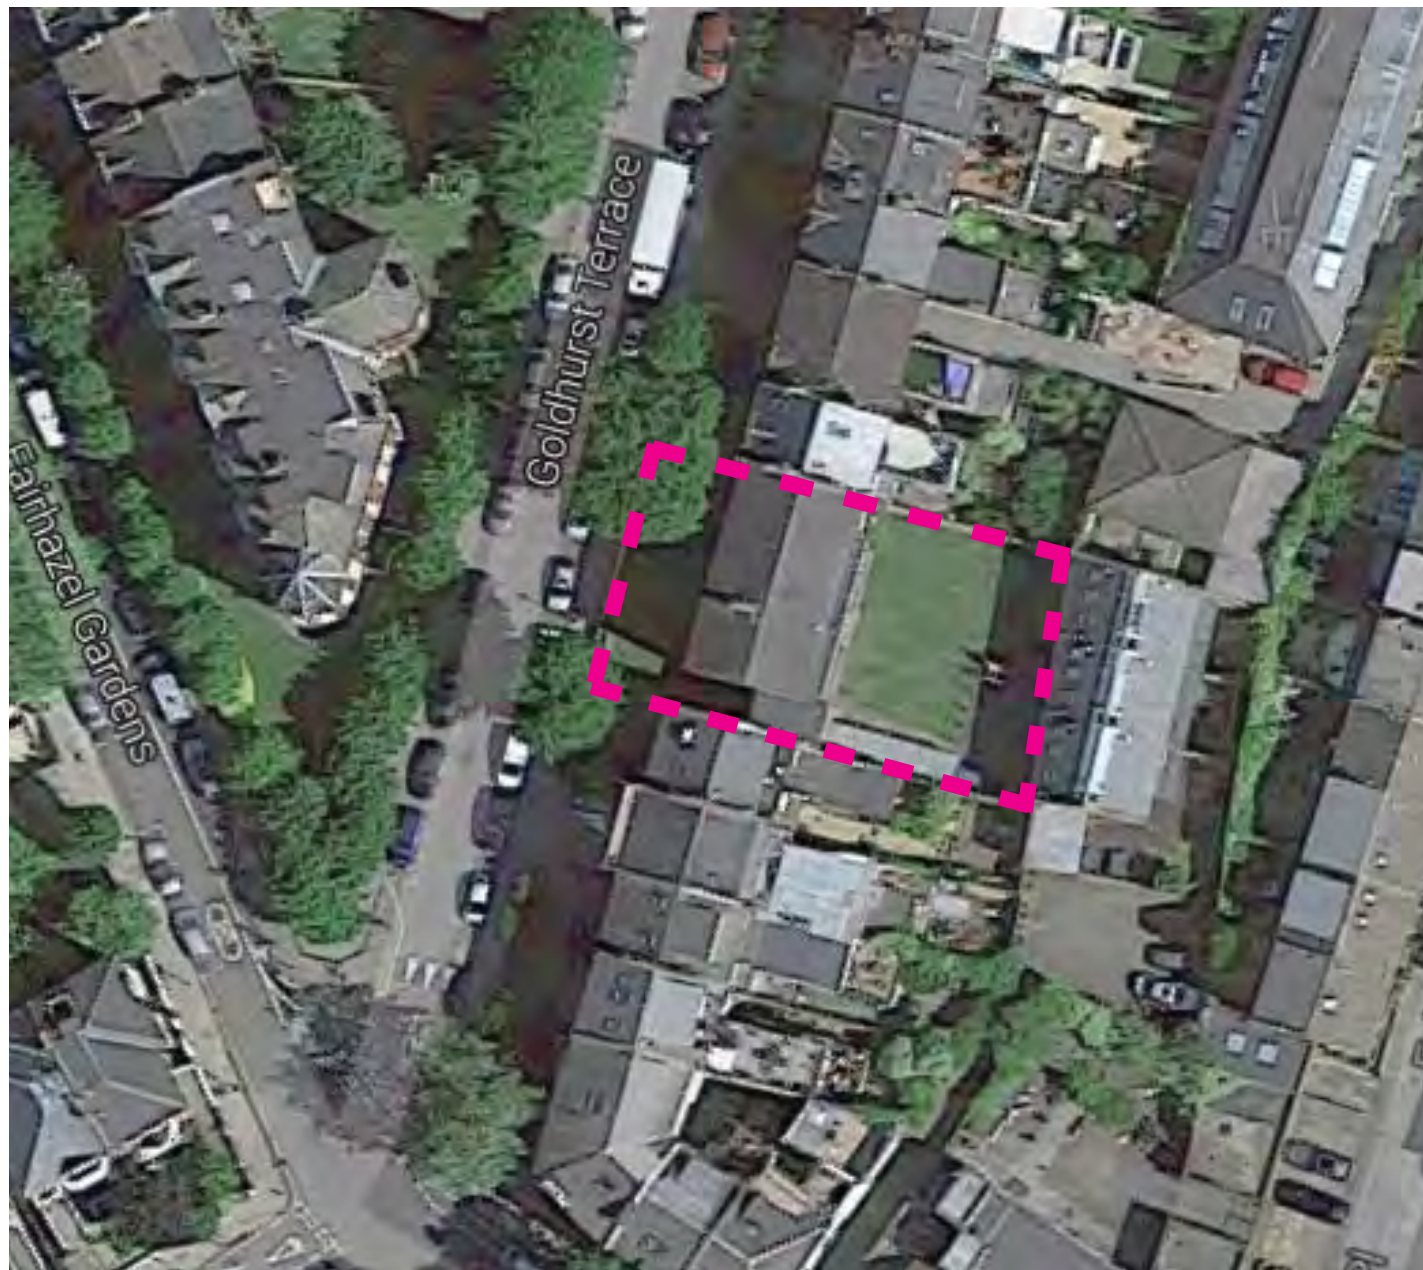
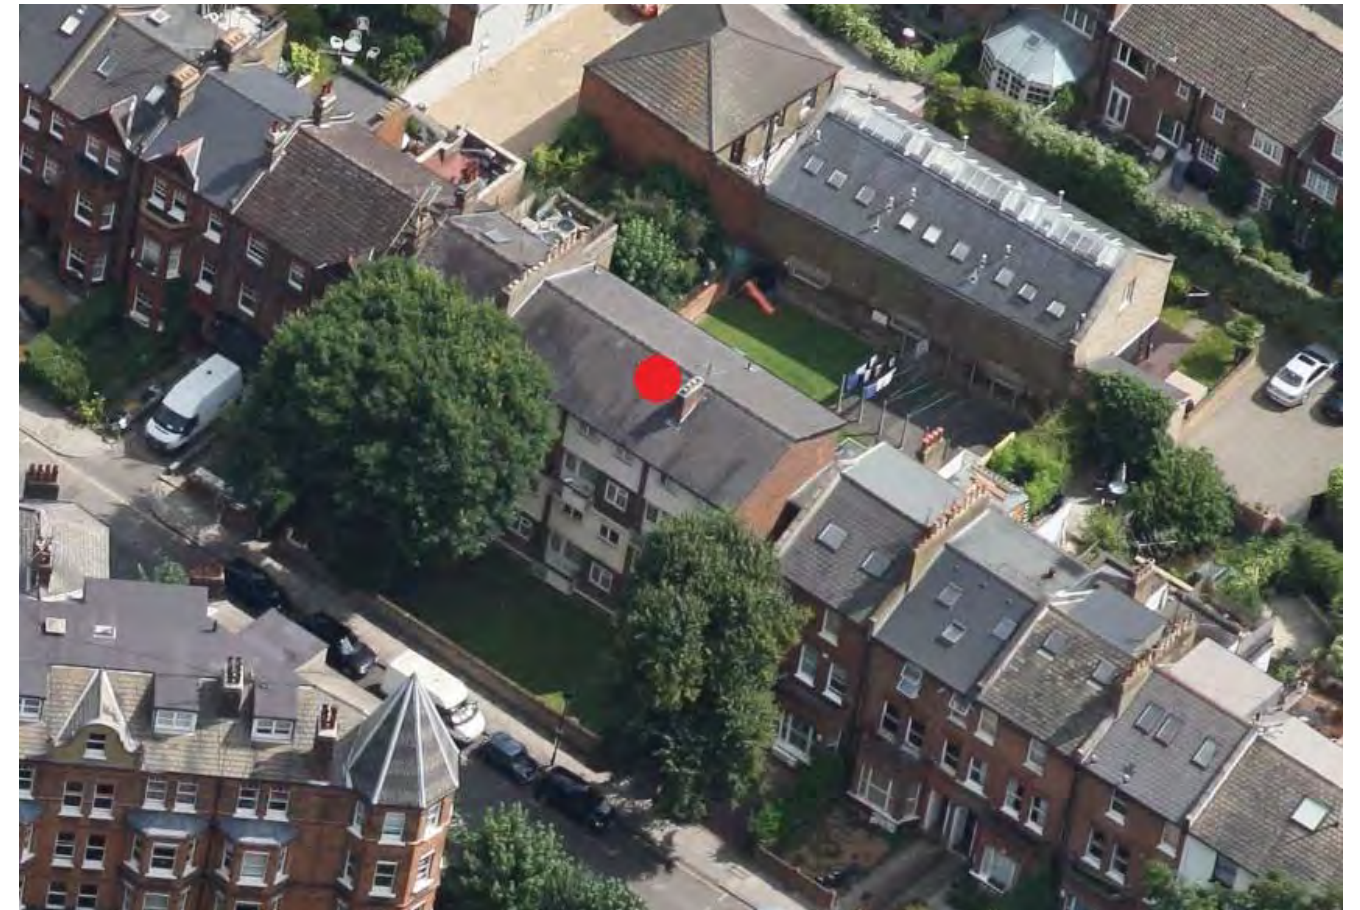
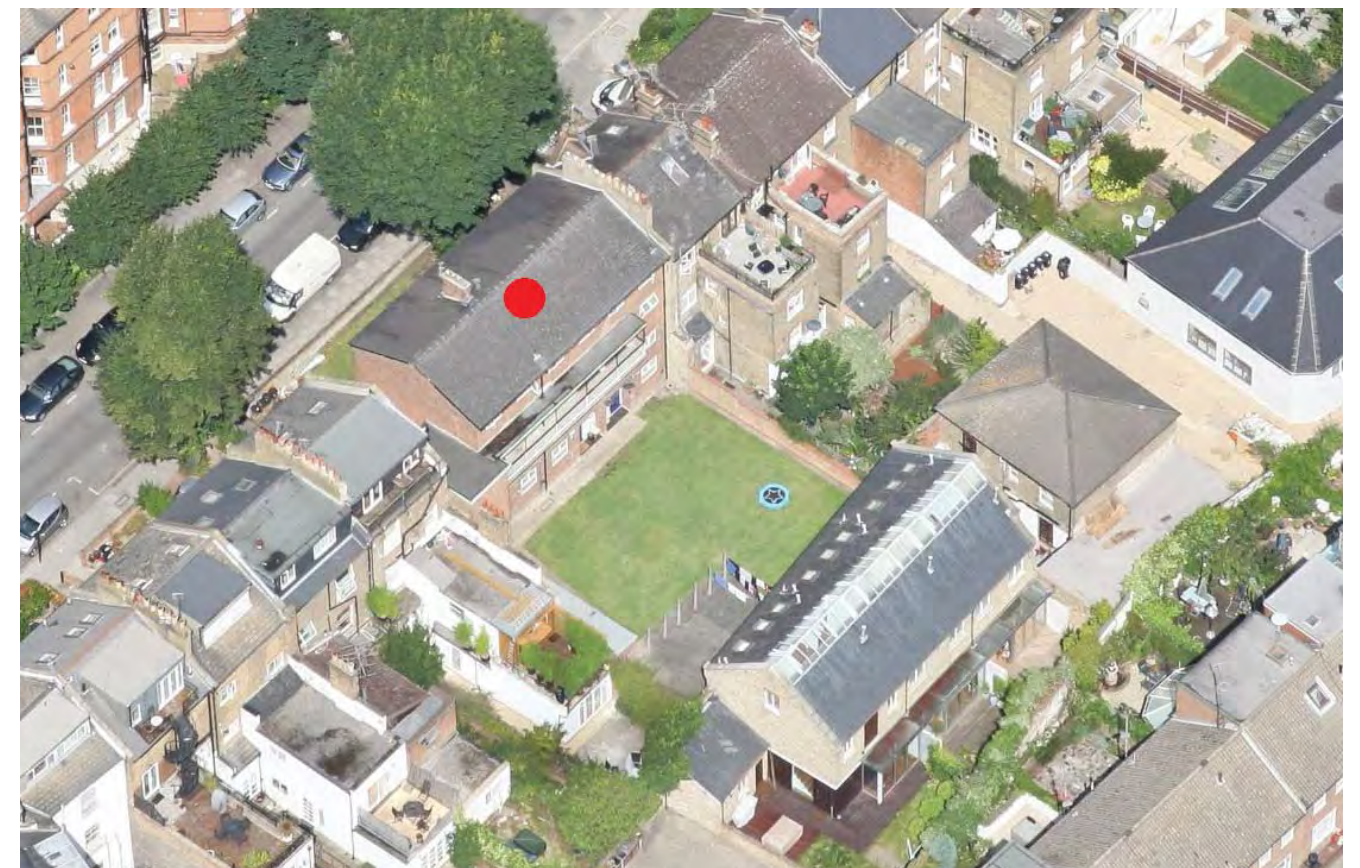
Aerial imagery further illustrates that the existing building sits inappropriately within its context. The rhythm of the existing street is ignored and the roof line is inexplicably broken. The rear elevation is disjointed and pays no respect to the pattern or the surrounding buildings.

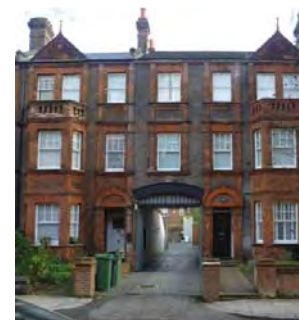
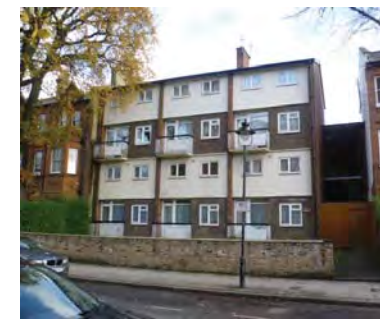
Maryon House  
115-119

Further analysis of the existing building's position within the streetscape illustrates that it is inappropriate for its context.

The rhythm and pattern of the street is abruptly broken by the existing building, detracting from the character of the conservation area.
