Arboricultural Impact Assessment

97 Camden Mews, NW1

Julian Cowie Architects

Address	97 Camden Mews, NW1		
Client	Julian Cowie Architects	Client Ref	-
ES Ref	D0305161201v2	Consultant	Jonnie Setterfield BSc (Hons)
Report Date	20 June 2016	Quality Checked	Gina Anderson BA (Hons)
Technical Arboriculture Approved Brian Higginson Dip.Arb (RFS) M.Arbor.A

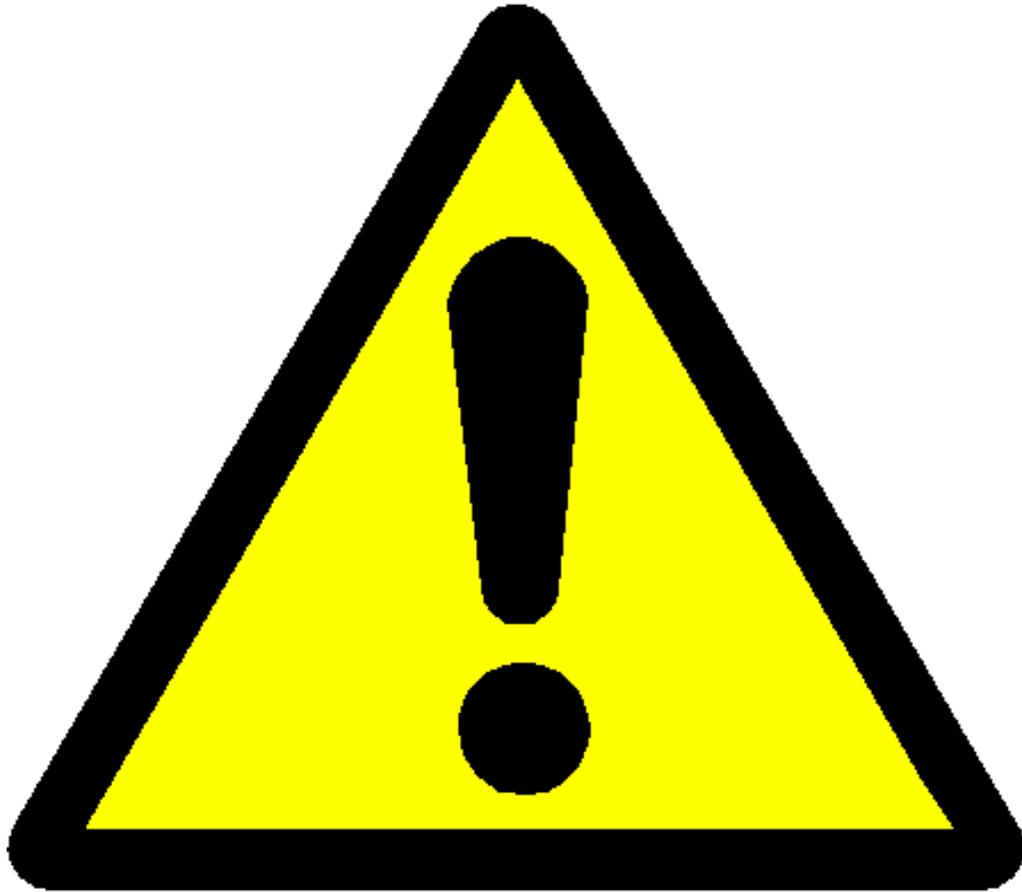
Suggested protective fencing warning sign format

**TREE PROTECTION AREA
KEEP OUT**

**THE VEGETATION PROTECTED BY THIS FENCE IS
PROTECTED BY PLANNING CONDITIONS AND/OR IS THE
SUBJECT OF A TREE PRESERVATION ORDER.**

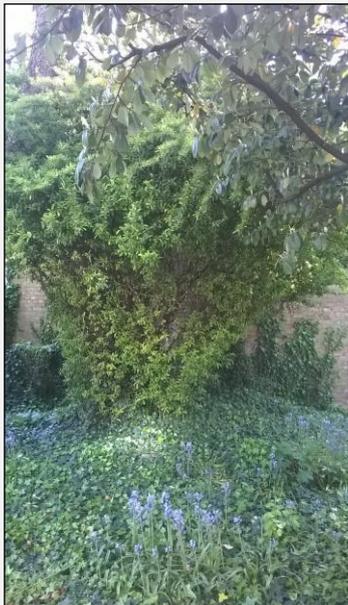
S2 - Pyracantha

S1	Pyracantha	0.06	M/s	3.5	1	1	1	1	C1	Semi-Mature	10_19	1.5	Average form, shape and condition. Ivy clad crown and stem unable to fully inspect.	No Works.	1
S2	Pyracantha	0.12	M/s	3.5	1	1	1	1	C1	Semi-Mature	10_19	1.5	Average form, shape and condition. Ivy clad crown and stem unable to fully inspect.	No Works.	5

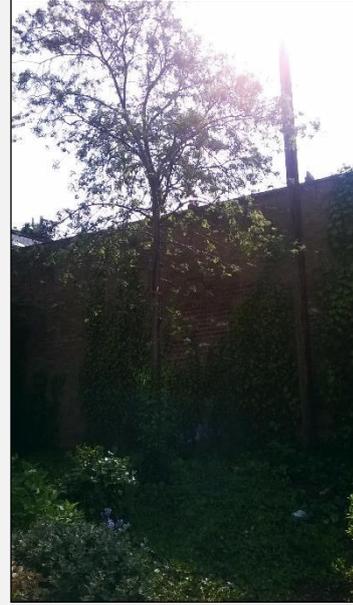
T1 - Rowan

Tree No.	Species	DBH	No of Stems	Ht (m)	N	E	S	W	BS Cat	Age Class	Life Expect	Cr Ht (m)	Observation	Recommendations	RPA (m2)
T1	Rowan.	0.12	1	6.4	2	2	2	2	C1	Early-Mature	10_19	2	Average form, shape and condition. 3rd party offsite tree, unable to fully inspect. Ivy clad crown and stem unable to fully inspect.	Cut back to suitable side growth point to provide 1-1.5m clearance from adjacent building.	7
T2	Cotoneaster.	0.27	M/s	3.5	2	1	2	3	C1	Early-Mature	10_19	0	Poor form (Asymmetric canopy), shape and condition. No significant recent crown management. Ivy clad crown and stem unable to fully inspect. 3rd party offsite tree, unable to fully inspect.	No Works.	23
T3	Cherry.	0.47	2	12	3	3	3	3	B1	Mature	20_39	4	Average form, shape and condition. Ivy clad crown and stem unable to fully inspect. No significant recent crown management.	Sever ivy at 2m from ground level and remove section. Cut back to suitable side growth point to provide 2m clearance from adjacent building.	69

Tree No.	Species	Proposed Tree Works	Reason	BS Cat
T1	Rowan.	Cut back to suitable side growth point to provide 1-1.5m clearance from adjacent building.	Average form, shape and condition. 3rd party offsite tree, unable to fully inspect. Ivy clad crown and stem unable to fully inspect.	C1
T3	Cherry.	Sever ivy at 2m from ground level and remove section. Cut back to suitable side growth point to provide 2m clearance from adjacent building.	Average form, shape and condition. Ivy clad crown and stem unable to fully inspect. No significant recent crown management.	B1
