## ATHLONE HOUSE

THE RESTORATION - 2016

DESIGN & ACCESS STATEMENT

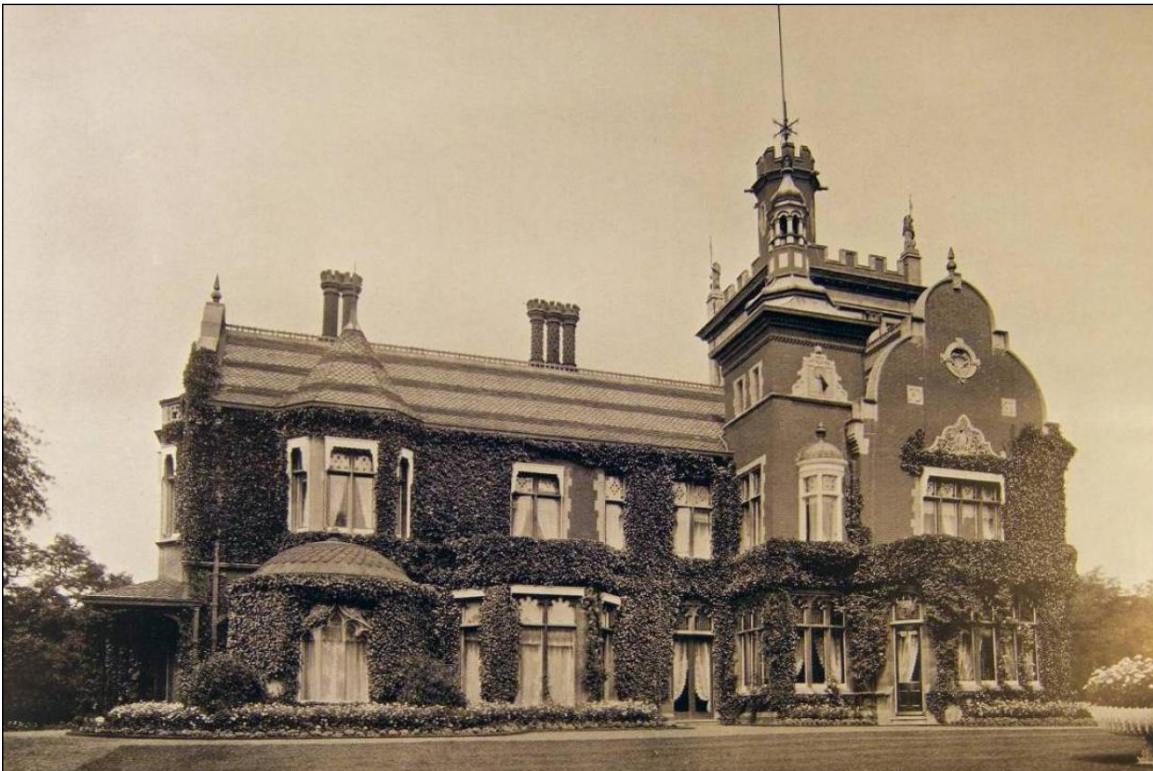
Image 1: Author: Unknown (1874-1880)

- 1) Athlone House: South front showing circular pavilion extension at left.
- 2) Athlone House: West front, heavily ivy clad showing veranda and glass house.

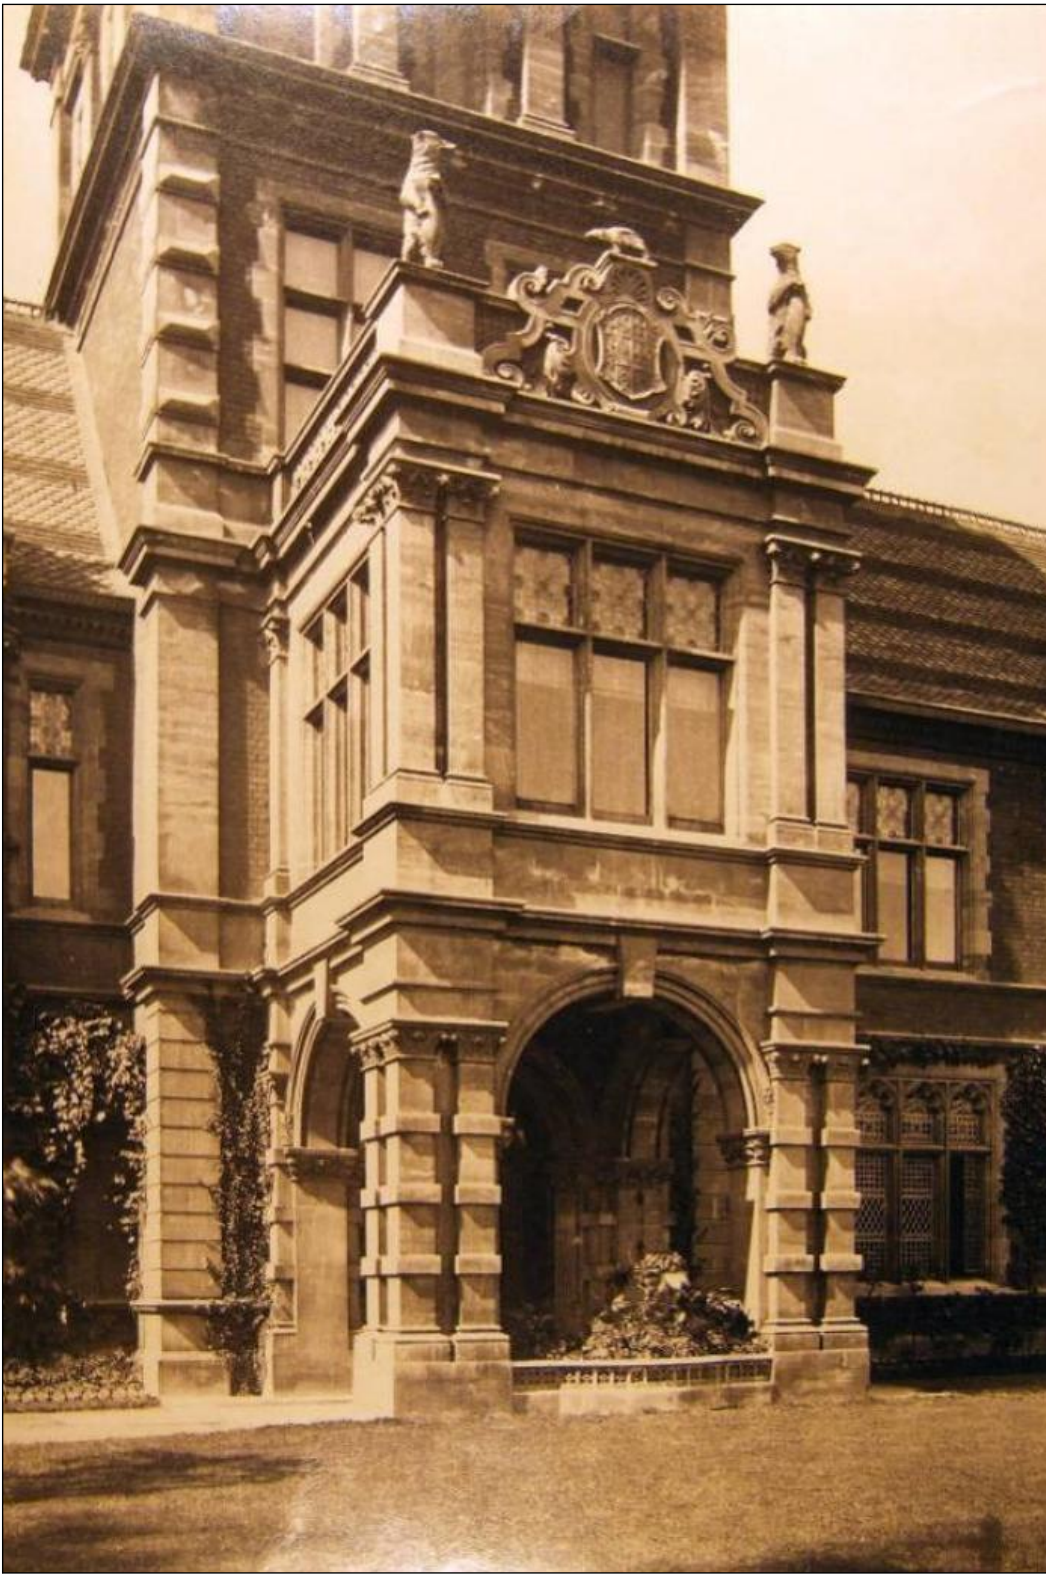
Image 3: Author: Unknown (1874-1880)

- 3) Athlone House: This view clearly shows the porte cochere against the tower. Detail appears clear and relatively crisp, though some staining of the stonework is already evident, and there appears to be some erosion of the heraldic beasts; there was also a porcupine above the centre of the strapwork that contained the armorial shield. The detail of the gable copings shows that they had a roll moulded projection, which should have reduced deterioration. The banded fishscale and plain tiling of the roof shows up clearly. To the right, part of a chimney shows that it had ornamental shafts of elaborately moulded brick. There were elaborate square section eaves gutters with zig-zag ornament discharging into ornamented rainwater hopper heads, with square section downpipes. All the upper lights of the first floor windows had ornamental leaded glazing of 'bottle glass' discs set against a rectangular grid. The ground floor windows had trefoil cusped heads, with ornamental leaded lattice, grid and disc pattern glazing throughout. Growth of ivy over the building was evidently being encouraged, with some applied trelliswork panels.

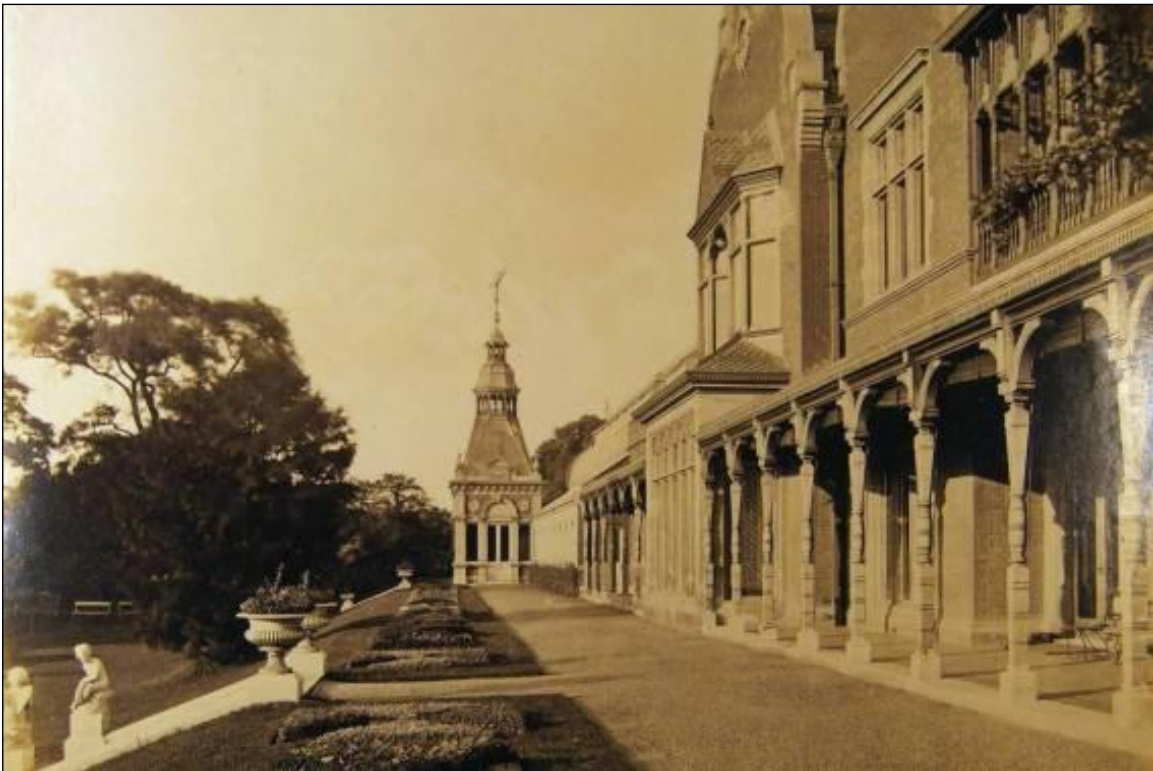
Image 1: Author: Unknown (1874-1880)

- 1) Athlone House: This view shows the west terrace, looking north towards the pavilion, obliquely along the west elevation of the house.
- 2) Athlone House: This view shows the house from the lower garden, looking towards the west elevation. Much of the detail of the south corner and return elevation is obscured by trees. However, it can be seen that there were projecting gargoyles below the crenulations of the upper stair turret above parapet level of the tower, and that heraldic beasts bearing flag standards stood on the square corner plinths of the tower parapet. The pierced stonework parapet above the right hand canted first floor bay is visible. The elaborate detail of the shafted chimneys is visible in a generalised way. The pent rooflight of the picture gallery is just visible above its crenelated parapet. Other details are as described above.

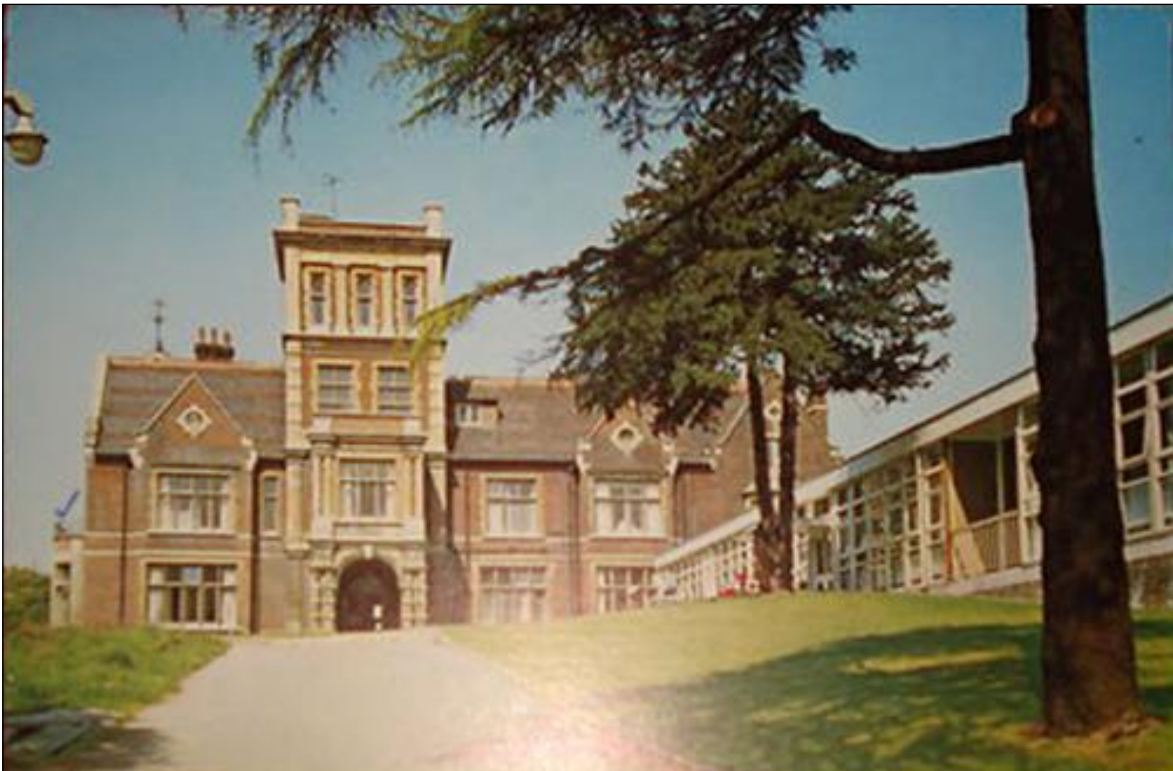
Image 3: Author: Unknown (1980)

- 3) Athlone House: View from driveway toward main entrance in the early 1980's with the single-storey NHS extension visible to the right.
- 4) Athlone House: Completed illustration from the Builder (1/06/1872) showing the west elevation and glass house.

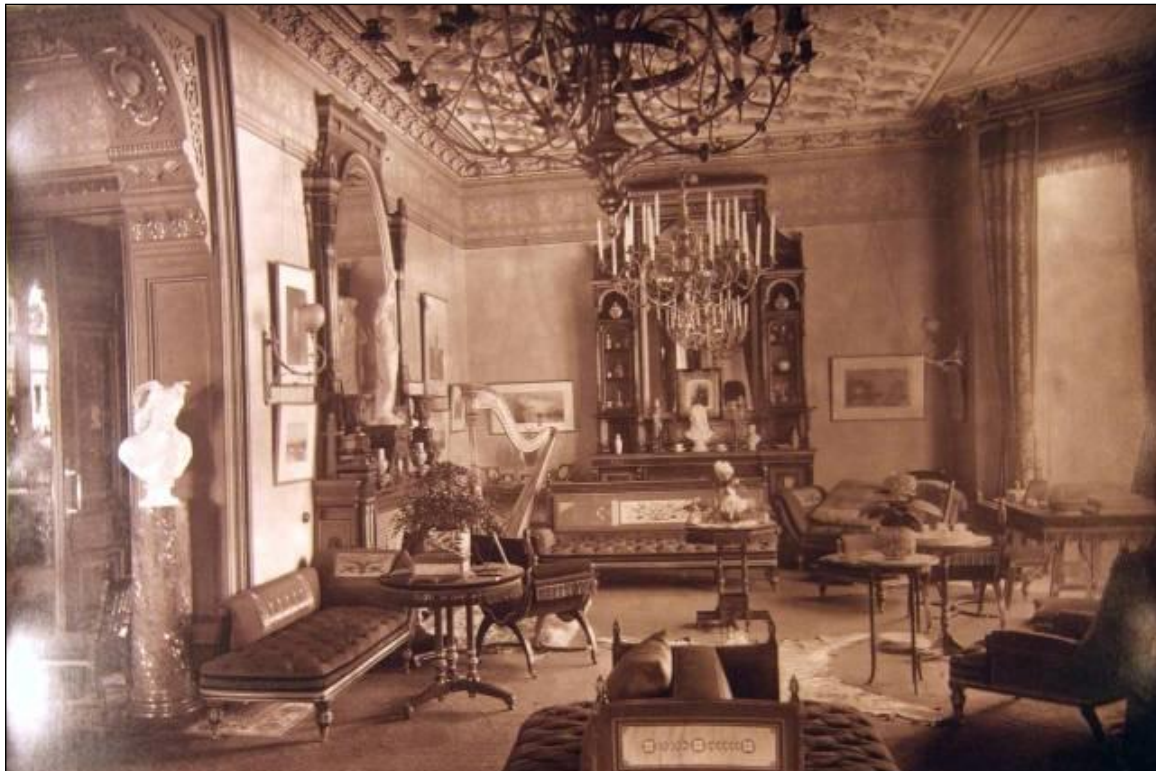
Image 1: Author: Unknown (1874-1880)

- 1) Athlone House: the Drawing Room, looking east, with the original recess at left. Virtually everything seen here, including the fireplace, cornice and ceiling has been destroyed
- 2) Athlone House: the Dining Room, where the elaborate fireplace and sideboard have long since disappeared, together with the panelled dado, cornice and the elaborate moulded ceiling beams (although the boarding above survives).
- 3) Athlone House: the Billiard Room. Architecturally the feature of greatest interest is the 5 light mullioned window, with panelled reveals and fitted seat below.
- 4) Athlone House: the Hall, looking across from the staircase recess. The hooded fireplace, panelled Drawing Room door, pilaster, polished Granite column and heavy beamed ceiling were all removed in a later remodelling.

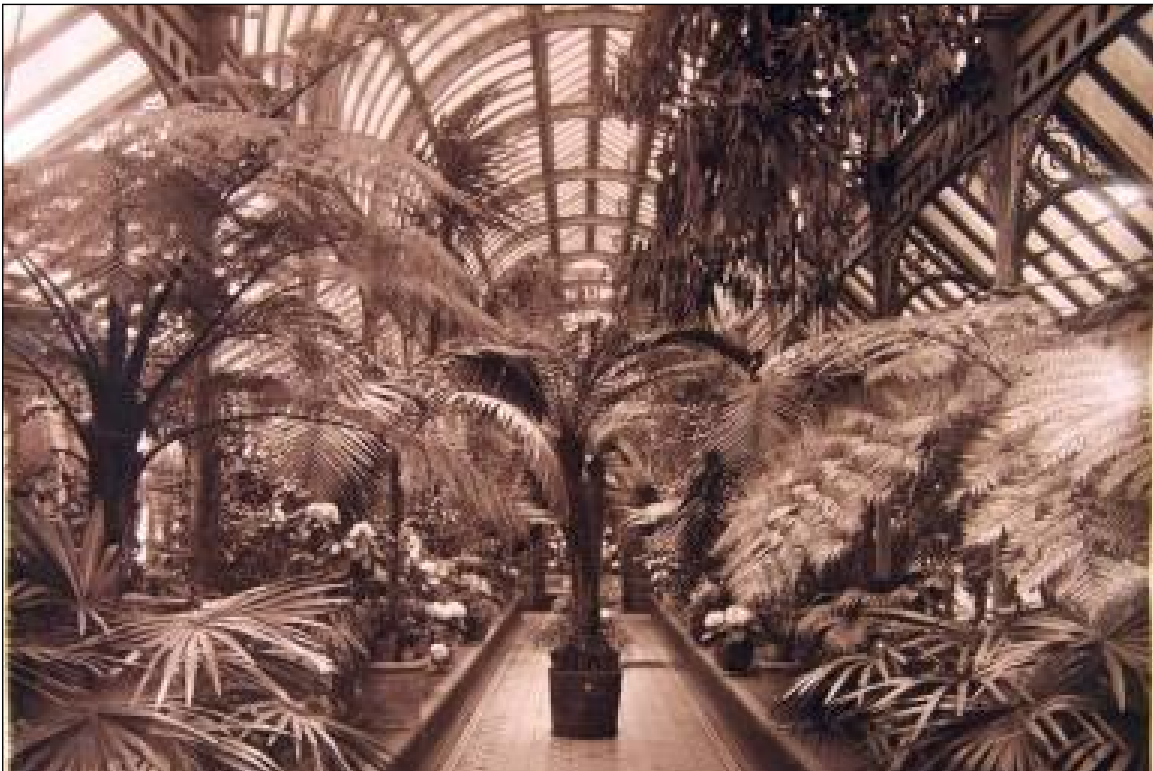
Image 1: Author: Unknown (1874-1880)

- 1) Athlone House: the glass house, looking north away from the Picture Gallery. The arched structure of cast iron is visible through the planting. This feature survived WW2 and was finally demolished about 1952/3.

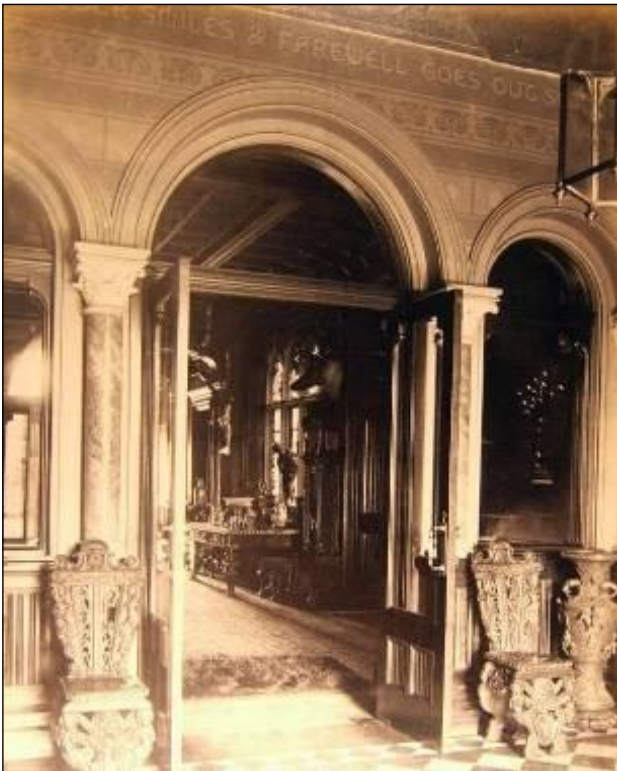
Image 3: Author: Unknown (1874-1880)

- 3) Athlone House: the ante-hall looking into the main hall. Although the layout survives, the screen was much simplified in the 1920s. None of the decoration (somewhat in the style of Christopher Dresser) survives. All panelling of main hall was stripped - some of bracketed ceiling remains. The window looking into the inner area evidently had stained glass inserts, and cusped heads.

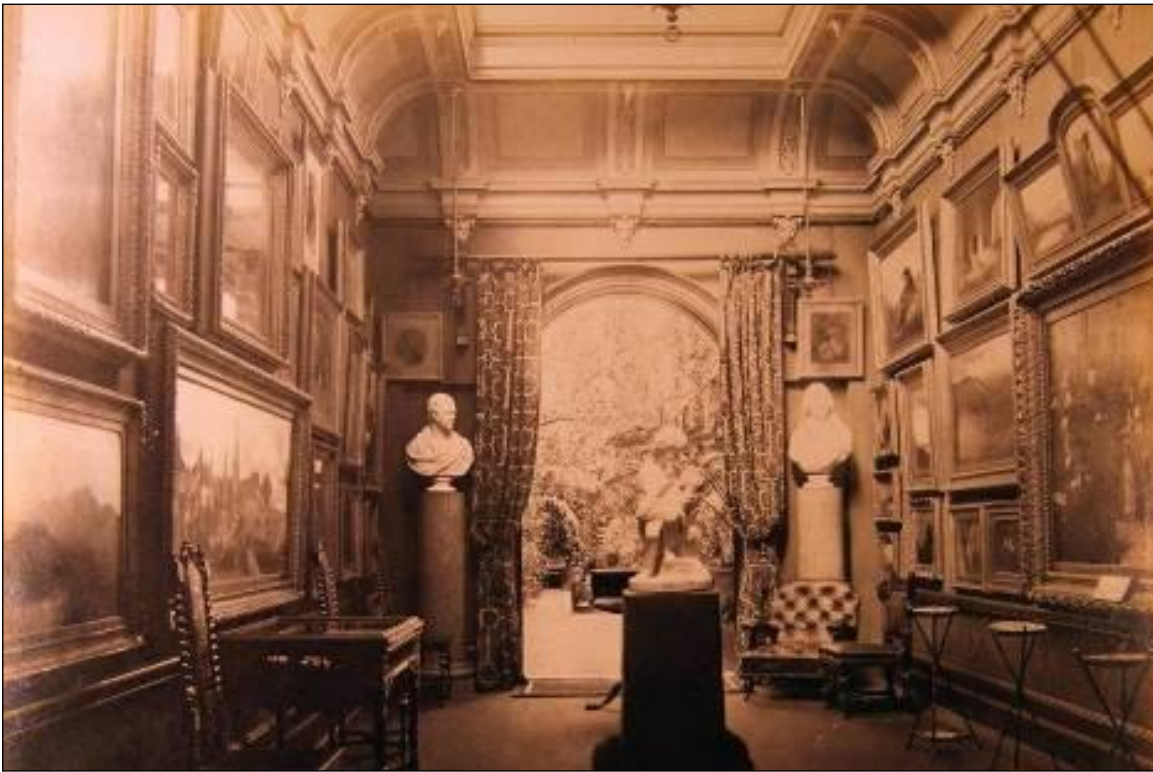
Image 2: Author: Unknown (1874-1880)

- 2) Athlone House: the Picture Gallery looking north into the glass house. The arch itself is exposed on the north elevation, following demolition of the later extensions for the hospital use.

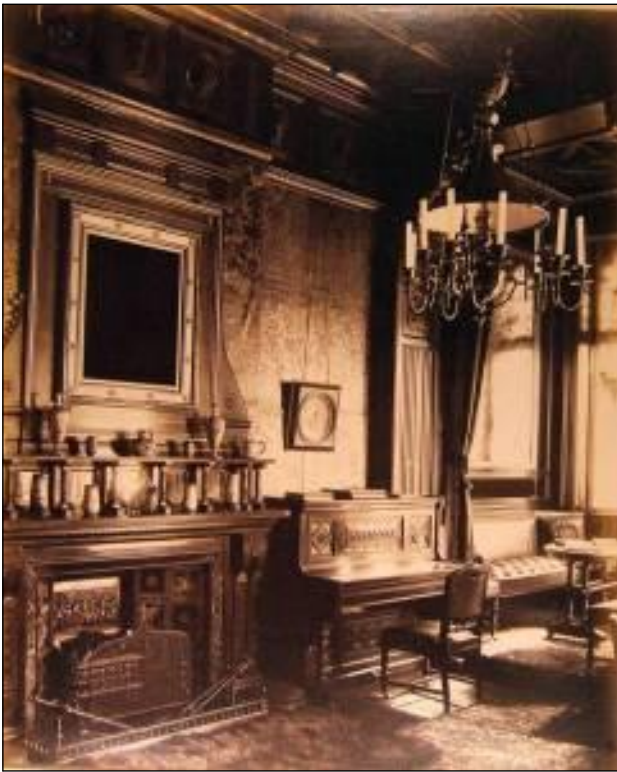
Image 4: Author: Unknown (1874-1880)

- 4) Athlone House: the Morning Room. This was opened out into the hall by Francis Cory Wright (see below), and later gutted to provide sanitary facilities for the hospital. All decorative features of significance appear to have been destroyed.
