Site Photographs - Internal

Existing internal images:

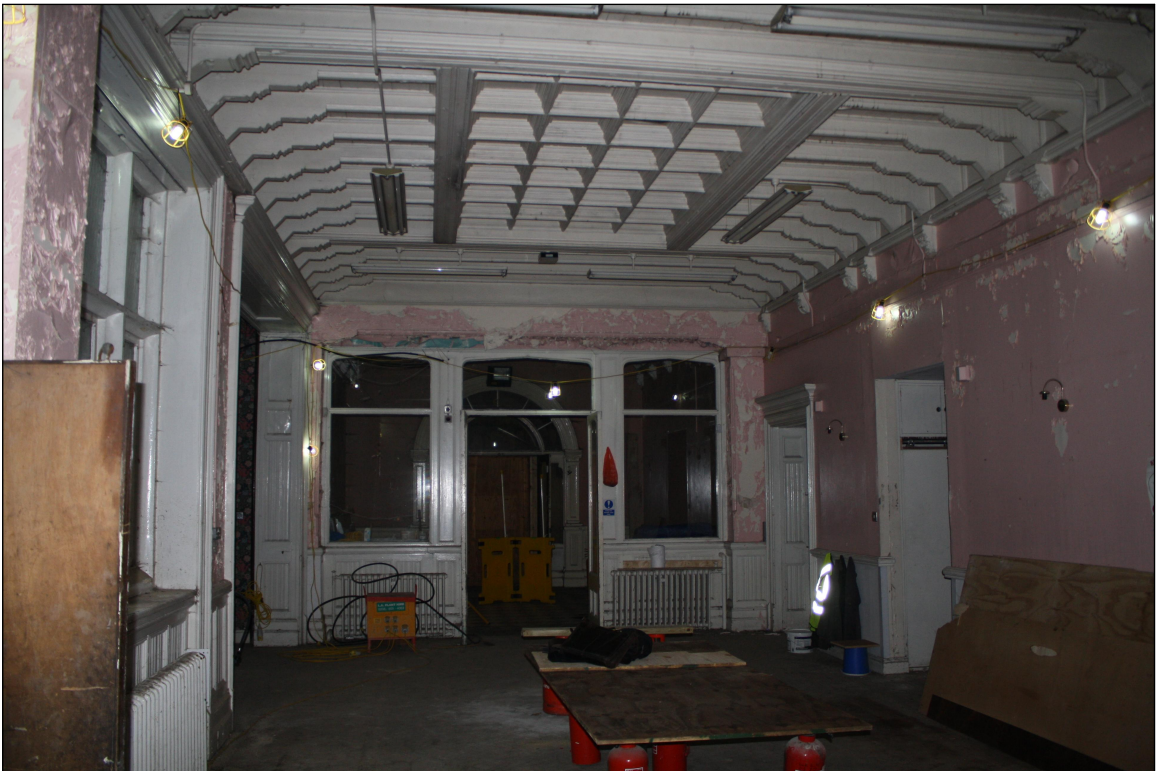
Image 1: Author SHH

- 1) Entrance hall looking towards the main entrance. The style of the original ceiling is still intact and will be retained whilst where possible when the opening is created.
- 2) Dining hall showing the original ceiling. This important feature will be fully restored and returned to its rich timber appearance.
- 3) Staircase hall feature window to be restored.

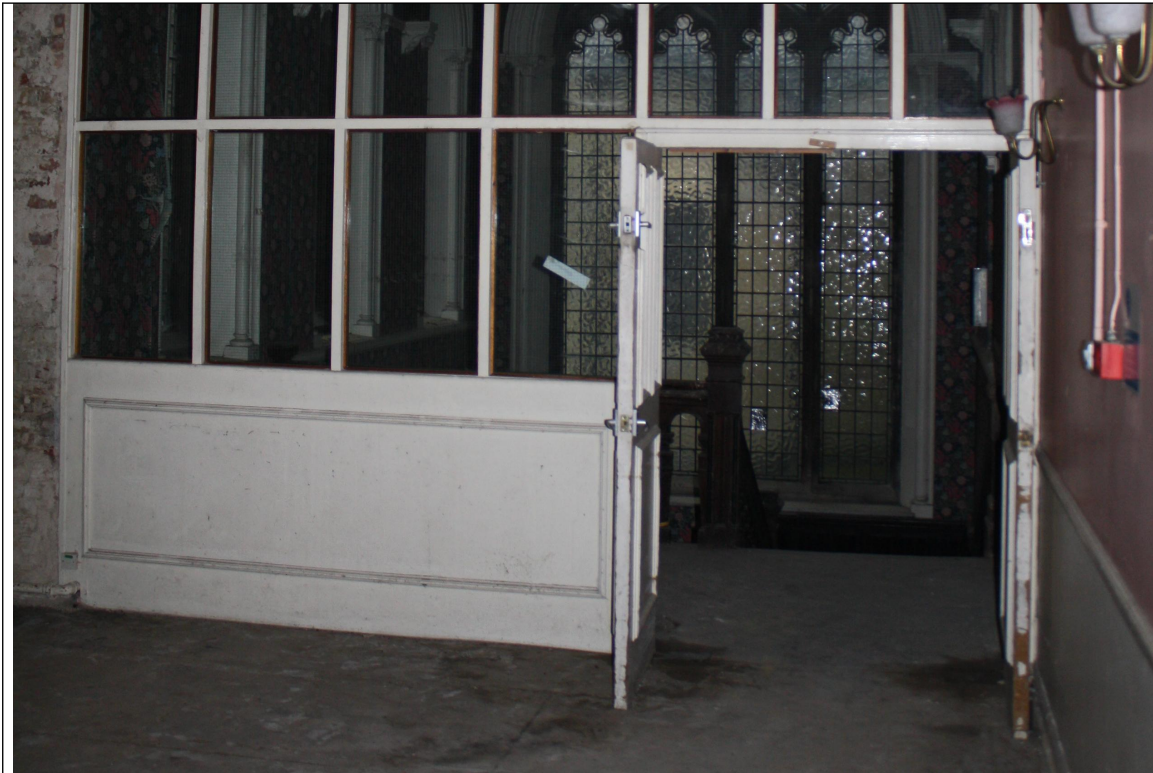
Image 1: Author SHH

- 1) Non-original wall partition built by the NHS on the first floor to be removed.
- 2) First floor windows looking over Heath. Condition of this room is typical through the house.
- 3) External face of inner courtyard window to be fully retained.
