**DESIGN AND ACCESS STATEMENT**

**WILKINS BUILDING DOORS REFUBISHMENTS**

**AT THE**  
**WILKINS BUILDING**  
**GOWER STREET, LONDON,**  
**WC1E 6BT**

**UNIVERSITY COLLEGE LONDON**

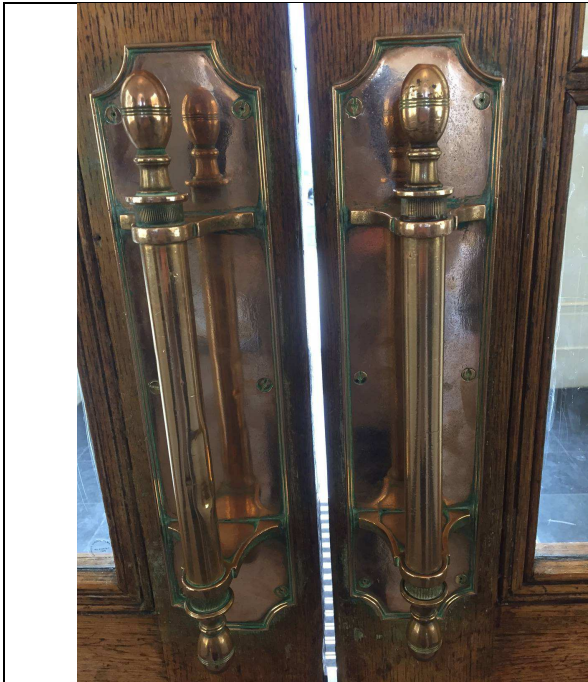
The double door sets do not close tightly together and gaps allow heat to be lost during colder and stormier months, of the year. The energy performance rating of the doors are deemed to be poor.

**Photo 1:** Typical brass door handles and gap between closing edges.

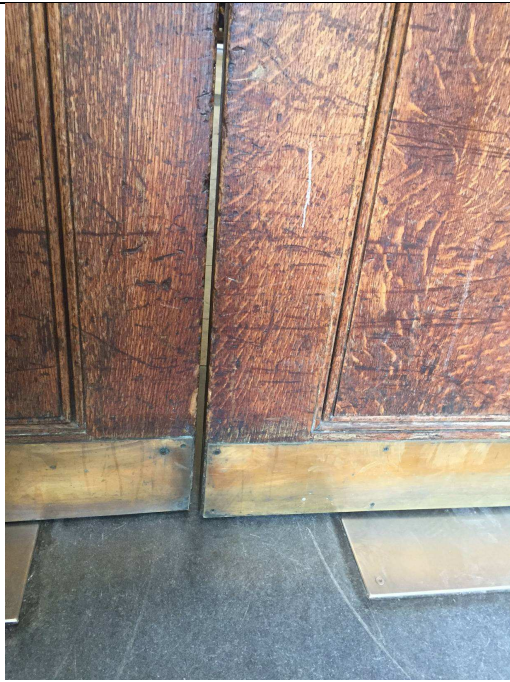
The doors kick plates, pull handles, push plates, hinges and escutcheons are brass and these are aged and tarnished. The kick plates have a cut out notch towards the hinged side. Some doors are fitted with an embed floor sprung door closure with a brass plate.

**Photo 2:** Typical Brass kicker plates and floor embedded door closures.

- All door sets will be temporary removed off-site to allow refurbishment, repairs and re-varnishing. The existing brass pull handles and brass escutcheons, will be rehung.
- The kicker plates will be replaced with ones that match the existing height, width and thickness
- The existing floor embed door closure operation will be permanently disused. The brass floor plate will be left in place. A new brass overhead door closure will be installed.
- The following is proposed, to improve the doors fire rating: -

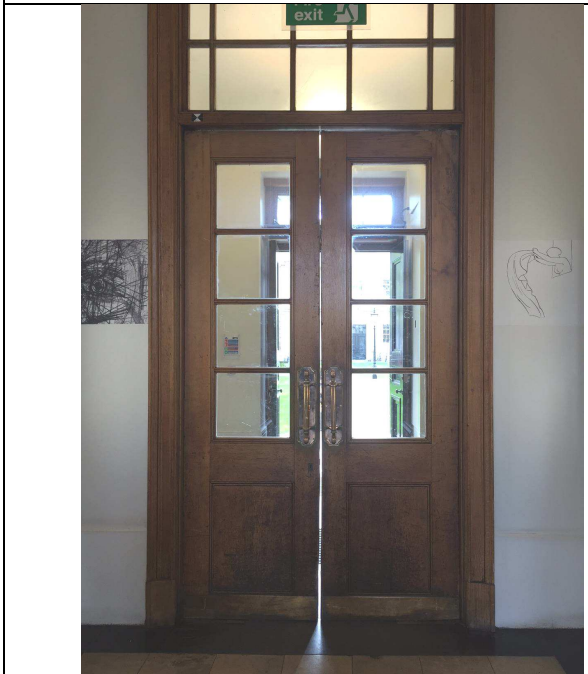
The doors are described as being, solid oak hardwood with clear glazed vision panels to the top half of the door sets. The door sets are finished with varnish. The door sets are complete with the fans above. The glazing have glazing bars that match the doors. The Architraves and the frames are also matching hardwood and finish. The door set provide a Georgian appearance.

**Photo 3:** Typical lobby door appearance.

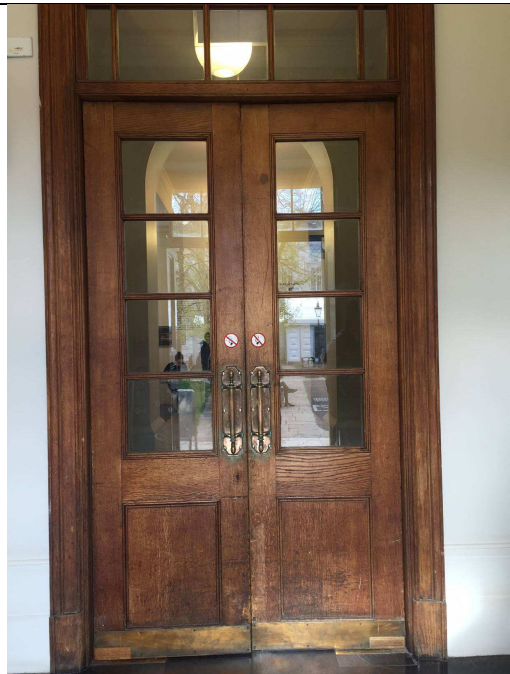
The condition of the existing doors are deemed to be tired, aged and damaged in localised areas. The varnish is heavily pealed, crazed and flaking and the exposed hardwood beneath have become dirty and notably darker.

Due to heavy use, the doors are also scrapped, chipped and has impact marks. These damaged areas also make the doors notably darker than areas of the doors in better condition.

**Photo 4:** Typical condition of the door sets

- To the perimeter of the doors, install intumescent strips. The colour of this item will best match the colour and tone of the doors, in order to reduce their visual impact.
- Install new matching hardwood stops to the frames of the doors. The wood species will be best matched to the existing door colour and tone.
- New fire door signage.
- Rehang hinges on intumescent pads.
- Replace glazing with clear fire rated glass. The view panes will be fitted with intumescent beads. The colour of these item will best match the colour of the doors to reduce their visual impact. The existing hardwood panel strip will be refitted around each pane or this can be achieved then a matching hardwood strip will be used and finished with varnish.
