**Geotechnical, Hydrogeological,  
Ground Movement & Land  
Contamination Assessment**

**Garages to the rear of  
26 New End Square  
London  
NW3 1LS**

LBH4379 Ver. 3.0

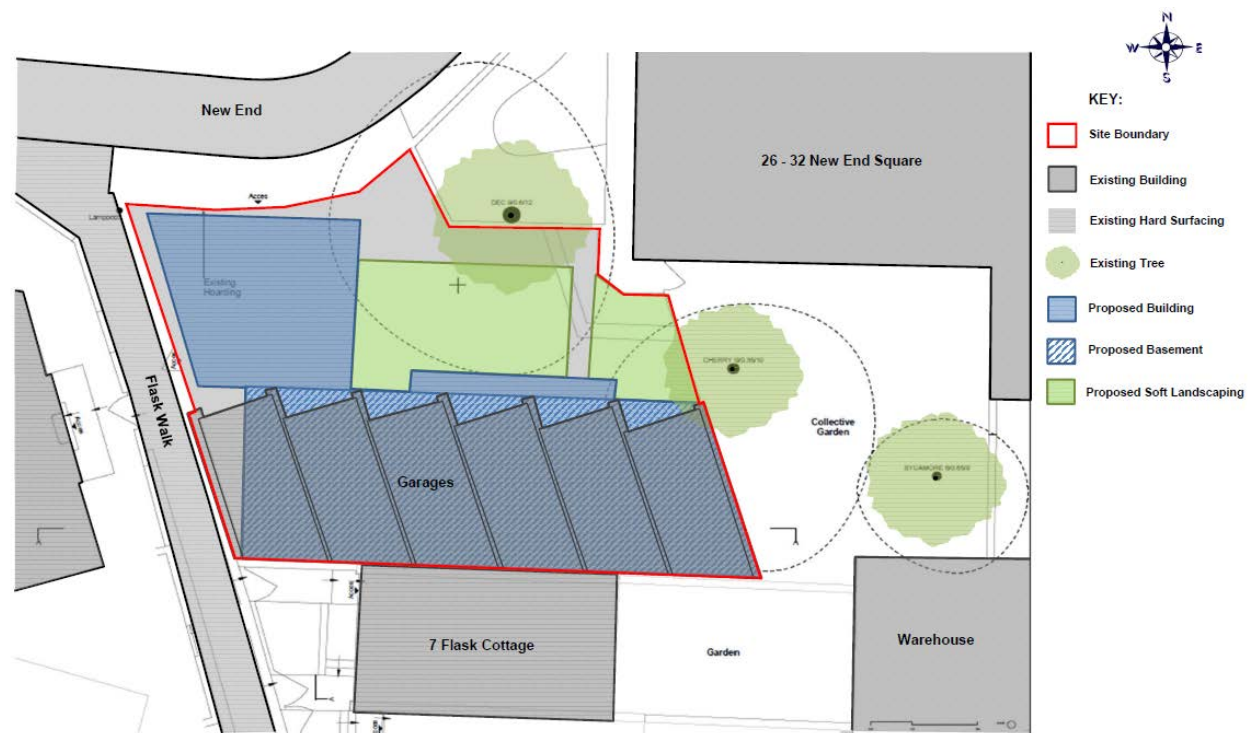
The proposed development will include a two-storey dwelling that will replace the existing garages. Additionally, a basement will essentially occupy the footprint of the existing garages and will be constructed to a depth of approximately 5.5m below the existing street level. Soft landscaping will be present in north-eastern area of the site.

Site Plan showing Proposed Development

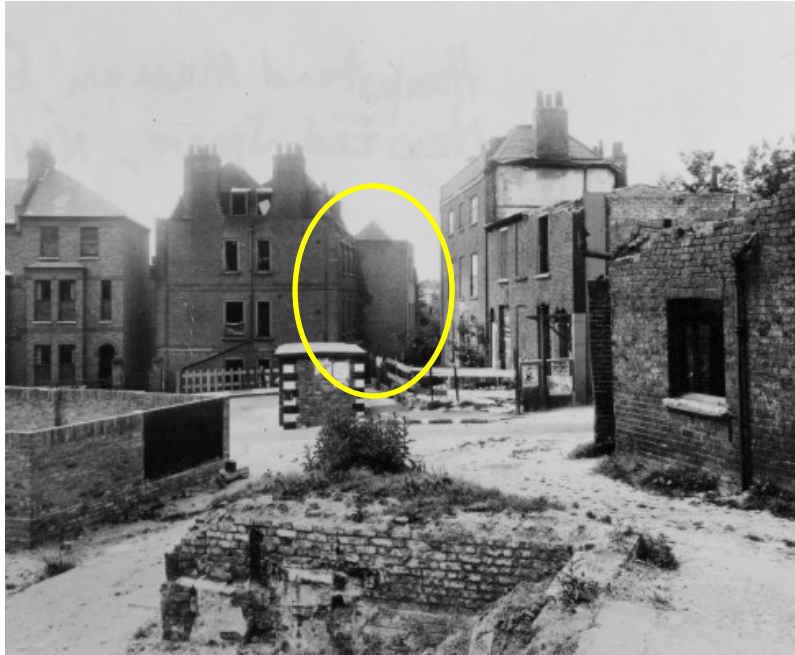
1945 View of site looking south-west from New End Square

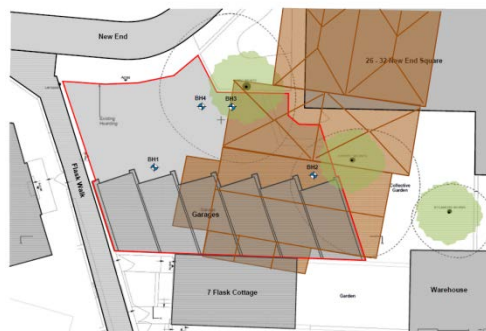
Plan showing location of previous buildings

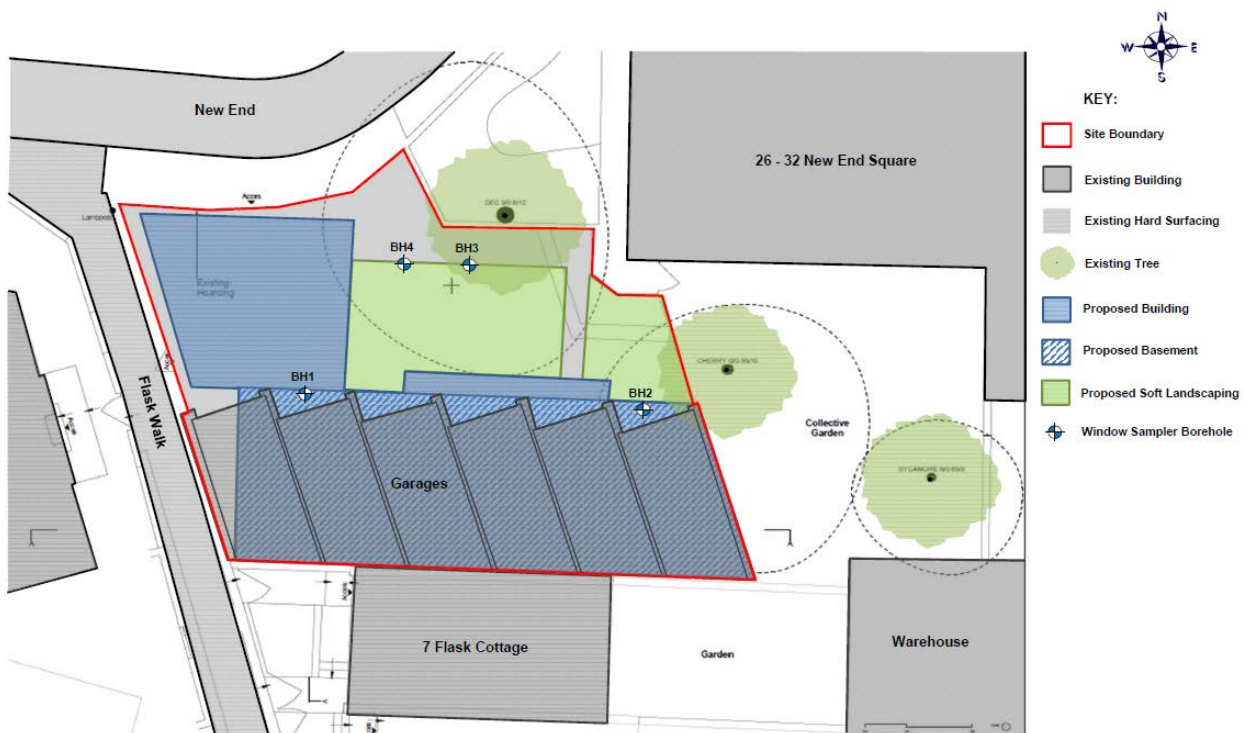
A total of four window sampler boreholes were drilled across the site to a maximum depth of 6.50m, as shown on the site plan below. The investigation included the recovery of disturbed samples for chemical and geotechnical testing.

Site Plan showing Exploratory Positions

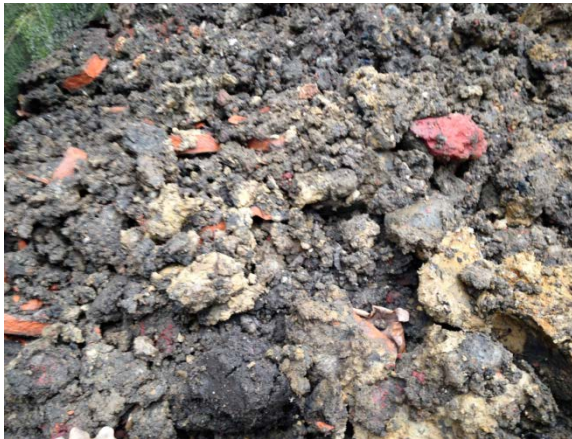
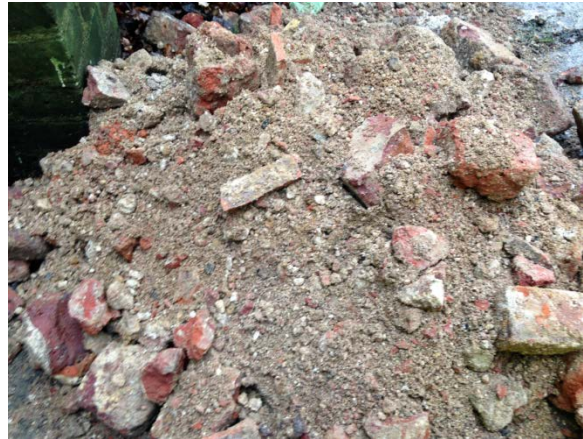
The made ground generally comprised dirty brown sandy clay with abundant fragments of brick, glass, slate, flint and rootlets. The deeper areas of made ground consisted of clayey sandy brick fill with abundant concrete fragments.

It is likely that the material is at least in part, composed of the demolished remains of the previous buildings that stood on the site. The increased depth of made ground in the southeastern area suggests that these previous buildings had basements, which were subsequently infilled following demolition.

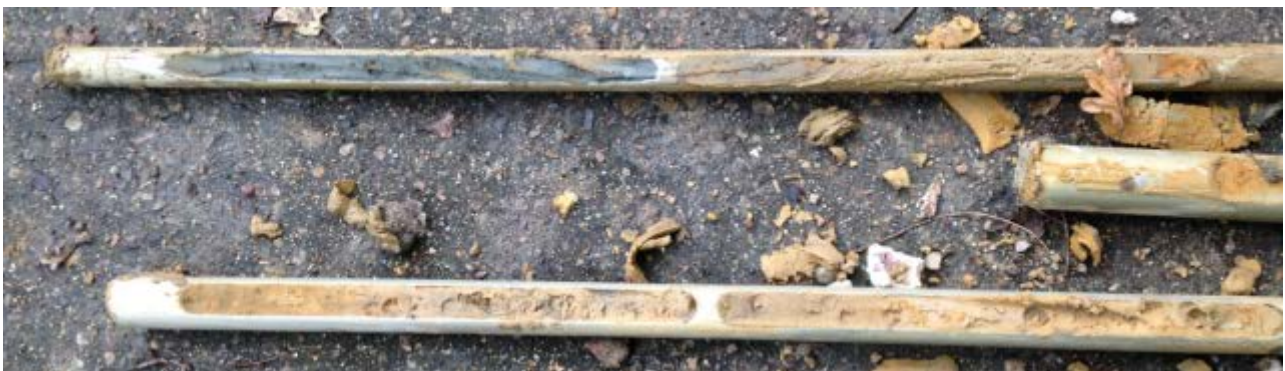
Beneath the made ground, the Claygate Member was encountered. These soils comprise a typically variable sequence of firm grey mottled orange-brown sandy clay with occasional rootlets, which was found to be locally very sandy. These soils became firm to stiff, grey silty sandy clay with rare pockets of sand at depth.

The Claygate was proved to over 6m depth by the investigation, but extends to around +85m OD, over 10m below the proposed basement.

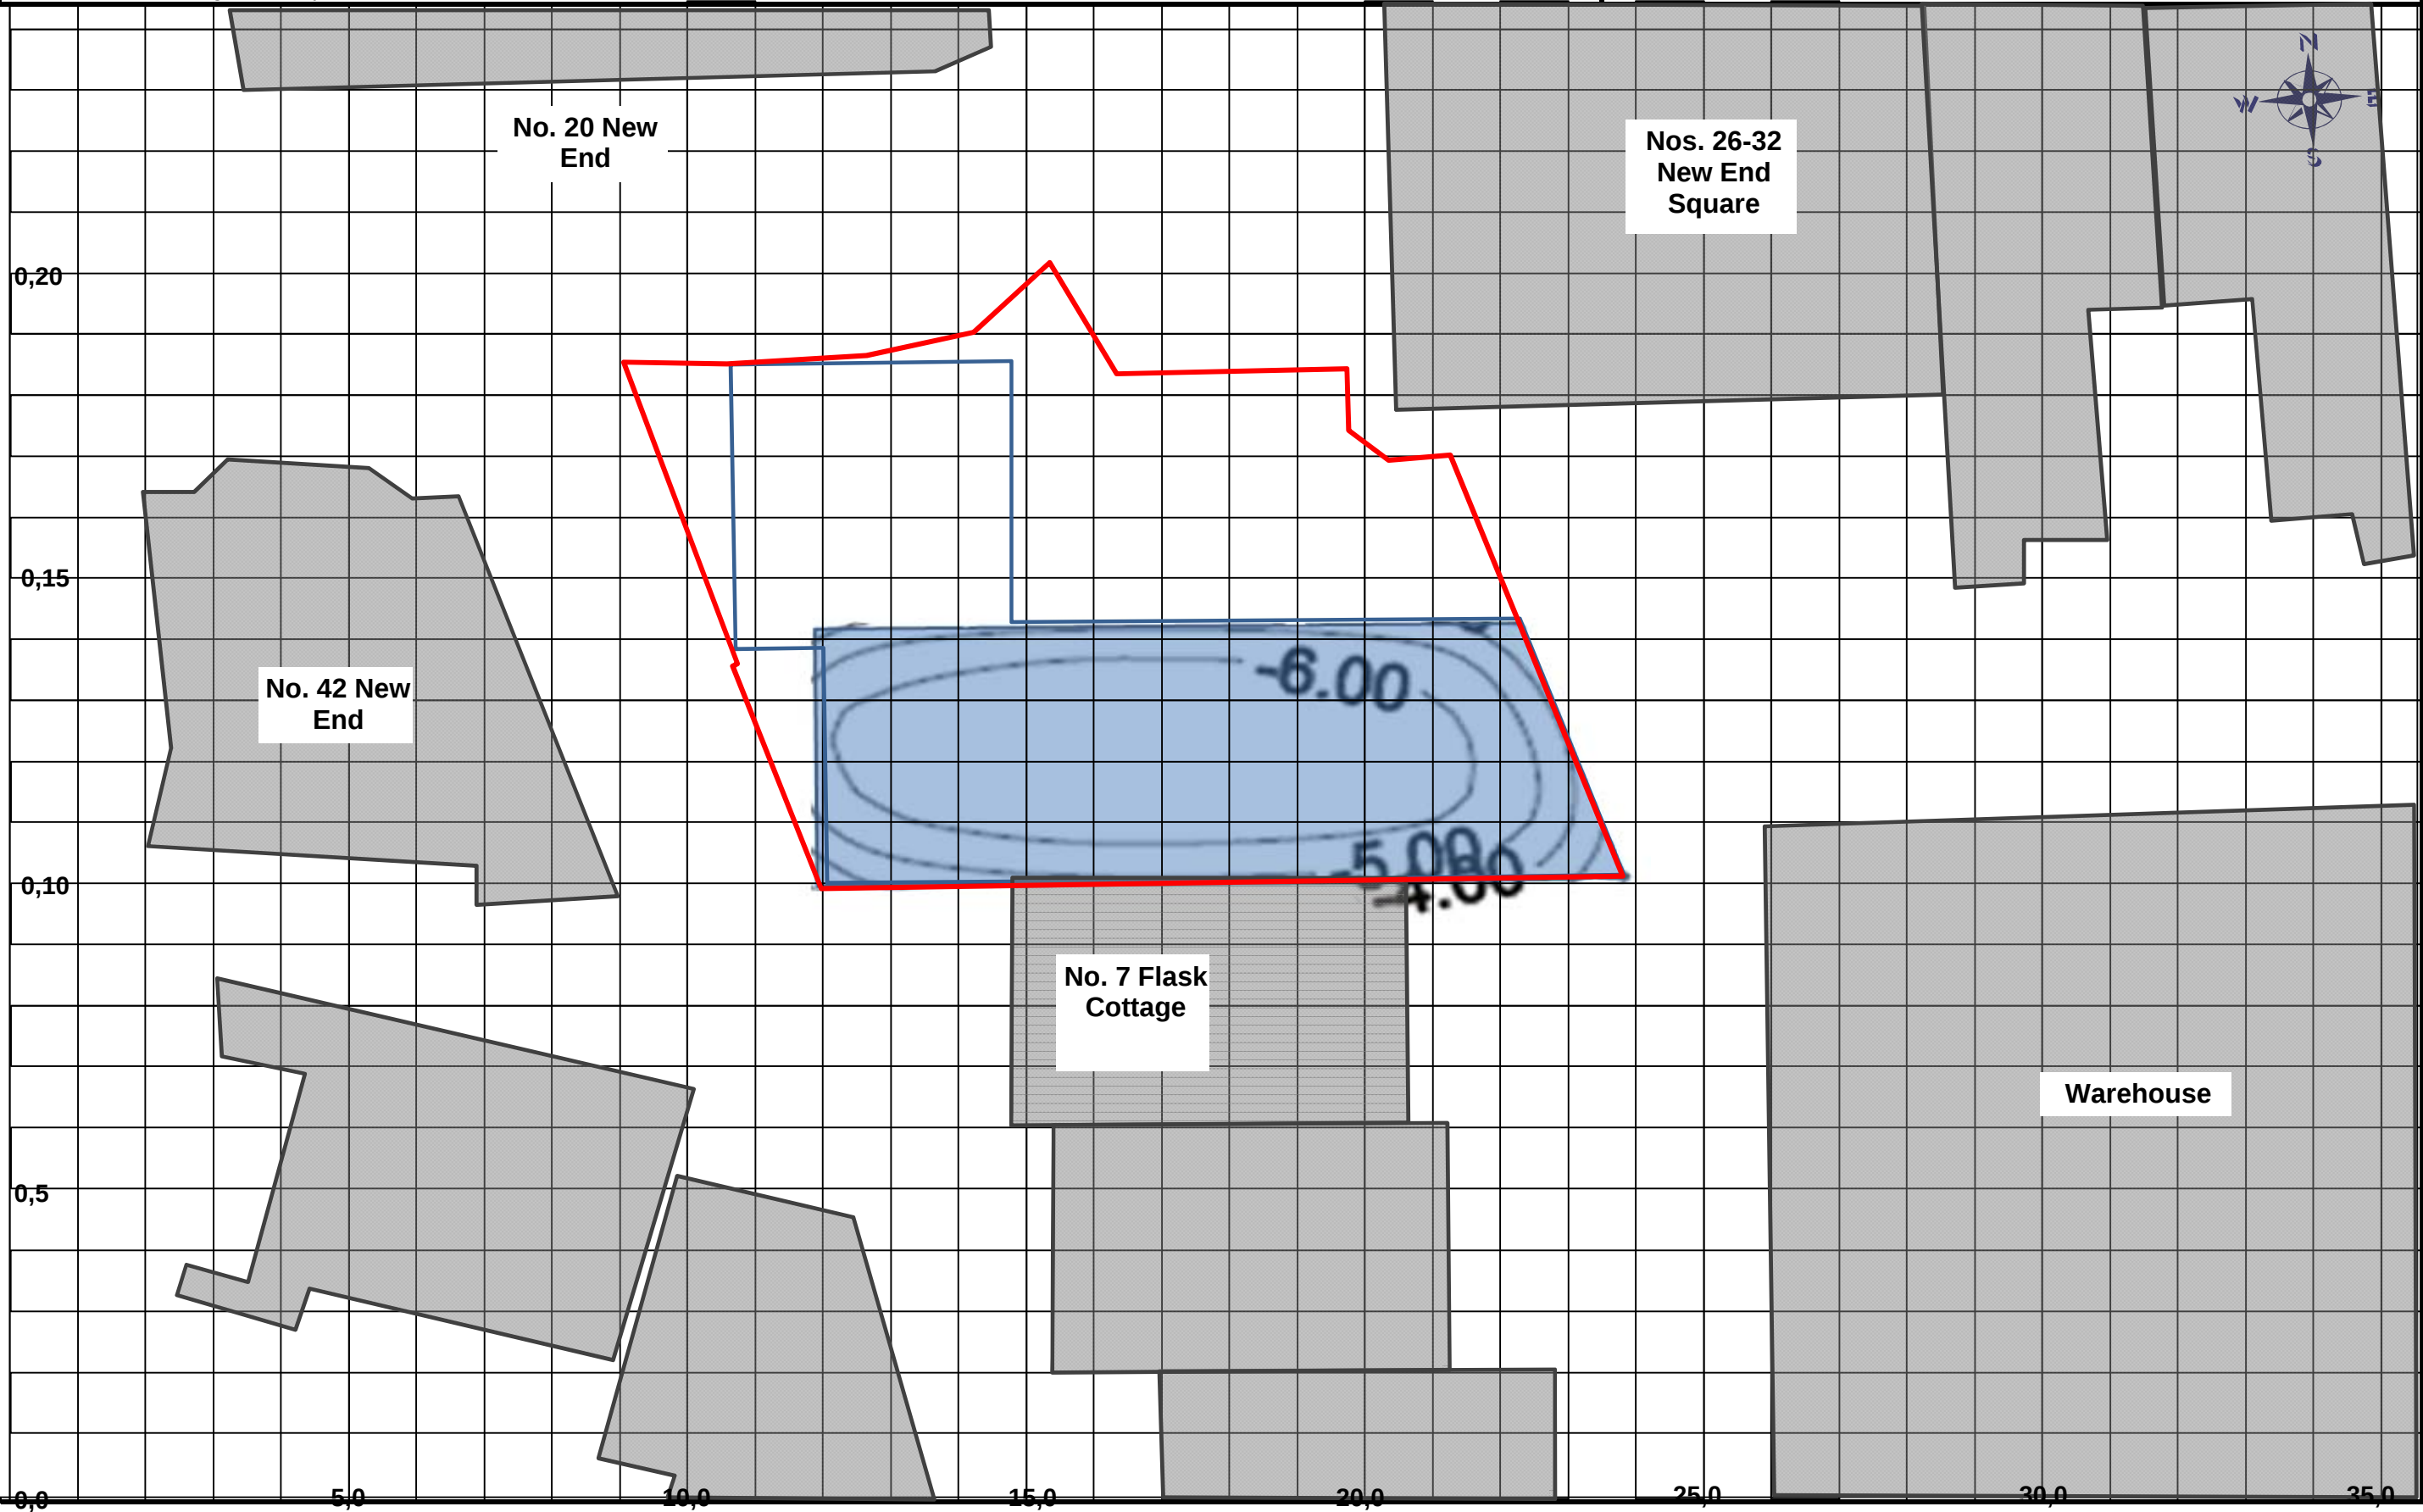
Long Term Heave (Post Construction) - mm
