Phase 1 Environmental Desk Study

246 Belsize Road, London

May 2016

Report No. A1451/16

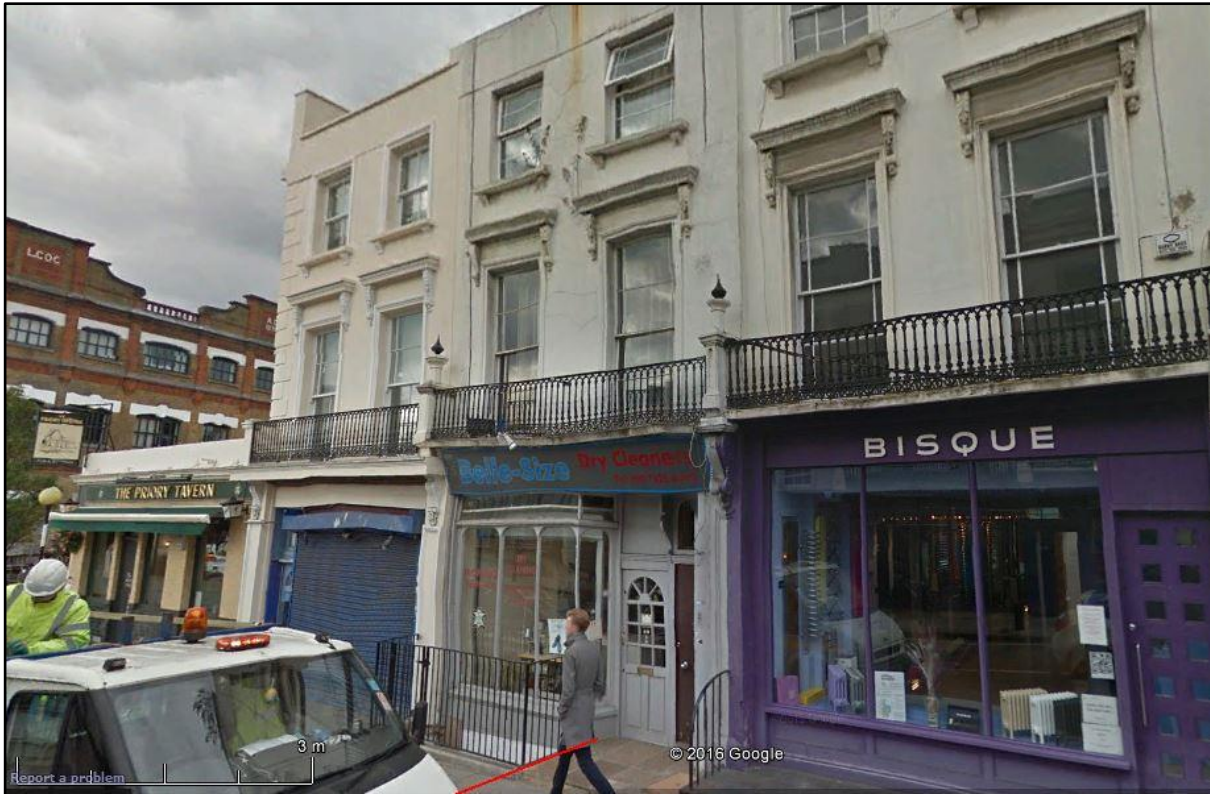
Figure 2: Existing Site Layout (Belle-Size Dry Cleaners)

2.1 The site is currently an existing residential three storey property which includes a dry cleaners on the ground floor. This dry cleaners is a drop-off and collection point only, with all cleaning processes being conducted offsite.

2.5 An existing site layout image is shown below in Figure 2.
