THE BRITISH MUSEUM

NORTH EAST ENTRANCE AREA

DESIGN AND ACCESS STATEMENT
TO SUPPORT
PLANNING APPLICATION

21st July 2016

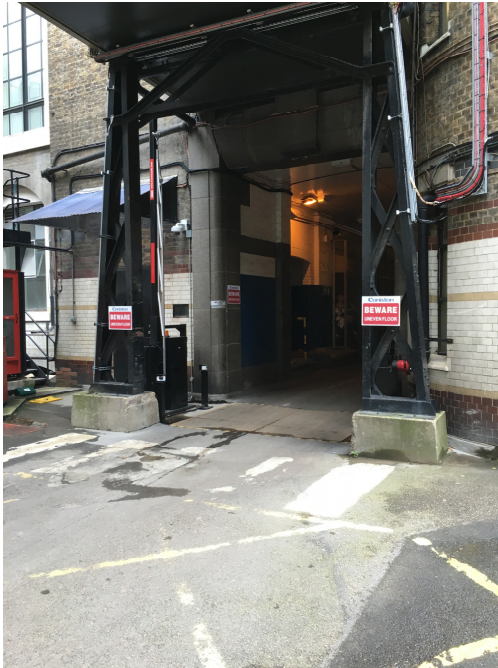
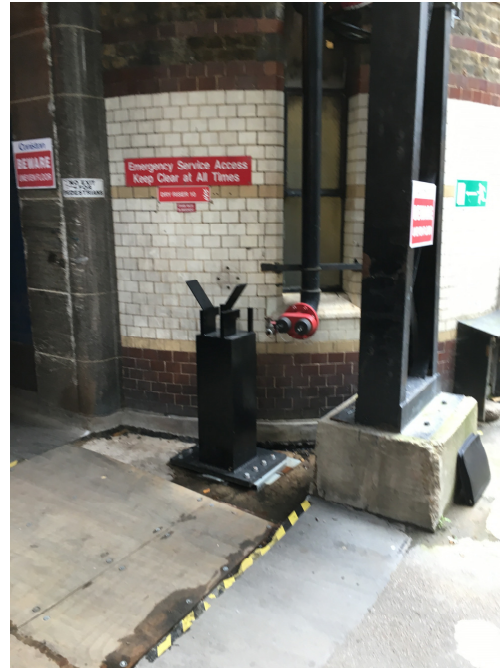
South side showing recent barrier in open position – note barrier rest on right hand side restricting access

The recent introduction of the barrier on the south side has limited the pedestrian (staff) access through route from the King Edward VII Building onto the service roads around the Bloomsbury site which are frequently used around the clock. When the barriers are down, the staff route is effectively blocked off.

As stated above, the introduction of the new security barriers restricts the staff access.

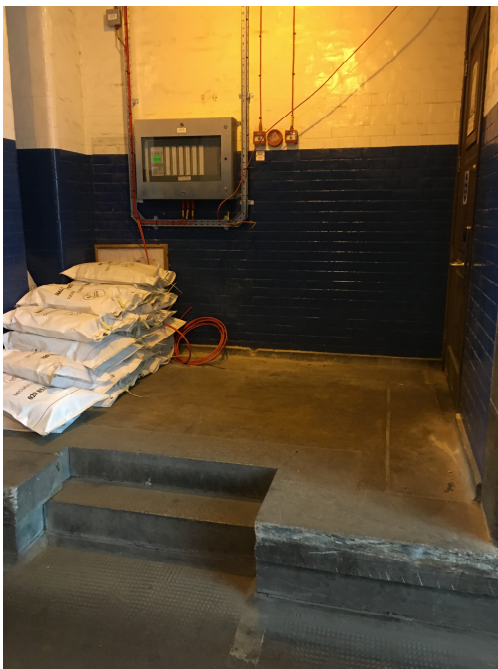
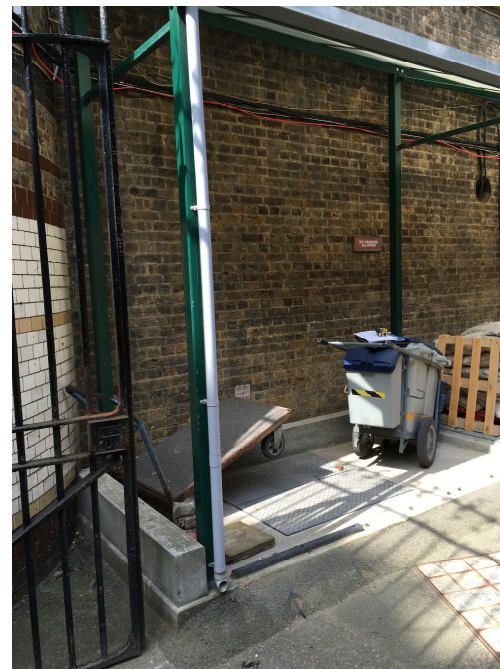
Inner wall to cartway loading bay and outer wall on east side where new opening proposed

To allow continuous pedestrian access for staff members and to maintain the fire escape route from the King Edward VII Building, the Museum would like to form a permanent opening through the east side wall of the "tunnel" (cartway) area the east wall of which forms and continues as the external wall to the King Edward VII Building.

The opening is located adjacent to the door access to the staircase turret. The new panelled hardwood door will reflect the size and profile of the existing door to the turret. The wall at this point is painted brickwork on the inner side and faced brickwork on the outer side. The proposal does not affect the glazed brickwork or the granite dressings. All making good to the wall will be in matching yellow stock brickwork to match the existing waling and will be painted on the inner side.

A new concrete slab will be formed at ground floor level with the loading platform on the inner side. The levels each side of the wall differ slightly and this will introduce a new single step at the continuation slab externally.

An underground service duct is present to the east side of the wall with a metal access hatch. The duct cover / slab is continuous along the east wall. The proposal is to relocate the access hatch to allow uninterrupted access through the new doorway.
