**GROUND INVESTIGATION REPORT**

**14 ROSECROFT AVENUE, HAMPSTEAD, LONDON NW3 7QB**

Report Reference: GWPR1540/GIR/March 2016		Status: FINAL
Issue:	Prepared By:	Verified By:
V1.01 March 2016

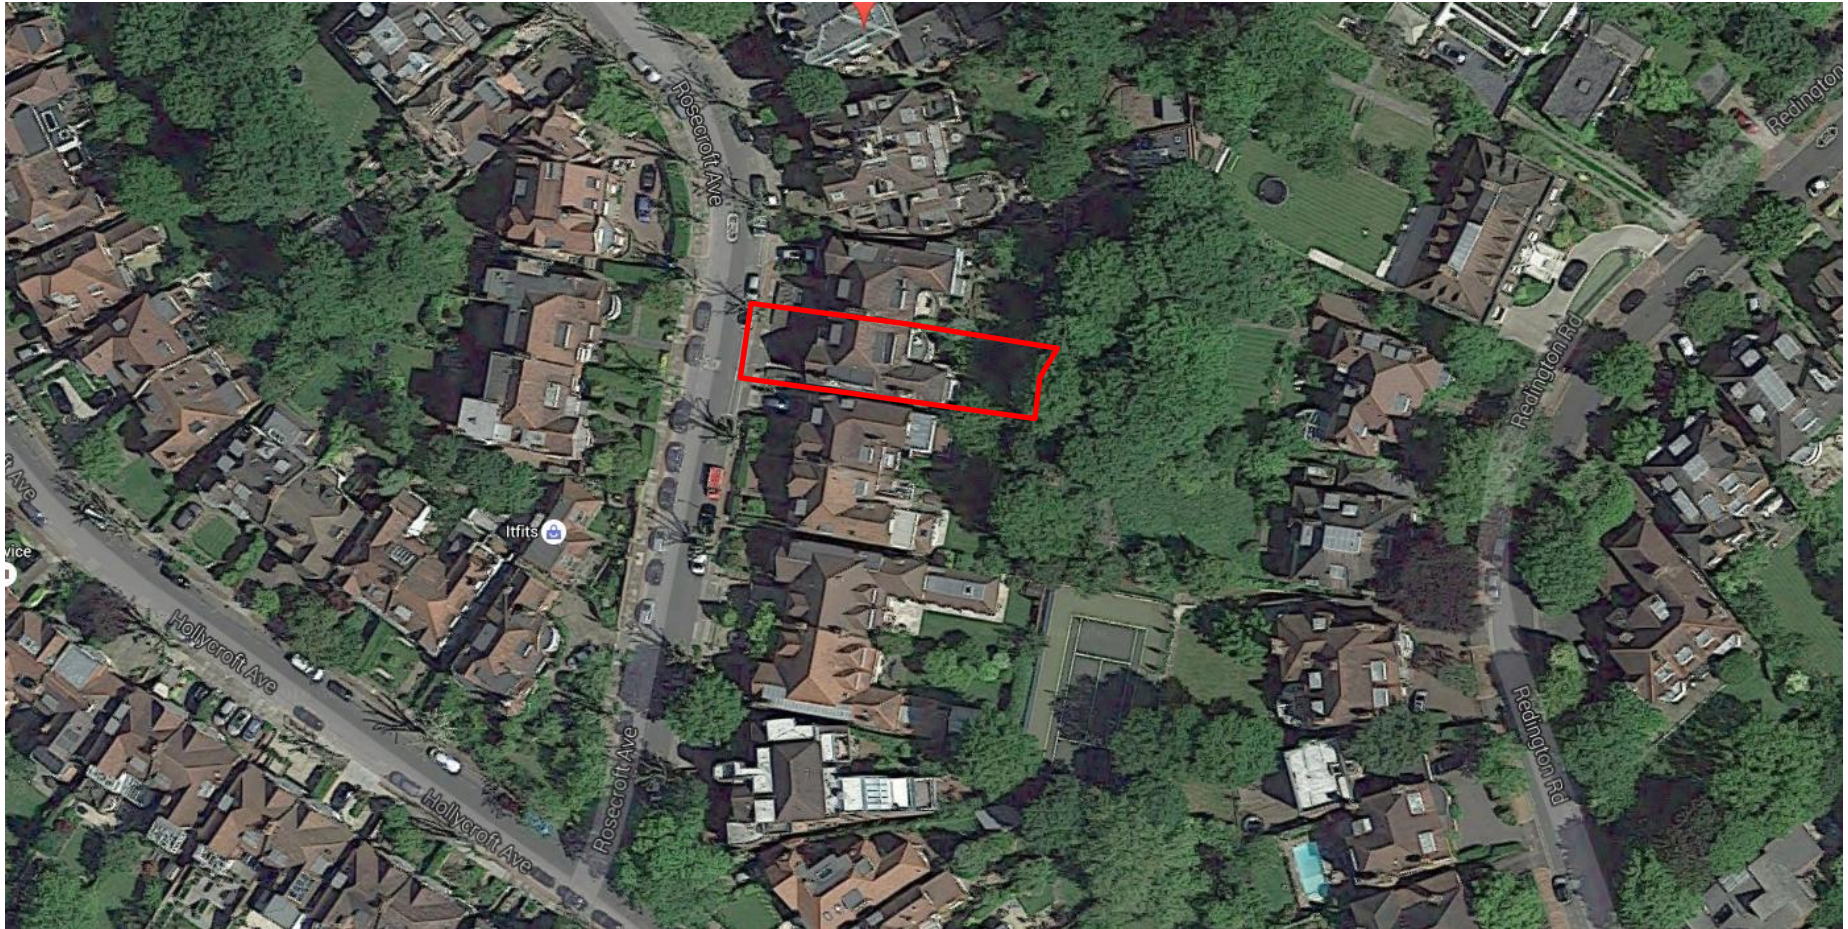
Figure 2

APPROXIMATE SITE BOUNDARY

The national grid reference for the centre of the site was approximately TQ 25517 86160. A site location plan is given within Figure 1. A plan showing the boundary of the site is provided in Figure 2.
