**DESIGN & ACCESS STATEMENT : APPENDIX I - PHOTOGRAPHS OF EXTG  
BRICKWORK**

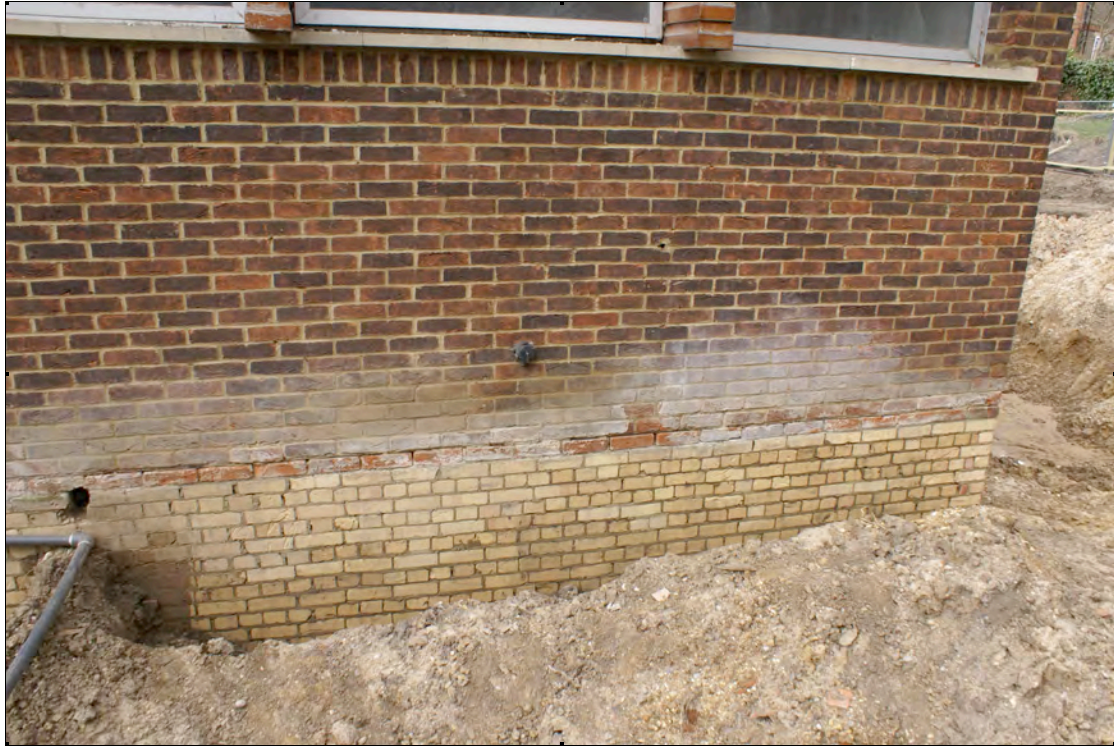
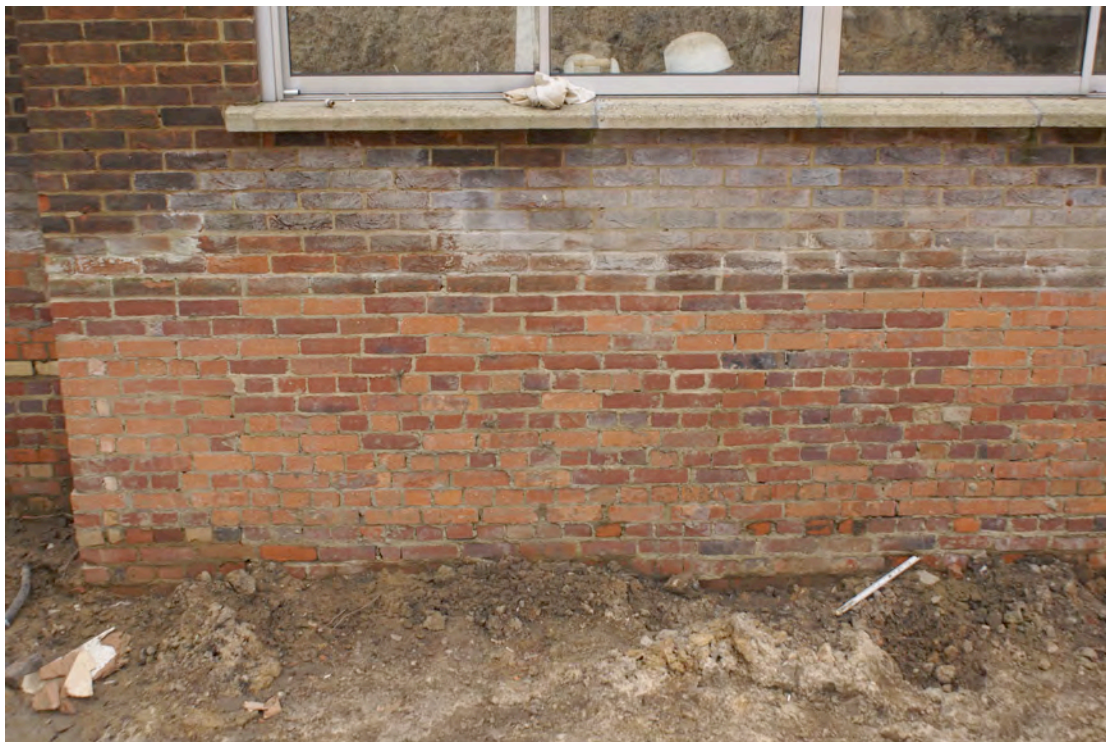
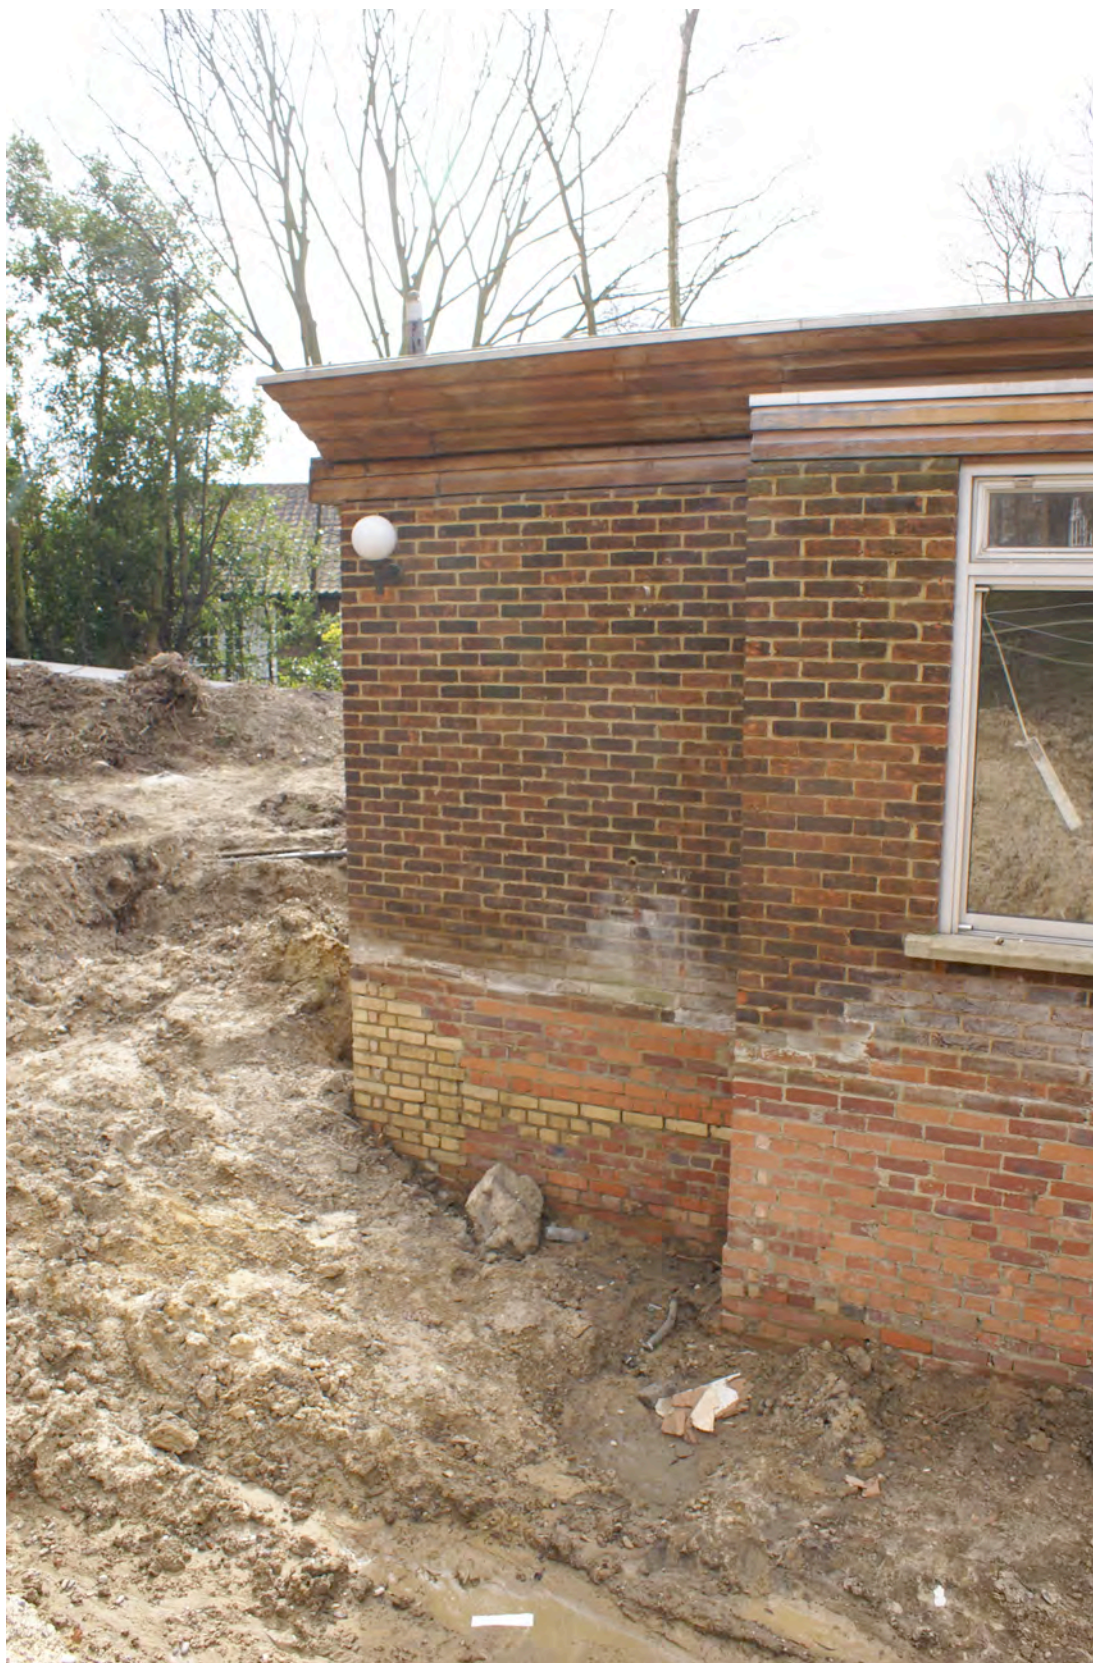
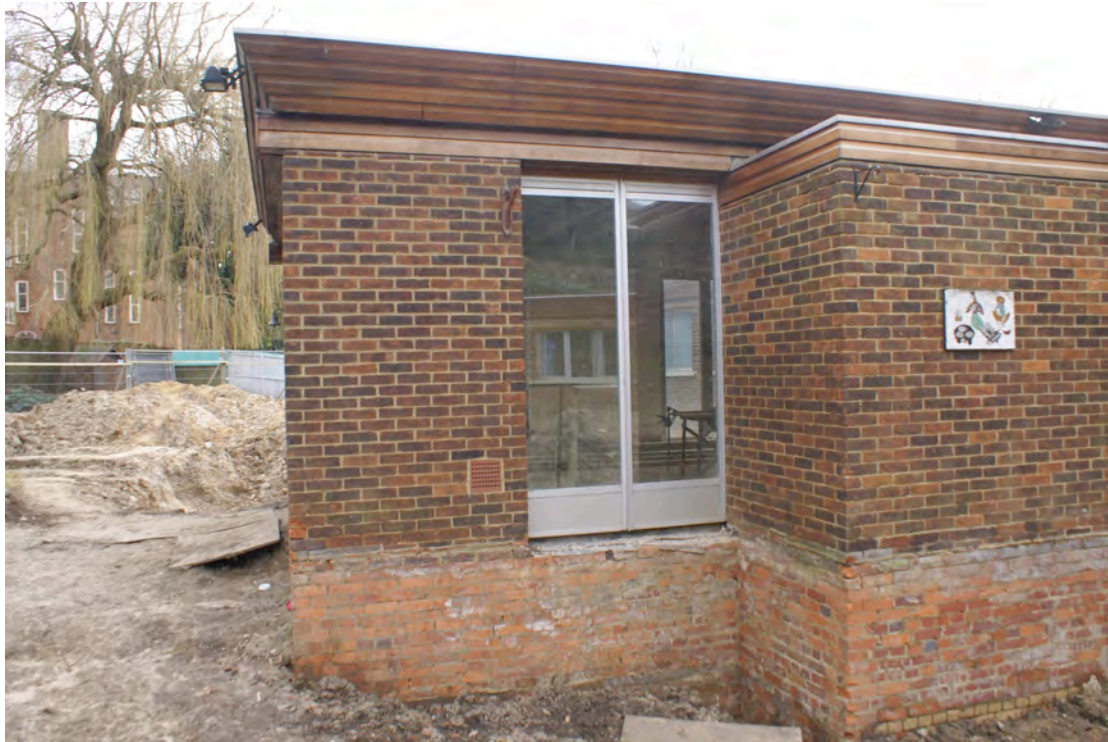
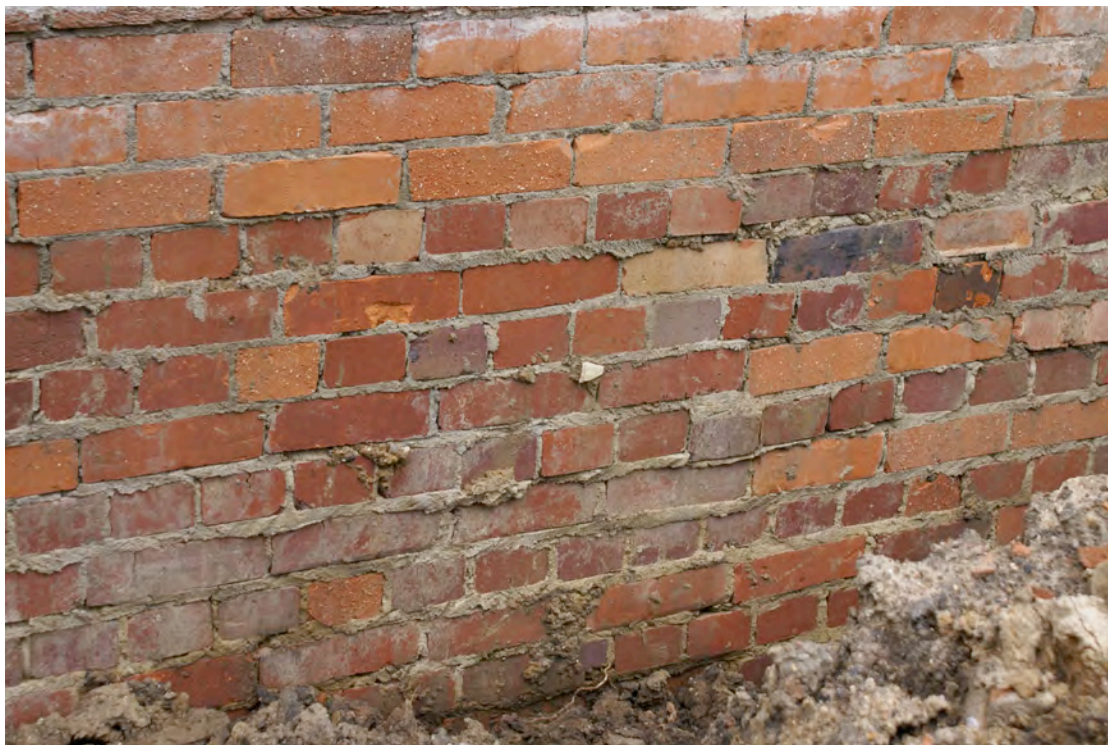
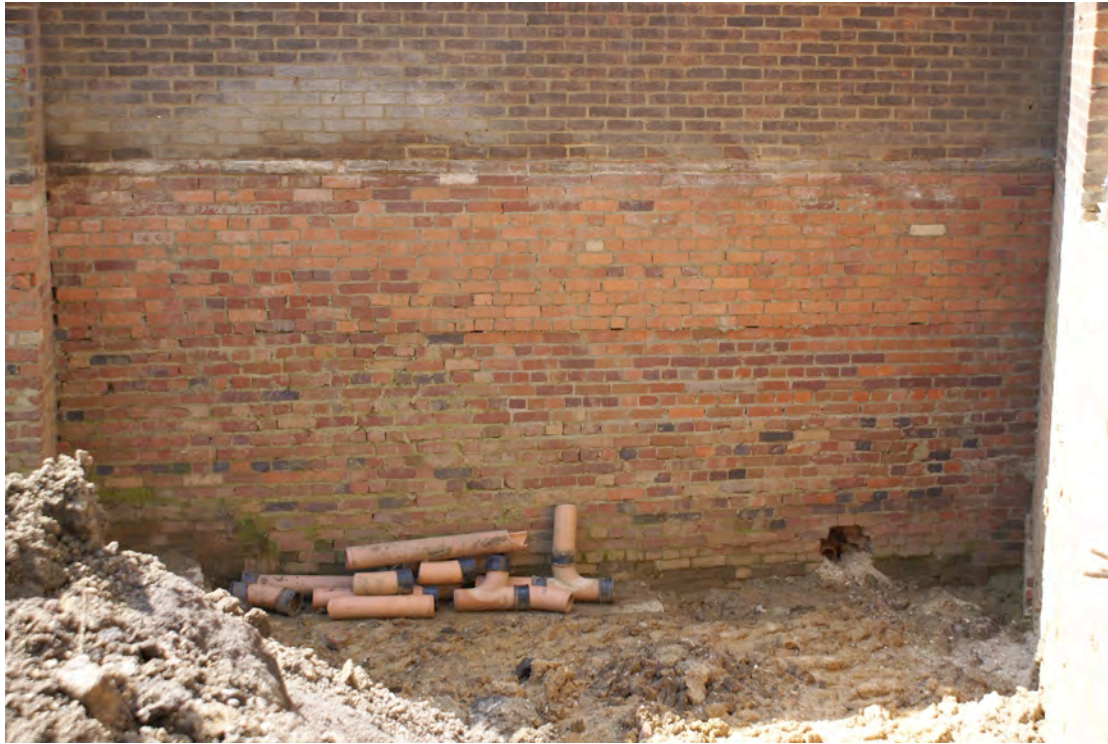
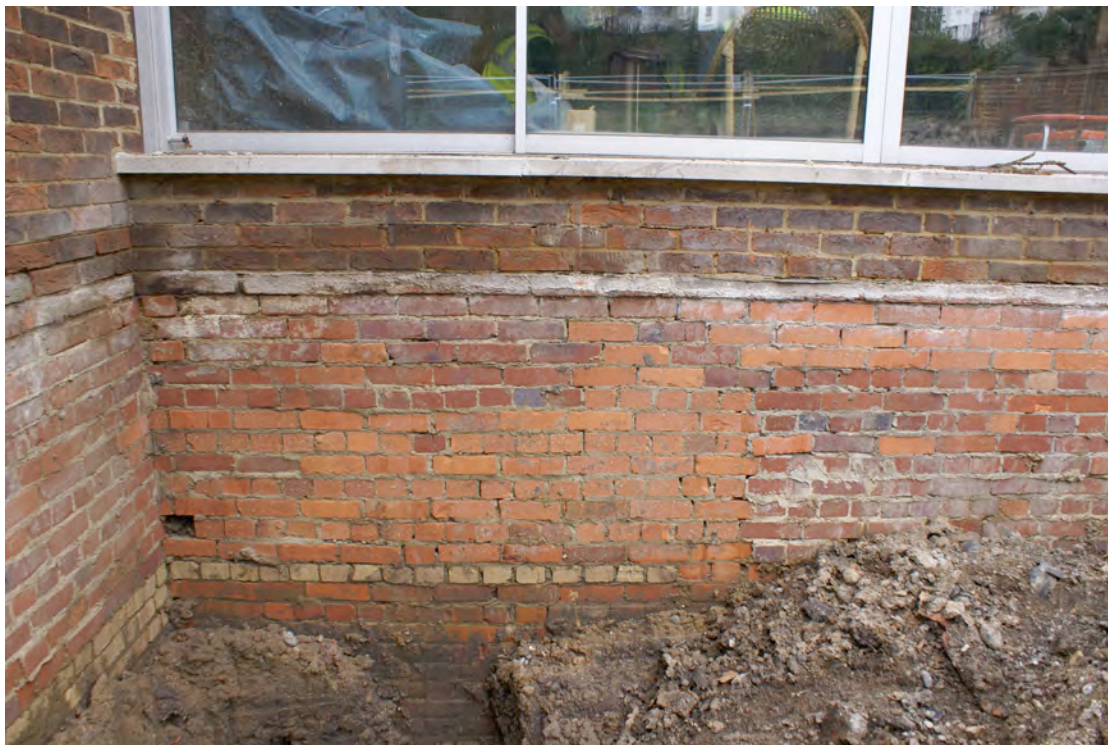
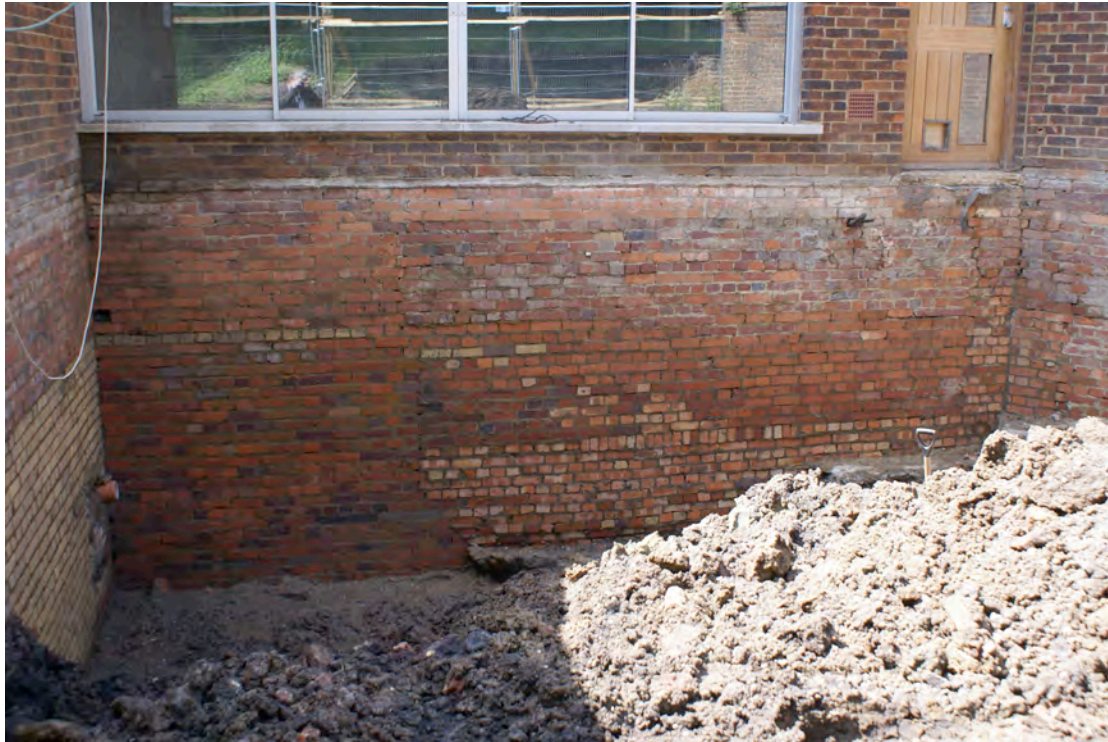
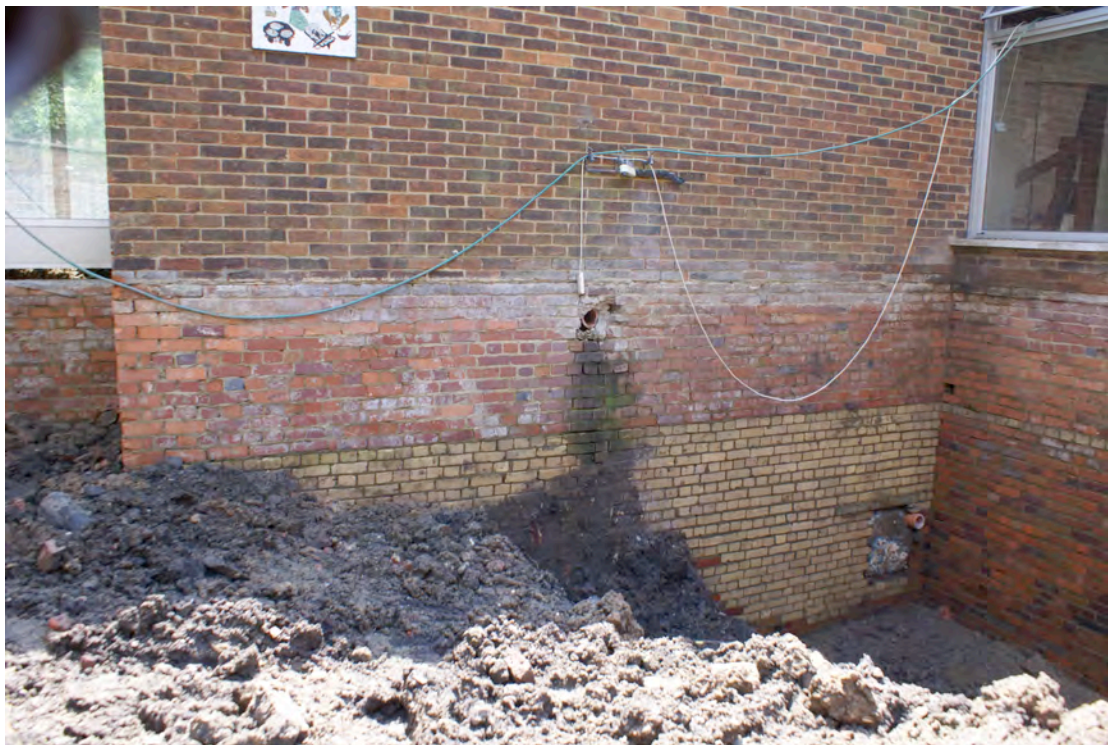
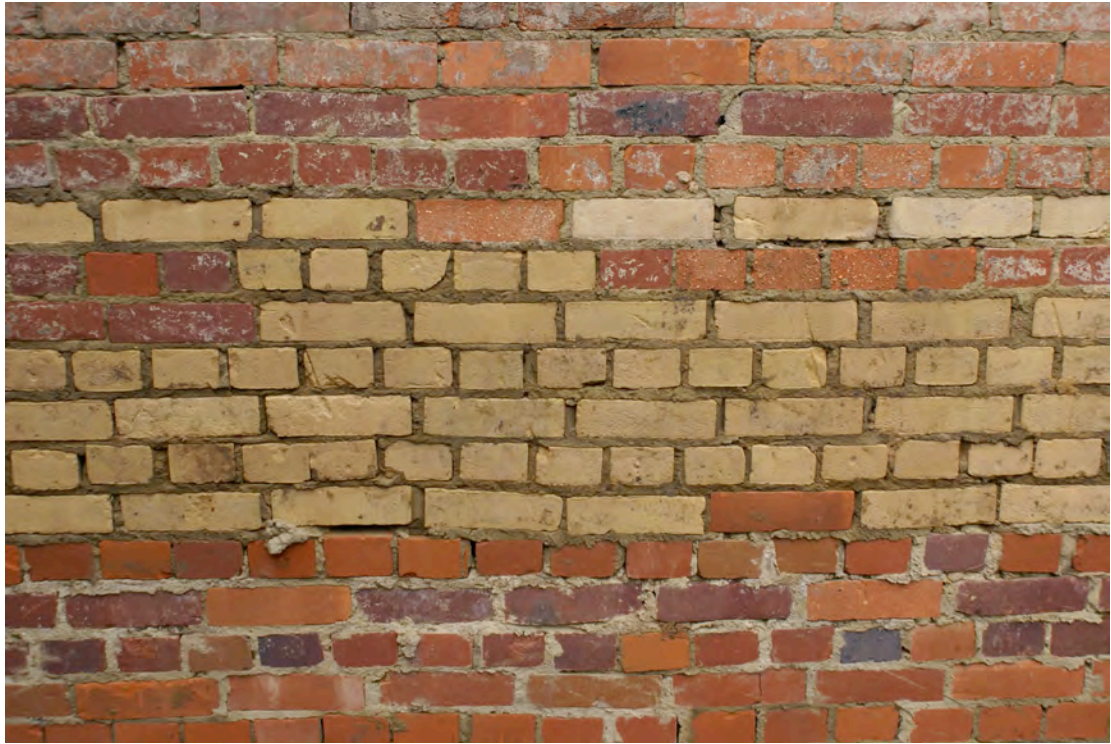
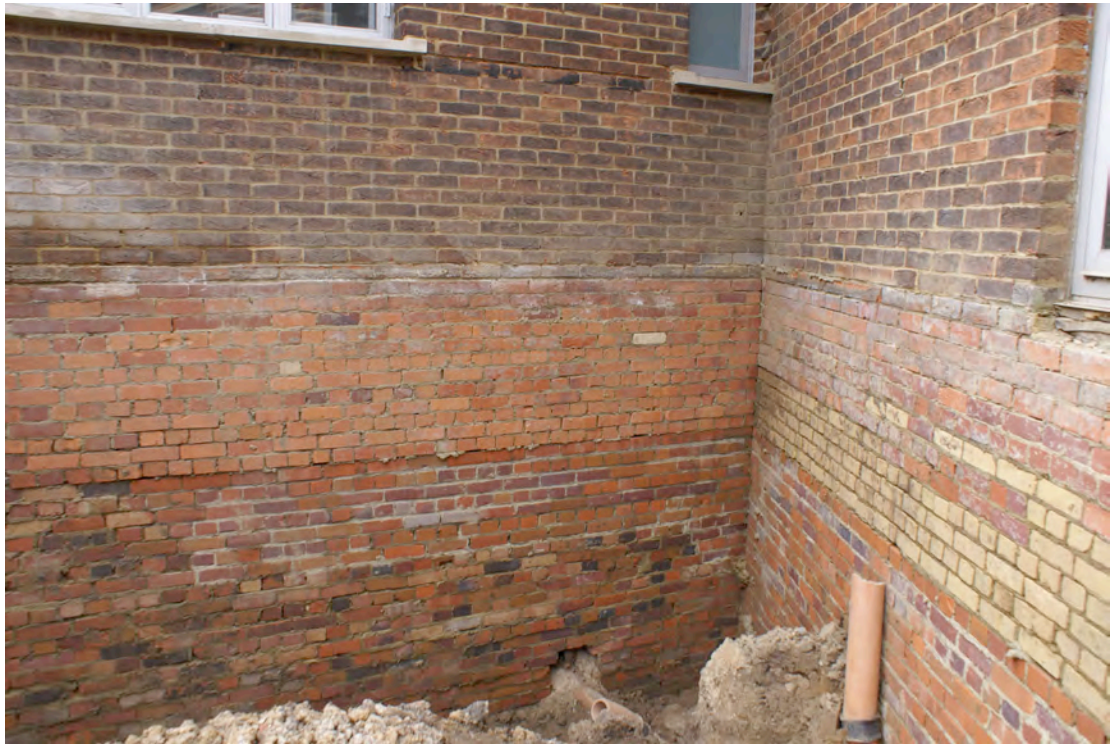
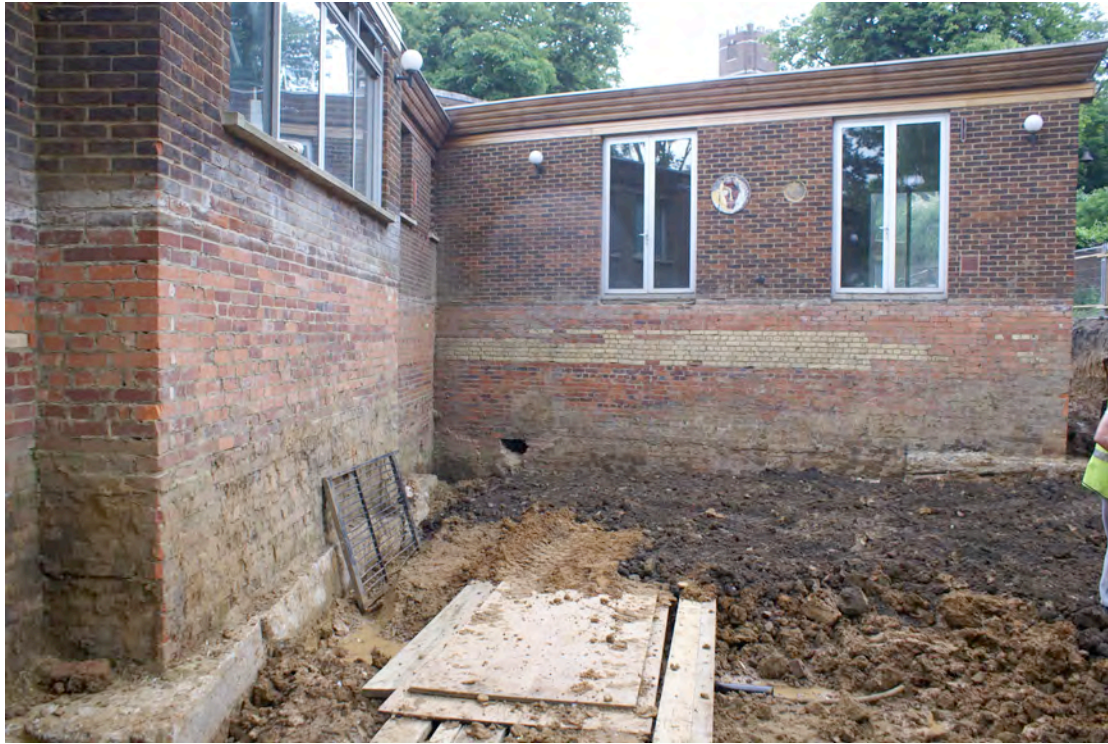
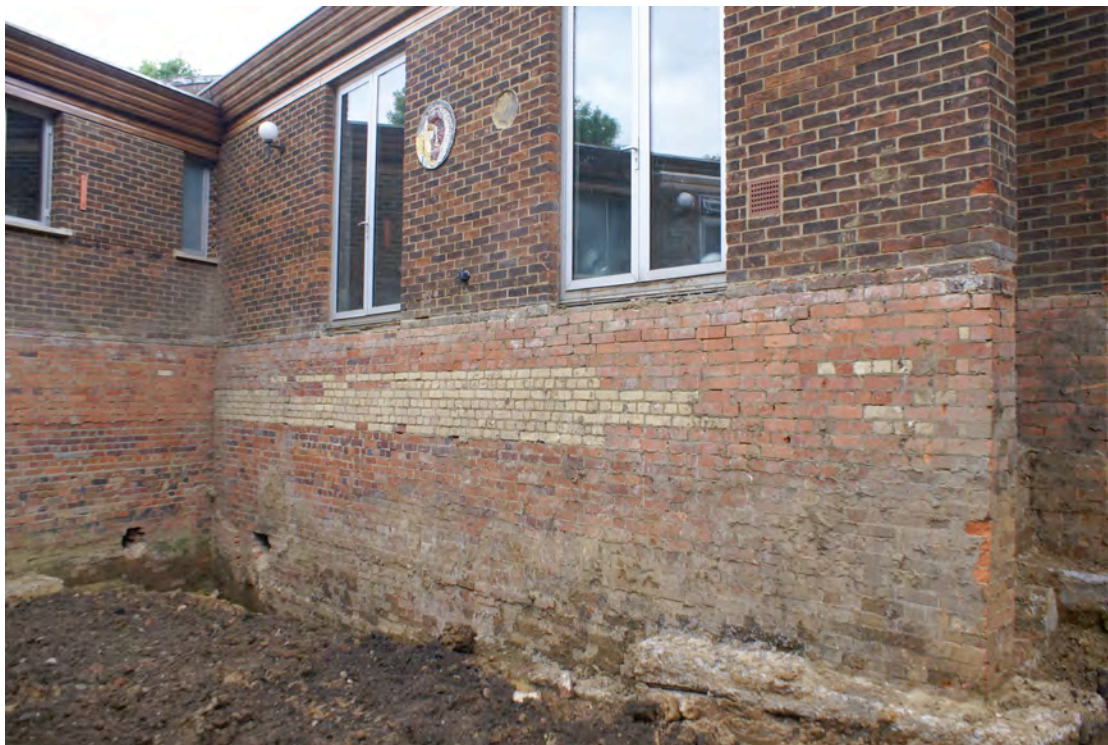
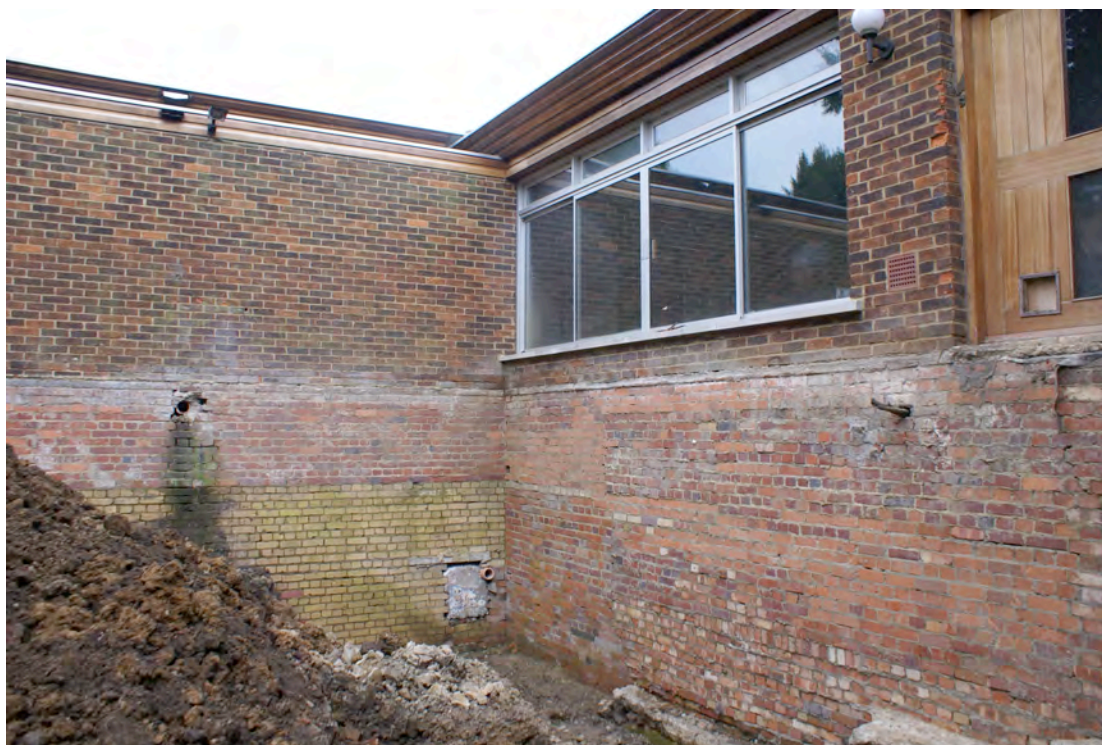
These photographs show the variety of different types of brickwork used in the original construction below the main grade level. They also show the generally very poor quality of the original construction, and the different types of bonding used.

Because of the extent of the variation in brick types used, and the extensive areas of poor construction, it would be highly impractical to retain large sections of the brickwork above the areas that would need to be replaced.
