Ref: Z16177
Project: 43-45 Bedford Square
Title: No. 43 Cantilever Stone Staircase Newel
Post Remedial Details

Newel Post Remedial Works Proposals

| Title Balustrade Remedial Works Details | | | | SK/501 | |

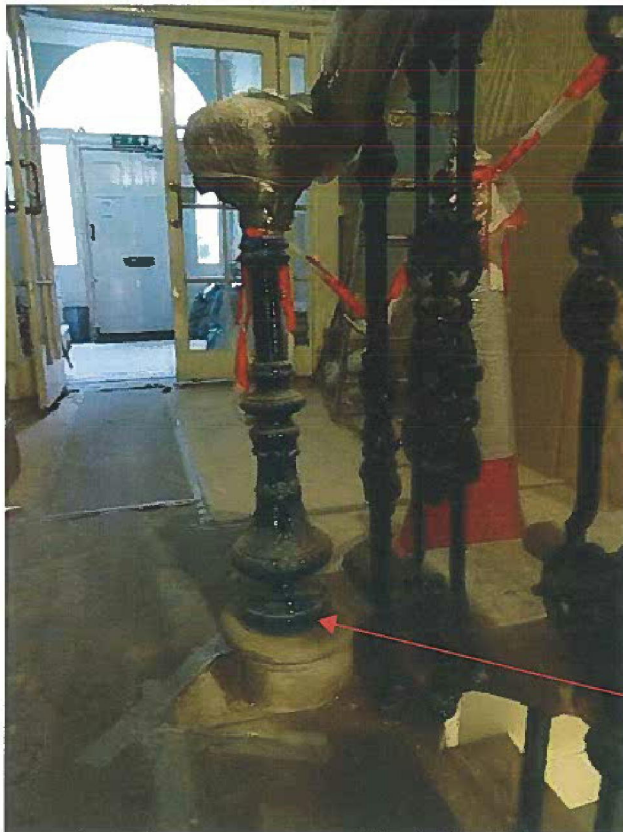
Location where repair is to be carried out.

**Methodology for Repairing Newel
Post Base Fixing:**

1. Carefully remove existing lead caulking by continuously drilling out around base of newel post.
2. Replace with SBD Epoxy Plus low viscosity resin leaving 4mm recess.
3. Fill recess with soft lead shavings carefully heated with fine jewelry maker's blowlamp to match original detail.

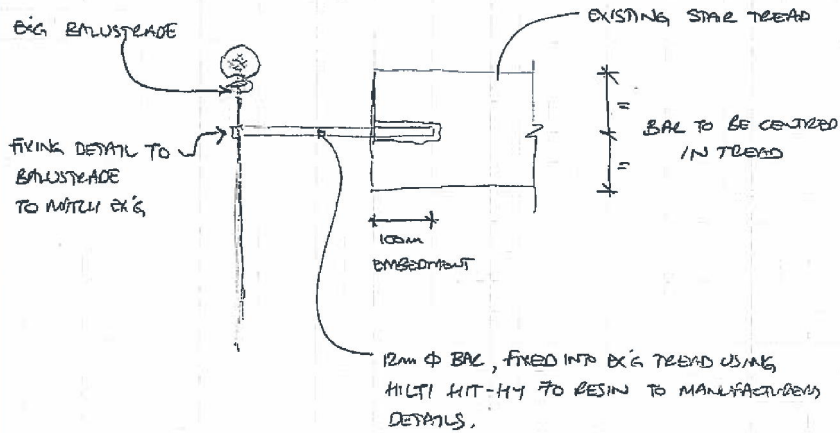
PROPOSED BALUSTRADE TIE BAR DETAIL (CHECK FOR TRANSFER) ALREADY PRESENT ON TREAD 25.
 N.T.S.
