Museum House

Details of Replacement Fenestrations
(like for like)

Fenestration Proposals

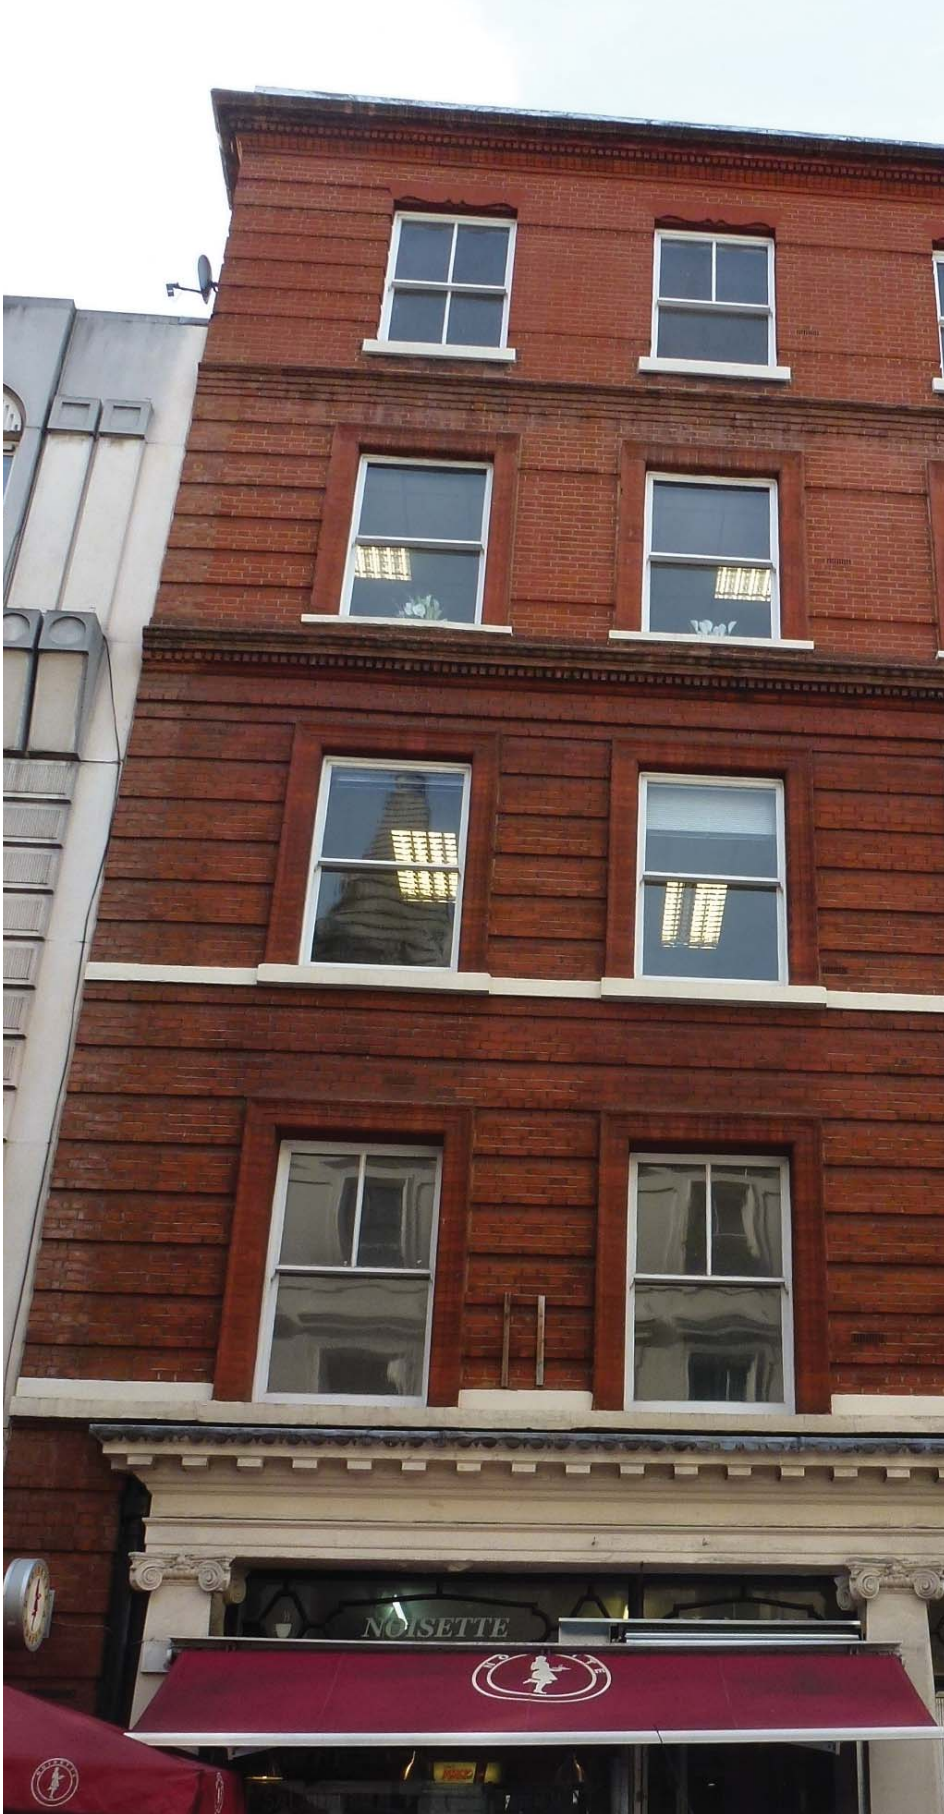
1.1 Existing Facade with Window Elevation/Details

Existing single glazed timber sliding sash windows finished painted white with weights & pulleys etc.

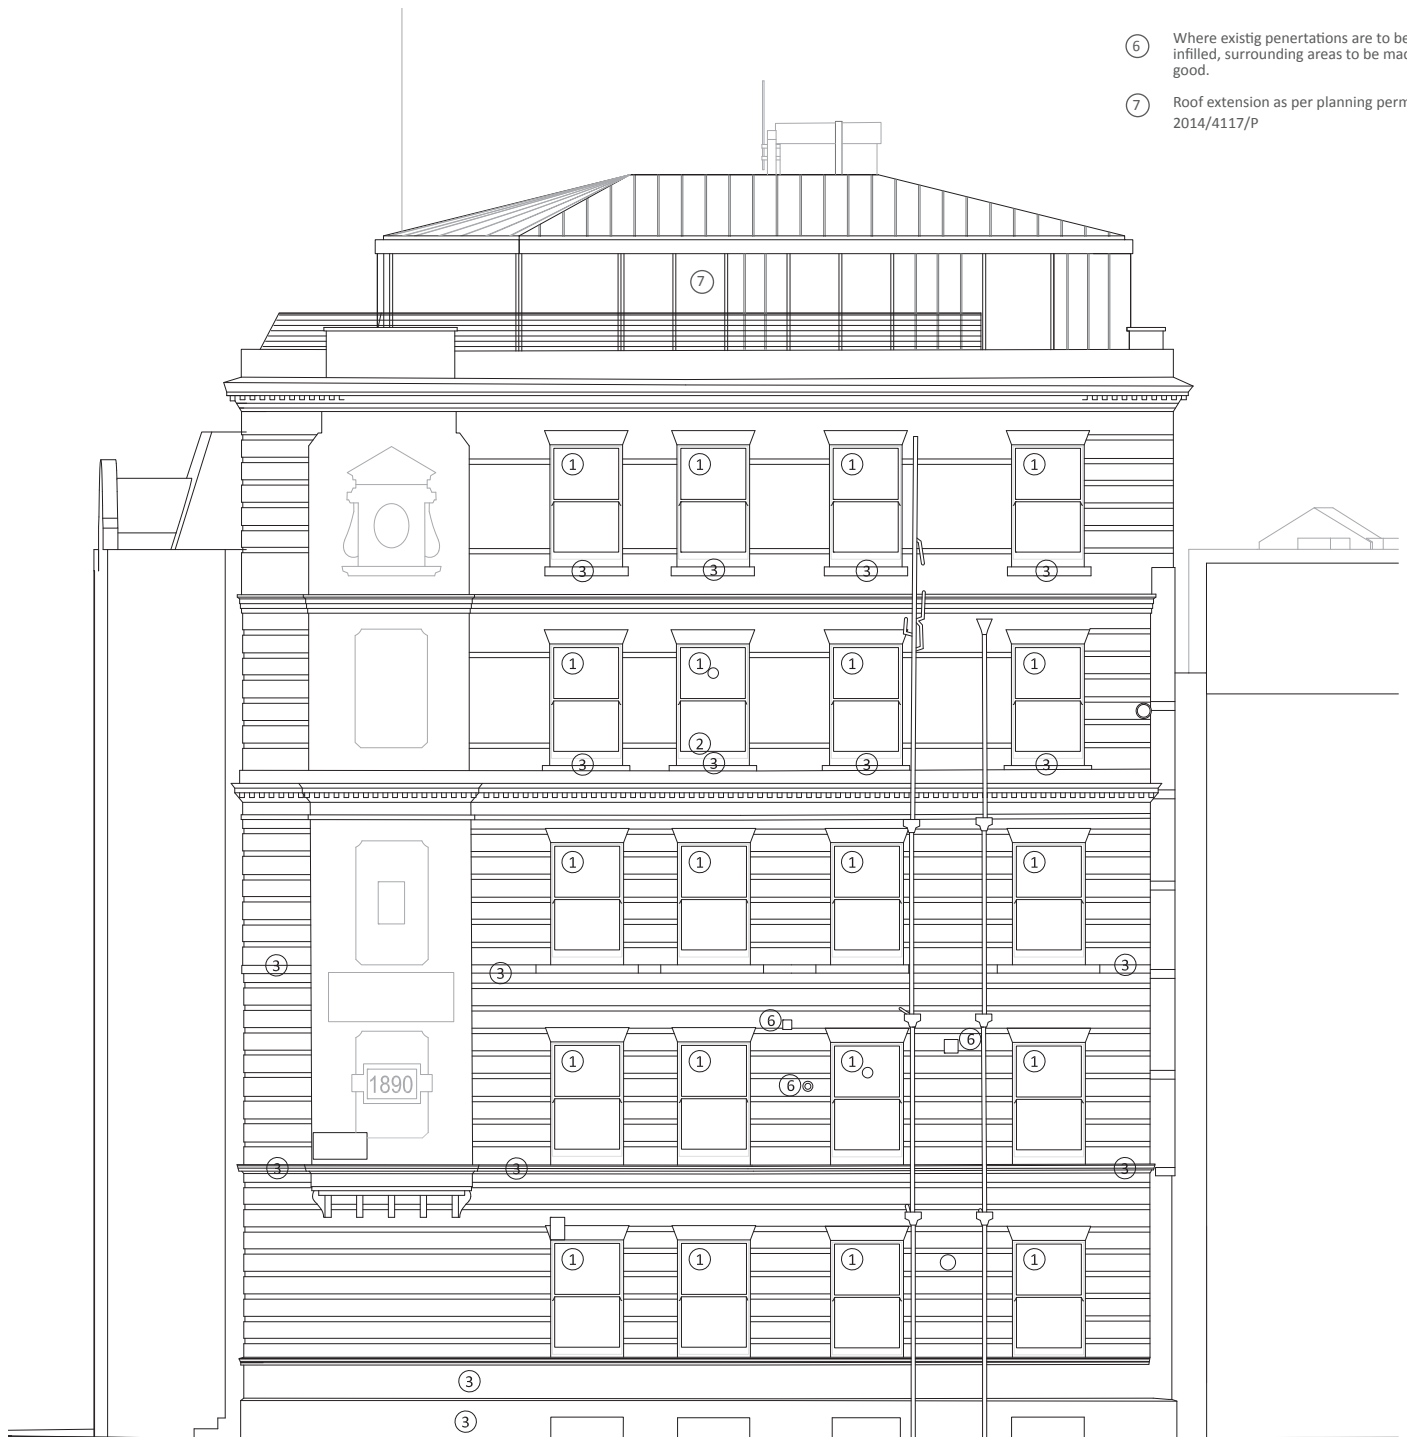
Proposed North West Elevation

- ① New Timber window spec.
- ② Existing cill to be cleaned and reconstructed using specialist concrete repair.
- ③ Existing paintwork to be cleaned , all loose material/ flaky materials to be removed, patch repairs as necessary and primed / undercoated and top coated using appropriate materials.
- ④ Existing glazed bricks to light wells to be cleaned as per spec using water and neutral detergent.
- ⑤ Existing services to be removed where applicable and made good
- ⑥ Where existig penetrations are to be infilled, surrounding areas to be made good.
- ⑦ Roof extension as per planning permisson 2014/4117/P

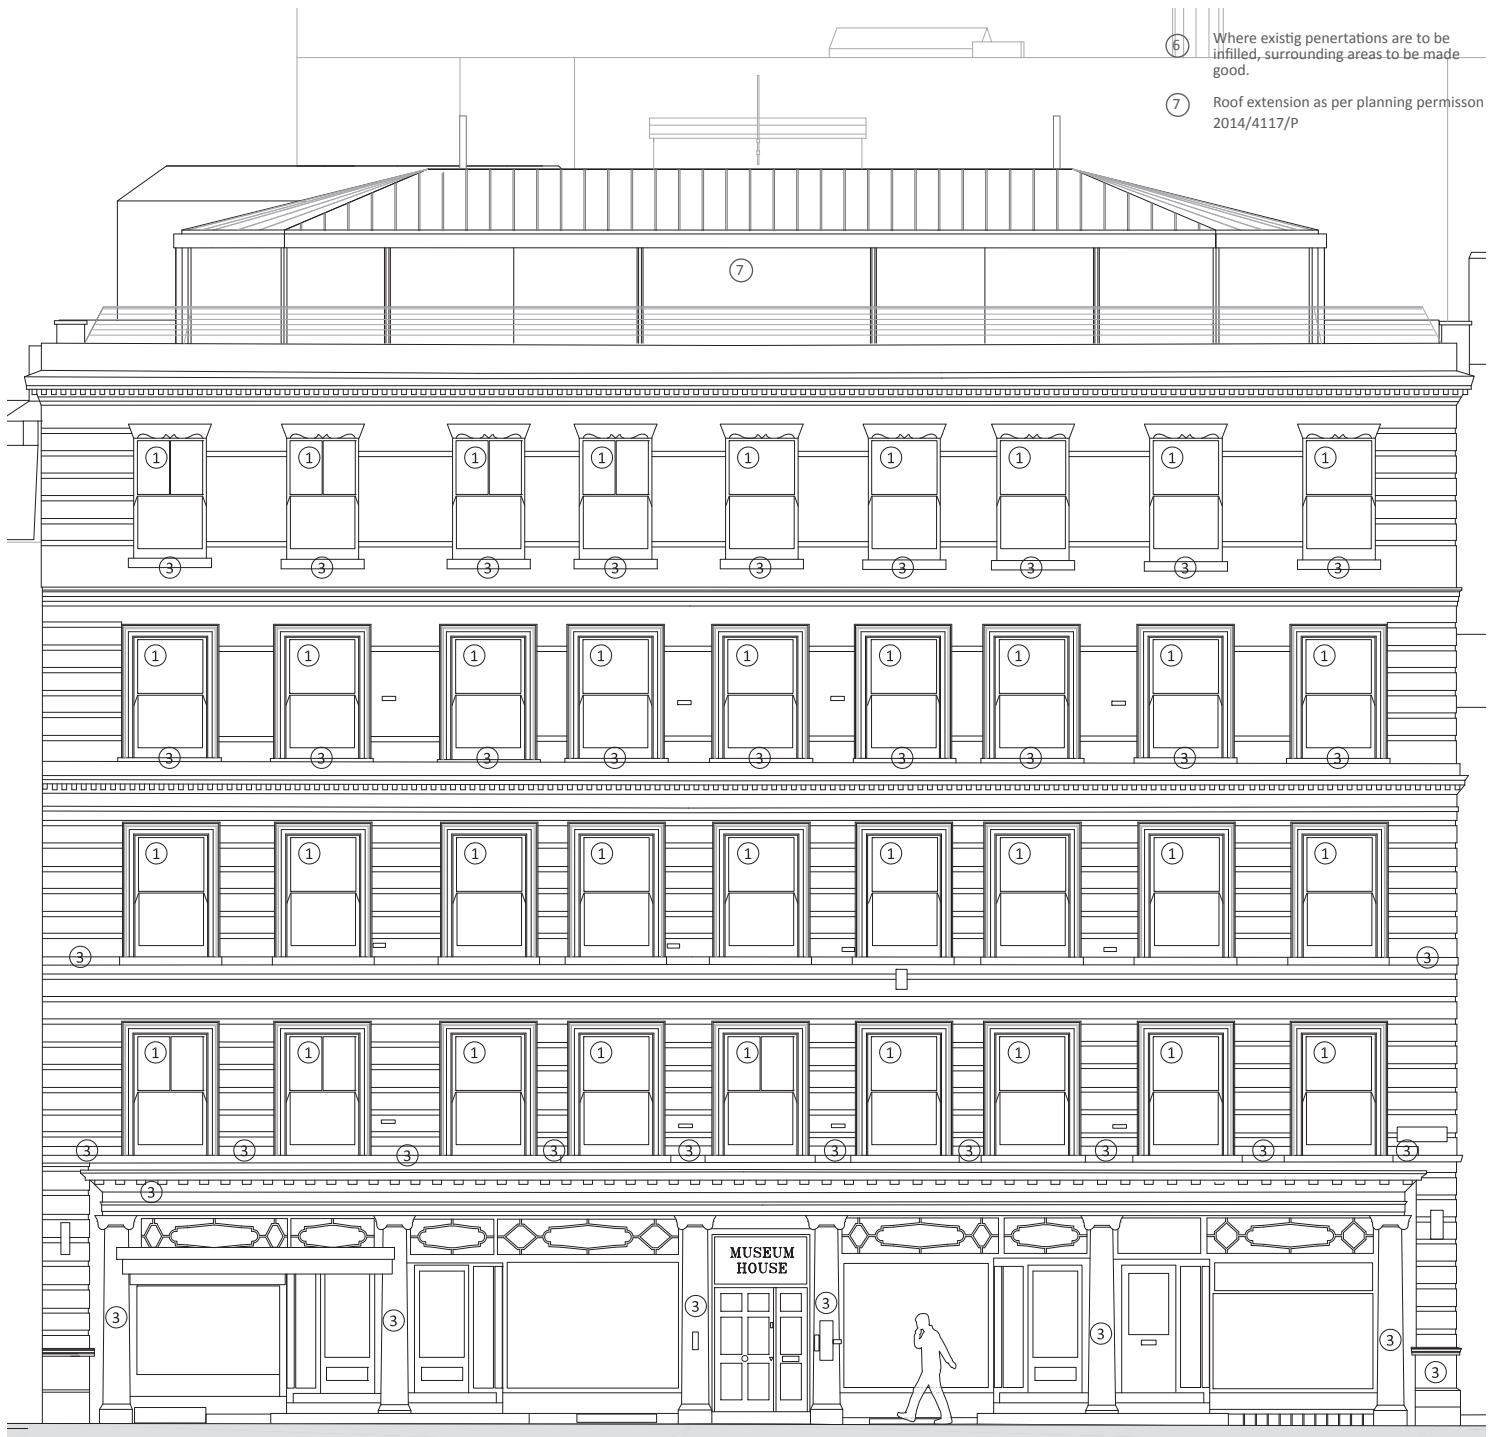
Proposed North East Elevation

- ① New Timber window spec.
- ② Existing cill to be cleaned and reconstructed using specialist concrete repair.
- ③ Existing paintwork to be cleaned , all loose material/ flaky materials to be removed, patch repairs as necessary and primed / undercoated and top coated using appropriate materials.
- ④ Existing glazed bricks to light wells to be cleaned as per spec using water and neutral detergent.
- ⑤ Existing services to be removed where applicable and made good
- ⑥ Where existig penetrations are to be infilled, surrounding areas to be made good.
- ⑦ Roof extension as per planning permisson 2014/4117/P
