Museum House

Discharge of Condition 4
Roof Cladding Sample

Ref 2014/4117/P – 23-26 Museum St, 5th floor roof extension – Condition 4

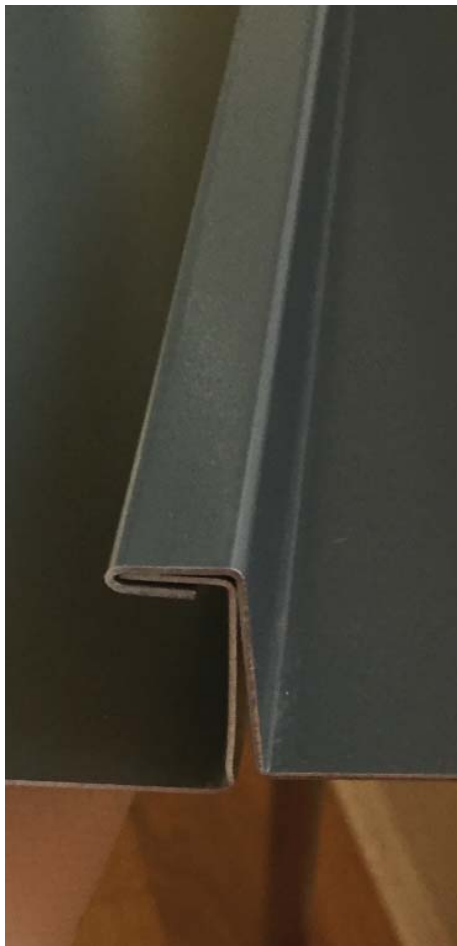
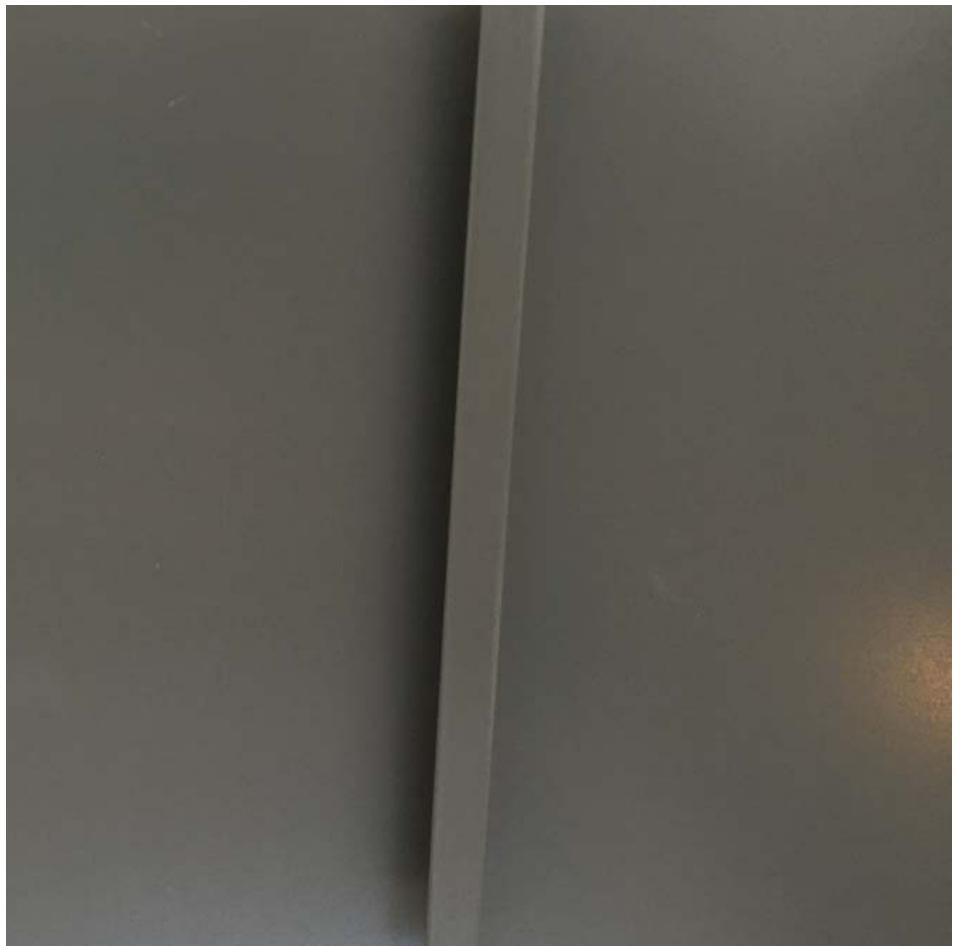
12041-2.1 Sample of the roof cladding

Photographic sample of the cladding system.

- ① Cladding system to be Aluminium powder coated standing seamsheet. Seams approx 450mm apart. Colour to be RAL7012
- ②

The sample can be viewed at ColldoCollins offices in London, or it could be couriered to your offices upon request.
