NO.11 THE GROVE, HIGHGATE N6
DESIGN, ACCESS AND HERITAGE STATEMENT
REV P1
08 AUGUST 2016

This document supports planning application and Listed Building consent for proposed works to No. 11 The Grove, Highgate London N6.

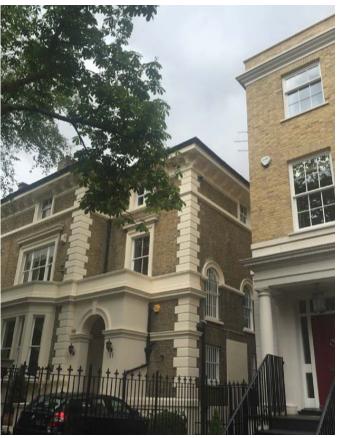
Fig. 21_ New rooflight not visible from street

The application also proposes to put a new rooflight over the centre of the existing staircase to bring more light down to ground floor level and in to the stair well generally.

The rooflight would be flush with existing roofline.
