THE GEORGIAN GROUP  
6, FITZROY SQUARE W1T 5DX

LISTED BUILDING APPLICATION  
FOR  
A FIREPLACE IN THE ENTRANCE HALL

DESIGN AND ACCESS STATEMENT  
AND HERITAGE STATEMENT

AUGUST 2016

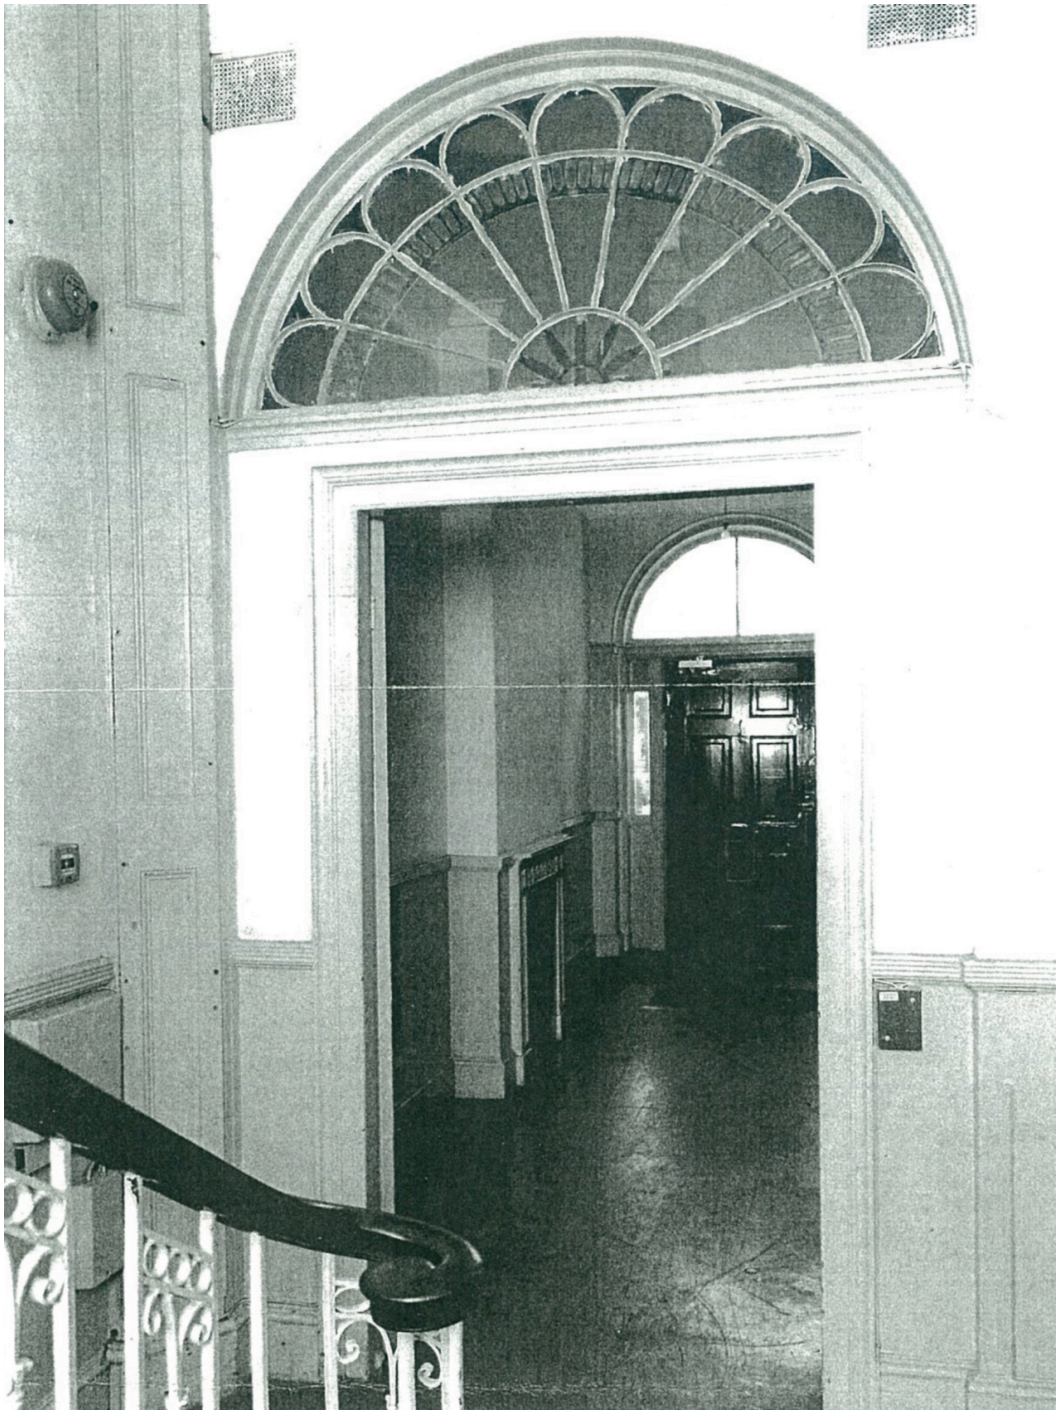
Appendix 1. NMR Photograph

There are no photographs of the lost entrance hall chimneypiece from N°6. The best evidence is a NMR photograph (appendix 1) showing one elsewhere in the square in an unidentified house. The photograph shows a projecting chimneybreast, which clearly N° 6 did not have. However the stair balustrade is identical to N° 6 and the inner fanlight matches other external fanlights in the Square.

- the jambs have recessed panels,
- the lintel a series of lozenges,
- the base block aligns with the unmoulded part of the skirting.

As drawing 6231/2 shows the jambs and base blocks then fall exactly where they should in the paving pattern. The overall height is the same as that shown in the photograph taking the sill of the front door sidelight as a datum.

The new chimneypiece will be made of fine-grained Portland stone. The material of the chimneypiece shown in the photograph cannot be known but it is probably not timber. If it were it would perhaps be the same colour as the painted dado and it is

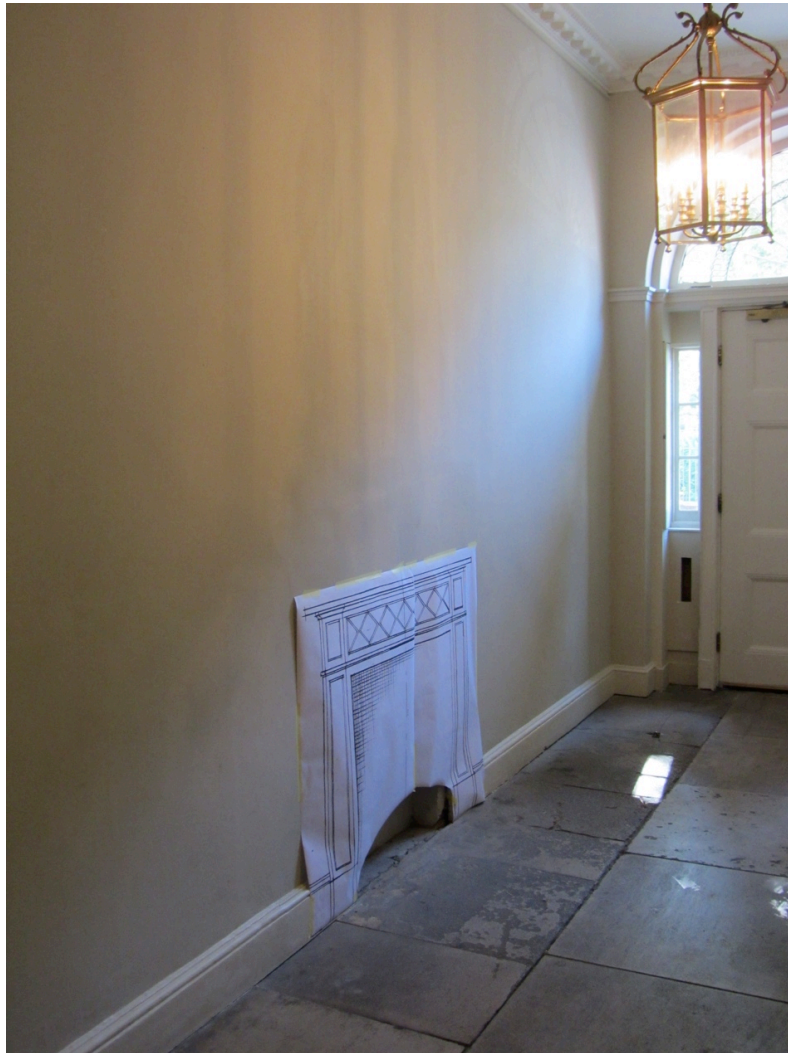
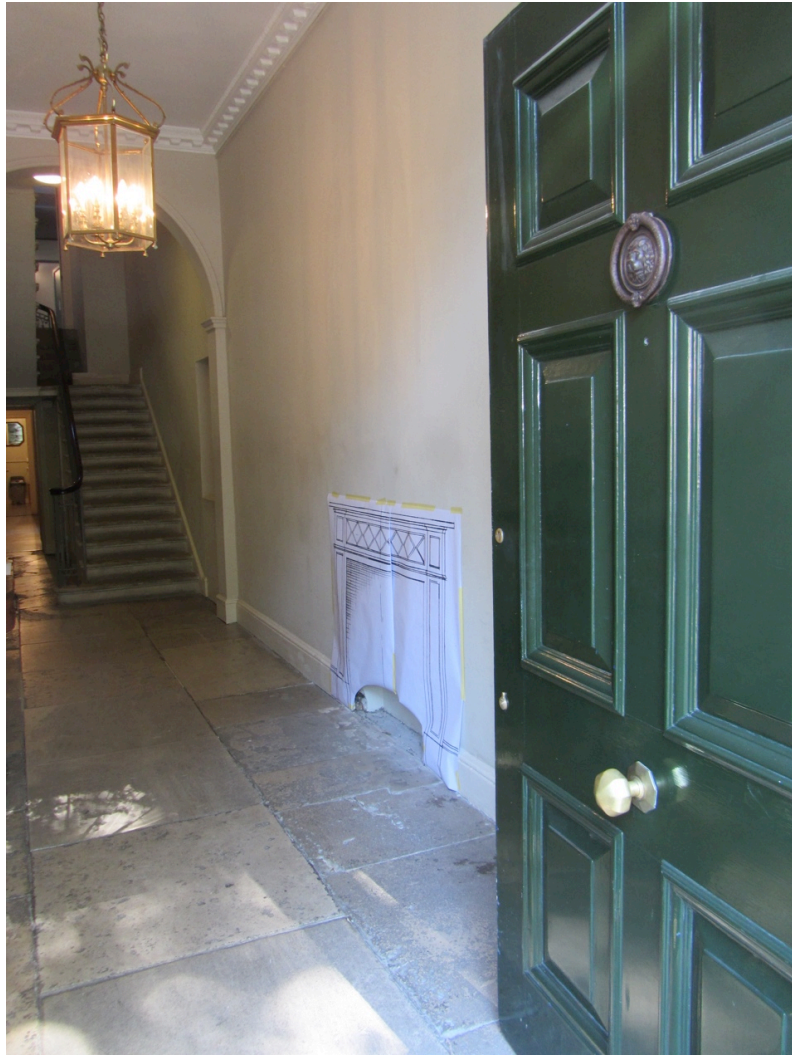
Appendix 2. Photographs of the Location

As noted in 4 above, the wall between the entrance hall and ground floor front room has been re-instated. In spite of that it appears that most of the Portland stone paving slabs in the entrance hall are original (or replacements of identical size). The paving is characterised by a uniform rank of 36" square slabs running down the centre and set out from the centre of the hall. Smaller slabs make up the space to the wall on either side.

On the wall surface it is possible to make out later re-plastering in the position of the original fireplace. However what may be taken as the ghost of the mantel shelf is far too high for any chimneypiece let alone one in an entrance hall. It may be the result of a new lintel inserted above the hearth opening.

The existing segmental headed recess in the wall is an approximation, a sign that there should be a hearth there, made when the Georgians first moved in.

In the skirting there are cuts and additions showing that the run of skirting was originally interrupted by a chimneypiece.
