Generic Roof Repair Details PROJECT: Project No:11581 Kidderpore Avenue SCALE: A1@ As Shown DATE: July'16 DRAWN: DA CHK'D: TP DRG NO. REV. 9100-DRG-00YY-DE011 -

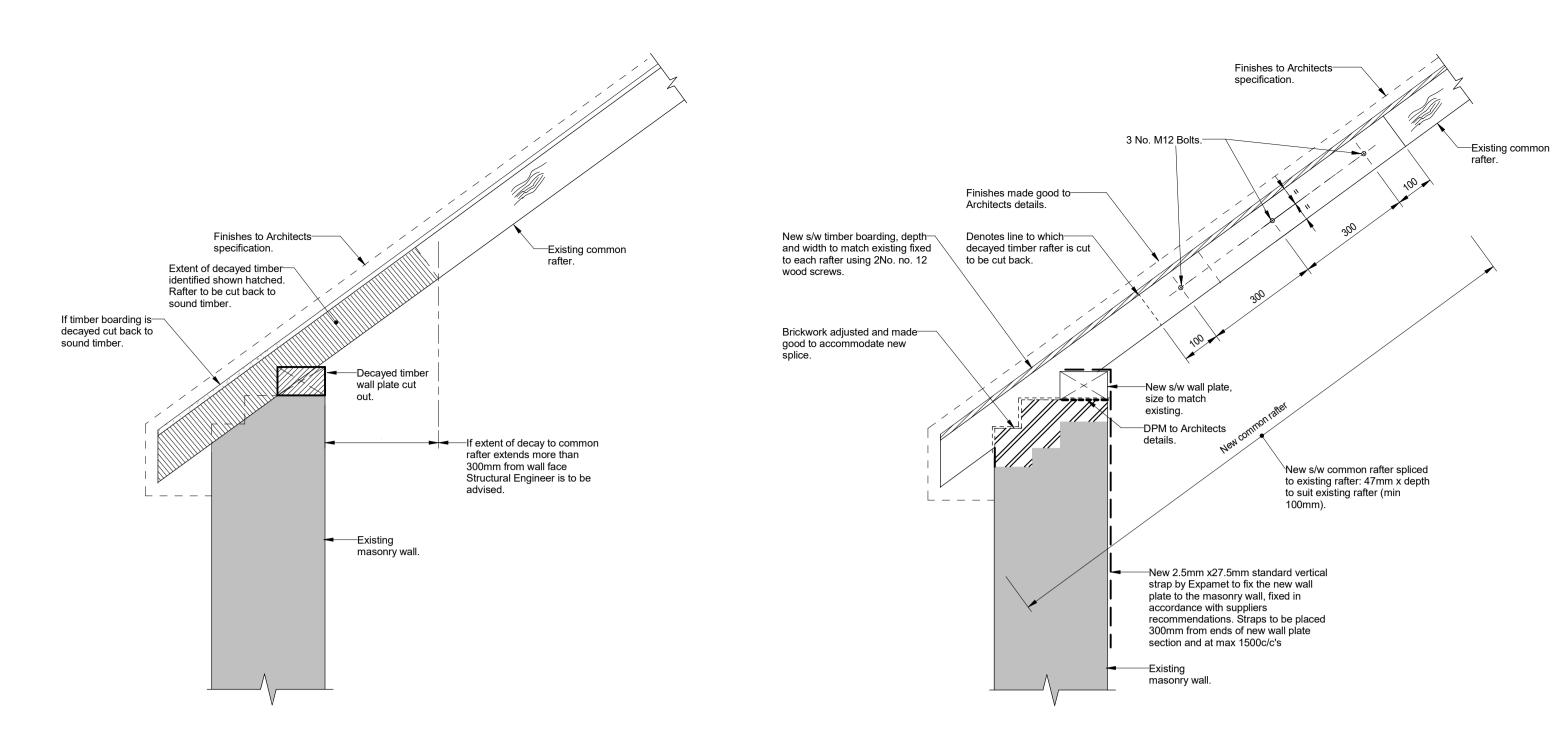
Detail 1: Decayed Common Rafter and Wall Plate <u>Existing Detail</u>

Detail 2: Decayed Common Rafter and Wall Plate Proposed Splice Detail scale 1:10

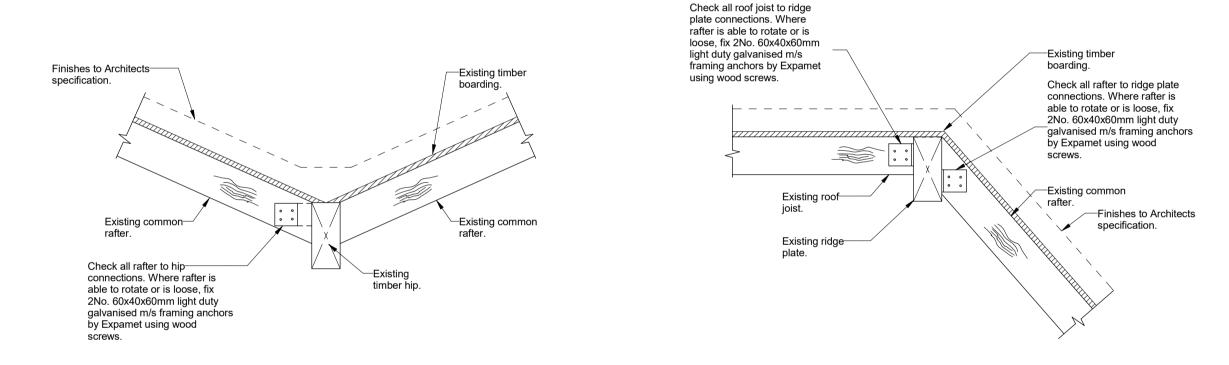
Detail 5: Rafter to Hip Connection Detail

<u>Detail 6: Rafter/Roof Joist to Ridge Plate Detail</u>

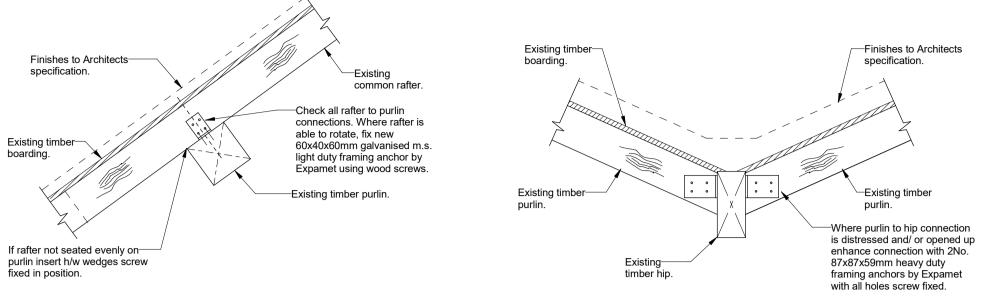
Detail 3: Common Rafter to Purlin Connections

Detail 4: Purlin to Hip Connection Repair
