Design & Access Statement for the
Refurbishment & Extension of 47 Albert St, London, NW1 7LX

August 2016

Introduction

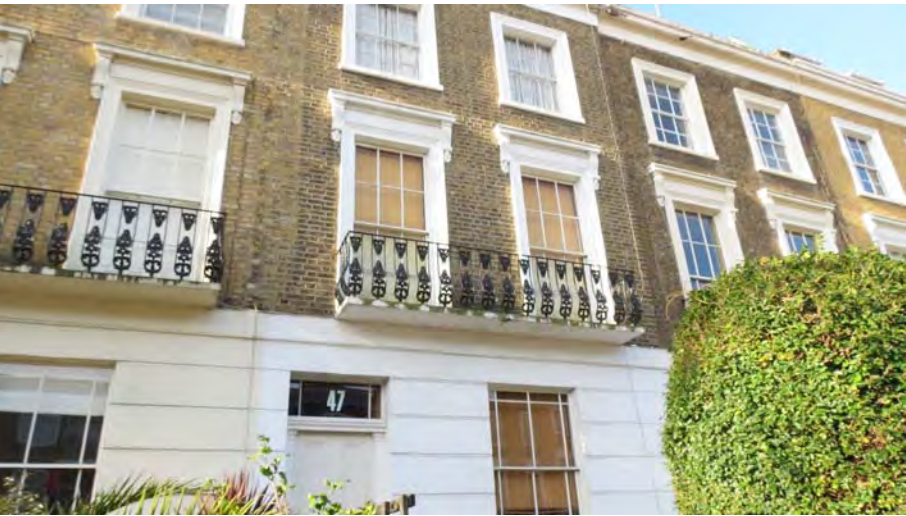
The front facade requires minor refurbishment

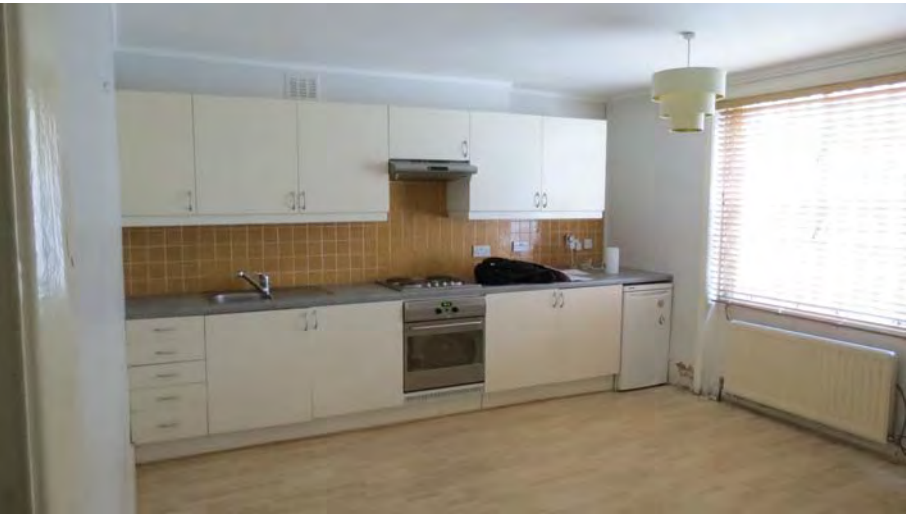
The kitchen/living/dining space in the lower ground flat is undersized and not compartmentalised

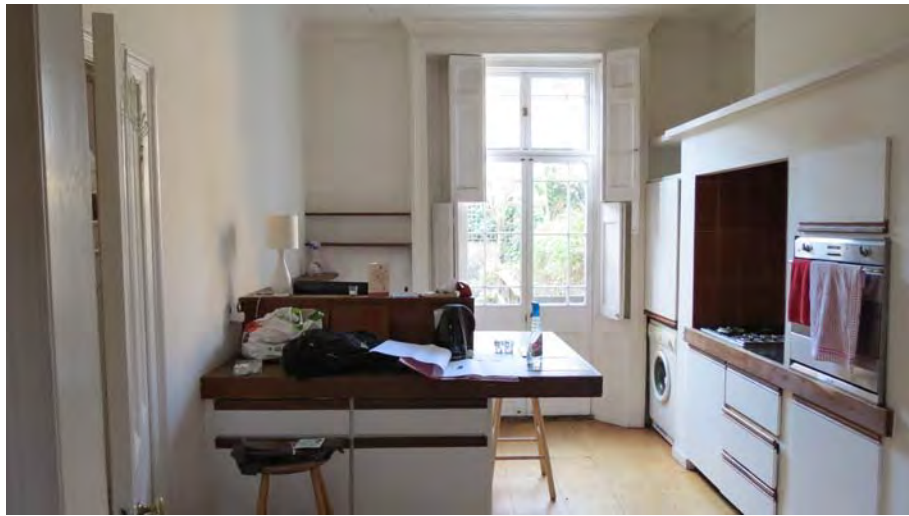
An unsympathetic kitchen in the ground floor was fitted as part of the 1980's alterations

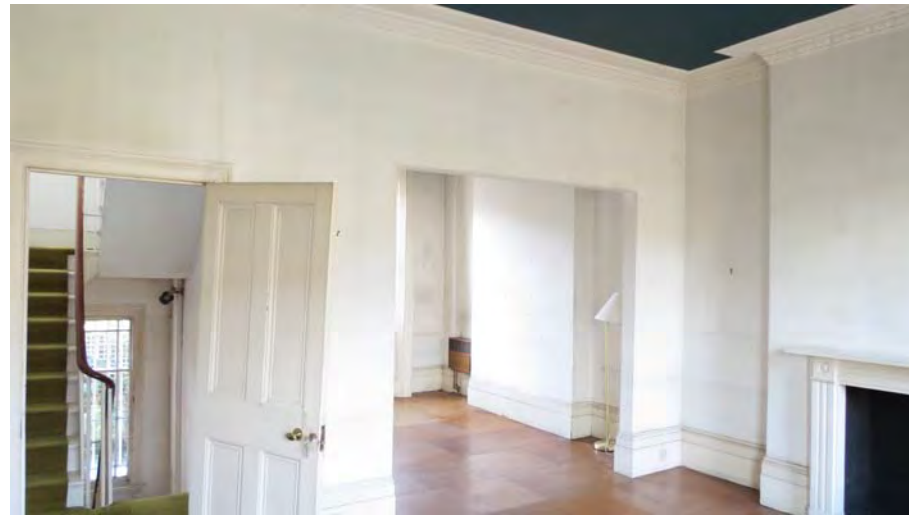
The spine wall on the first floor was opened up in the 1960's and is causing structural issues

Further research has shown that the building was significantly altered in the 1960’s with the removal of internal walls and fireplaces.

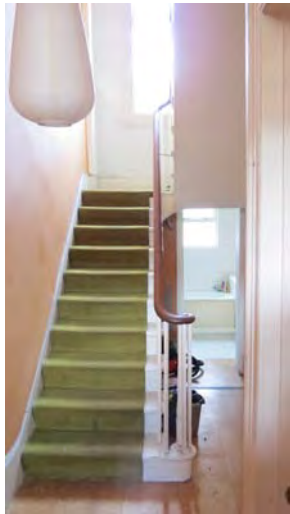
The original staircase needs refurbishment

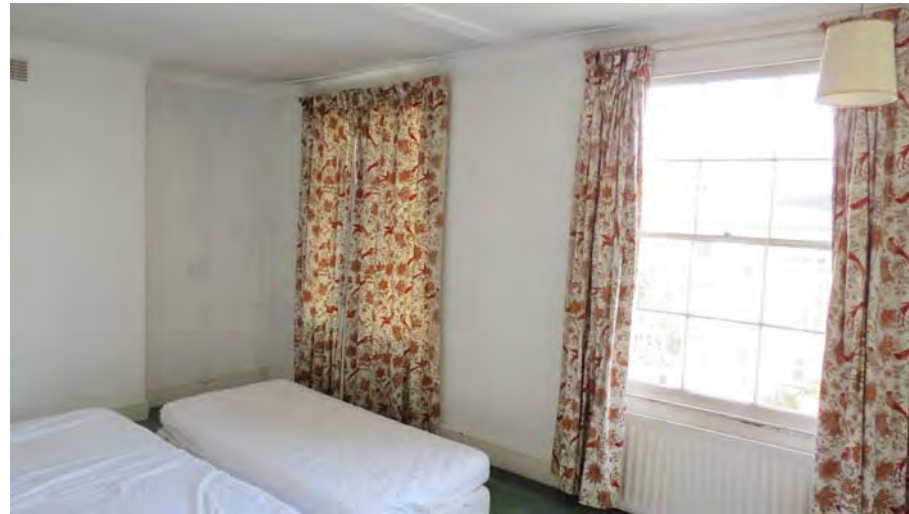
The second floor suffers from water ingress from the roof

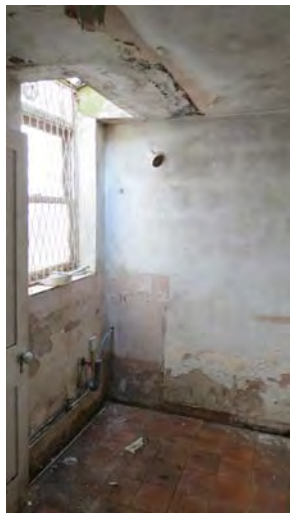
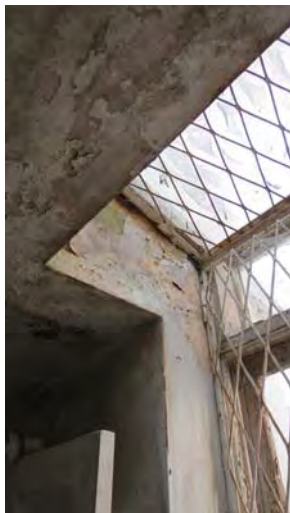
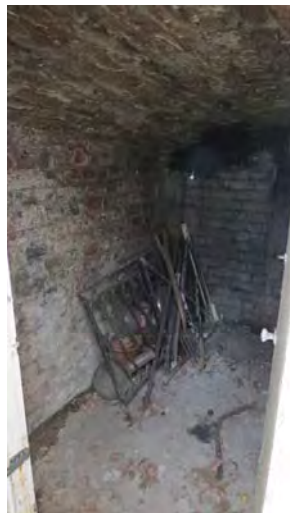
The coal-holes were knocked altered in the 1980's and now suffer from water ingress

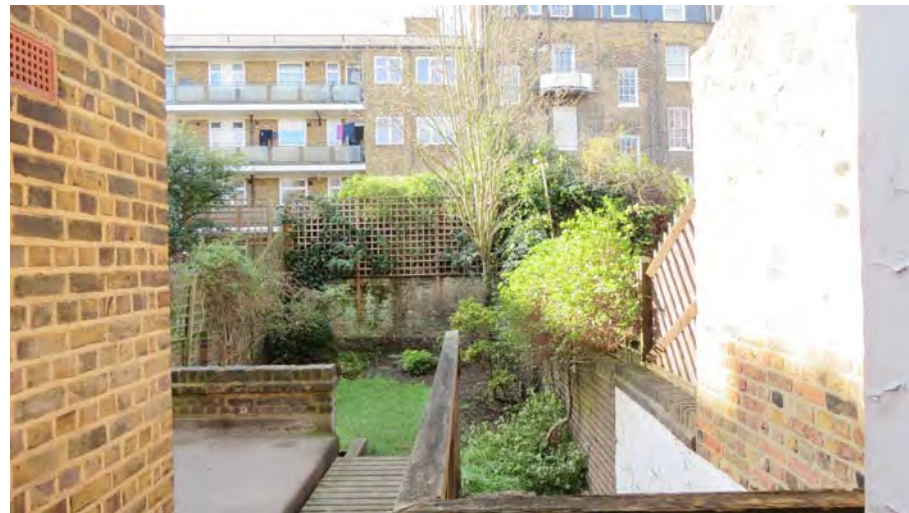
The garden can only be accessed from the house via an unstable timber walkway

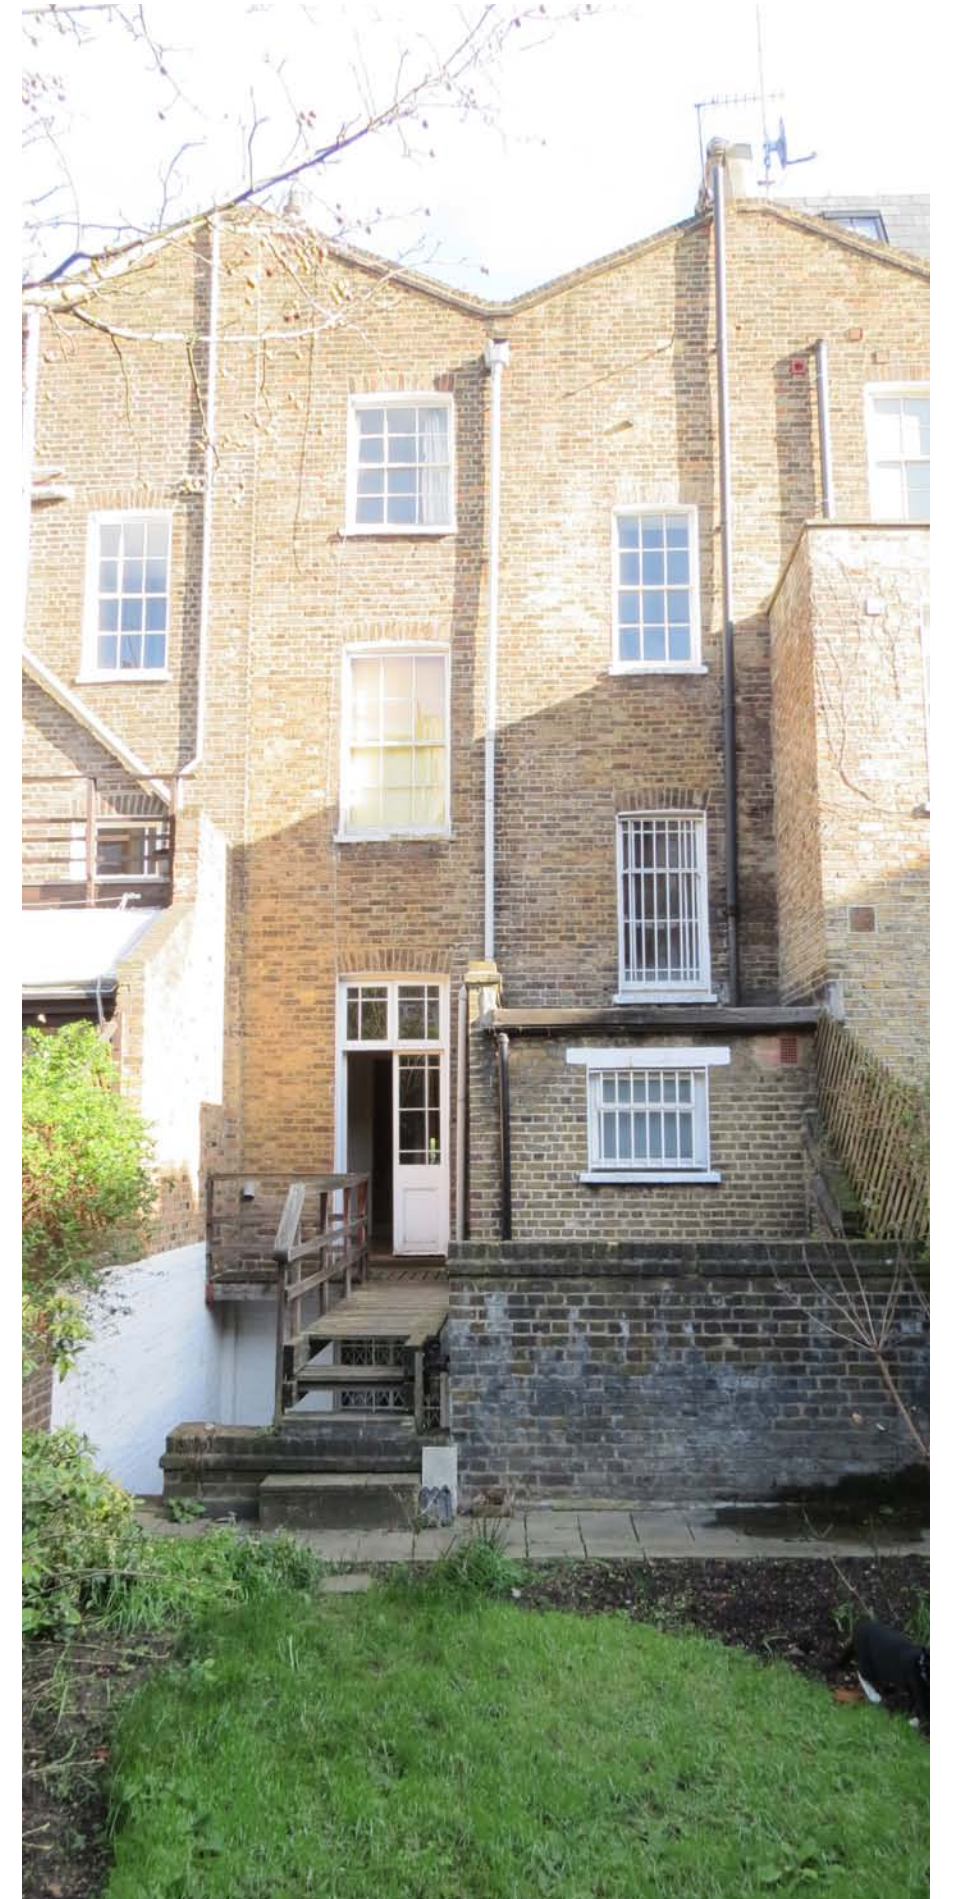
The non-original closet wing does not enhance the original form

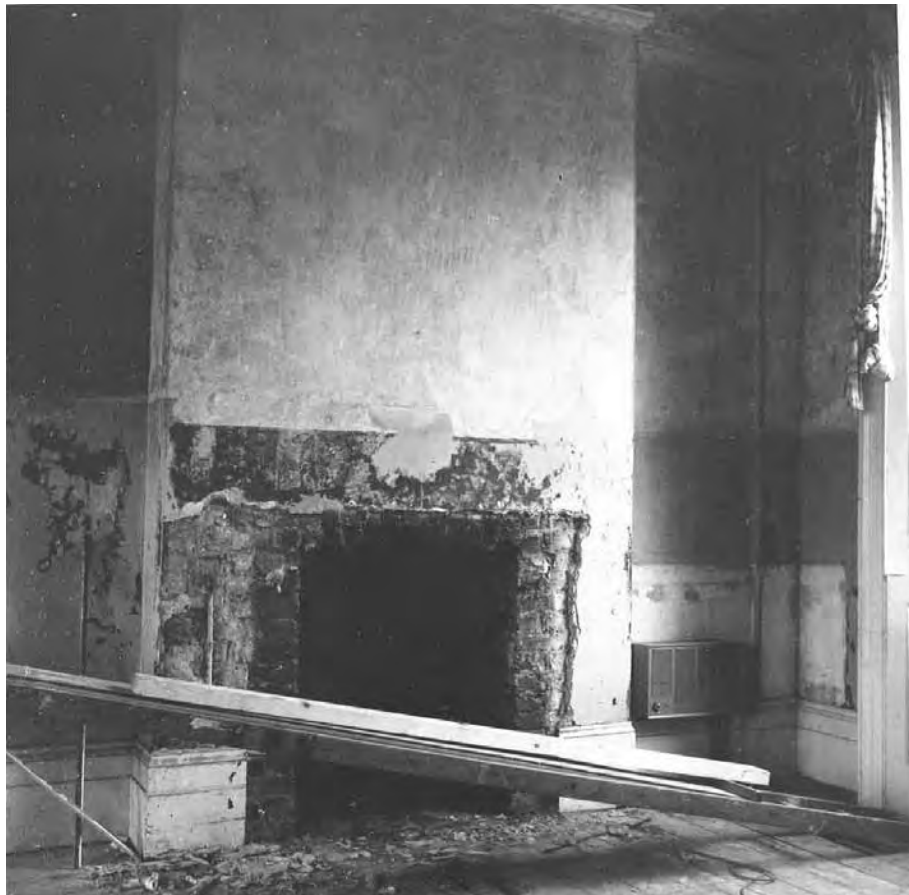
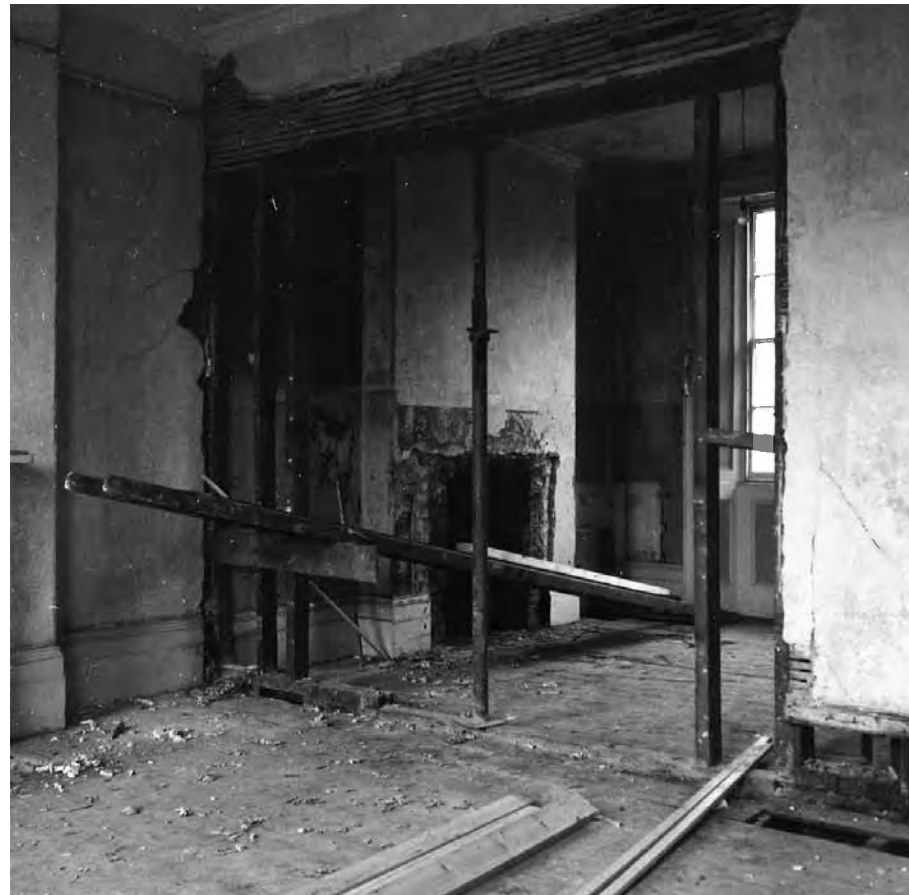
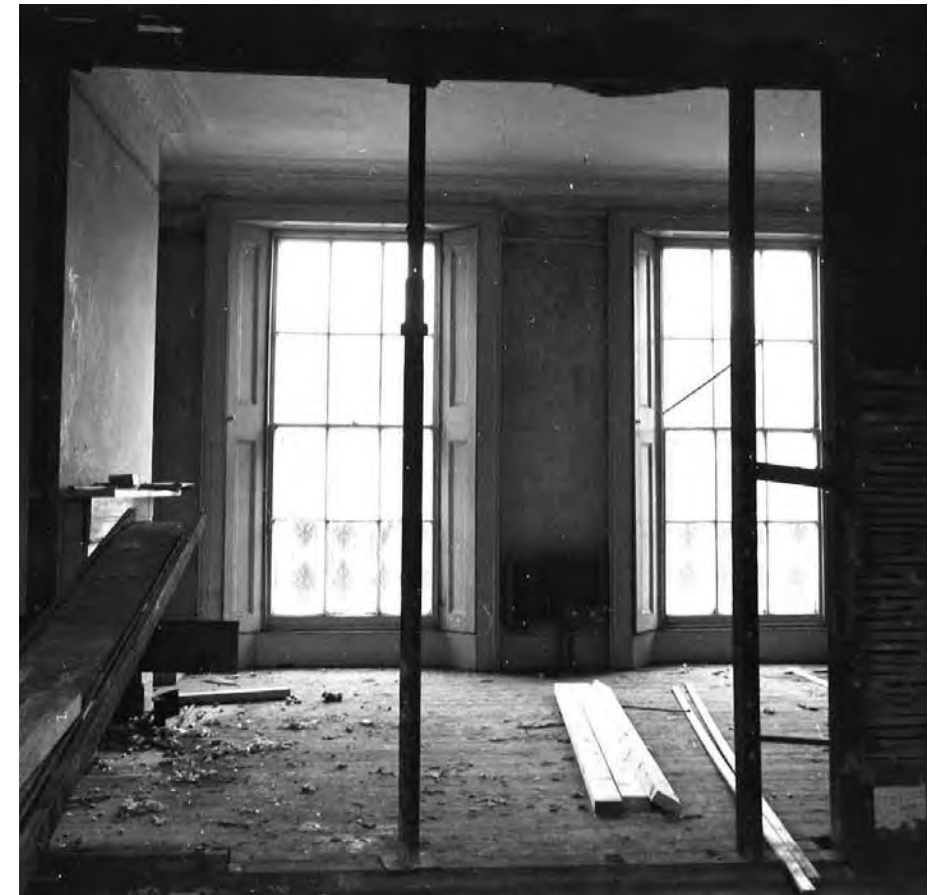
Photographs from the 1960's to show the extent of alterations undertaken to the upper floors
