Window Conditions Survey for the
Refurbishment & Extension of 47 Albert St, London, NW1 7LX

August 2016

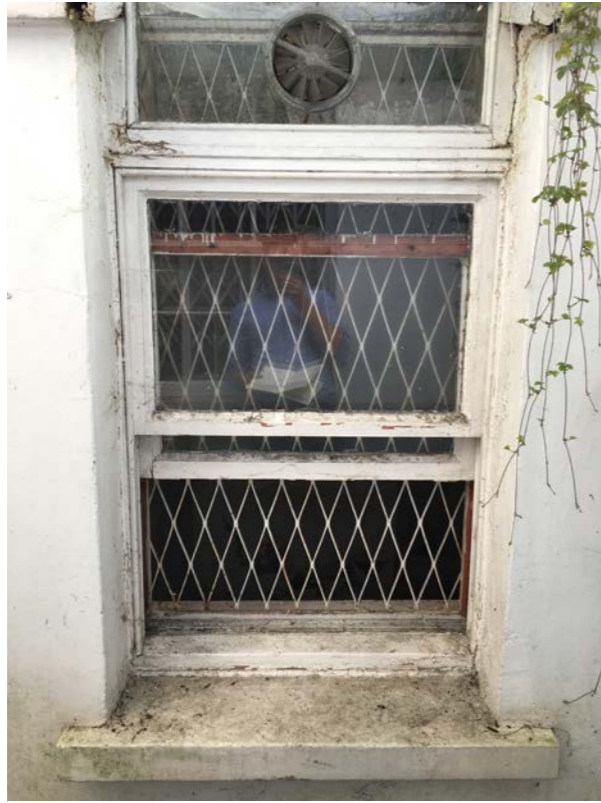
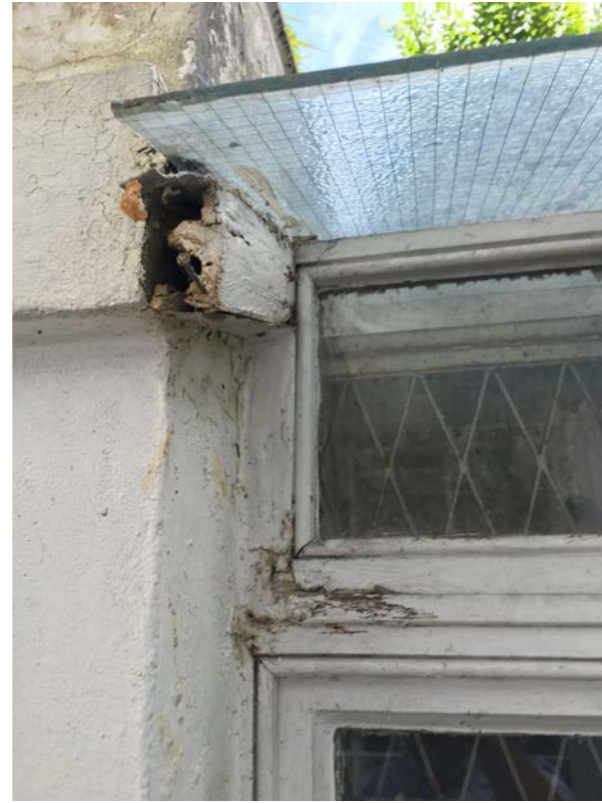
W-01

Non-original timber box sash with transom window and glazed rooflight above

Poor:

- Some rot to framing
- Flaking paint finish
- Overpainted

Remove and replace with wider timber casement window

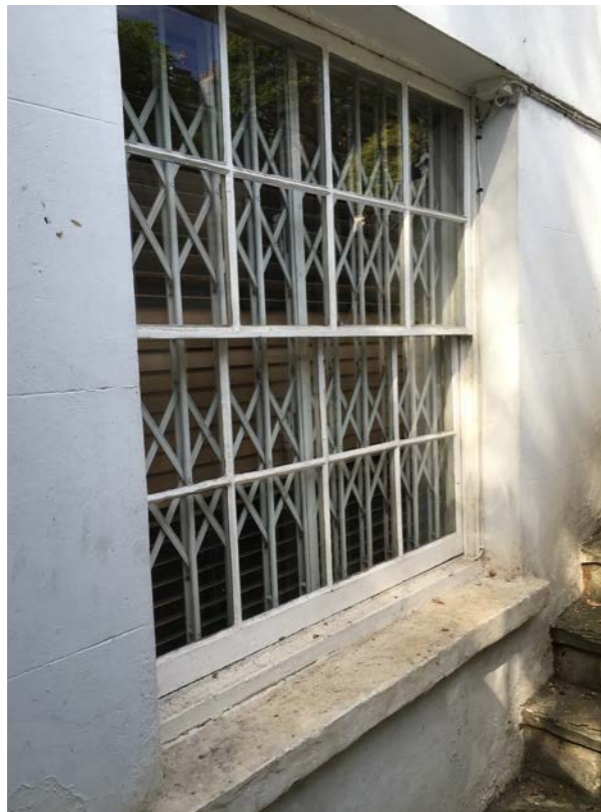
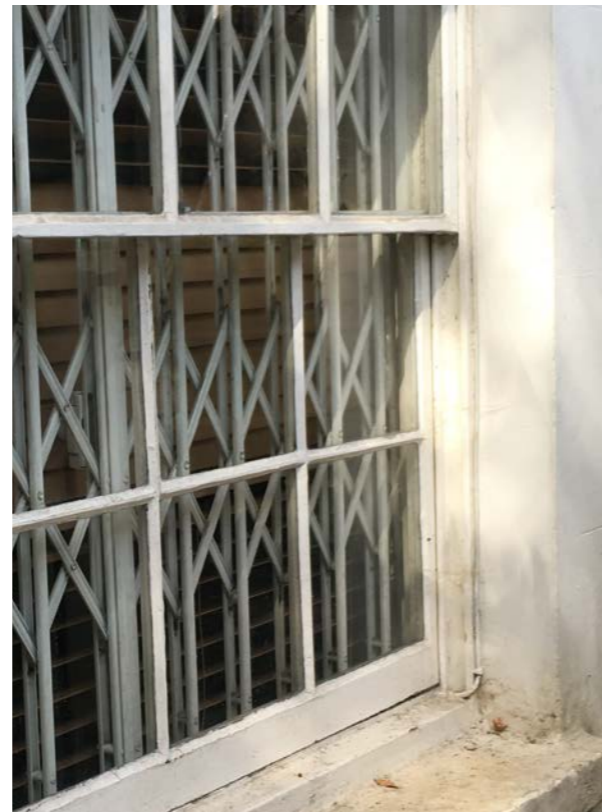
W-02

Original timber box sash

Fair:

- Overpainted
- 1 no. cracked pane

Refurbish, add locks and remove internal shutter

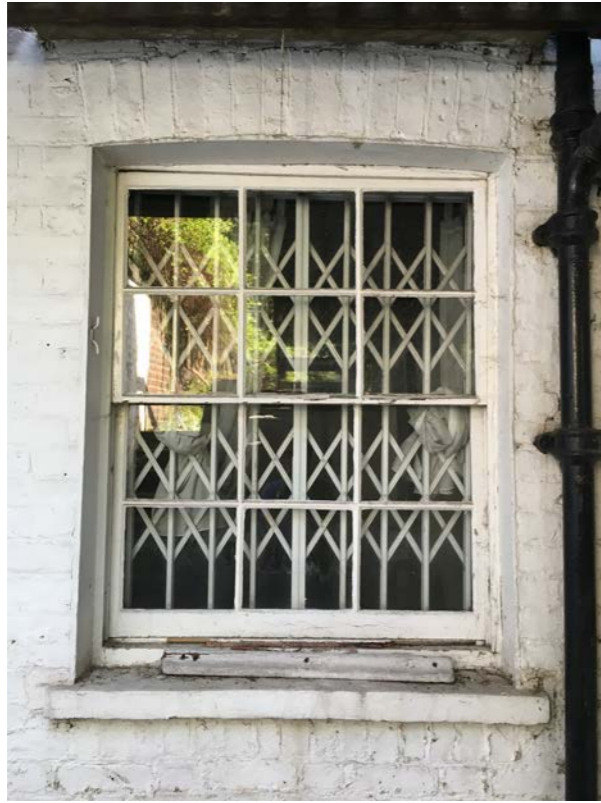
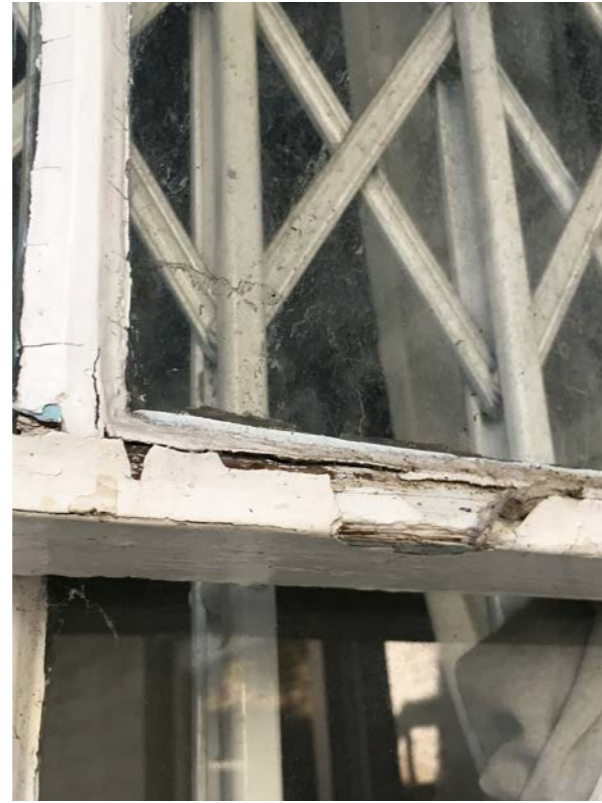
W-03

Original timber box sash

Poor:

- Some rot to framing
- Flaking paint finish
- Overpainted

Remove window and lower sill to form opening

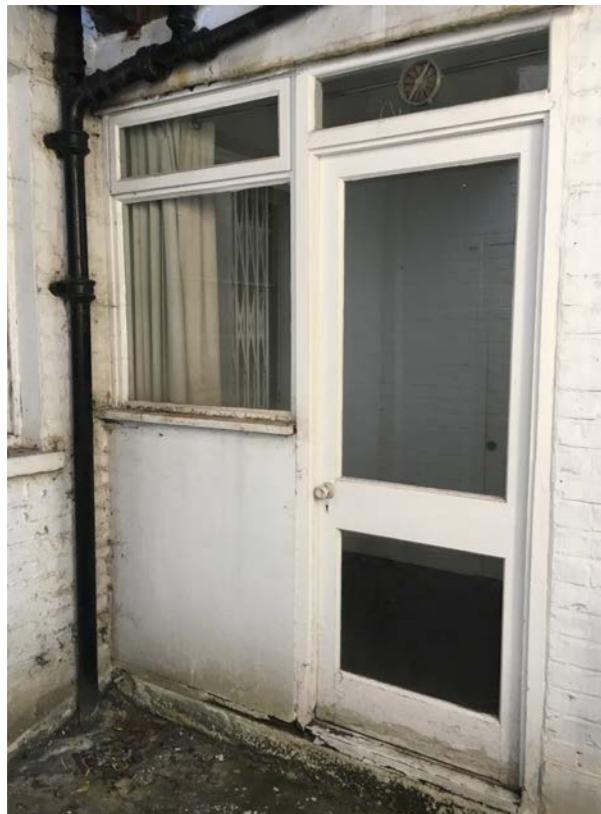
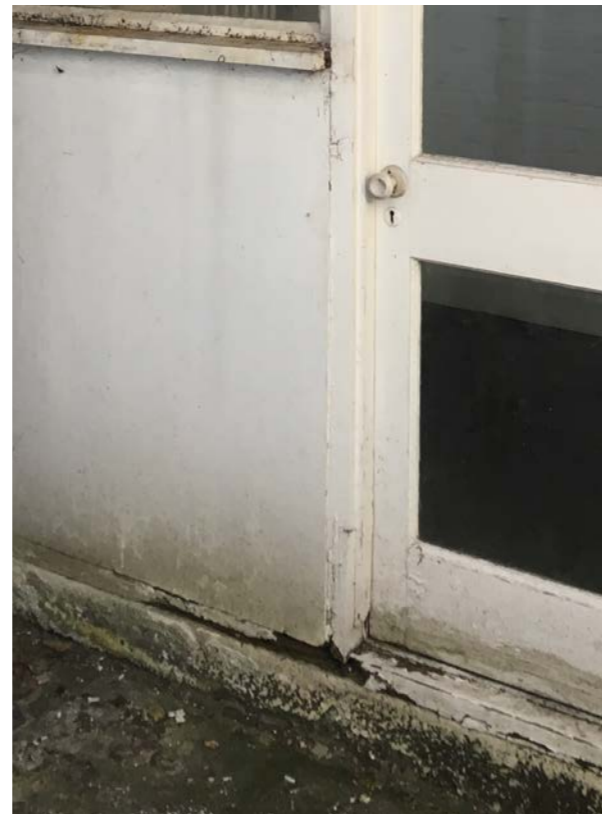
W-04

Non original glass/timber door with transom window and fixed side panel with top hung section

Fair:

- Rotten sill
- Flaking paint finish

Remove as part of closet wing demolition

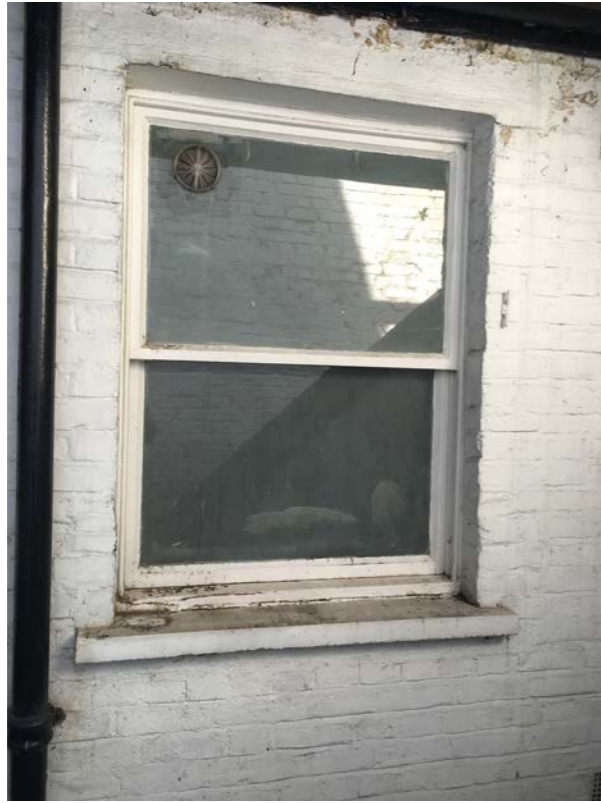
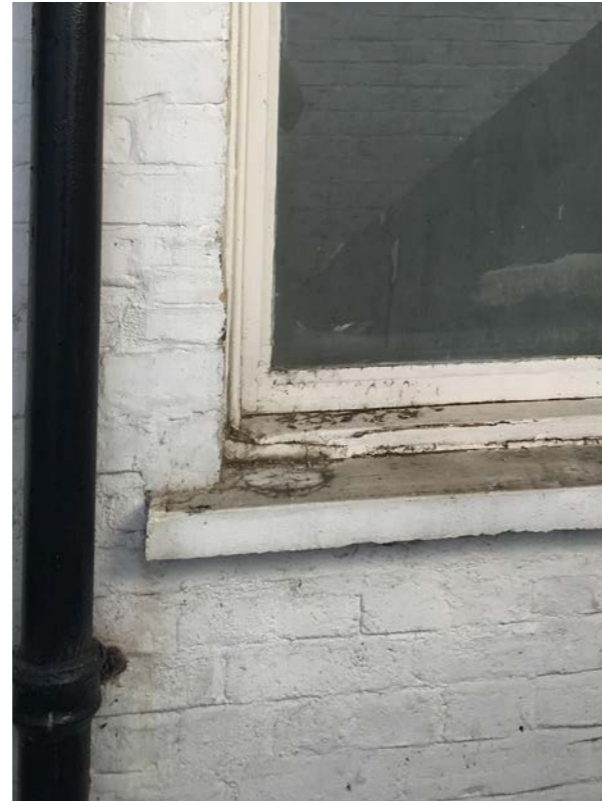
W-05

Non-original timber sprung sash

Fair:
- Flaking paint finish
- Rotten sill

Remove as part of closet wing
demolition

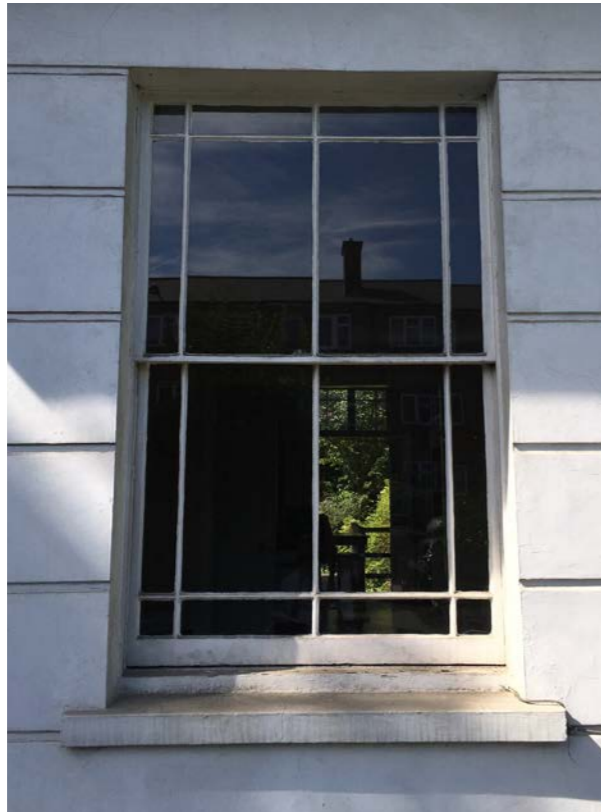
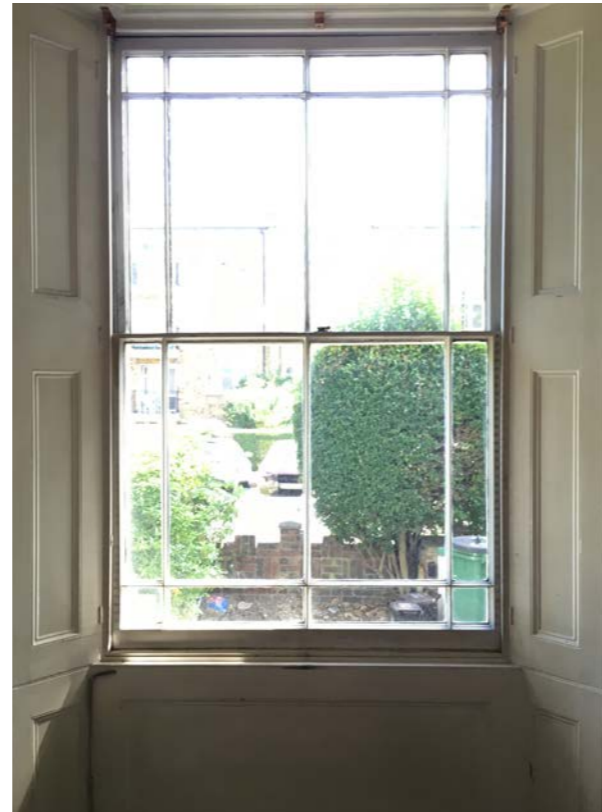
W-06

Original timber box sash

Fair:
- Some overpainting

Refinish

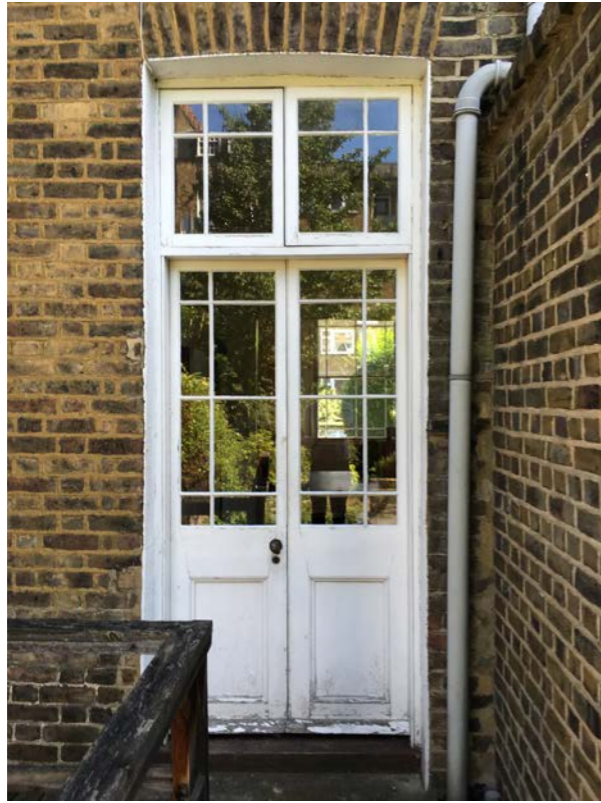
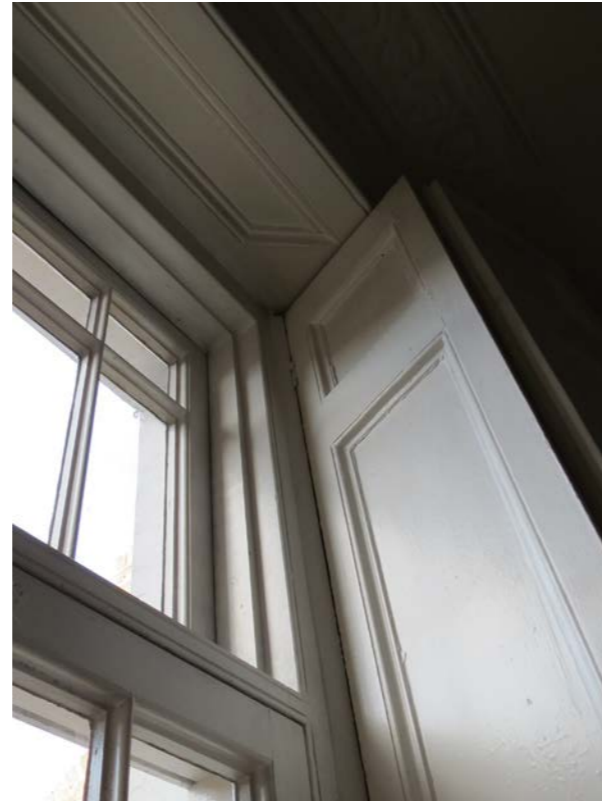
W-07

Non-original timber french doors with openable transom window

Fair:
- Rotten sill
- Flaking paint finish

Remove door leafs, transom window and bar. Retain and refurbish frame, internal shutters etc.

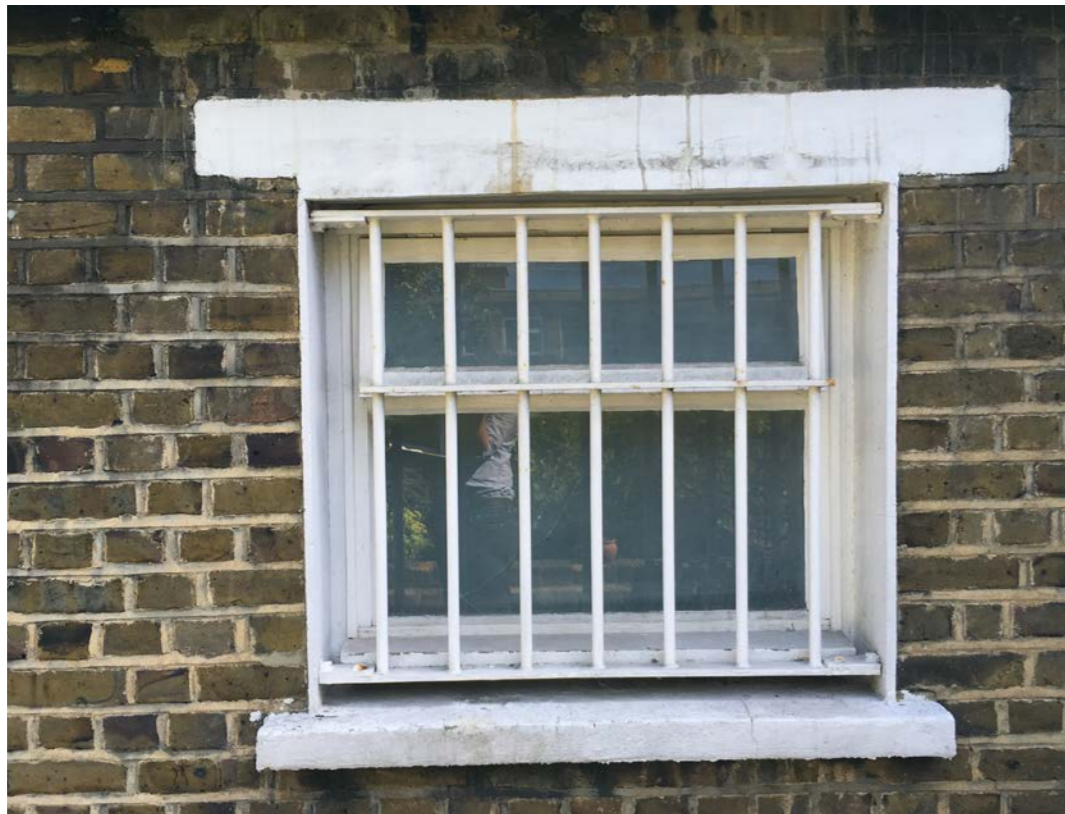
W-08

Non-original fixed panel with top hung section above

Fair:
- Cracked pane

Remove as part of closet wing demolition

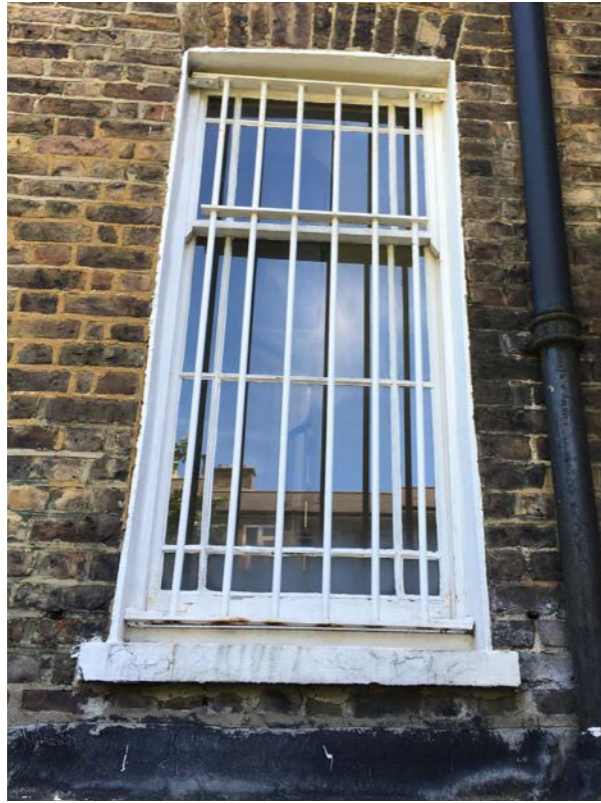
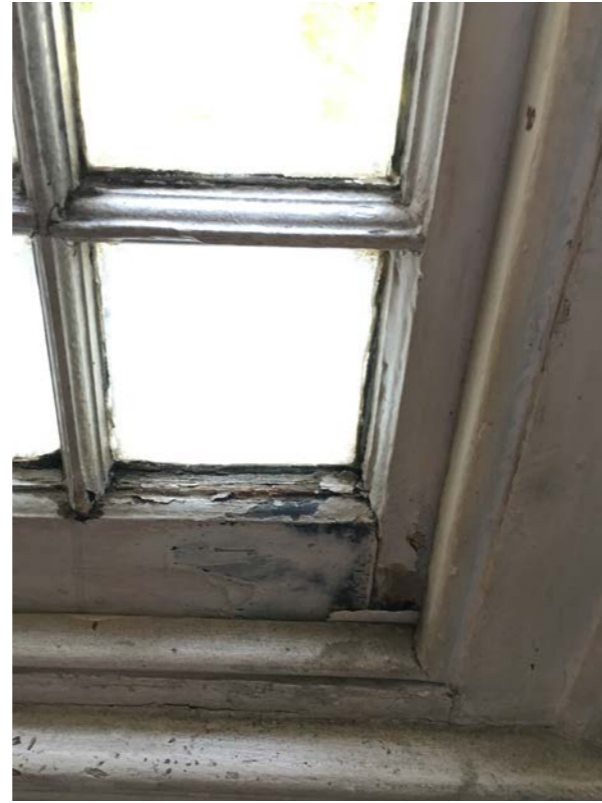
W-09

Original timber box sash

Poor:

- Painted shut
- Overpainted
- Flaking paint finish
- Some rot to framing

Remove external bars and refurbish or replace like-for-like

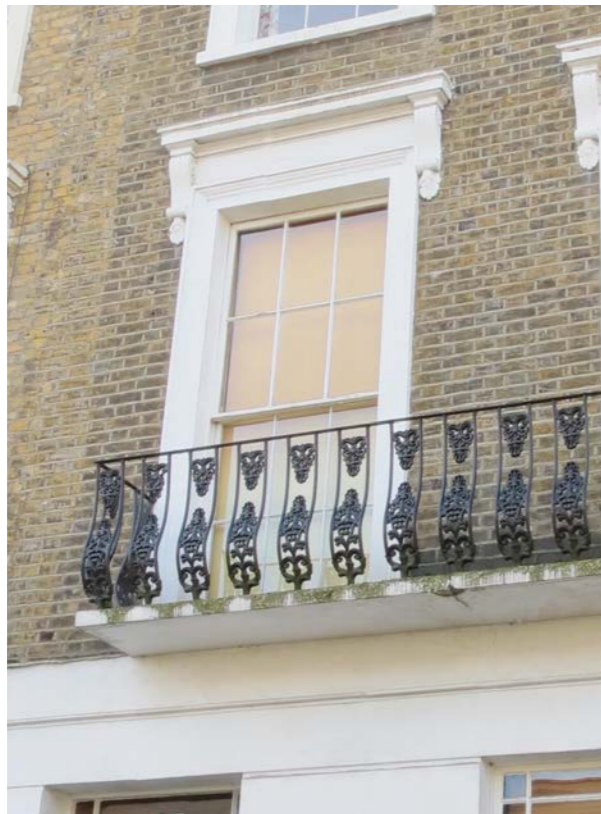
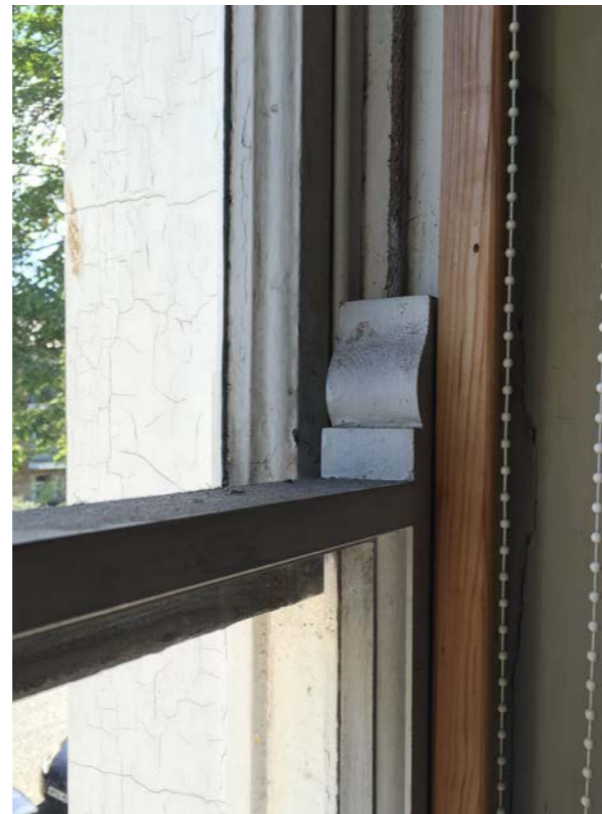
W-10

Original timber box sash frame and top sash, non-original bottom sash and beading

Fair:

- Top sash fixed shut
- Some rot to framing
- Cracked pane
- Overpainted
- Rotten sill

Refurbish or replace like-for-like

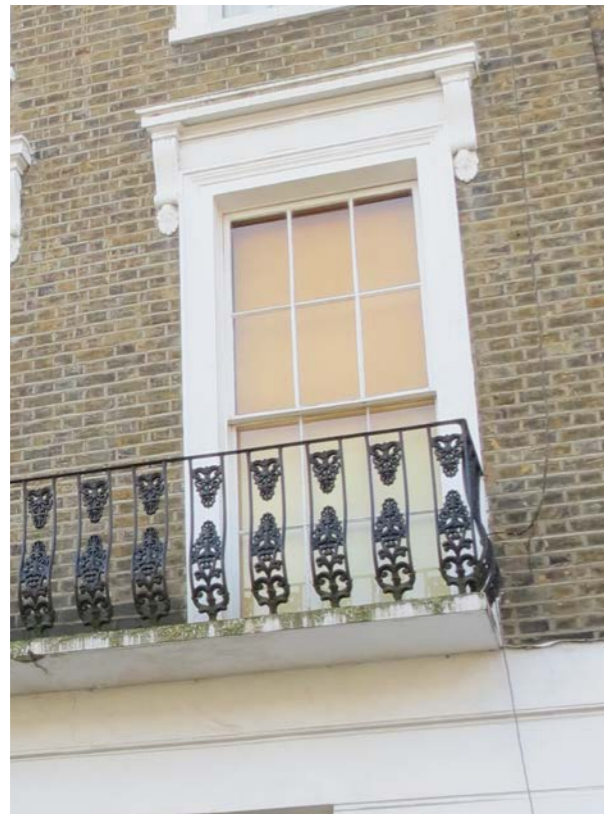
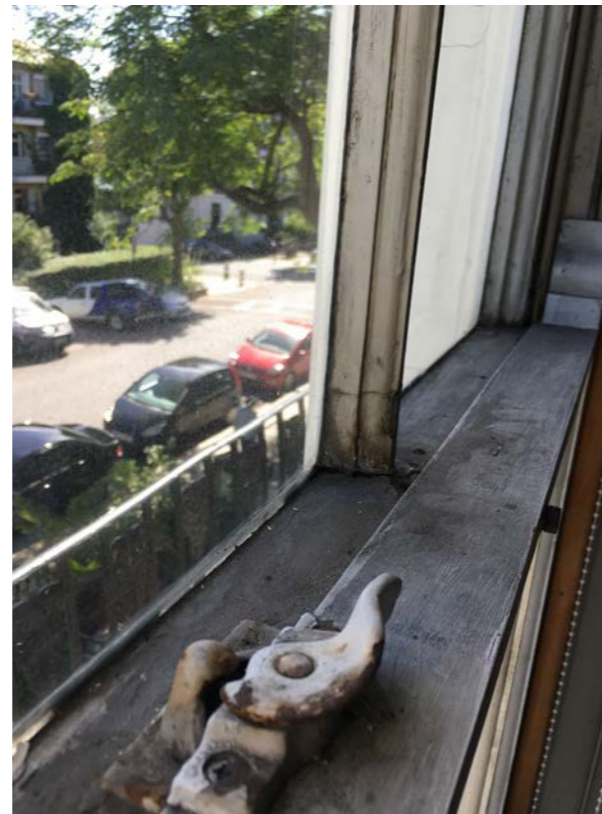
W-11

Original timber box frame and top sash, non-original bottom sash and beading

Fair:

- Top sash fixed shut
- Some rot to framing
- Cracked pane
- Overpainted
- Rotten sill

Refurbish or replace like-for-like

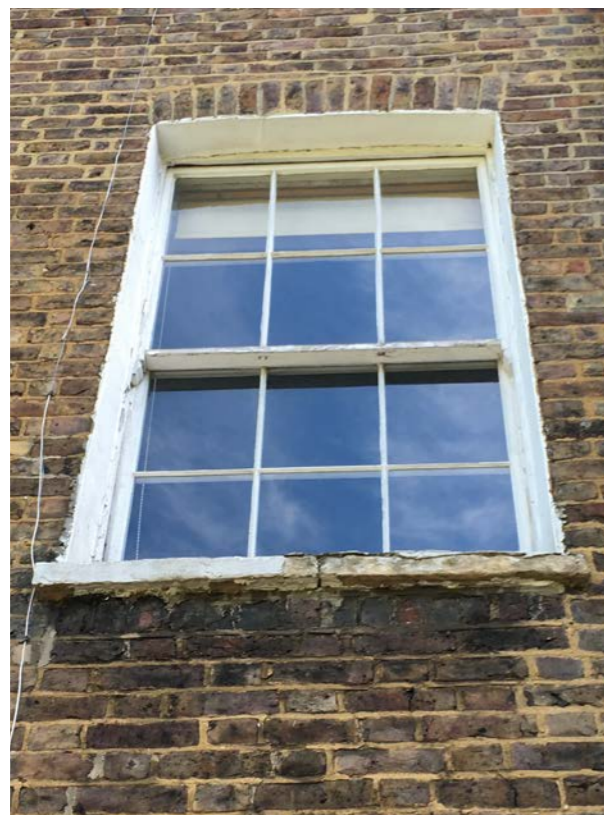
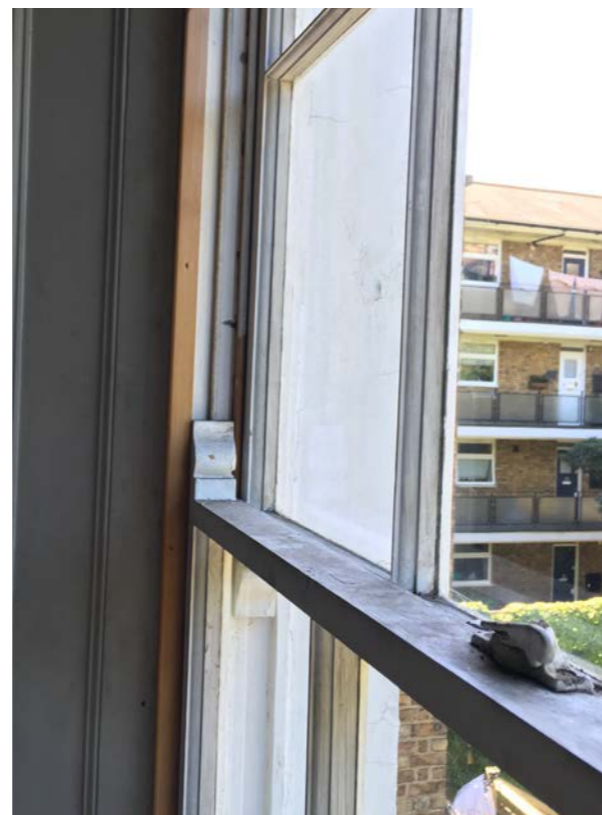
W-12

Non-original timber box sash

Fair:

- Flaking paint finish
- Broken sill

Refinish, repair sill

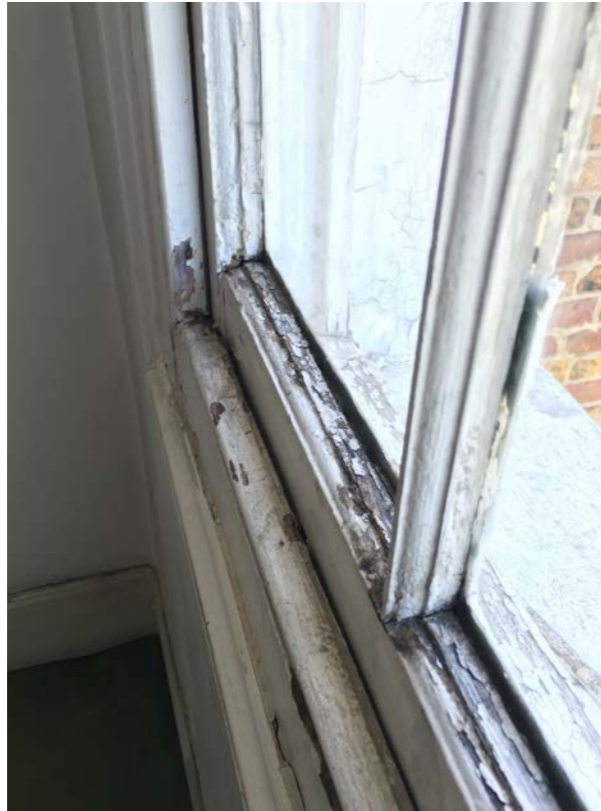
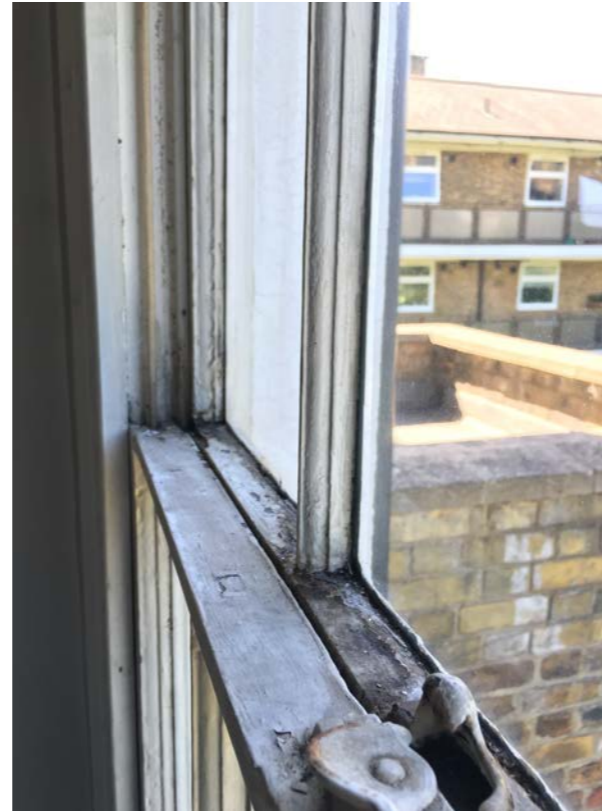
W-13

Original timber box sash

Poor:

- Flaking paint finish
- Top sash fixed shut
- Some rot to framing

Refurbish or replace like-for-like

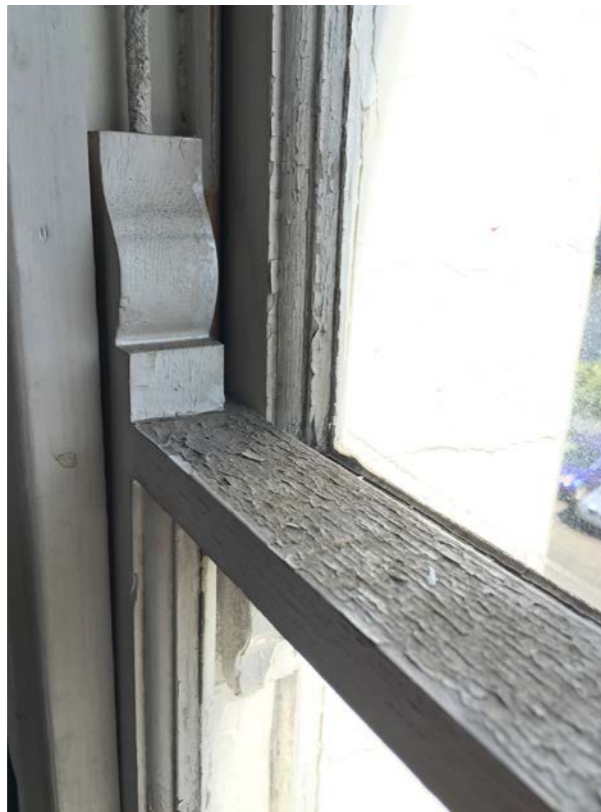
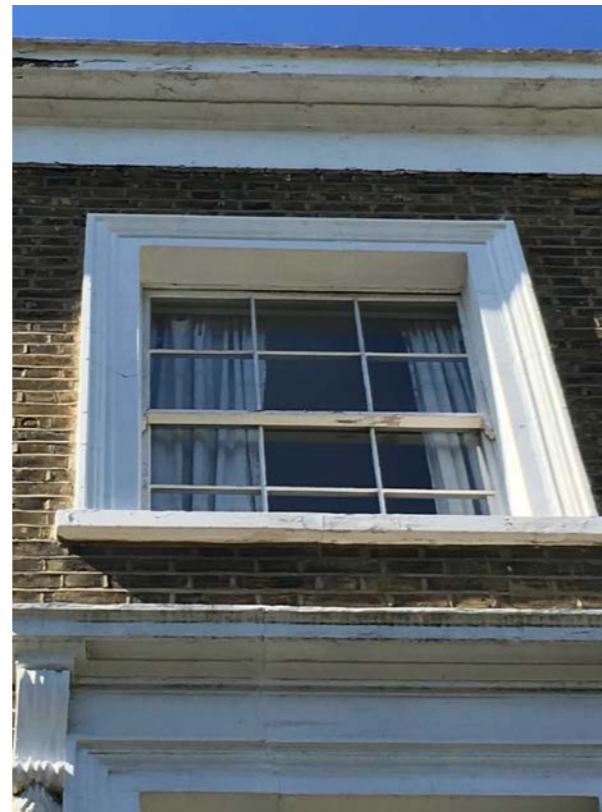
W-14

Non-original timber box sash

Fair:

- Flaking paint finish

Refinish

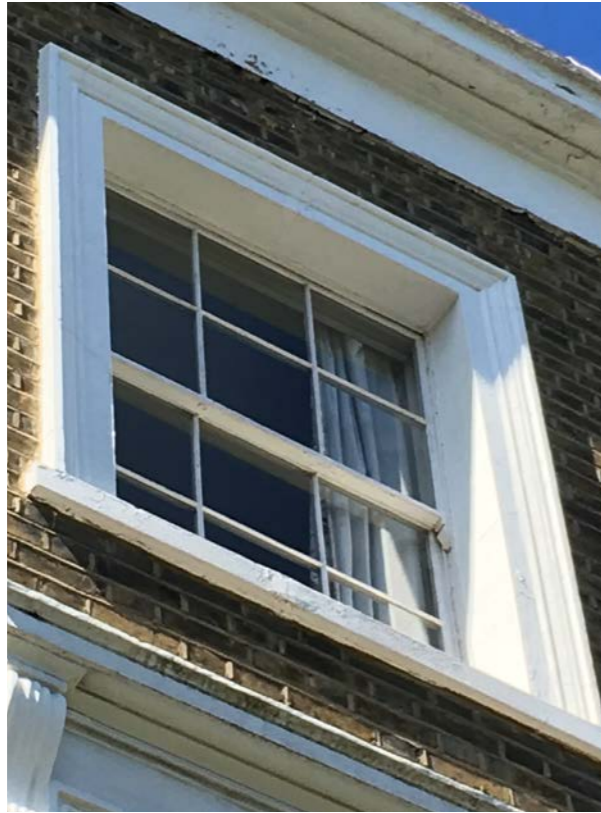
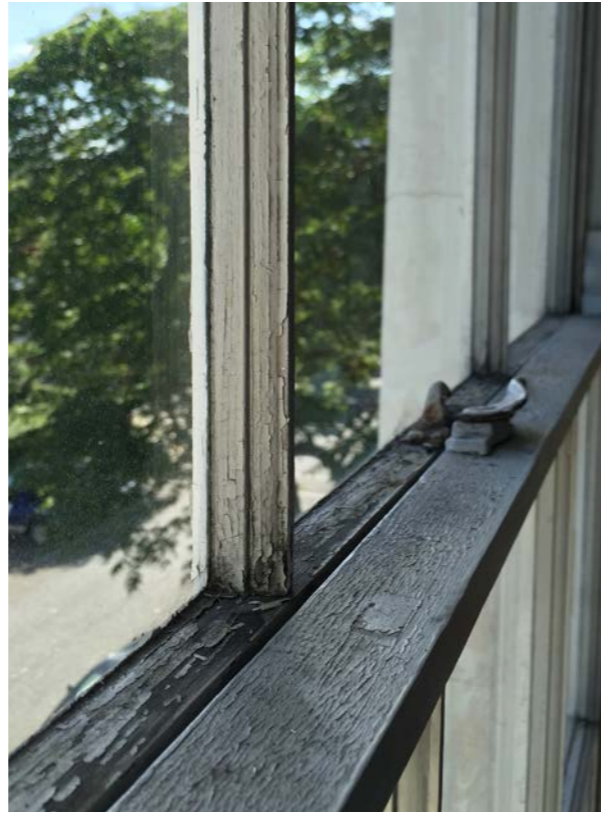
W-15

Non-original timber box sash

Fair:
- Flaking paint finish

Refurbish

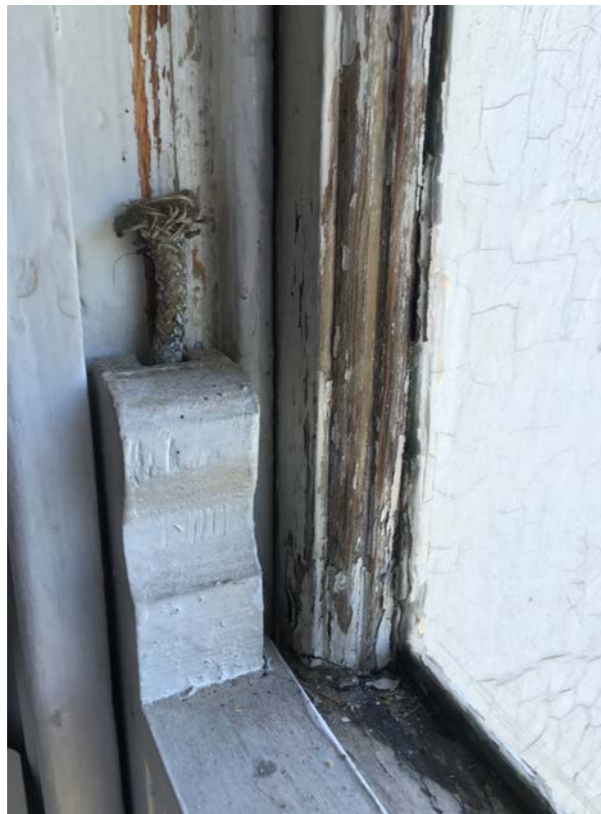
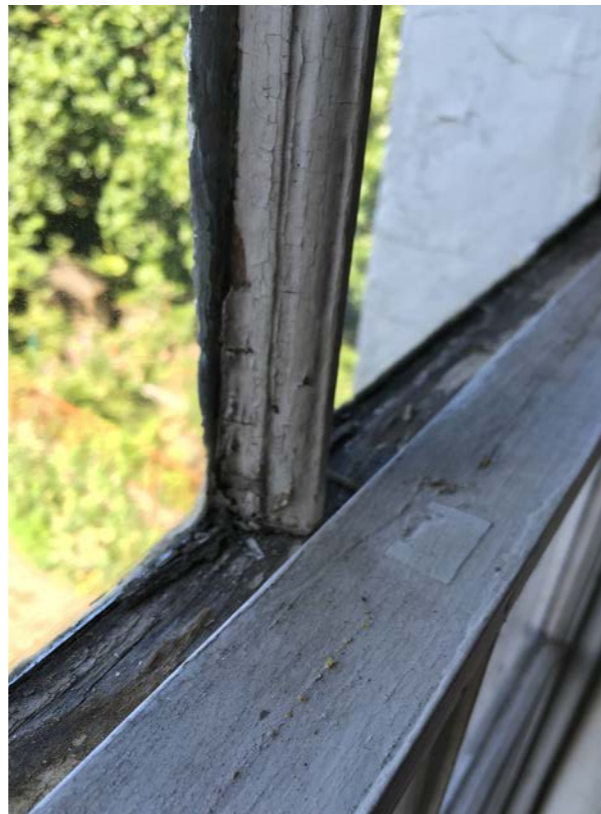
W-16

Original timber box sash

Poor:
- Flaking paint finish
- Broken sash cord
- Some rot to framing
- Overpainted

Refurbish or replace like-for-like
