# Simon Pryce Arboriculture

**Site:** Rear of 106 Highgate Road, London, NW5 1PB

**Subject:** Trees and their implications for foundation design, effects of the proposal on the trees

**Reference:** 16/046

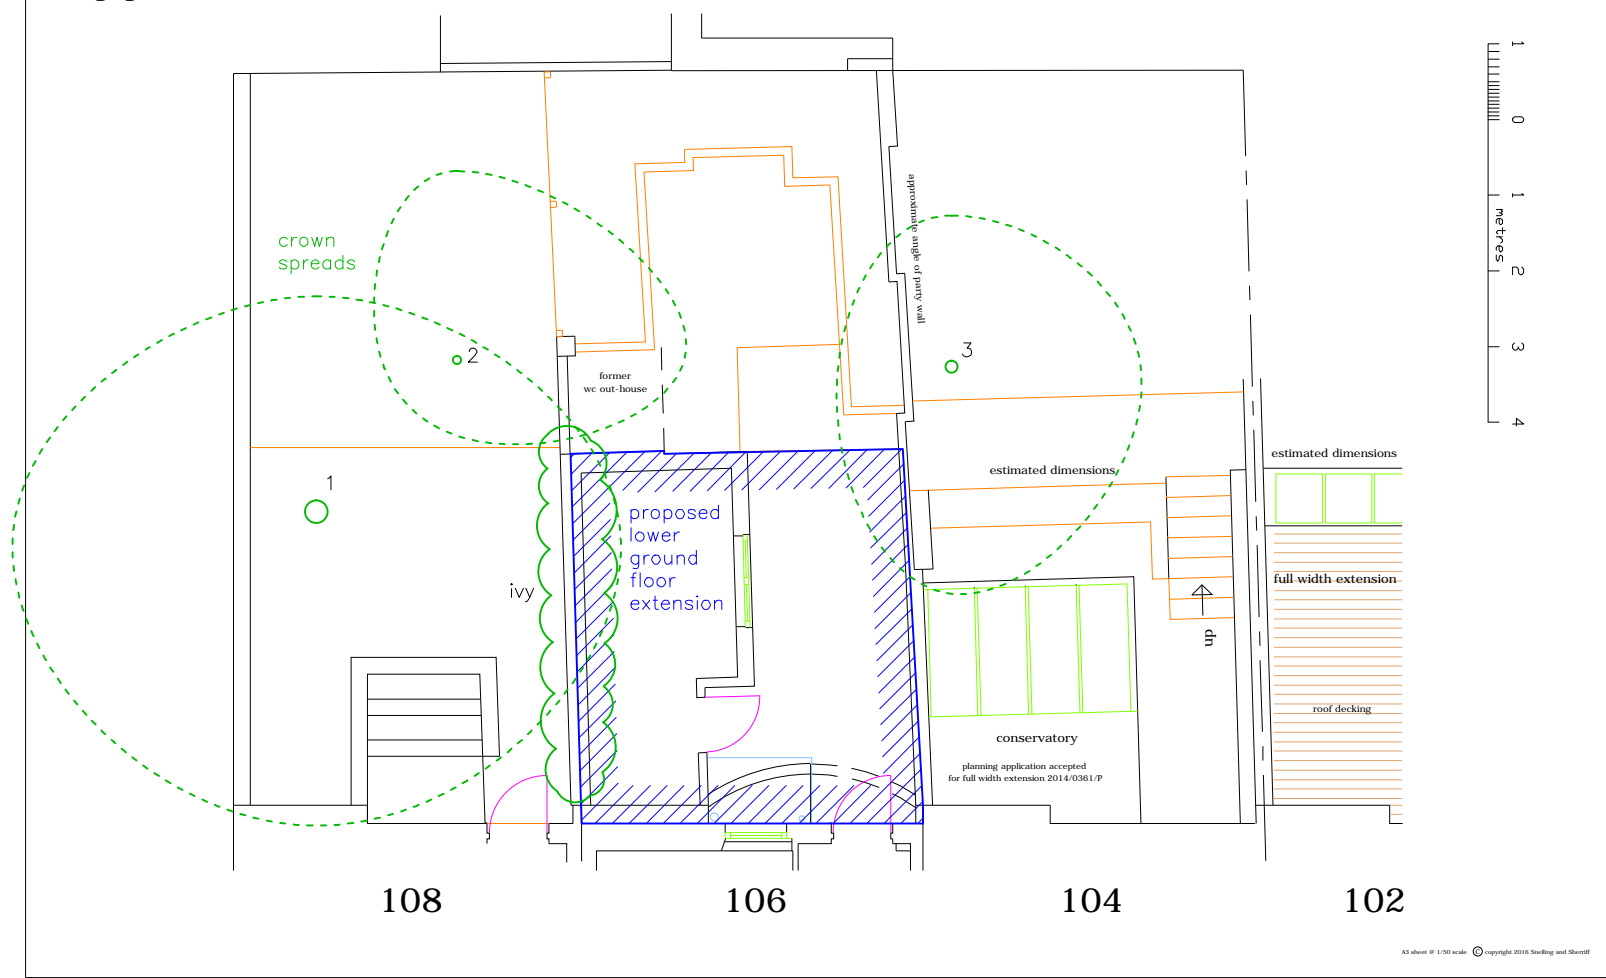
Title:  
Tree survey - foundation depth  
assessment

- 1.5 General matters are discussed below and the trees are listed in the attached schedules with dimensions and other relevant information. They are shown on the site plans, based on an original drawing by Snelling & Sherriff.

- 2.2 The proposal is to demolish the existing rear outbuilding and to extend the lower ground floor into the rear garden to occupy the former outbuilding footprint and extend across the full width of the garden. The attached plans show the existing site and the new footprint has been superimposed in blue.

Tree no.	Species	Distance D	Height	Trunk dia.	Max ht H	WD	D/H	depth	Comments
<p>The trees are described in sequence as shown on the plan. Maximum heights and water demands for tree 2 are from NHBC Standards Chapter 4.2, trees 1 and 3 are not listed in the standard and the figures are derived as set out in the report. Depths are based on highly shrinkable clay. M = moderate water demand.</p>									
1	Golden rain tree	3.25m	8m	300mm	15m	M	.22	2.0m	Exotic species with no close relatives hardy in the UK for comparison, although it is distantly related to maples and horse chestnuts, which are generally moderate water demanding species. It is unusual but not very rare yet there appear to be no recorded cases of it causing subsidence. Medium sized tree of moderate growth rate so is probably moderate water demand. This one is close to the back of the house and has been crown reduced periodically, no doubt to maintain clearance. Camden's records show that being allowed in 1995 and 2008.

2	Rowan	1.8m	5m	110mm	11m	M	.16	2.1m	One sided and being suppressed by the golden rain tree and has signs of fire blight in some twig ends. Classified by NHBC as a moderate water demander but is in the lower part of the category. It has sparse foliage, indicating decline, its healthy life expectancy is limited and it would be beneficial to remove it to limit the spread of the disease.
3	Quince	1.3m	5m	160mm	10m	M	.13	2.2m	Healthy looking, although it is in the adjacent garden and decking has been built round the base with the trunk emerging from a hole. Not listed by NHBC but is closely related to apples and pears, in fact it is often used as a root stock for grafted pears. There it has been treated as moderate water demand.
