Description of Flat 8 Inverforth House

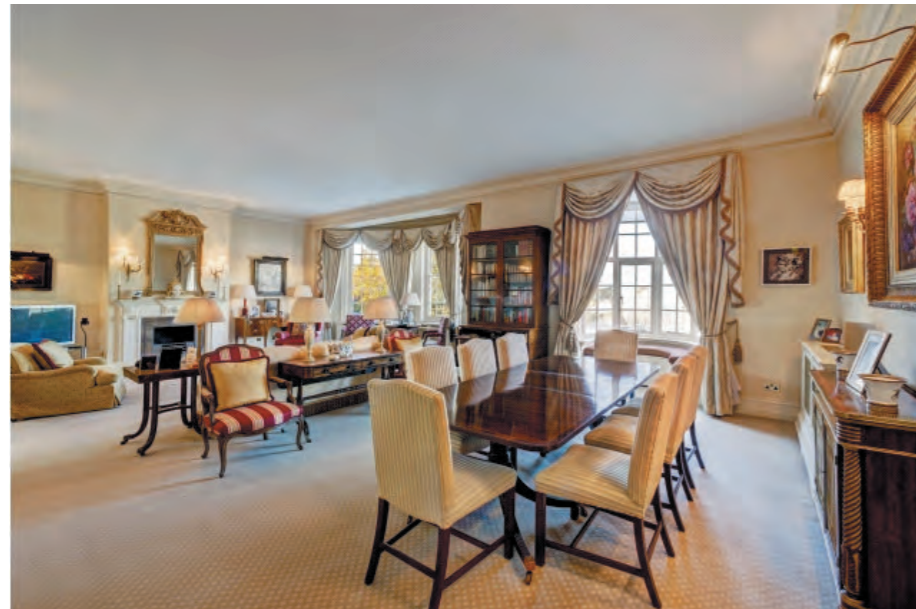
Existing Grand Reception.

The present internal layout of the flat is shown on the survey drawing commissioned by the client. In the case of the Grand Reception there have been significant changes to the general plan form. The original chimney breast and connecting wall have been removed, opening up the space into one large room for lounge and dining use. A false chimney has been created along the far southern most wall creating a new fireplace. The southern most wall has also been altered to line directly with the exterior of the large bay window.

The flooring in the Grand Reception is non original carpet in need of replacement. The movement of these doorways, internal walls and fireplace suggests the cornice and architraves of the Grand Reception are not original, or of quality replication.

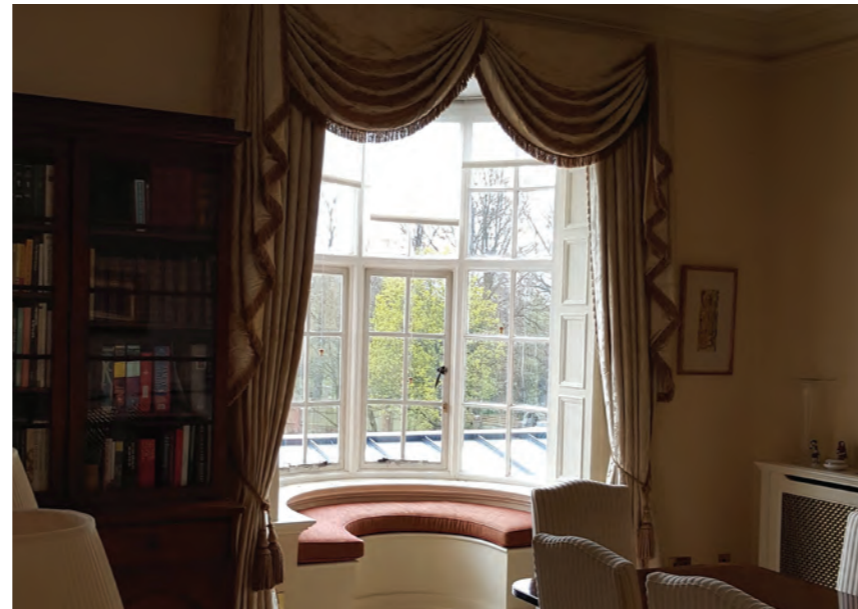
Existing Smaller Bay Window in Grand Reception.

The large bay window remains unchanged, along with the majority of the smaller bay window. These will be retained. The outward swing casements of the small bay window at some point have been replaced with crittall casements, which given the condition would benefit from being replaced to match existing casements.

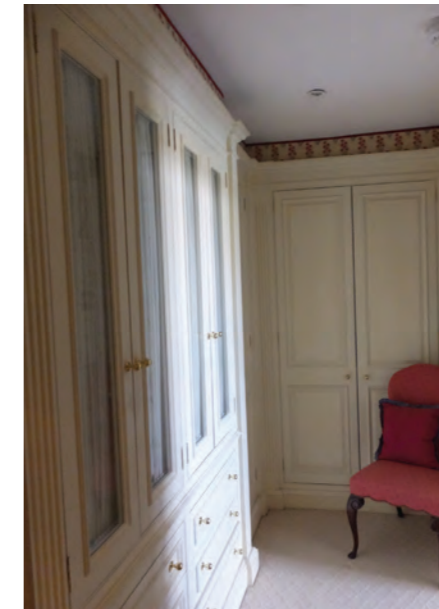
Existing Lowered Ceiling in Master Dressing.

The ceiling to the Master Dressing Room has been lowered, as seen on Camden planning permission dated 8th of March 2004, to accommodate an air conditioning unit.

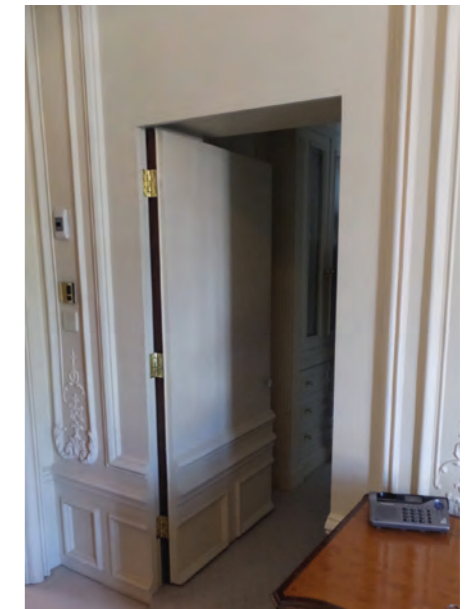
Existing Jib Door to Master Dressing.

The original doorway to the now Master Dressing Room has been removed and plastered, with a new entrance created via a jib door from the Master Bedroom.

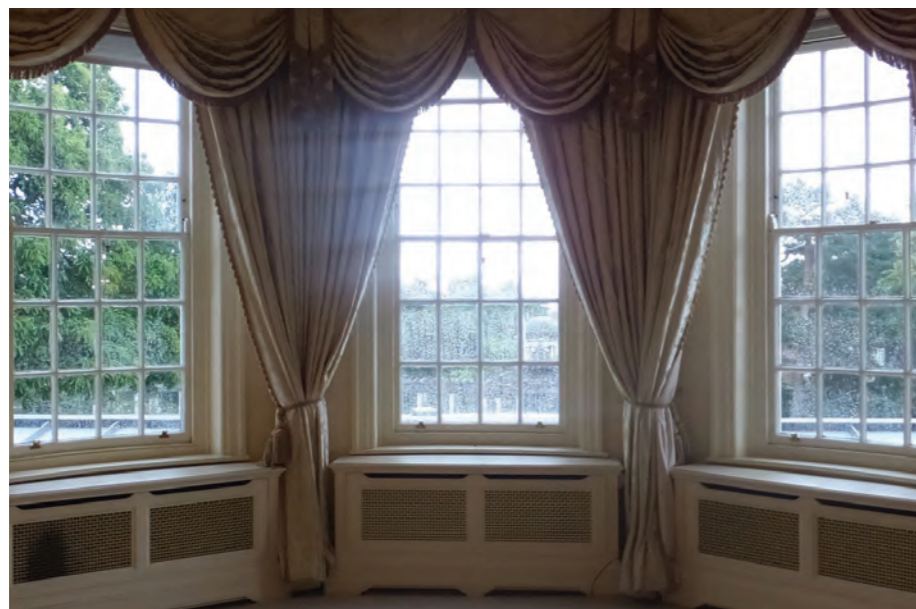
Existing Large Bay Window in Grand Reception.

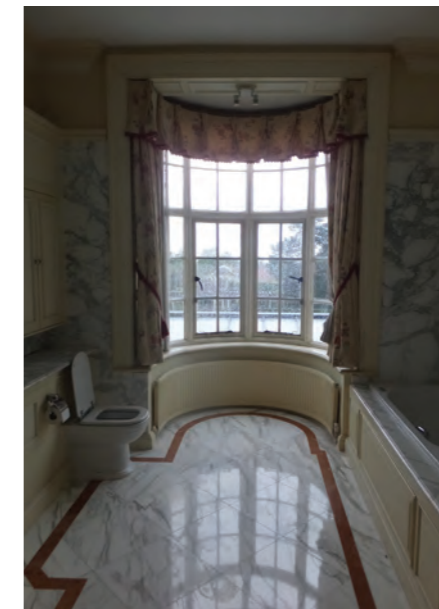
Existing Bay Window in Master Ensuite.

The bay window in the existing Master Ensuite, shown in 2016 Survey Plan, matches the smaller bay window of the Grand Reception. It too contains outward swing casements which have been replaced with crittall casings, which given the condition would benefit from being replaced to match existing casements.

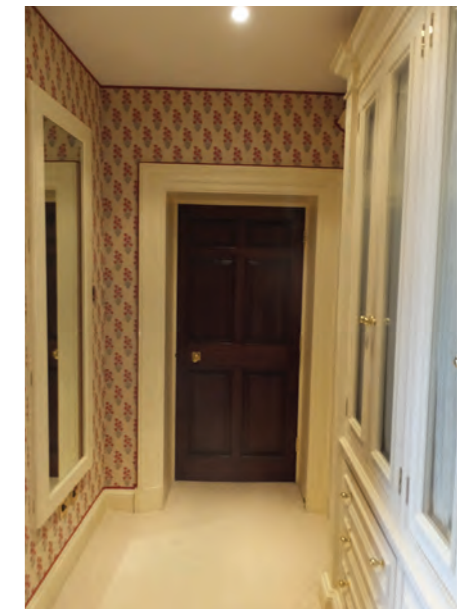
Existing Lowered Ceiling in Master Dressing.

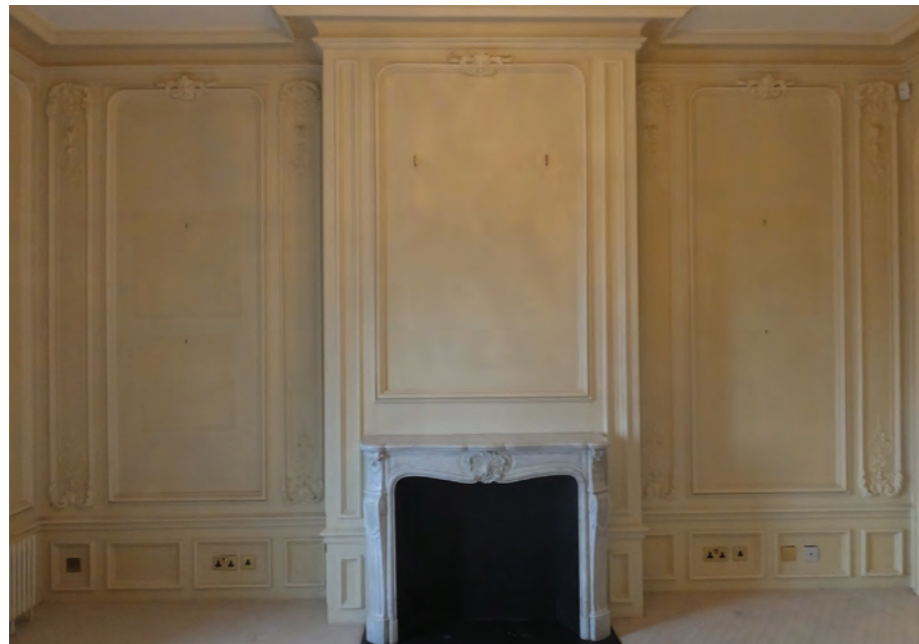
Existing Master Bedroom

The flooring in the Master Bedroom is of non original carpet, also in need of replacement.

The Master Bedroom walls are of decorative panelling, which appears to be late c19th early c20th in the French style, with Jib doors set discretely within. These clearly must be retained. The addition of a fireplace has been made, as seen on Camden planning permission dated the 8th of March 2004. Therefore this fireplace holds no historical value to the room.

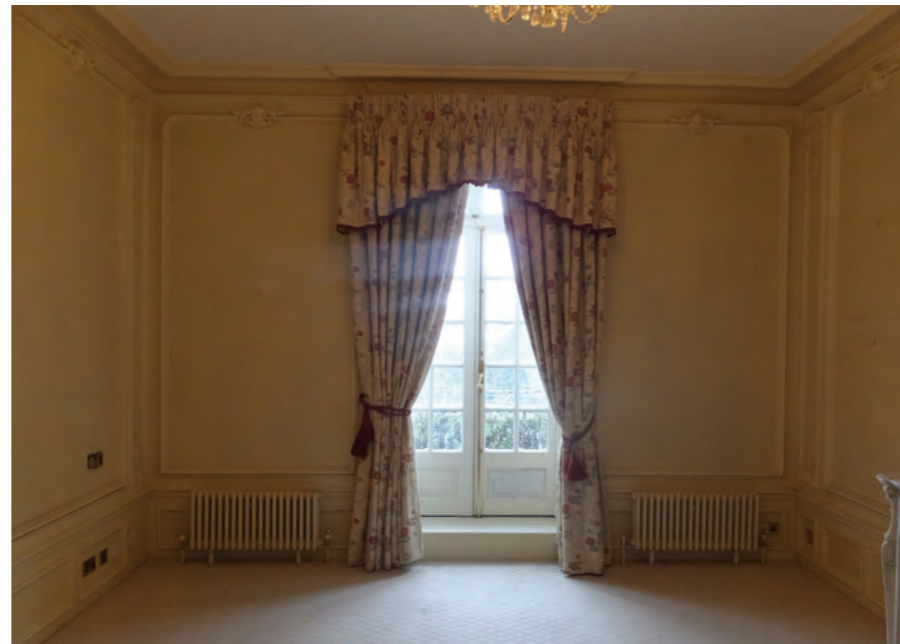
Existing Door to Terrace in Master Bedroom.

The doorway to enter the Master Bedroom off the Hallway, retains the internal panelling to coincide with the panelling on the walls. A new jib door has been cut into the panelled wall to make way for an entrance into the Master Dressing. The doors to the Terrace retain the location as depicted in 1993, yet require refurbishment as are not in a good condition.

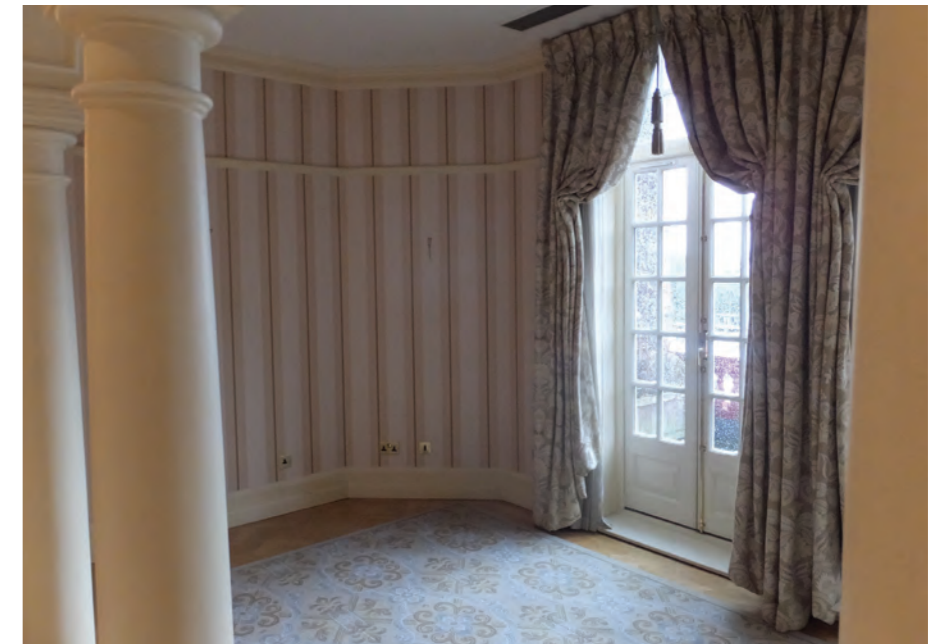
Existing Informal Dining Room

The present layout of the Dining room has been unaltered. The wall separating the Hallway from the Dining Room, as seen in the 1993 Survey, has been removed and replaced with four Doric columns which suggest arches over, forming a screen to retain definition of the plan form. These columns hold no historical significance to Inverforth House.

The flooring in the Dining Room is of non-original parquet, continuous from the adjoining Hallway.

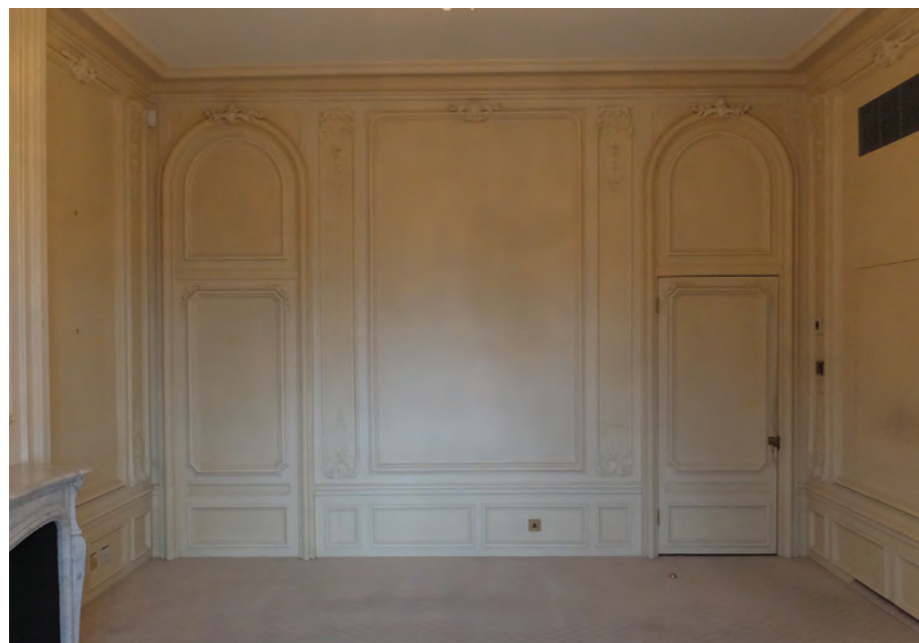
Existing Jib Door to Master Bedroom from Hallway

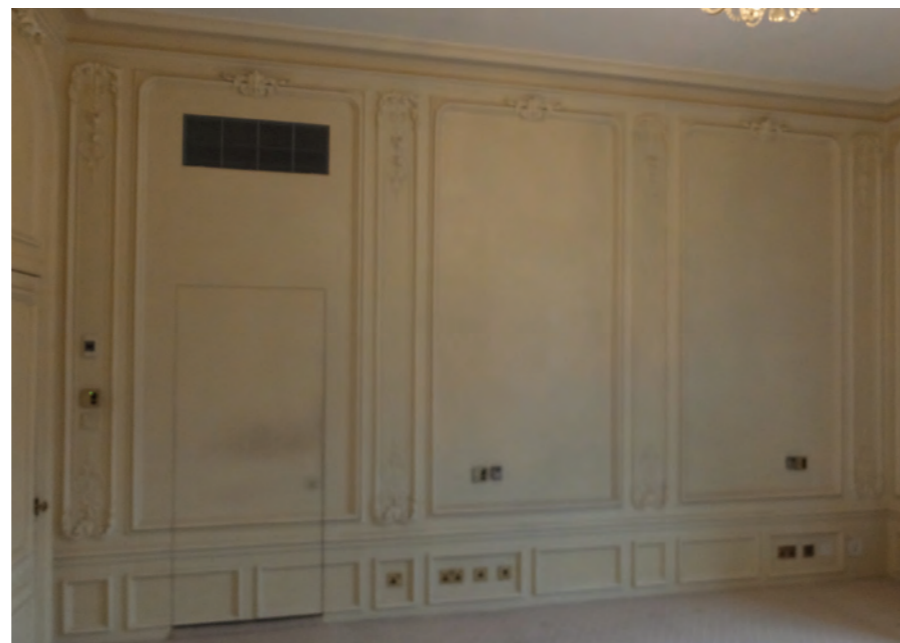
Existing Jib Doors to Master Ensuite

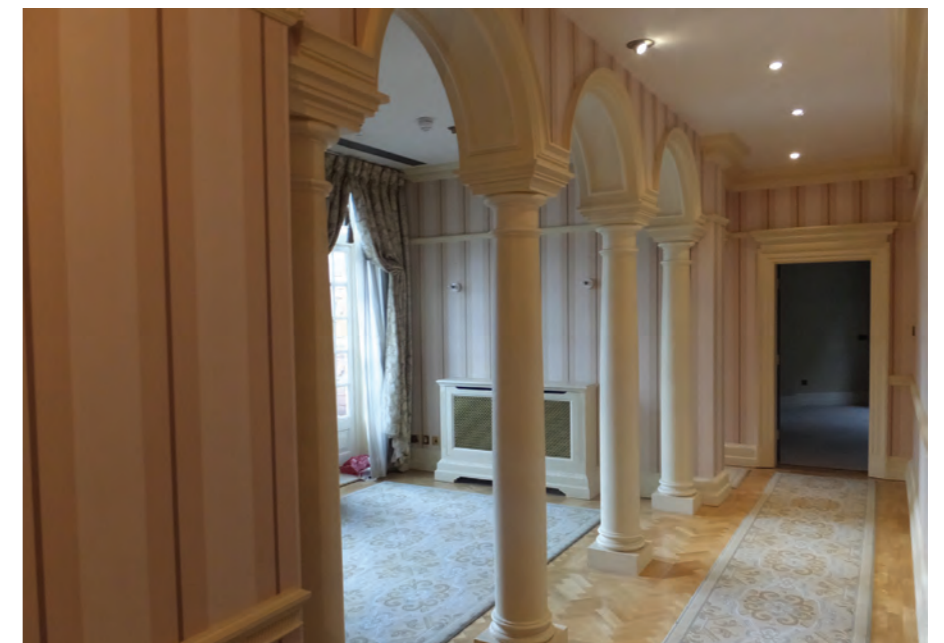
Existing Informal Dining Arched Columns.

The door from the hall into the Dining Room was removed along with the wall to make way for the four arched columns. The doorway connecting the wing has been in-filled with access no longer available through this path. The doors to the Terrace retain the 1993 location, yet require refurbishment as are not in good condition.

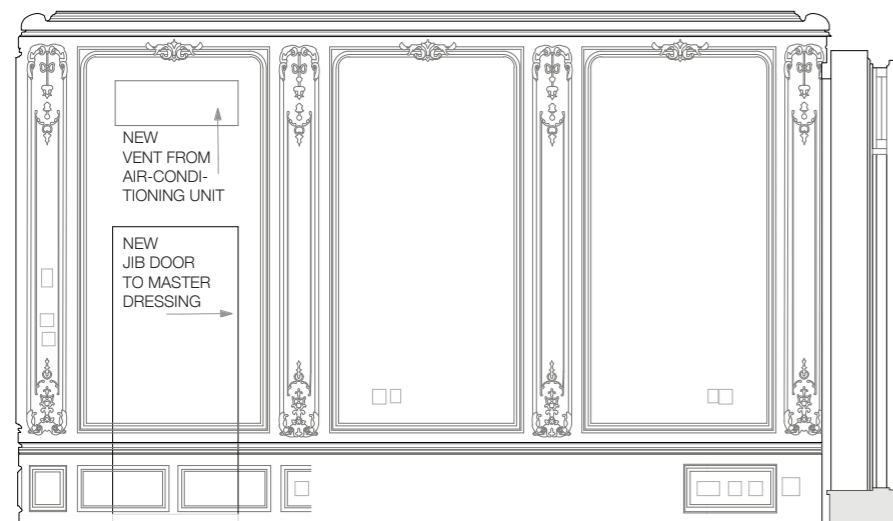
Existing Master Bedroom Panelling Elevations.

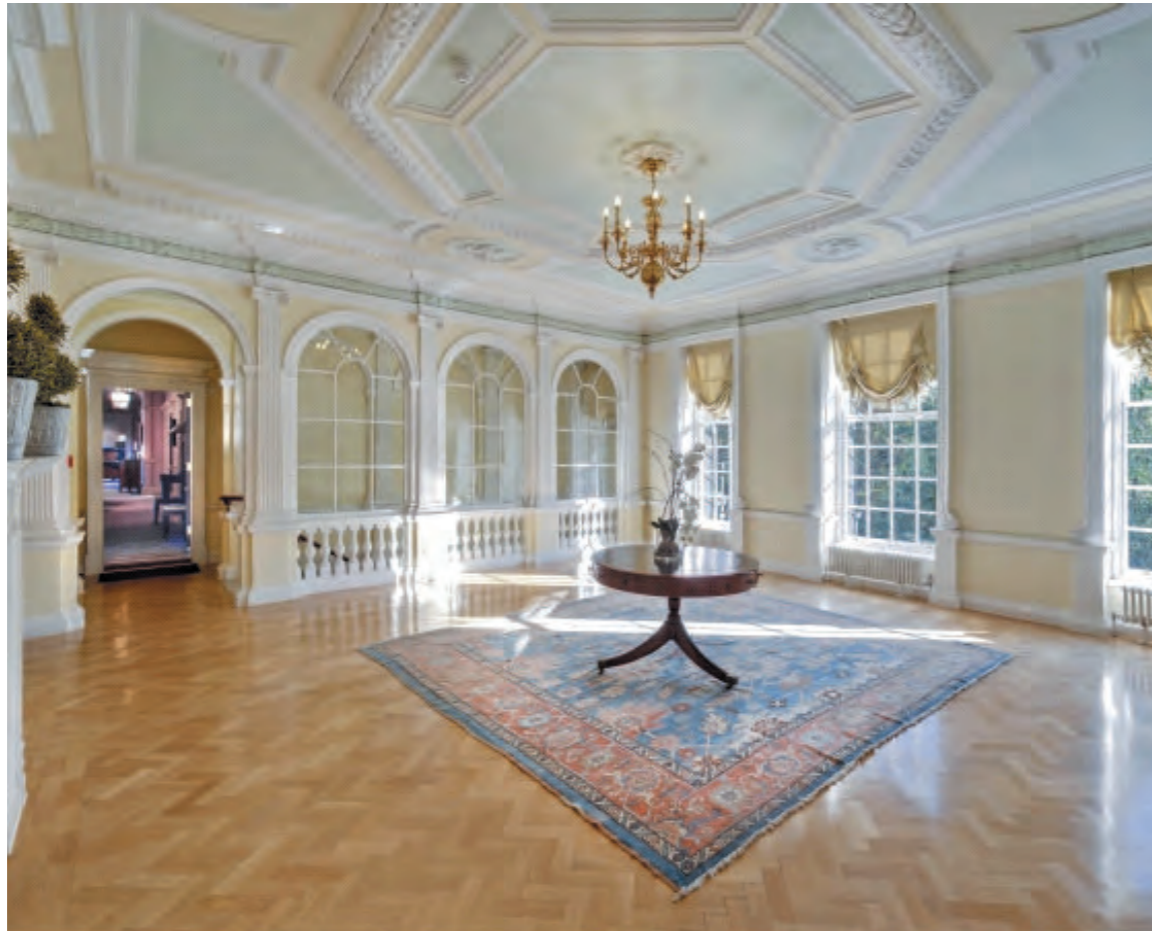
Existing Entrance - View from First Floor Communal Space to Entrance of Flat 8.

The Entrance to Flat 8 of Inverforth House is off the main carved marble staircase to the First Floor. It is noted that the original doorway to this portion of the building, as seen in the 1993 Survey, has been pushed back, to allow space between the staircase landing and the entrance into Flat 8. The double leaf door has been replaced with a single swing, therefore it can be assumed new architraves have also been applied.

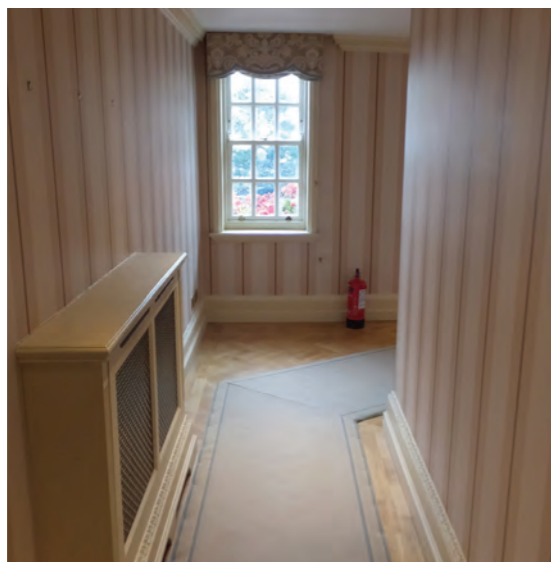
Existing Secondary Hallway.

The second portion of the Hallway, located in the 'Queen Anne' angled Northern wing, has seen the most drastic change to plan form. As shown in the Survey Plan of 1993 this hallway ran through the wing slightly off centre, with small rooms coming off to the left and larger rooms to the right. In the 2016 Survey Plan the Hallway is shown to have been moved to the perimeter wall of the angled wing, creating larger rooms coming off the hall to the right. New interior walls have been created between this portion of hallway and the rooms to the right. Therefore it can be assumed the cornice and skirting, which matches that of the main Hallway, has also been a new addition in 1998.

The windows along the second portion of the hallway in 2016, remain in the same location to that of the 1993 Survey. The sash windows have at some stage been overhauled and the glazing lights replaced with double glazed lights. It appears that the third window along has also been converted into a door.

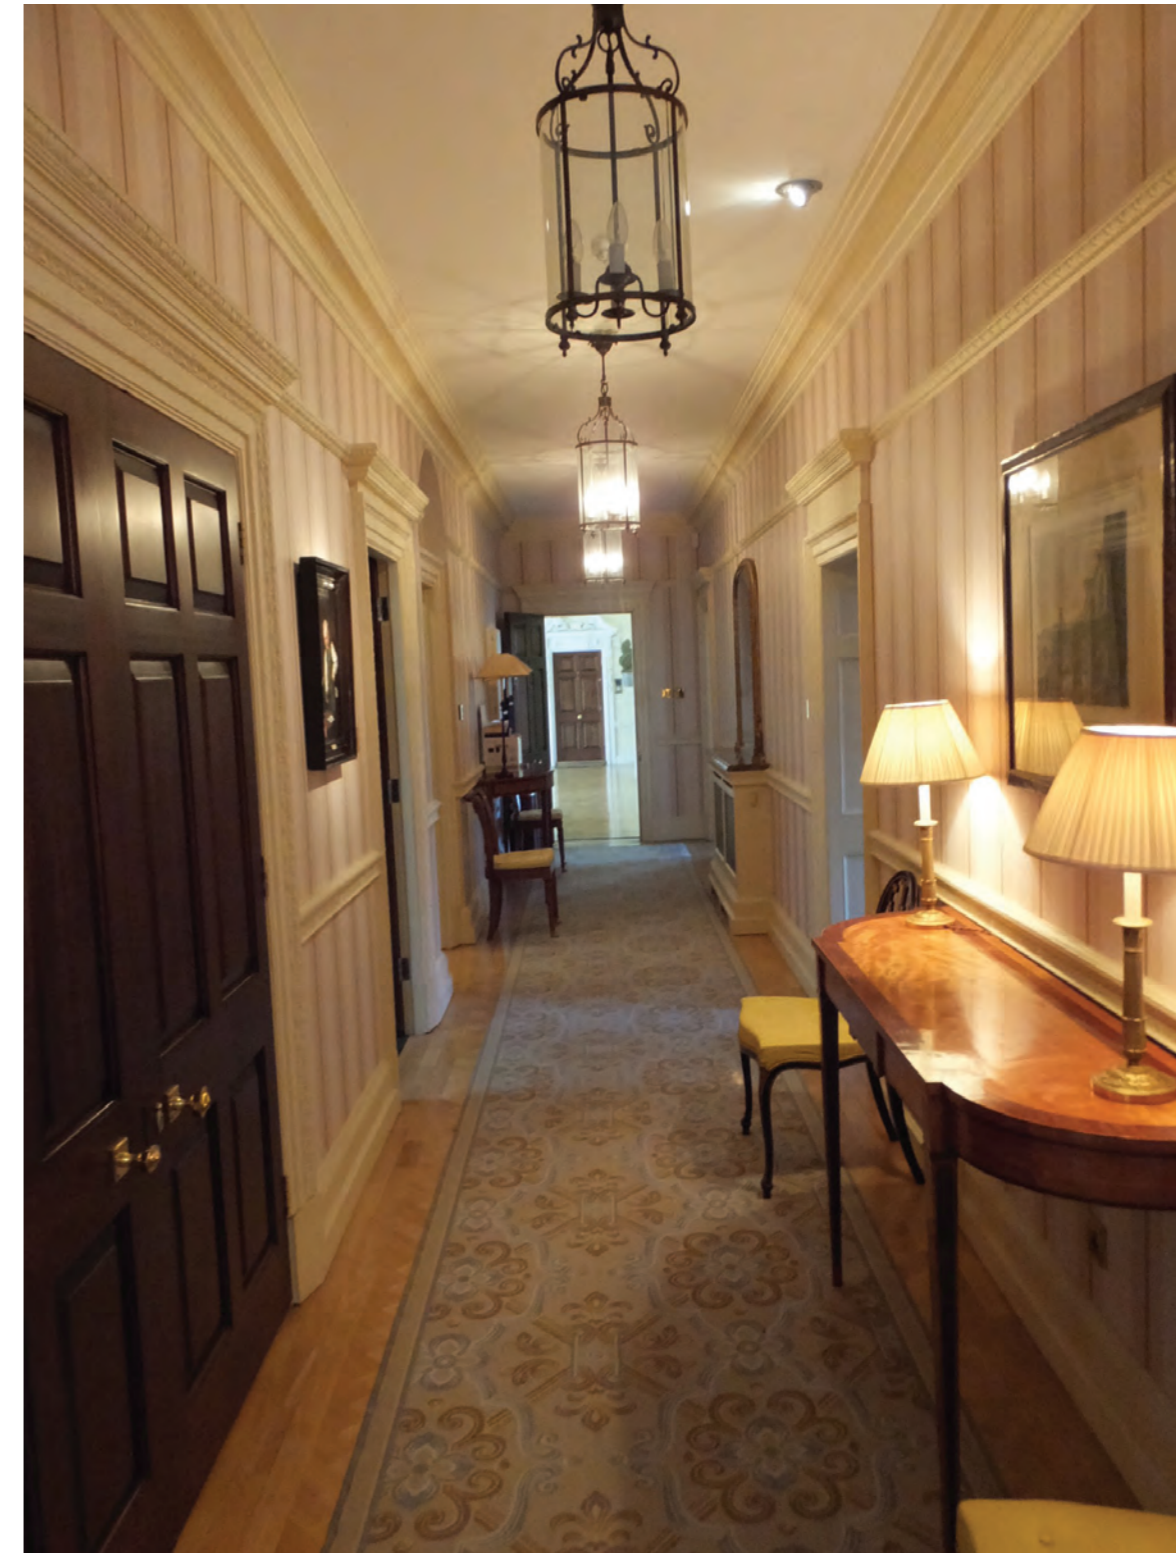
Existing Main Hallway.

The main Hallway as surveyed in 2016, remains relatively similar in plan form, to that of the Survey of 1993. The main alterations consist of the change as discussed above to the entrance, shortening the Hallway, and the movement, removal or addition of doorways into adjoining rooms. The only main structural change is where the arched columns to the Dining Room in the survey of 2016 replaced the pre existing wall.

The Hallway has Neo - Georgian architraves, cornices, dado rails, picture rails and skirting as a matching set, reminiscent of the Georgian period. However, the relocation, addition and removal of many doors and one wall along this main Hallway suggest that these are a later addition to the flat, when converted from hospital to flats in 1998.
