## Description of Flat 8 Inverforth House

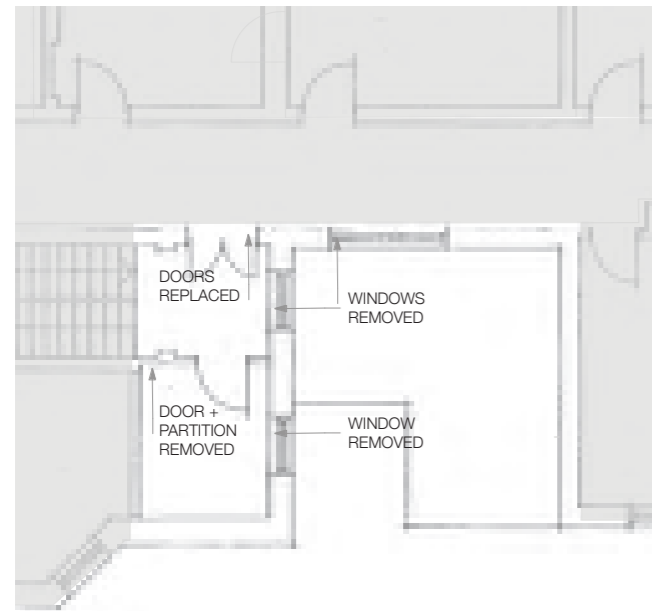
Original Survey Plan of First Floor 1993  
Thomas Brent Associates.

The Survey Plan of 1993 displays the absence of rooms where the Guest W.C, Utility, Terrace and Hall Cupboard are shown in the Survey Plan of 2016.

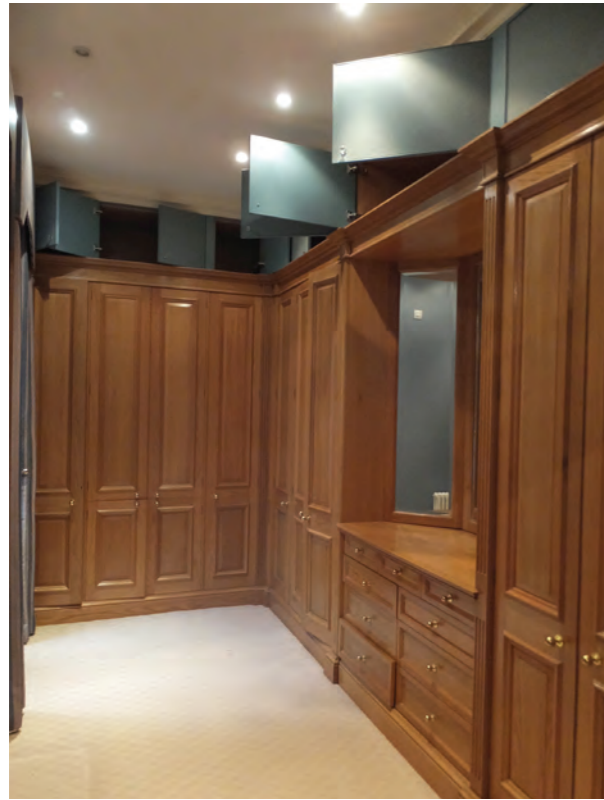
Existing Dressing Room.

The second Dressing Room, as seen in the Survey Plan of 2016, did not exist in the 1993 Survey Plan. The secondary staircase has been moved across and altered so that the landing no longer lies to its right, allowing space for an additional room to Flat 8.

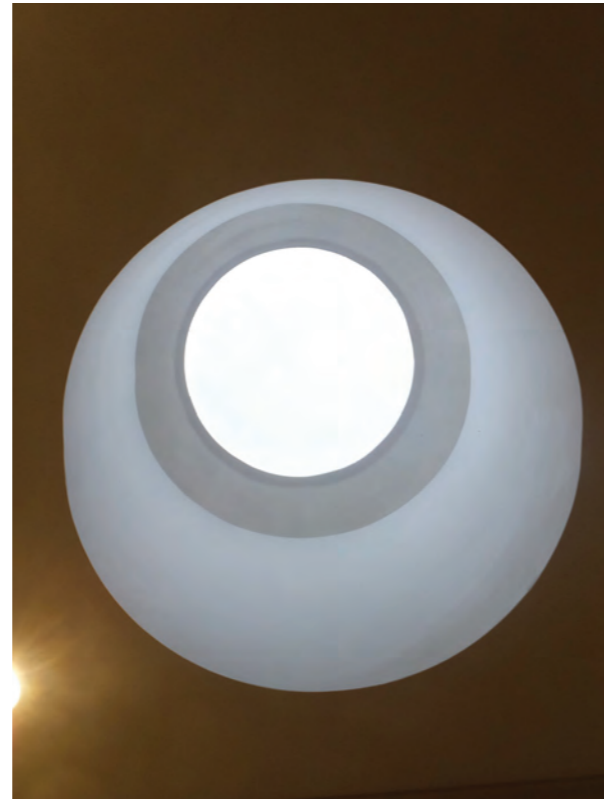
Existing Guest W.C. Skylight.

The addition of two skylights has also been included in the extension, one in the Guest W.C. and one in the Utility, as neither room contains windows.

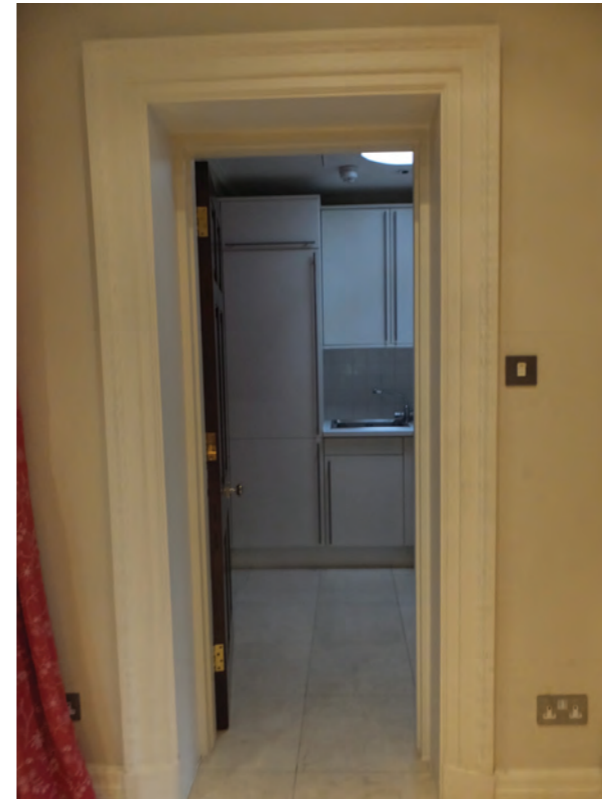
Existing Utility off Kitchen

New doorways have been added to the Hallway for the Guest W.C. and Hall Cupboard, from the Kitchen to the Utility and Double Leaf Glazed Panelled Doors to the Terrace from both the second Dressing Room and Kitchen.

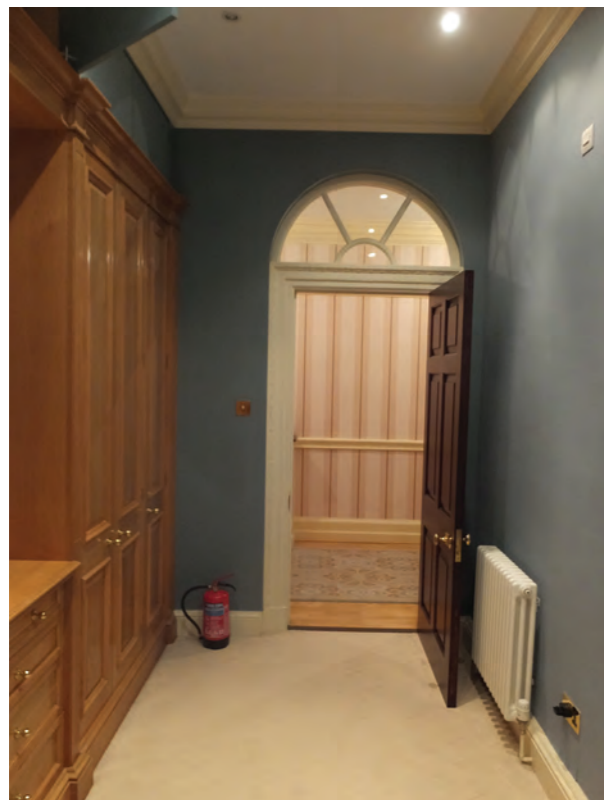
Existing Dressing Room Door Fan Light.

Although the door has been changed from double leaf to a single swing, and the architraves replaced to match that of the other doors off the Hallway. The Late Georgian period saw the introduction of semi-circular over door fanlights, most often constructed of wood. This is also a feature of the doorway into the second Dressing Room. It is likely that they relate to the original secondary staircase removed in the 1990's refurbishment, and therefore these elements should be retained.

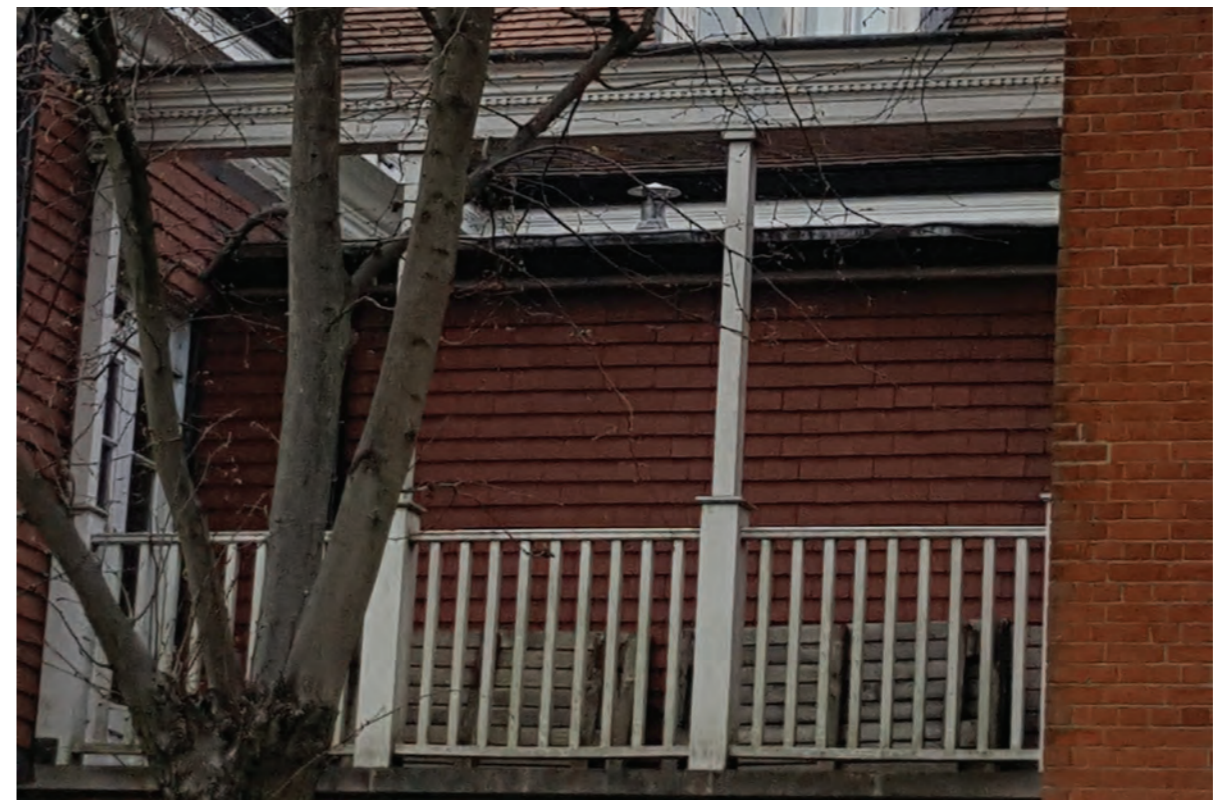
Existing Terrace

Existing Terrace - Street View.

The addition of this flat roofed portion has altered Flat 8 from the street, viewing a four columned balustrade branching across the previous void. The removal of the window between the Hallway and the exterior has detracted from the quality of light in the Hallway.

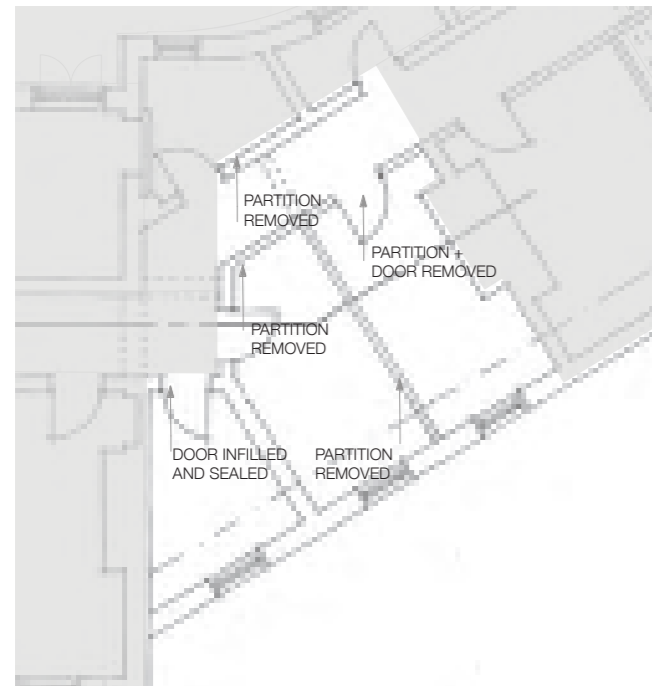
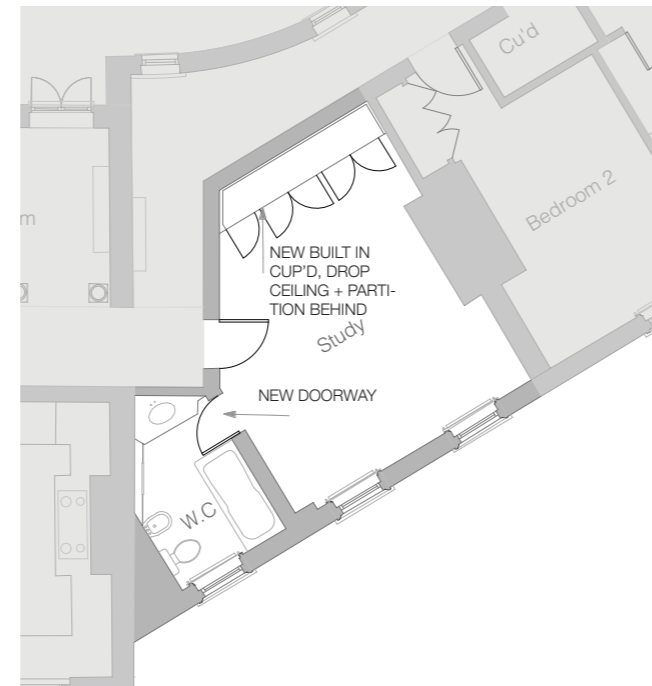
Original Survey Plan of First Floor 1993  
Thomas Brent Associates.

This portion of the Flat is contained within the Queen Anne angled wing and has undergone significant changes in plan form. The Study, as seen in the Survey Plan of 2016, retains the existing chimney breast which can also be seen in the 1993 Survey Plan. The space, which appears as two rooms in the 1993 Survey Plan, has had the middle partition removed to create a larger Study. The wall dividing the secondary Hallway and Study has been moved approximately 1000mm, further enlarging the Study.

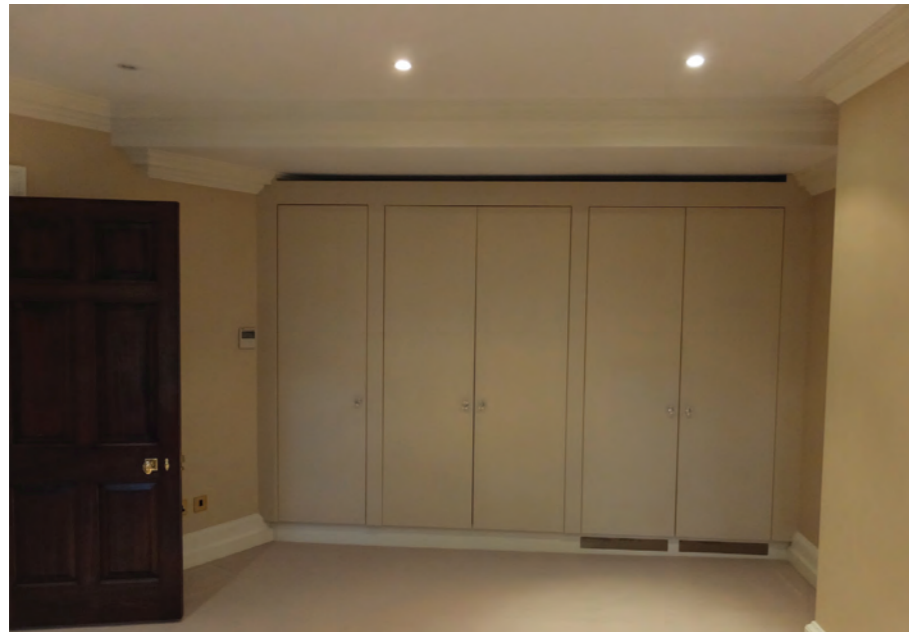
Existing Study Drop Ceiling and Built in Cupboards.

Camden planning permission, dated the 8th of March 2004, was given to drop the ceiling in the study at the end of the room closest to the secondary Hallway. This was to allow for an air conditioning unit within. Full height built in cupboards are fitted beneath the dropped ceiling, slightly obscuring the modern cornicing.

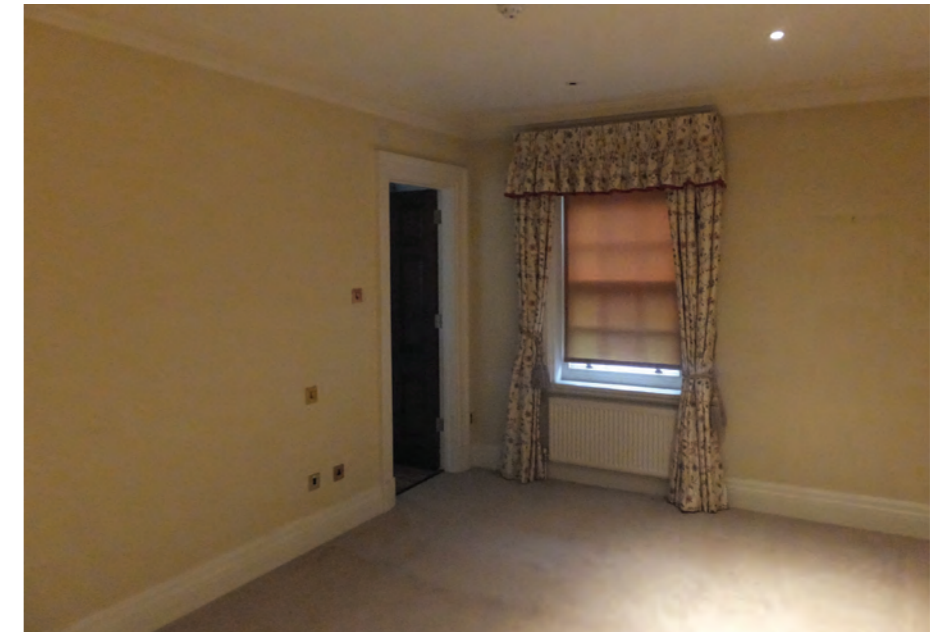
Existing Bedroom 2

The 2016 Survey Plan shows Bedroom 2 to have undergone alterations to the plan form since the 1993 Survey Plan. The existing chimney breast remains relatively the same, whilst the wall dividing the room from the secondary Hallway has been moved by 1000mm, enlarging the space within. This addition includes a Cupboard accessed via the secondary Hallway. The ceiling to the entrance of the increased space has been dropped to house an air conditioning unit within. Considering the alterations made it can be assumed all cornice, architraves and skirting are non original.

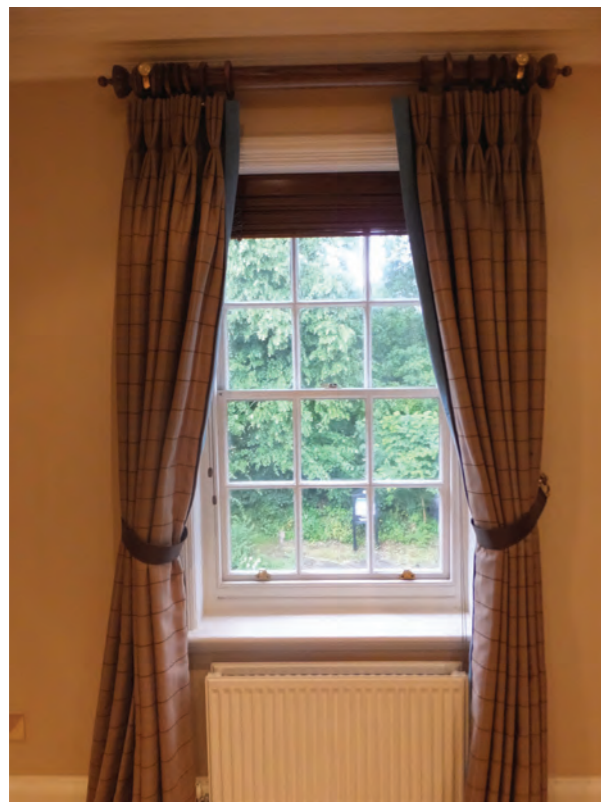
Existing Sash Windows to Study, W.C, Bedroom 2 & Ensuite.

The two sash windows remain in the same location as seen in the 1993 Survey Plan, and appear to contain original casements. These windows allow dust and traffic pollution to enter the Flat. They should therefore be retained and restored to benefit the sustainability and quality of the Listed Building.

The sash windows in both Bedroom 2 and the Ensuite remain in the same location as seen in the 1993 Survey Plan, and appear to contain original casements. These windows allow dust and traffic pollution to enter the Flat. They, like those found in the Study and W.C., should therefore be retained and restored to benefit the sustainability and quality of the Listed Building.

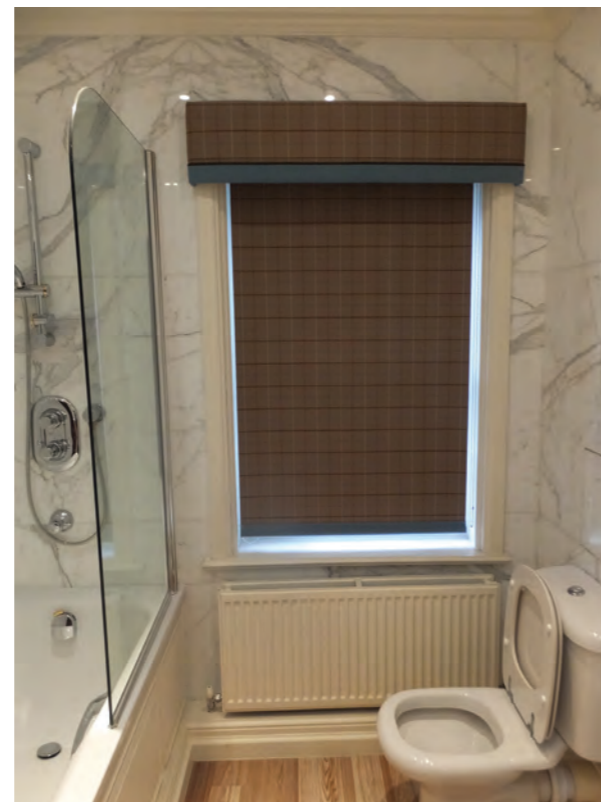
Existing W.C.

The W.C. as seen on the 2016 Survey Plan, has been reconfigured slightly. The far triangular corner has been boxed out to allow for a flat wall and square end to the room. The doorway off the main Hallway has been removed, fitting one off the Study in its place. The sash window remains in the same location as seen in the 1993 Survey Plan and is a duplicate and is in the same condition of those found in the Study space next door.

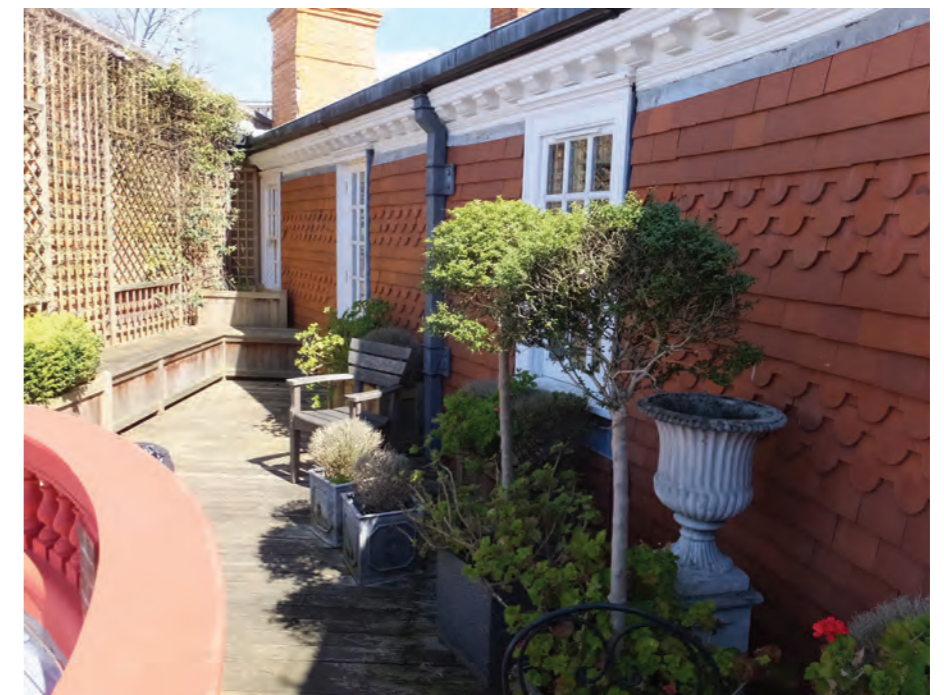
Existing Terrace

The wooden decking and in built seating / planters are of course new additions, along with the bright red colour of the balustrade.

The terracotta tiling to the exterior of the Flat is an existing feature of the Queen Anne wings. It therefore must be retained and restored to good condition.
