**DESIGN AND ACCESS STATEMENT**

**TOILET REFURBISHMENTS**

**AT THE  
WILKINS BUILDING  
GOWER STREET, LONDON,  
WC1E 6BT**

**UNIVERSITY COLLEGE LONDON**

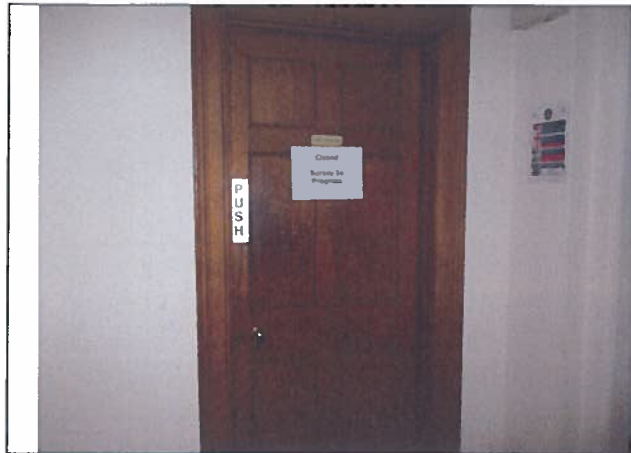
**Photo 1:** Existing door leading from North Cloister corridor to Room 125 – to remain

- **Note:** It is believed that the plastered 105mm thick decorated masonry walls are not original.
  - **Note:** The 135mm thick decorated plaster dividing wall with borrowed lights above between room 125 and the corridor (incl. fire hose reel) is to remain unchanged. The existing timber solid door leading from the corridor is to remain also.

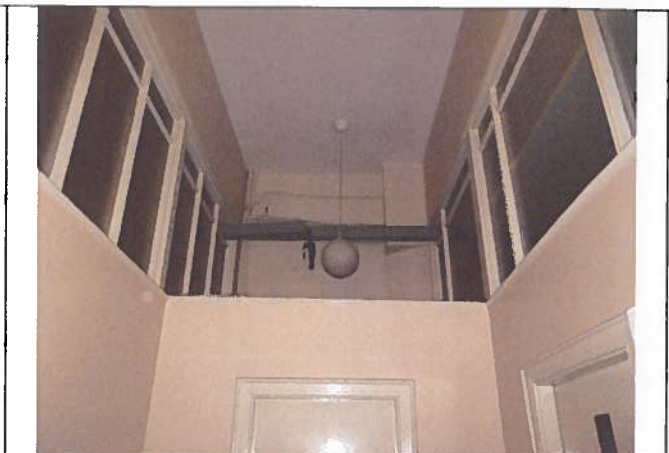
**Photo 2:** Existing Room 125 ceiling and high level borrowed light windows. The windows located on the North Cloister corridor are to be remain, whereas the windows opposite to be removed.

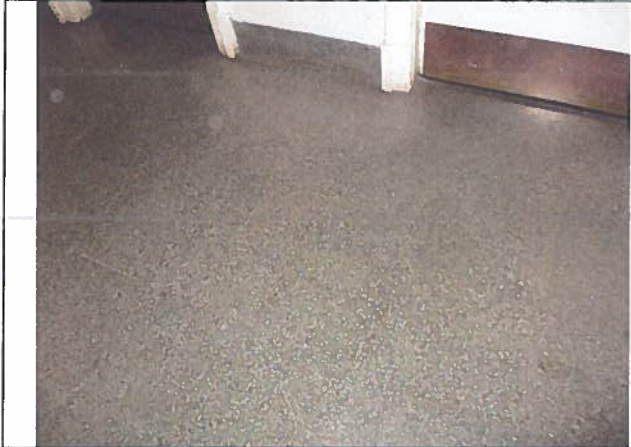
**Photo 3:** Existing Room 125 tiled floor covering with upstands.

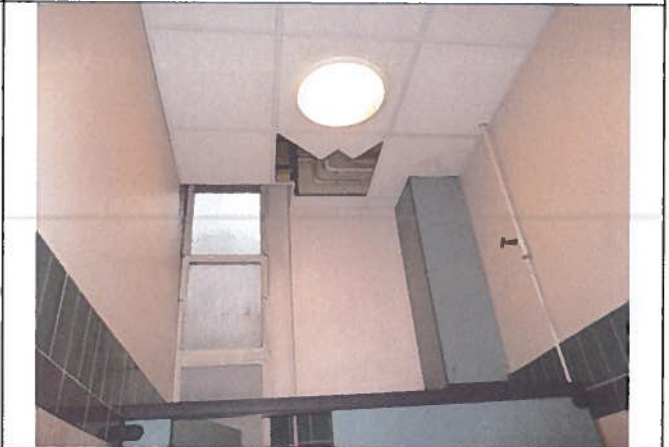
**Photo 4:** Existing Room 125B suspended ceiling, metal window, tiled and decorated walls.

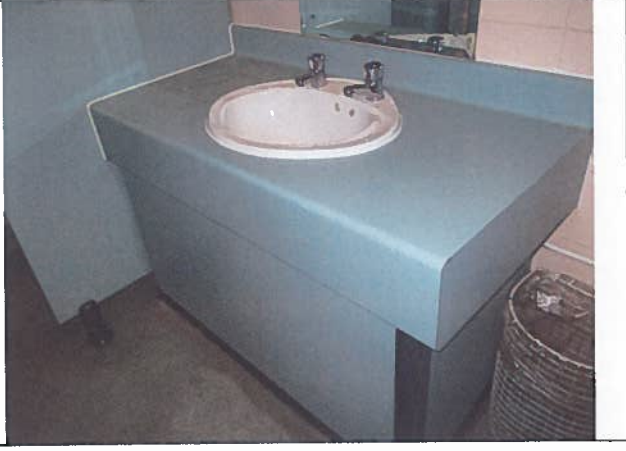
**Photo 6:** Existing Room 125B wash hand basin, vanity unit and vinyl floor covering.

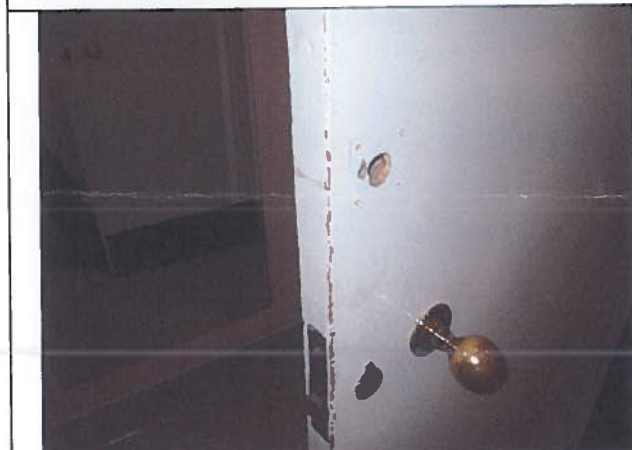
**Photo 7:** Existing Room 125C solid timber doors to Rooms 125A, 125B and 125C.

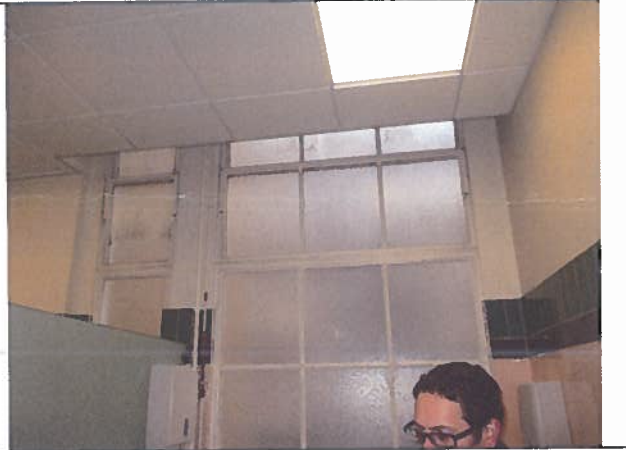
**Photo 8:** Existing Room 125C metal windows, tiled and decorated walls & suspended ceiling with recessed lights.

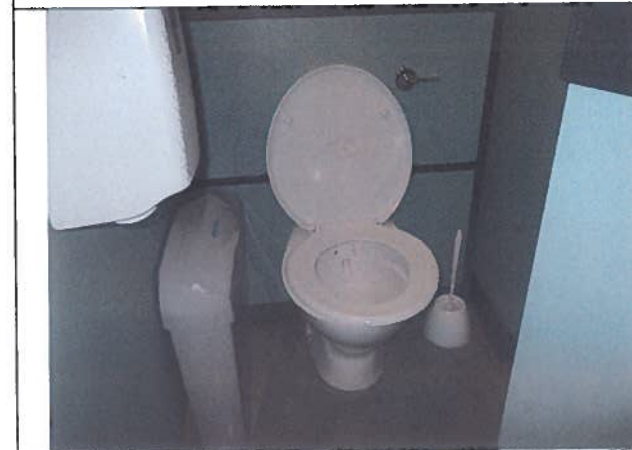
**Photo 9:** Existing Room 125C pan and concealed cistern behind wall panels.

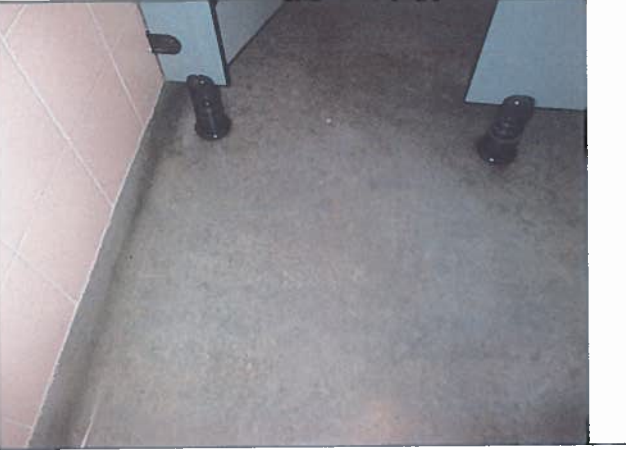
**Photo 10:** Existing Room 125C floor covering and tiled wall.

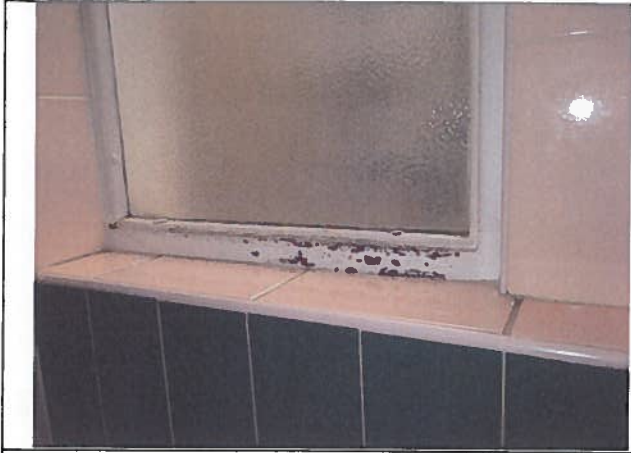
**Photo 11:** Existing internal tiled cills.

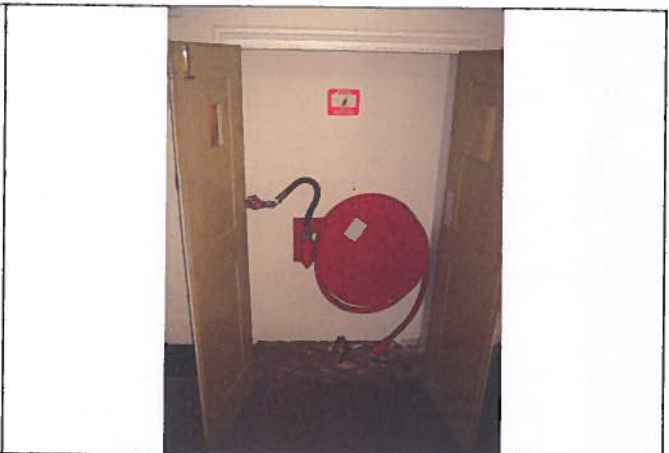
**Photo 12:** Existing corridor fire hose reel recessed in to Room 125A.

Room 125 cluster – Once the existing dividing walls within the Room 125 curtilage will be demolished, (except fire hose reel - recessed in to room 125) and fixtures and fittings removed, the space will be fitted out with a new male and female toilets. The existing services are to be adapted to suit the new layout. To separate the male and female toilets WC a new floor to ceiling stud partition wall will be installed. The male WC will be an L-shaped room and the female a square shaped room. The existing lobby (125) will be reduced in size to serve both the new male and female toilets.

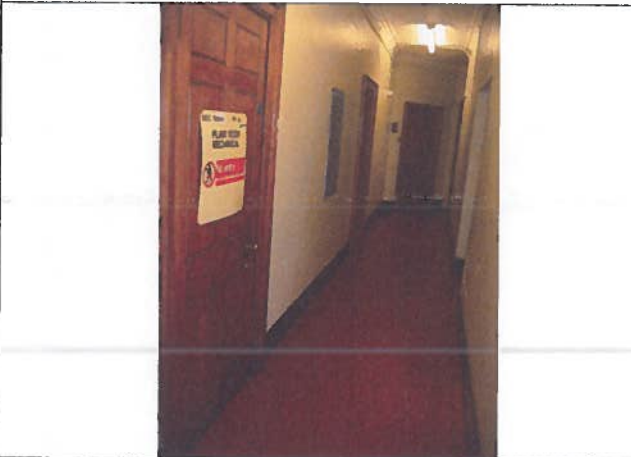
**Photo 13:** Existing corridor outside rooms 220 & 221 and lift.

Access to the second floor 220 and 221 rooms is via a lift that is fitted with a hearing loop. The lift is outside room 221.

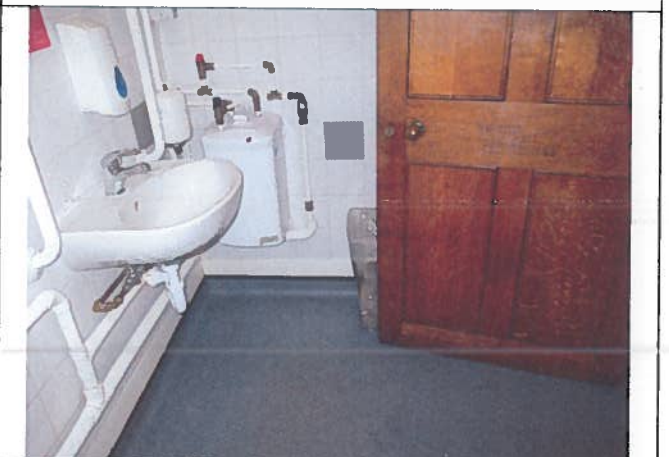
**Photo 14:** Existing room 220 floor, solid timber door, tiled walls, vinyl floor with covered upstands and Part M install.

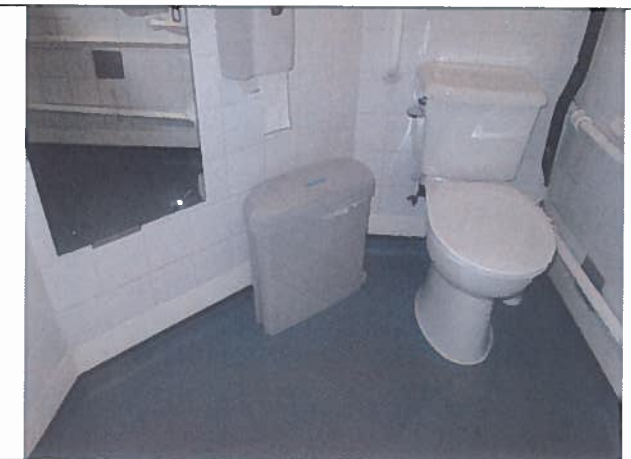
**Photo 15:** Existing room 220 floor, solid timber door, tiled walls, vinyl floor with covered upstands and Part M install.

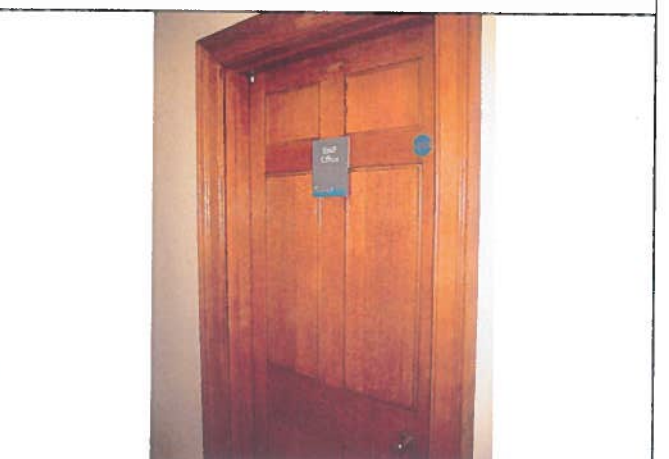
**Photo 16:** Existing room 221 solid timber door, to remain.

- Wall remodelling:
  - **Note:** There is no demolition of any existing walls. A stud wall will be inserted to form a new entrance lobby area. The existing solid existing timber door will remain.
- The new male toilet will have new trough hand wash basin, 2no. WC cubicles and 3nr. urinals with a duct panelling system to the toilets and urinals. The lighting system is to be a LED suspending light fitting.
- The services located in the existing assessable toilet adjacent to the existing library will be adapted for the new male toilet. The external appearance will not be affected, except for the new extract ventilation that will be mounted in the window.

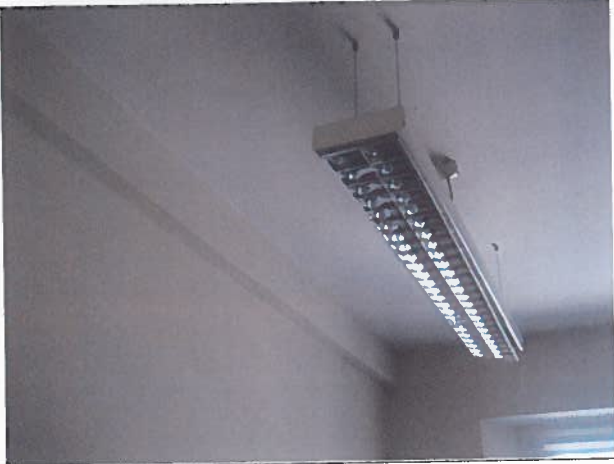
**Photo 17:** Existing room 221 hung strip lights and decorated plaster walls and ceiling.

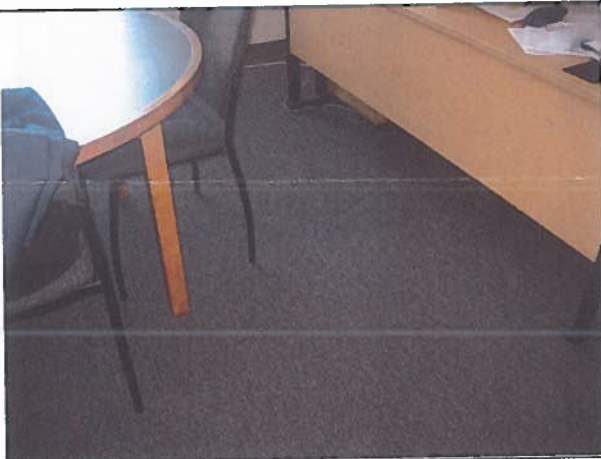
**Photo 19:** Existing room 221 roll carpet floor.

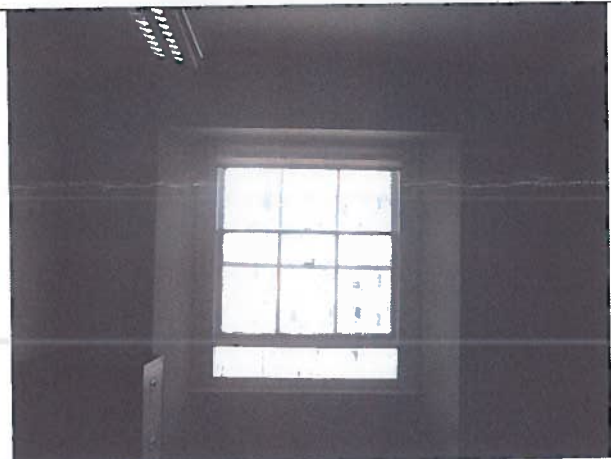
**Photo 20:** Existing room 221 sliding sash timber windows with single clear glazing.
