## Basement Impact Assessment (BIA) – Addendum

**Project:** Gloucester Lodge

**Job No:** 15060

**Date:** 21.09.2016

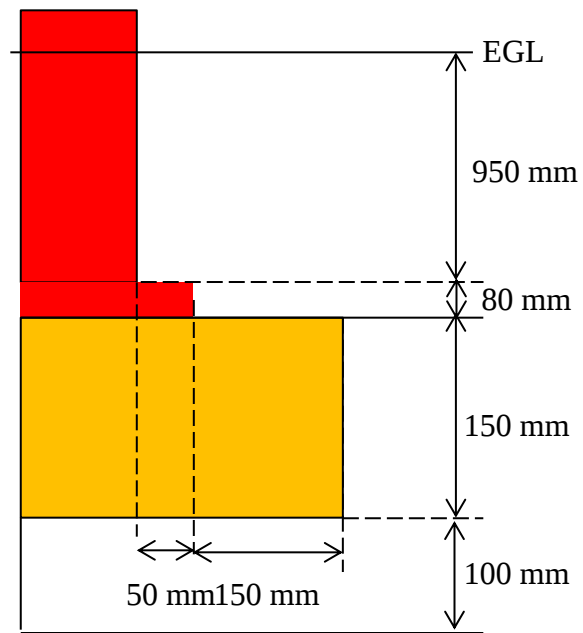
Loose dark brown clayey  
TOPSOIL.

1030 mm

Stiff locally firm light brown  
CLAY. (LONDON CLAY)

150 mm

Encountered 1030mm of topsoil overlying a sandstone footing, the sandstone footing had a maximum thickness of 150mm. London Clay was encountered at 1.03m begl.

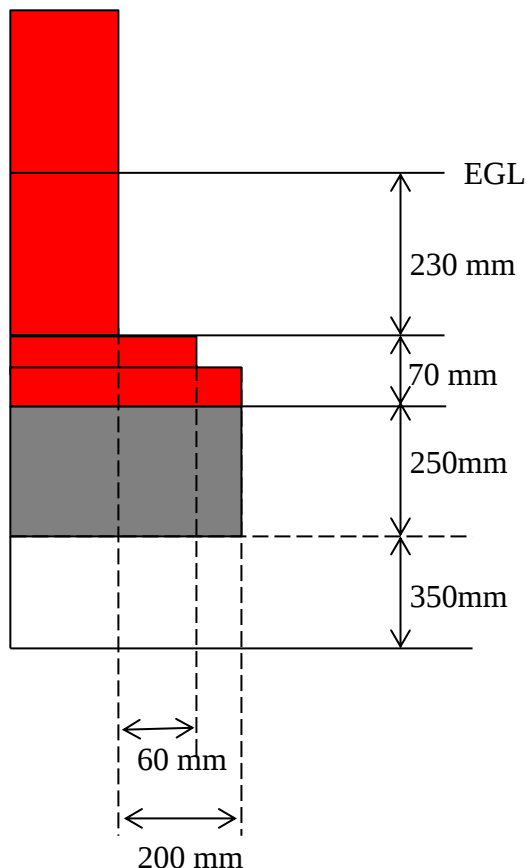
15mm Screed over concrete floor.

Stiff dark brown gravelly CLAY. Gravel is fine to coarse angular to subangular brick, sandstone and quartzite.

Stiff locally firm light brown CLAY. (LONDON CLAY)

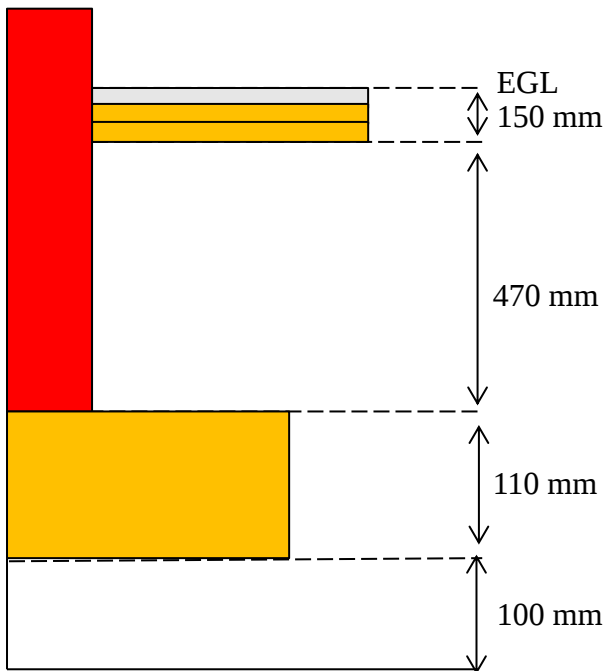
Concrete floor with 30mm of screed over 70mm of concrete and 50mm of sub base.

Stiff locally firm light brown CLAY. (LONDON CLAY)

Encountered 150mm thick unreinforced concrete floor slab comprising, 30mm of screed, over 70mm of concrete with 50mm of sub base. The floor slab was underlain by 470mm of London Clay sitting on a sandstone pad with a maximum thickness of 110mm.

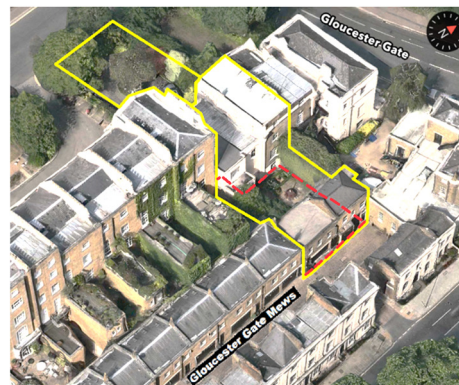
Fig. 1 Aerial view of Gloucester Lodge, dashed line represents extent of basement extension

A single storey basement extension to an existing residential building is to be constructed and is situated adjacent to Gloucester Gate Mews, London. The building neighbours the Mews to the east and existing buildings to the remaining sides as can be seen in the aerial view in Figure 1 below.

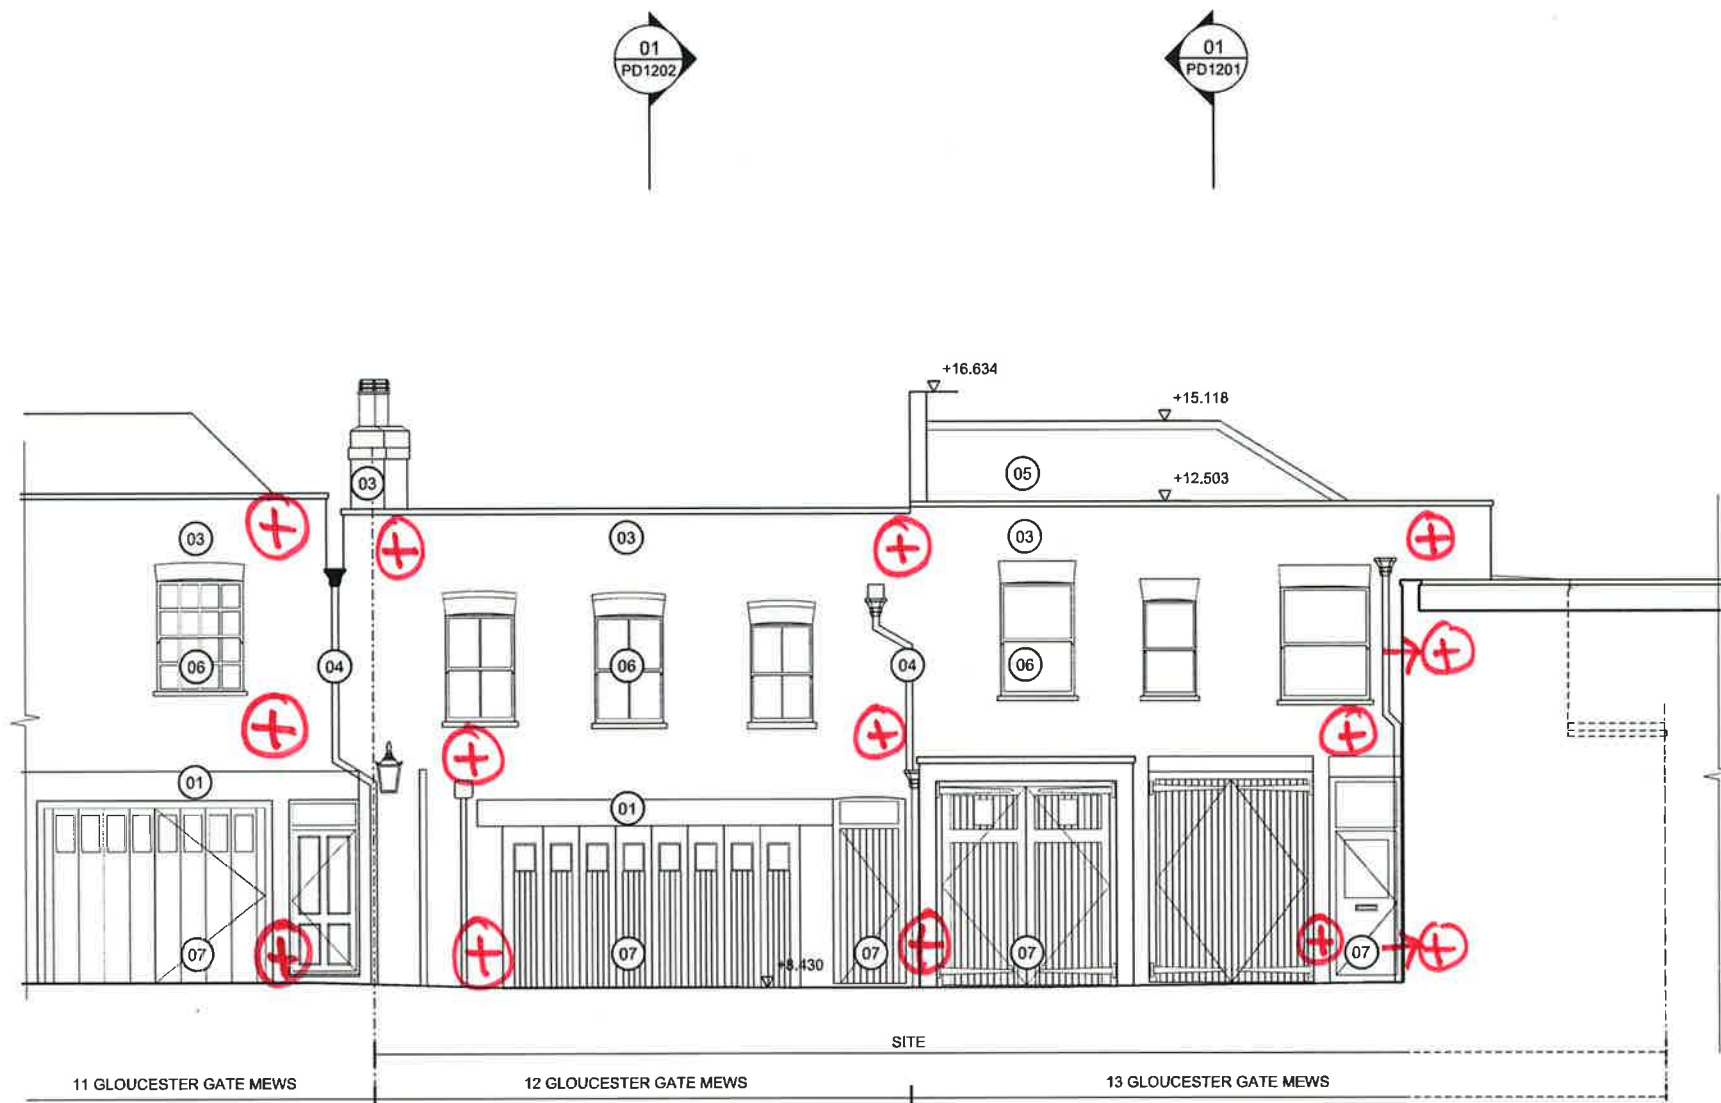
**01** Existing elevation 02  
1:50

- MOVEMENT TO BE MONITORED IN X, Y/Z DIRECTIONS.
- MONITORING STATIONS TO BE INSTALLED PRIOR TO FOUNDATION WORKS

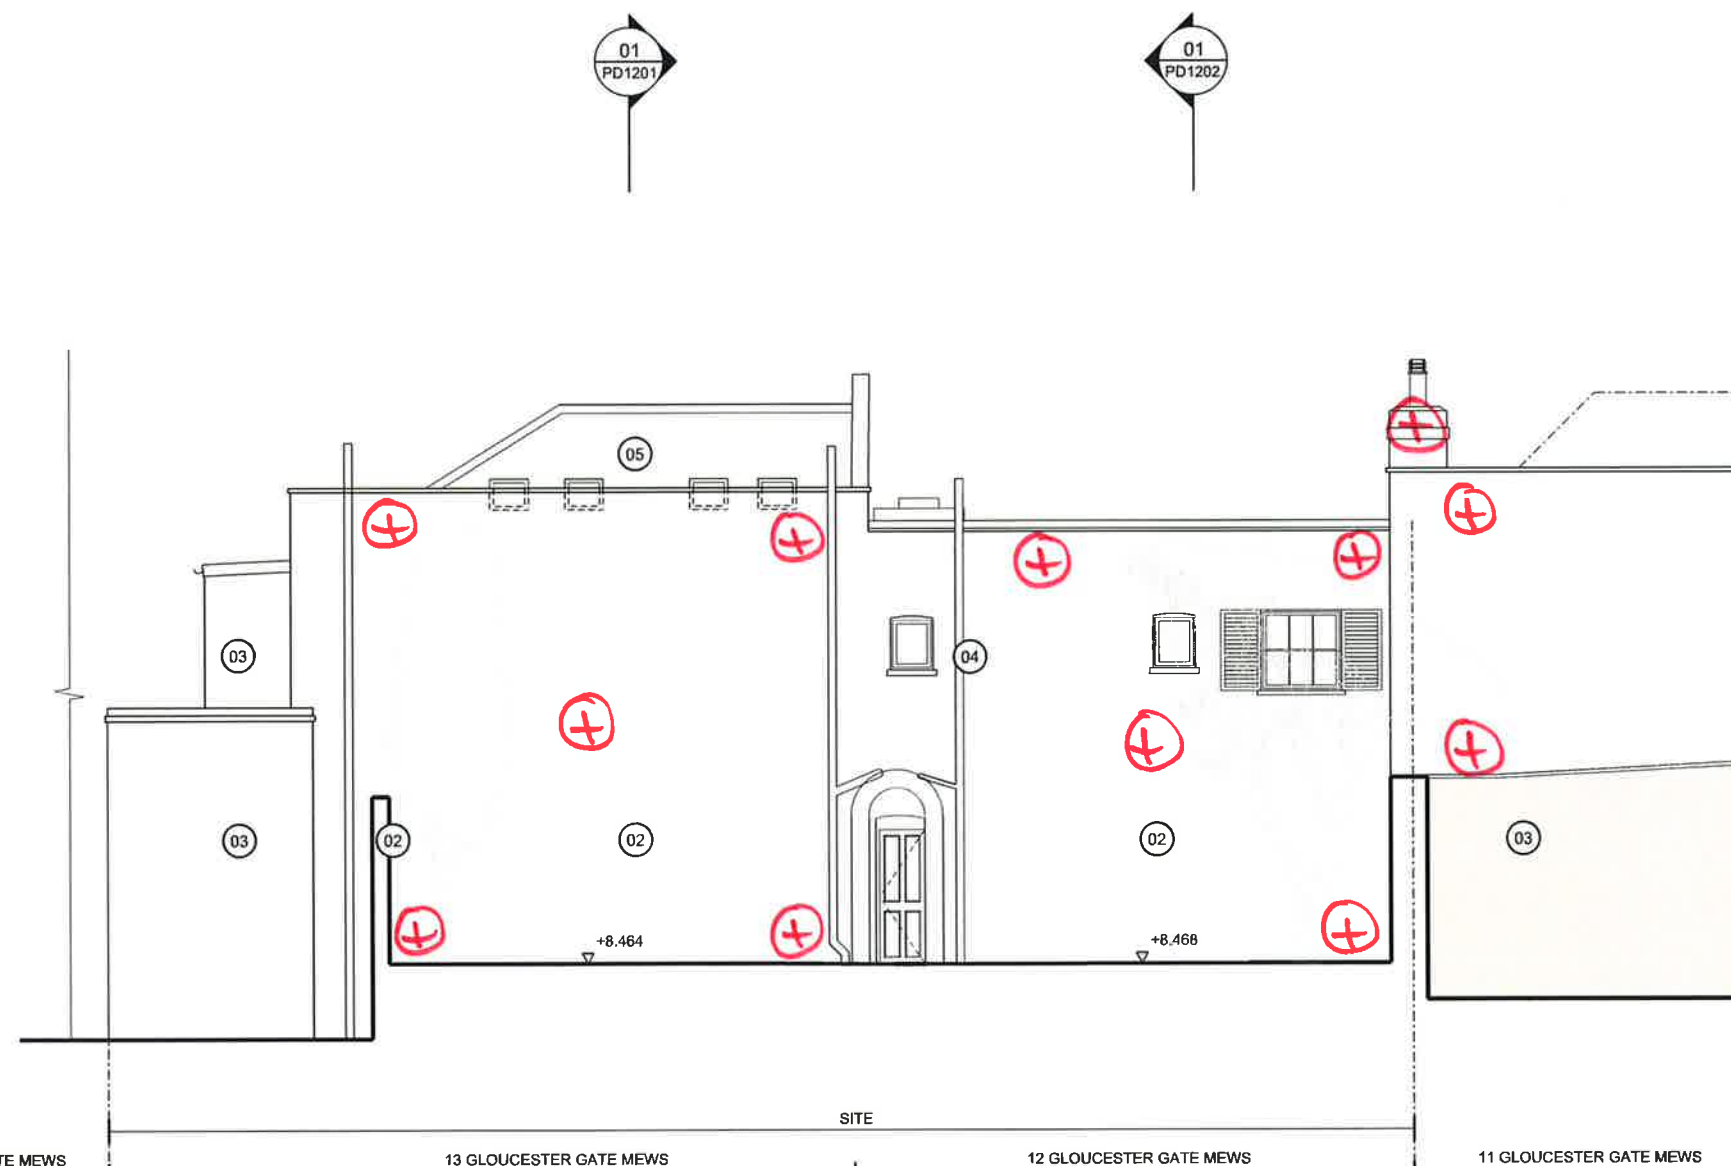
## 01 Existing section D

- ⊕ PROPOSED MONITORING STATIONS
- MOVEMENT TO BE MONITORED IN X,Y,Z DIRECTIONS
- MONITORING STATIONS TO BE INSTALLED PRIOR TO FOUNDATION WORKS
- TO BE READ WITH CORRELATION WITH REPORT IS060/07
