Basement Impact Assessment: Groundwater 63 Goldhurst Terrace, NW6 3HB

Reference: 30161R1D1

The objective of this report is to provide the hydrogeological aspects of a Basement Impact Assessment to support a planning application for construction of a basement at 63 Goldhurst Terrace, NW6 3HB.

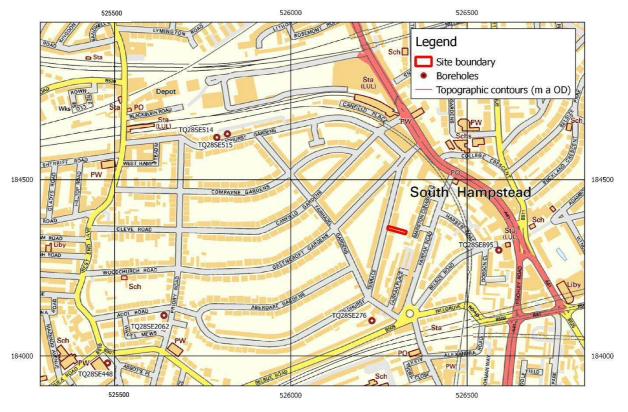
Figure 2.1 Site location
Contains Ordnance Survey data © Crown copyright and database right 2016

Ordnance survey topographic data show the site to lie at approximately 40 m OD contour, with ground elevations falling to the southwest, as shown in Figure 2.1.

Table 2.2 presents geological data from selected BGS borehole records³, and Figure 2.1 shows the location of the boreholes. The local borehole records confirm the presence of Made Ground overlying London Clay.

Background information has been derived from a Groundsure report for the site (Appendix A); geological information has been derived from on-line BGS sources (Geology of Britain Viewer, Geolndex, Lexicon); on-line mapping and aerial photography have been derived from Streetmap and GoogleEarth. Table 2.1 presents relevant background information for the site. The site location is shown in Figure 2.1.

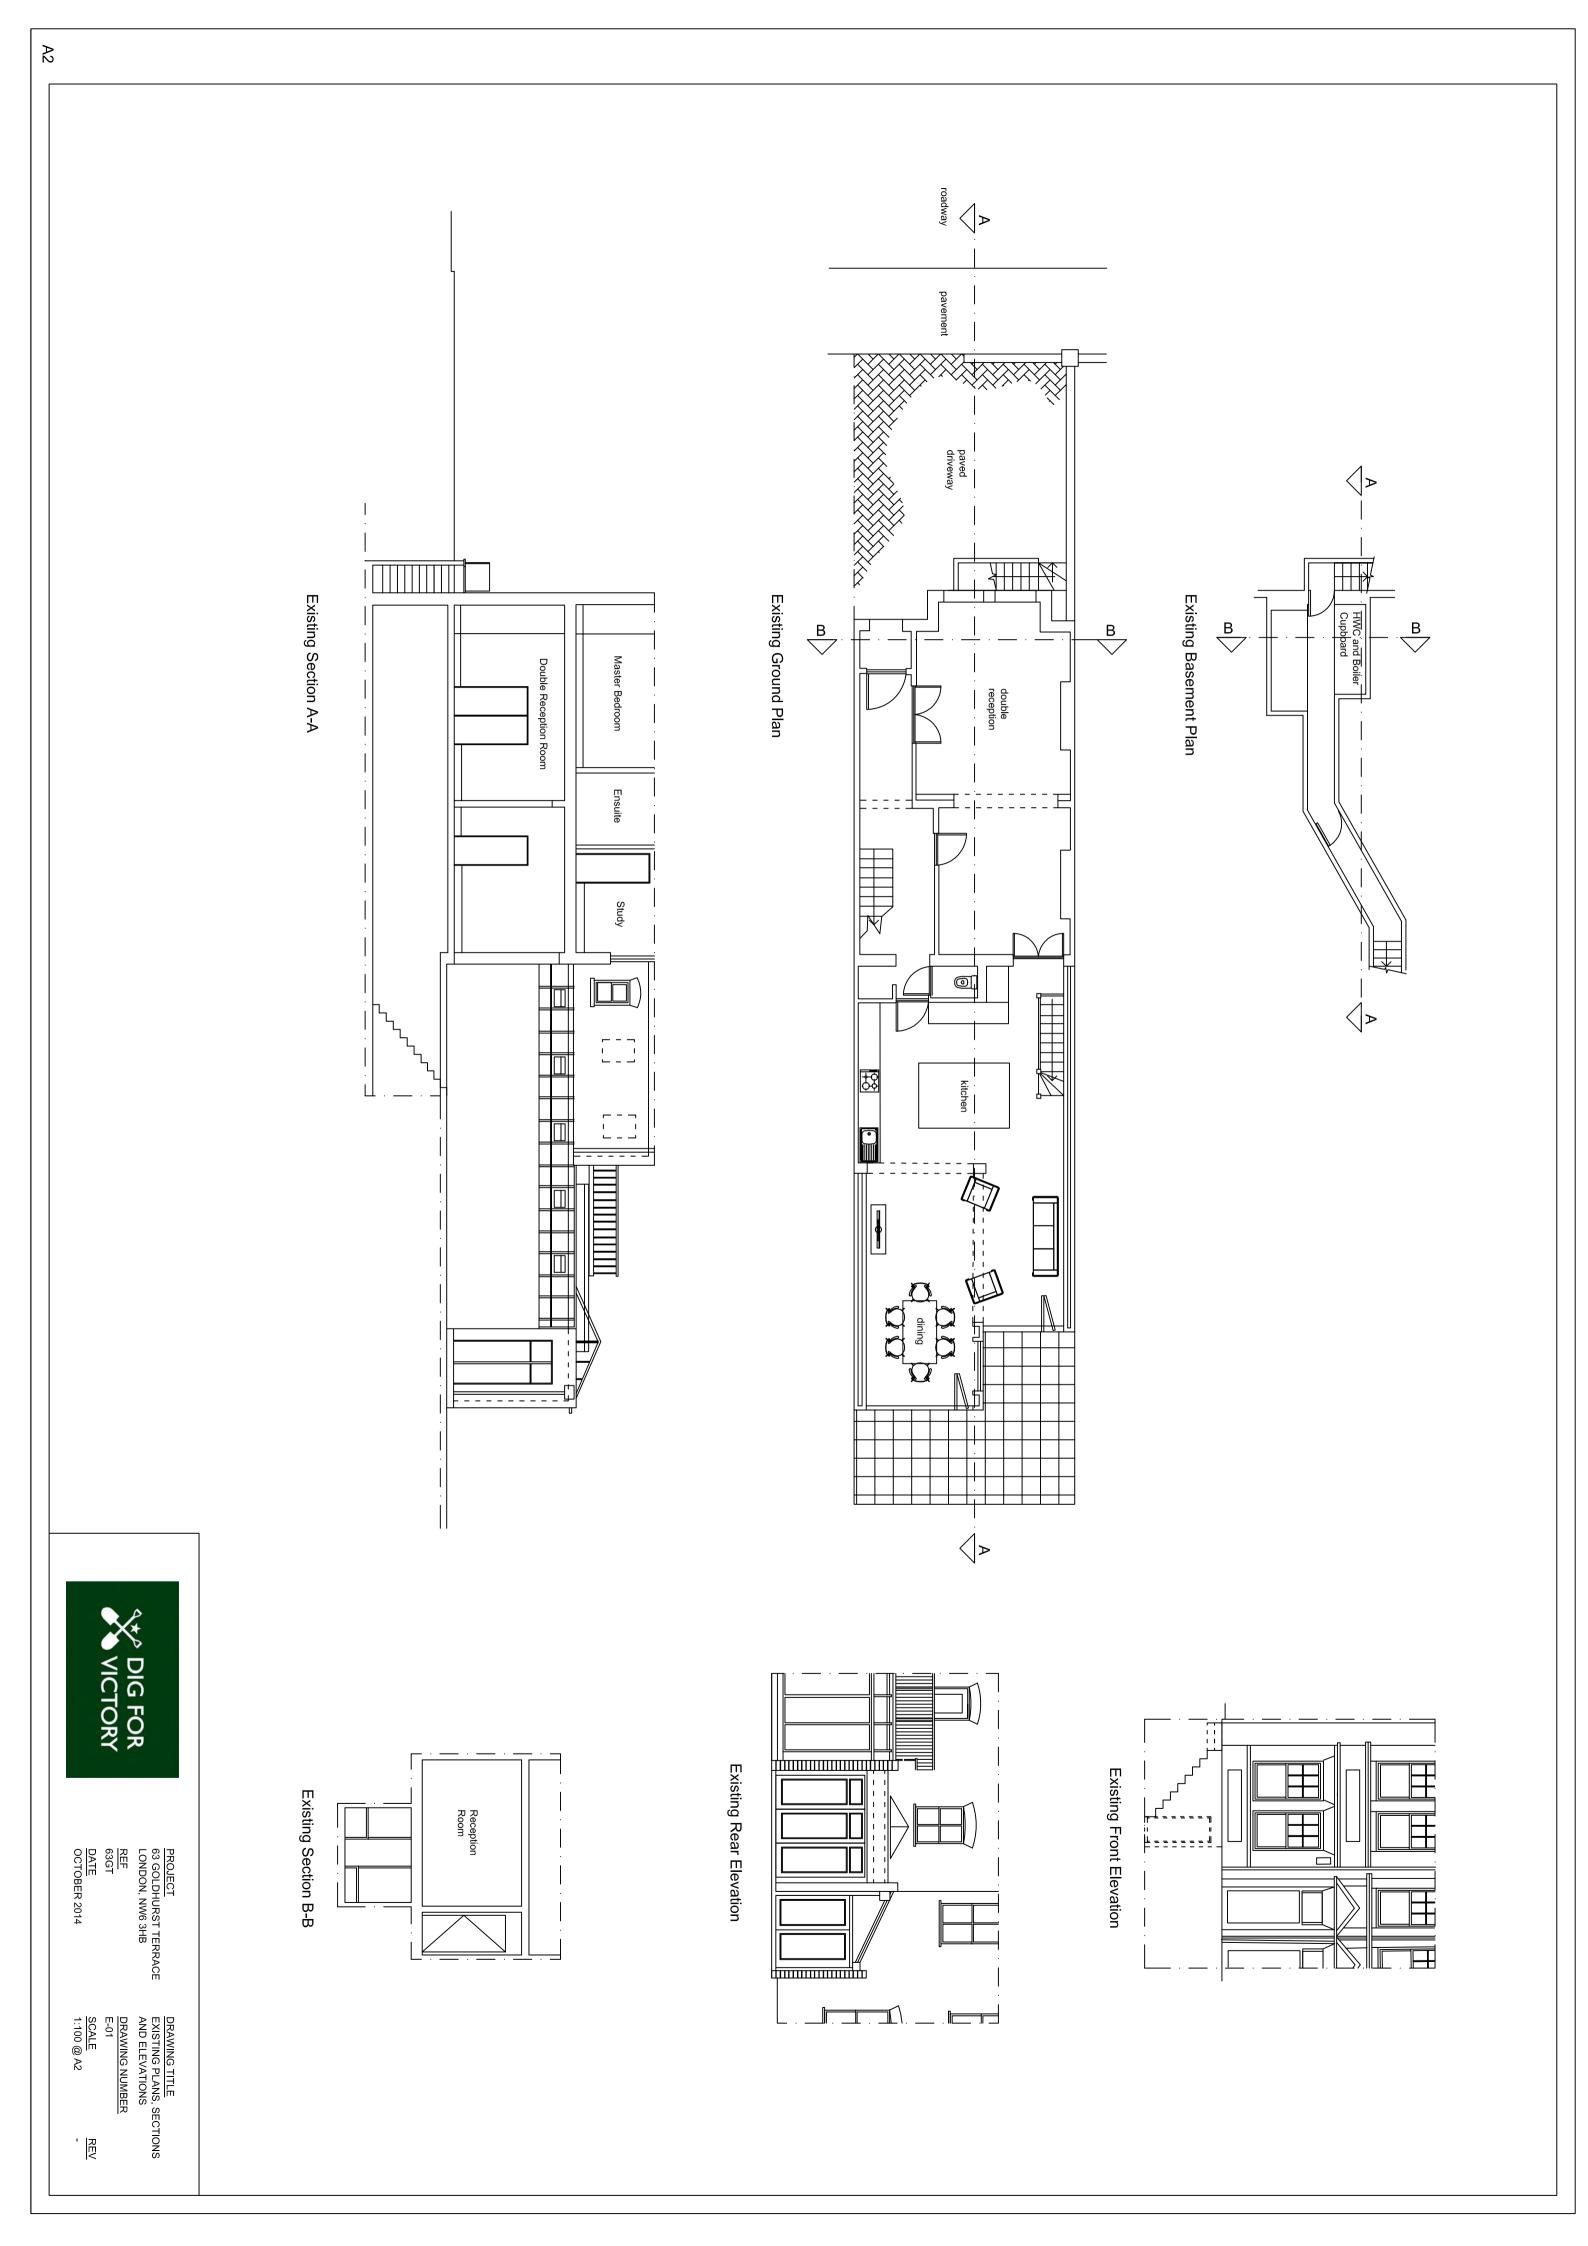
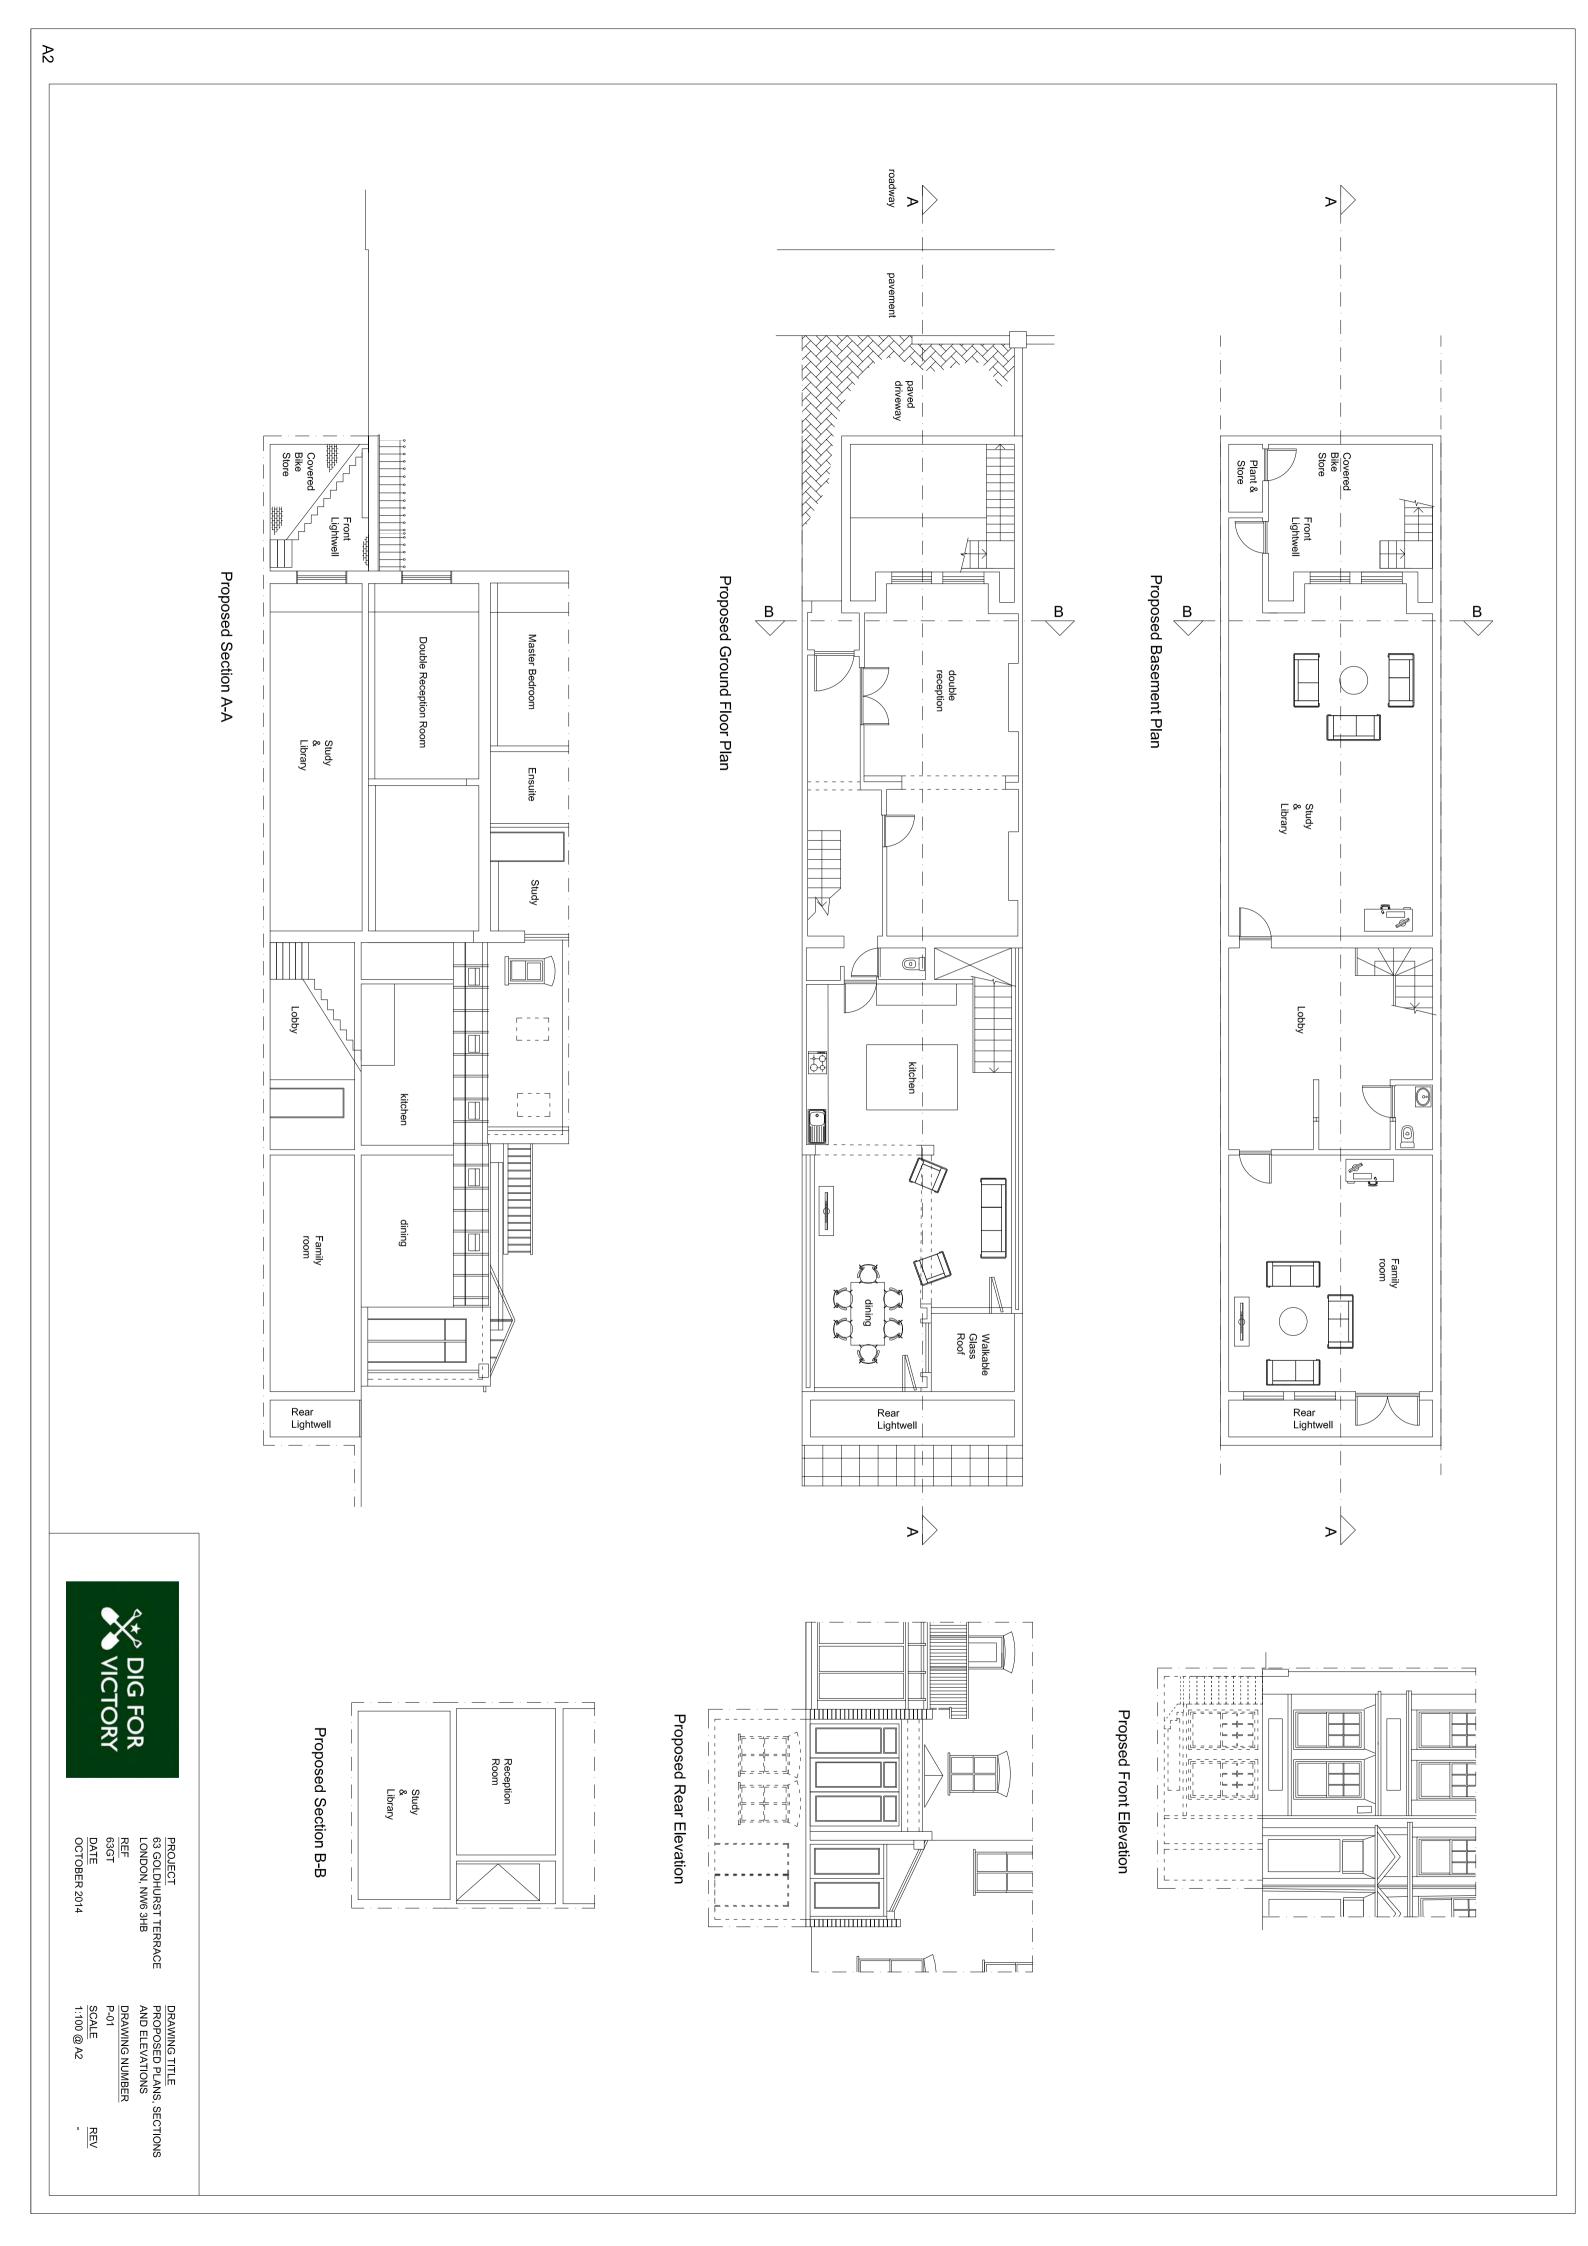
Site Plans

The proposals are to develop a 3 m deep basement below the footprint of the existing property. The external access at the front of the property will be maintained, but the area of the lightwell extended and the access steps realigned. The proposed basement will extend the full width and depth of the ground floor, with a lightwell to the rear. Both front and rear lightwells will occupy an area currently covered with paving.

Site plans are shown in Appendix B.
