125 Shaftesbury Avenue

Arboricultural Development Report

SEPTEMBER 2016

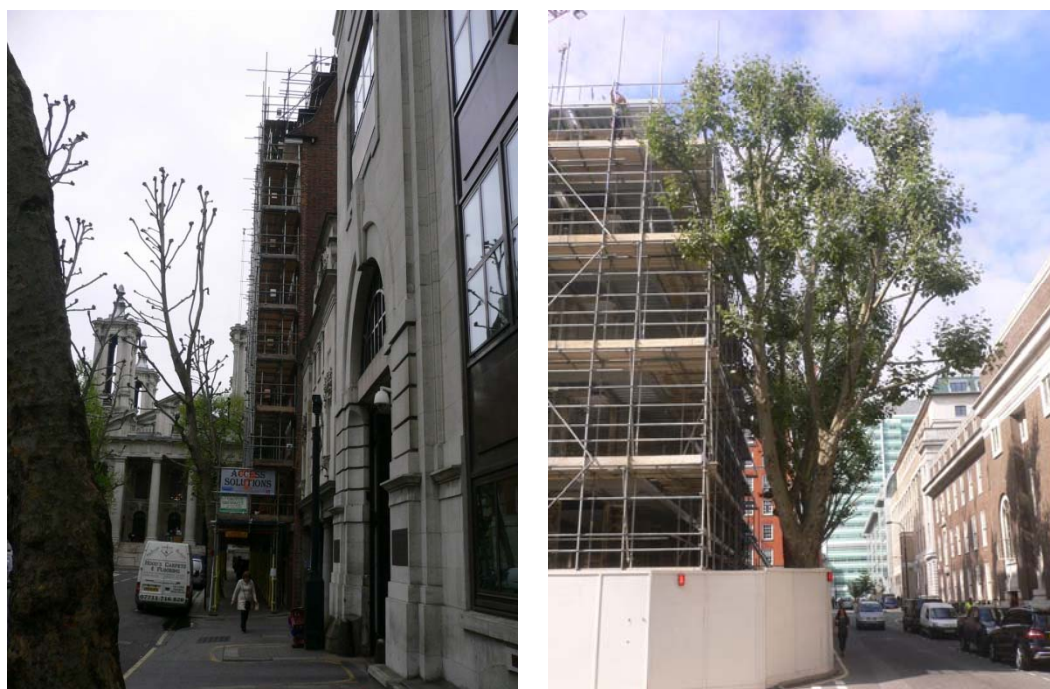
6.9.3 Following pruning, the street trees will be wholly excluded from the site for its duration to avoid physical damage to the tree trunks.

Examples of exclusion are illustrated below

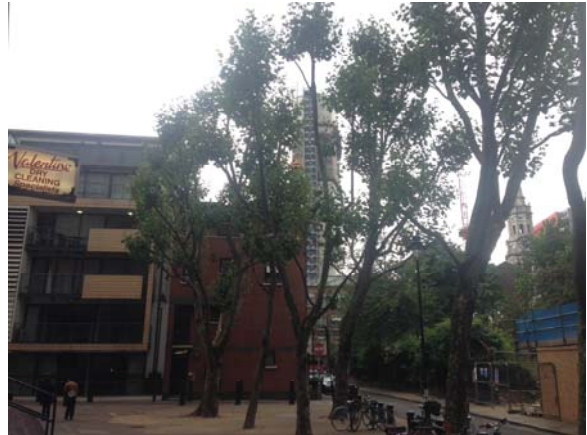
1. General view of London Plane (T1 to T6) located to north east of building within paved open space.

- 5.7 In general, the trees are typical of street tree species with London Plane forming the principal trees.
- 5.8 To the north of the site, six early mature London Planes are located within a block paved amenity space. The trees appear to be of a similar age class and it is therefore likely that they were planted at the same time as part of landscape improvement works or previous redevelopment. All trees are of fair health and display previous cyclical pruning to maintain their crown extents. Located within Stacey Street, the trees are visible from the surrounding road network with restricted views along Phoenix Street from Charing Cross Road. As such, the trees accrue public visual amenity.

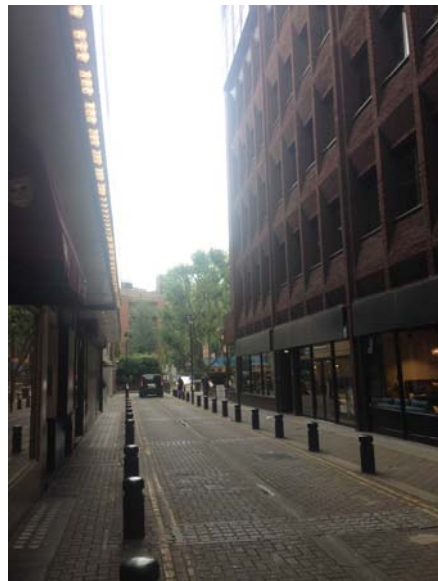
2. London Plane (T6) visible from Charing Cross Road east along Phoenix Street.

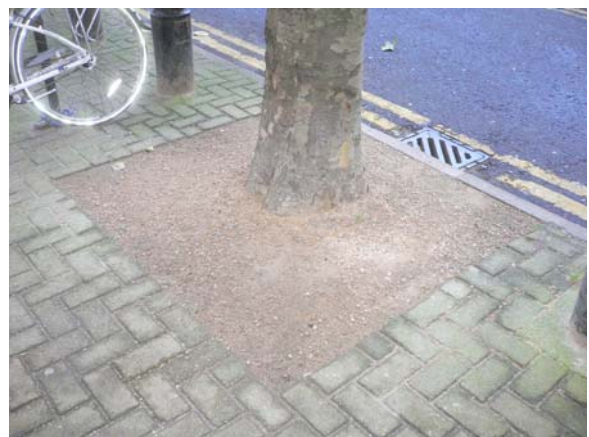
3. Typical tree station detail around London Plane T1 to T6 .

- 5.10 Within the tree group, gullies and manhole covers are visible within the block paving and therefore infrastructure and utilities are likely to be present within the RPA's of these trees.

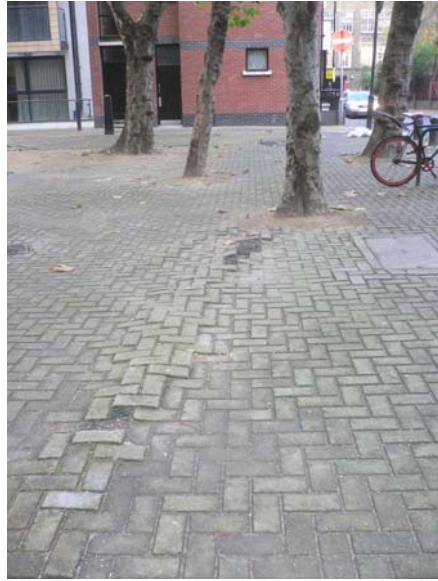
4. Detail view of London Plane (T4) with block paving displaying radial disturbance to south typically characteristic of surface root action.

- 5.11 Similarly, block paving forming hard surfacing within the tree group displays radial distortion. This is typically characteristic of tree root action and it is likely that significant individual surface roots are present just below the block paving. In particular, linear distortion is prominent to the south of T4 and a large surface root extends to the south west of T6 where paving blocks have been removed.

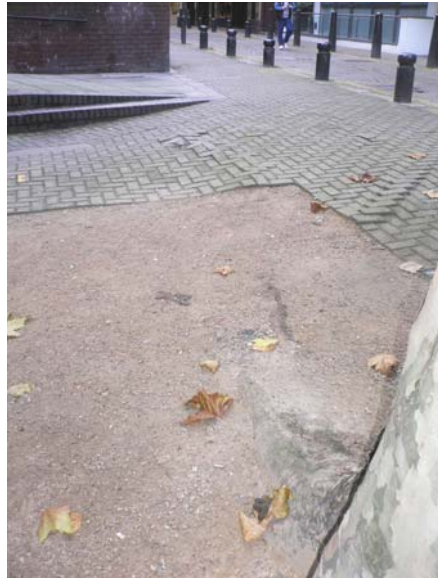
5. Detail view of London Plane (T6) with block paving displaying radial disturbance to west typically characteristic of surface root action..

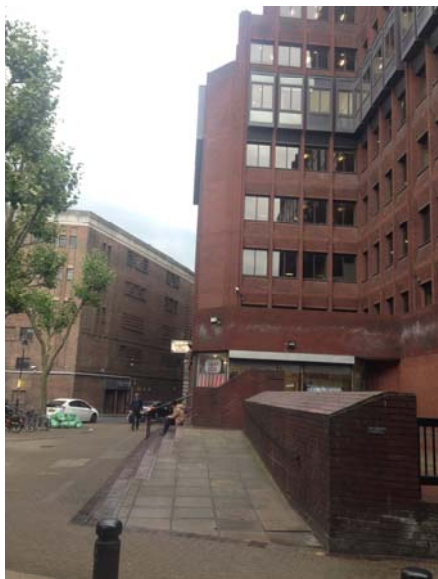
6. Detail view of existing plinth forming basement adjacent amenity area (Stacey Street).

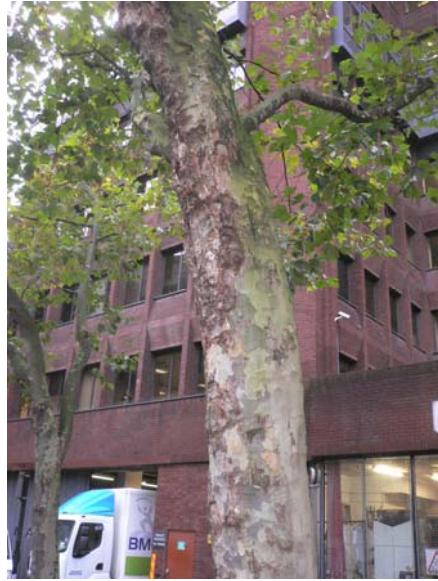
7. Detail view of typical vehicle damage on highway side 3m a.g.l.

- 5.14 Due to the influence of the building, the inclined trunks over the highways have been subject to occasional vehicular damage with the majority displaying significant damage on their leeward side.

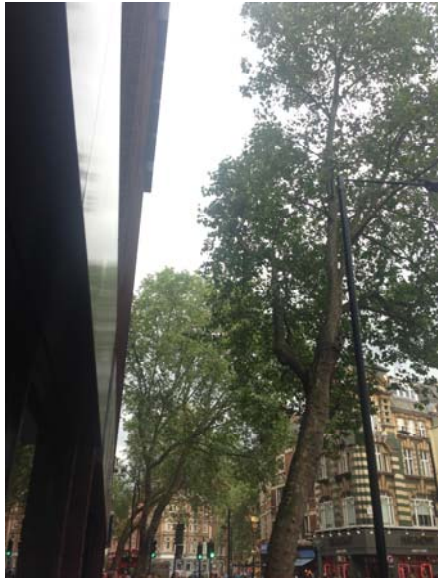
8. General view of London Plane within Charring Cross Road inclined to west over highway due to proximity of buildings.

- 5.12 To the south east and west of the building, London Planes are located within the footway adjacent to Charing Cross Road and Shaftesbury Avenue. These trees are mature and inclined to the highway due to the proximity and influence of the adjacent building. Located adjacent to a main thoroughfare, the trees accrue significant public visual amenity.

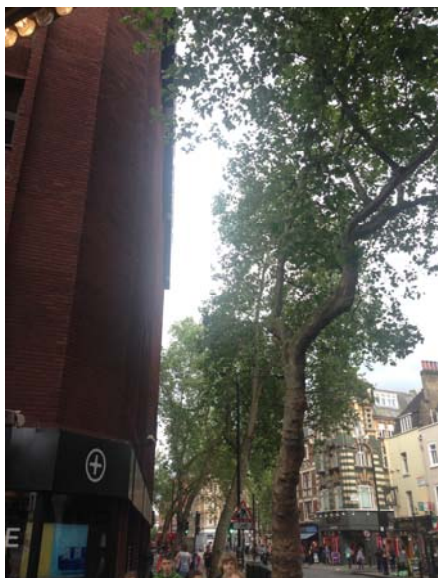
9. Detail view of London Plane (T8 to T11) displaying asymmetrical crown architecture and maintained clearance to building.

- 5.13 From visual observation, the tree's architectural form has matured in response to their urban environment and are inclined to the highway. The trees display an asymmetrical crown with limited major scaffold branches on the profile located adjacent to the building elevations. The trees appear to be regularly managed and as such reasonable clearance of between 1.5m to 2m to the building is maintained.
